2020 DEPRECIATION REPORT
FOR
ARBUTUS VILLAGE
PARKWAY DRIVE,
SPRINGTREE DRIVE, AND
ARBUTUS STREET, VANCOUVER

November 3, 2020

Sense's Project No. 20vA015A

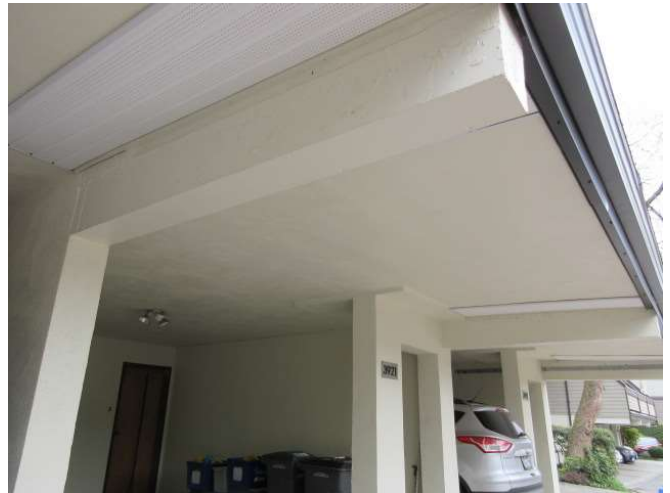
Photo 1: Typical concrete framed parking areas at Buildings 1, 3, 5 and 7.

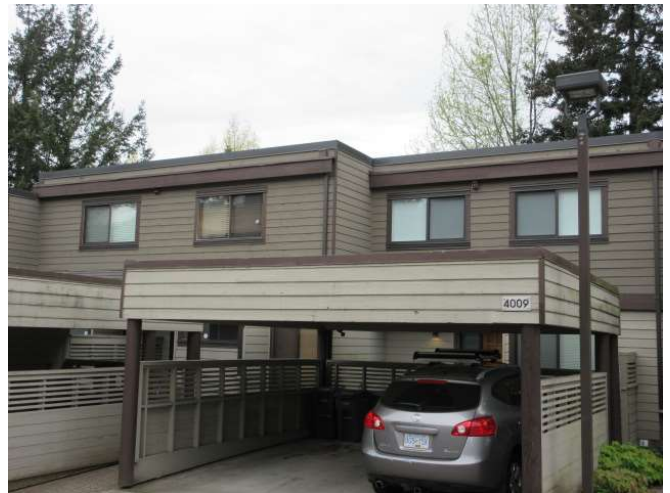
Photo 2: Typical carport at Buildings 2, 4, 6, 8, 11, 13, 15, 17, 19 and 21.

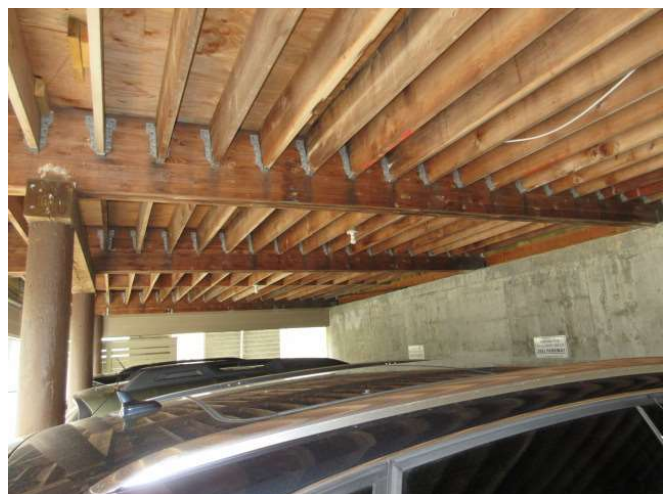
Photo 3: Parking area below the pool lounge.

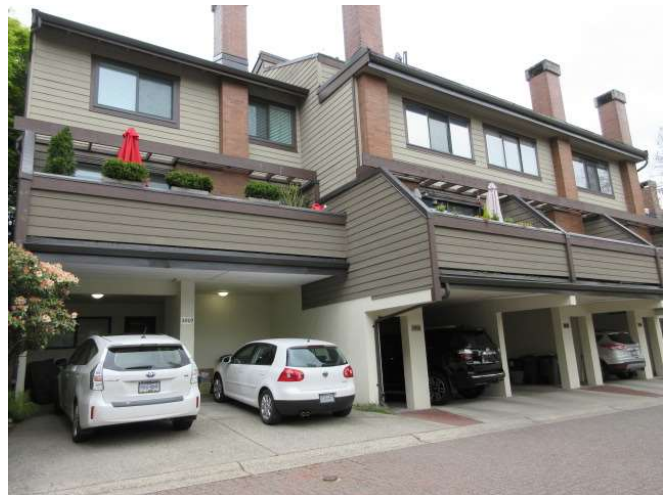
Photo 4: Typical balconies at building 1.

We were not made aware of any significant problems with any particular balconies. The Strata has proactively maintained and repaired the balconies over the years, including replacement of waterproofing and guards. However, waterproofing at most of the balconies is believed to be 17 years old, or more.

It is imperative that the balcony waterproofing be maintained water-tight and replaced well before the waterproofing is no longer effective as significant deterioration of the structural components supporting the balconies can occur if there is leakage through or at the perimeter of the waterproofing. Structural damages to the framing below the waterproofing can significantly increase the cost of repairs.

The projected expenditures include for a detailed assessment of all balconies to provide the Strata with an accurate accounting of the present condition of the balconies and a recommended phased program of future repairs and replacement work.

Pending results of the balcony assessment, the projected expenditures include for a phased program of re-waterproofing the balconies and wood decking based on pricing received from Variant. Localized repairs to the structural elements should be expected. We assume that only about 70% of the wood decks will require replacement by the Strata, since about 30% of the decks would be individual unit owner responsibility due to upgrades made by the owners.

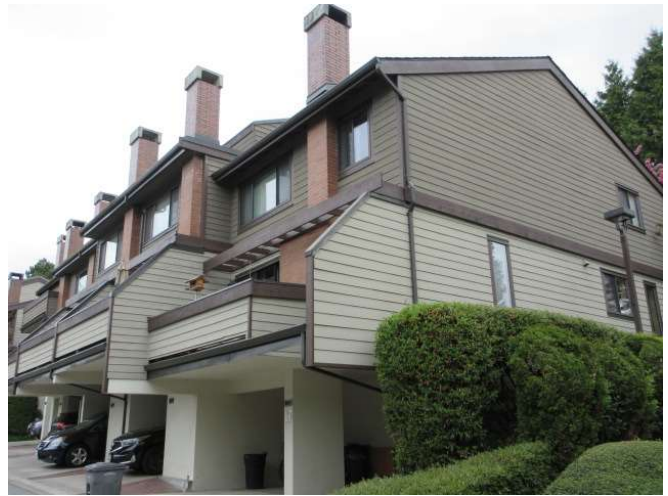
Photo 5: Typical exterior walls.

Some areas of original wood siding are showing signs of wear and rot. One area of more extensive wear and rot is the north elevation of 4009 Parkway Drive.

- Repaint exterior walls in 2025 at an estimated present day cost provided by Variant of \$450,000.
- Replace existing siding with fibre cement siding at building 1 (south), building 8 (south) and building 17 (north) in 2023 at an estimated present day cost provided by Variant of \$155,000, and similarly three more walls in 2033.

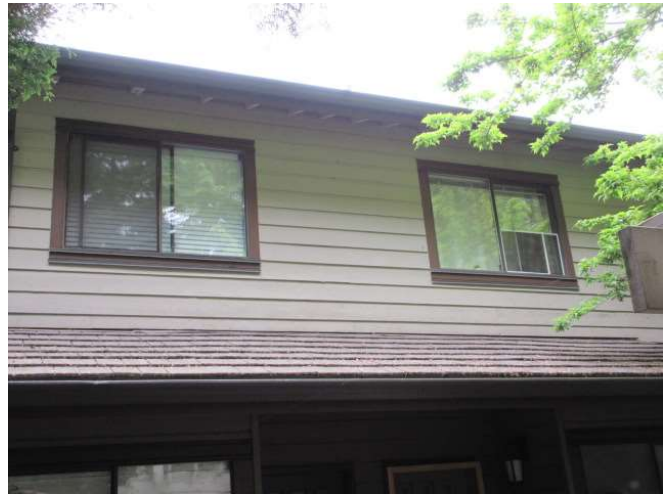
Failure of IGUs can be expected to start occurring after about 10 to 15 years of service and the frequency typically increases with age. We expect that failed units will be replaced on an as-needed basis funded out of operating budgets. We also expect that weatherstripping and window and door hardware will be replaced on an as-needed basis funded out of operating budgets.

Photo 6: Typical windows.

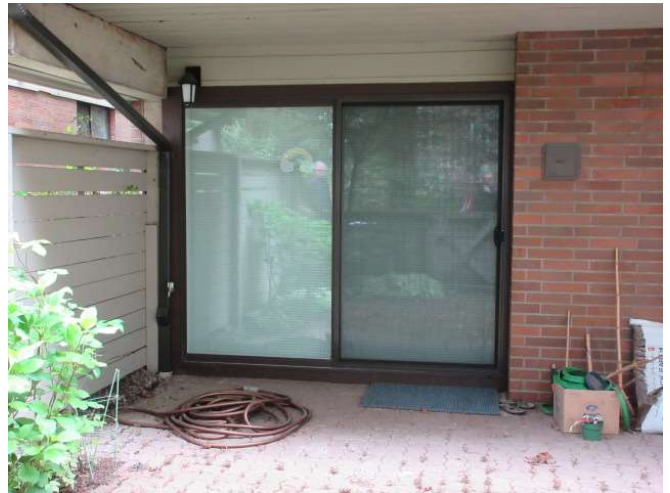
Photo 7: Typical patio door.

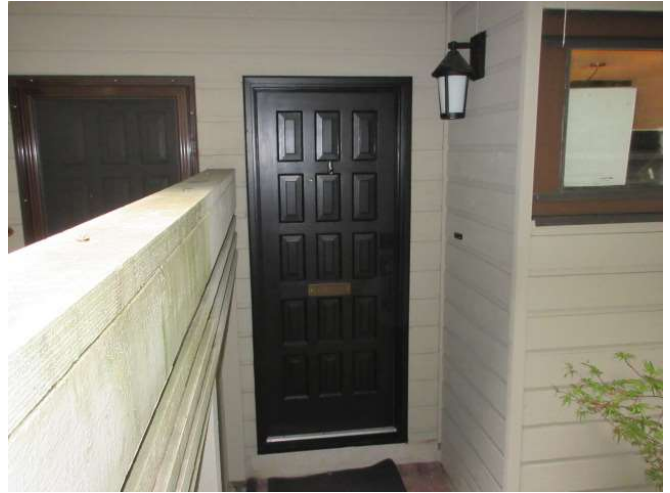
Photo 8: Typical exterior entrance doors.

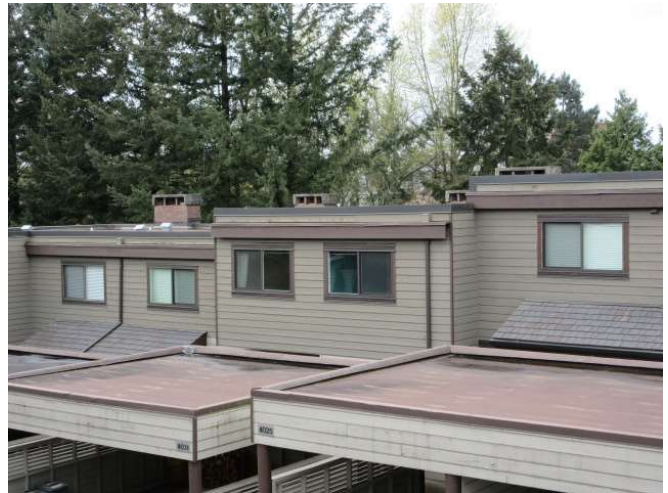
We were not made aware of any current problems with the roofs.

Photo 9: Typical flat roofs over the buildings and carports.

Exposed modified bitumen roofs in the Lower Mainland climate tend to have a serviceable life of 20 years before requiring replacement. Uninsulated roofs such as over the carports and roof decks protected by wood decking tend to have a slightly longer service life.

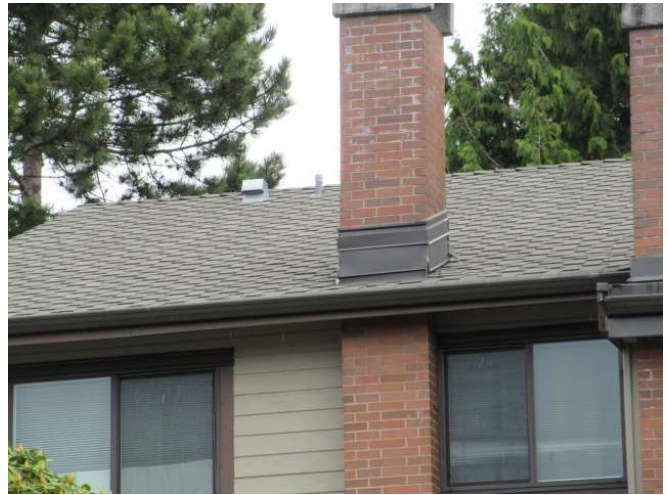
We were not made aware of any current problems with the roofs.

Photo 10: Typical sloped roof with asphalt shingles.

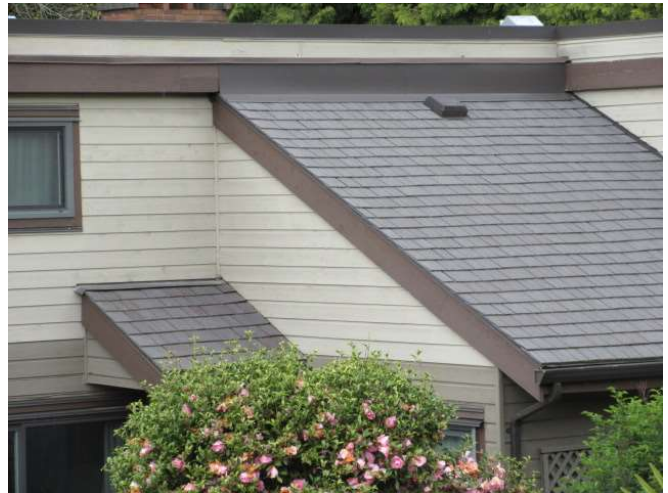
Photo 11: Sloped roofs with Enviroshake shingles at building 15.

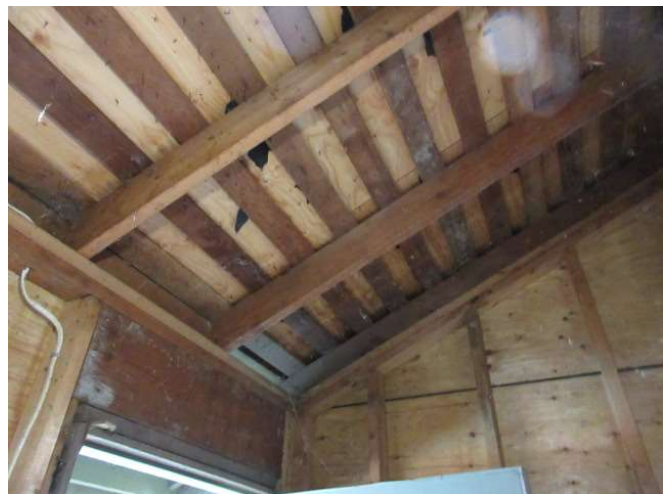
Photo 12: Underside of roof in pool house with original wood strapping and plywood sheathing over top.

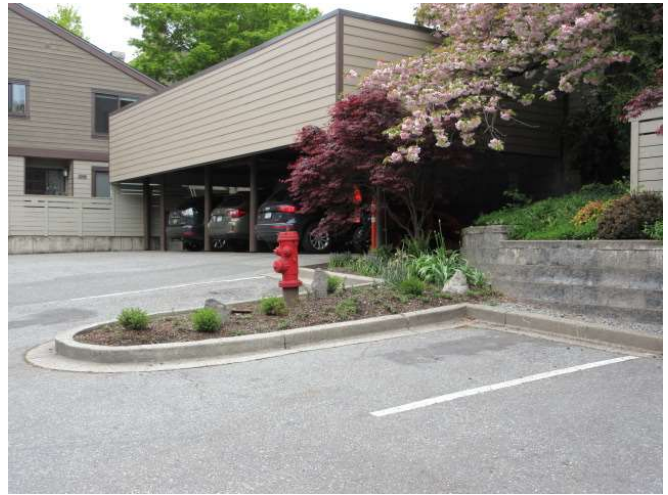
The fire hydrant on the site is inspected annually and torn down and re-built every few years by Fraser Valley Hydrant Services. Although fire hydrants can last over 100 years, the gaskets and seals typically harden, fail and become obsolete after 50-60 years, often requiring replacement of the hydrants. That said, some seals can last longer than others, and there are some hydrants that are over 100 years old and still in service. We do not expect replacement of the hydrant to be required within the term of this report; however, an item to replace the hydrant may be required to be brought into the Depreciation Report as part of future updates. We assume that annual fire hydrant maintenance (such as lubrication of the head mechanism and replacement of gaskets), will be completed as part of routine maintenance funded out of operating budgets.

Photo 13: Fire hydrant opposite the north-west corner of unit 4035 Springtree Drive.

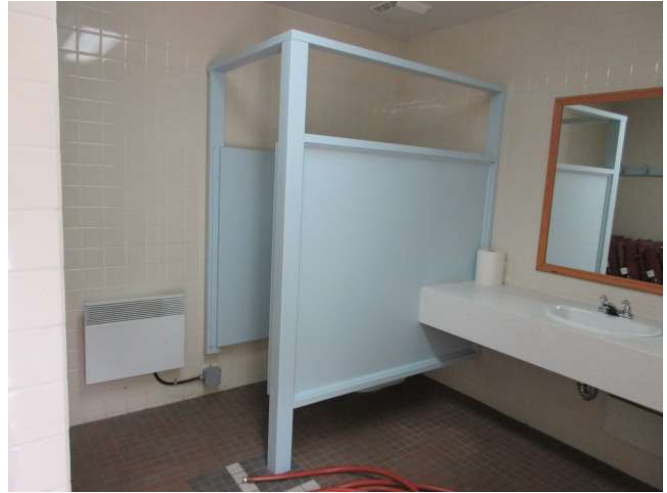
Photo 14: Typical change/washroom in the pool house.

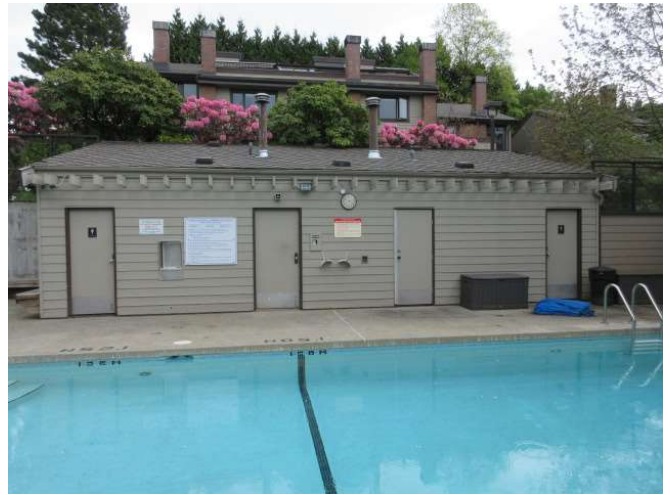
Photo 15: Pool area and pool house.

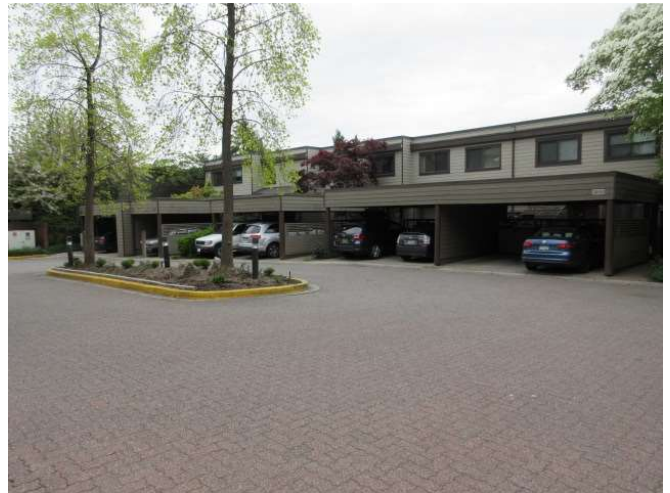
Photo 16: Typical paving.

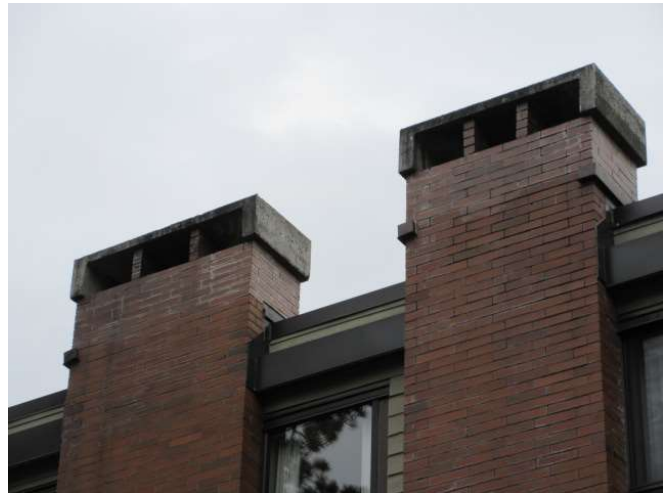
Photo 17: Typical fireplace chimneys.

We understand that less than half of the fireplaces are in use. We were not made aware of any problems with the fireplace chimney flues. All chimney flues should be inspected (camera surveyed). Wood burning chimney flues can be problematic and eventually require replacement. When replacing flues, fire separation problems are often found which can add significantly to the flue replacement costs. These problems tend to arise because the chimneys are typically placed against a demising wall, creating an atypical section of wall construction, which often gets built incorrectly. The Strata is not aware of any issues, but pending results of the recommended survey, the projected expenditures include a periodic allowance for eventual phased flue replacement, but we have not included any extensive allowances related to fire separation repairs. We recommend that a mock-up be completed in advance of general replacement to identify issues before the competitive tendering process. The extent of required replacement and associated costs should be monitored and projected expenditures updated as part of future updates to the Depreciation Report.

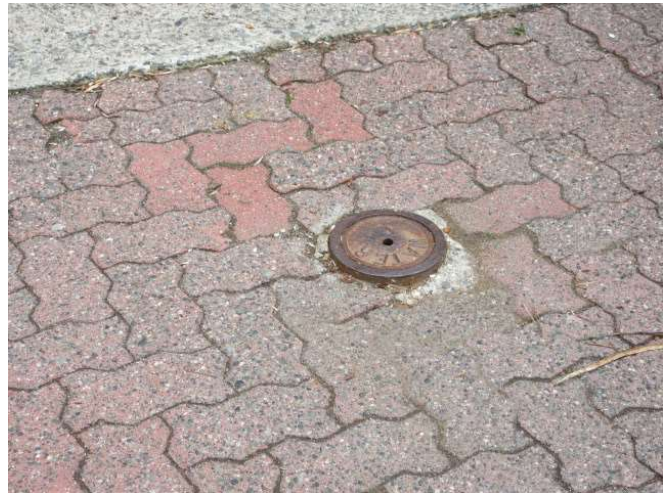
Photo 18: Typical water shut-off from the main supply line.

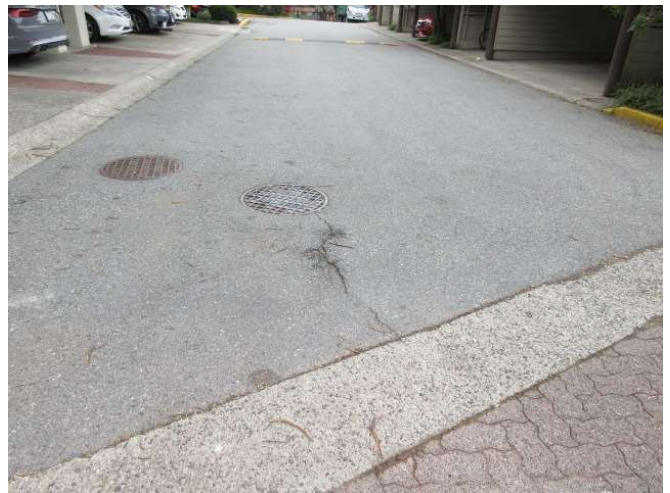
Photo 19: Typical sanitary sewer manhole covers.

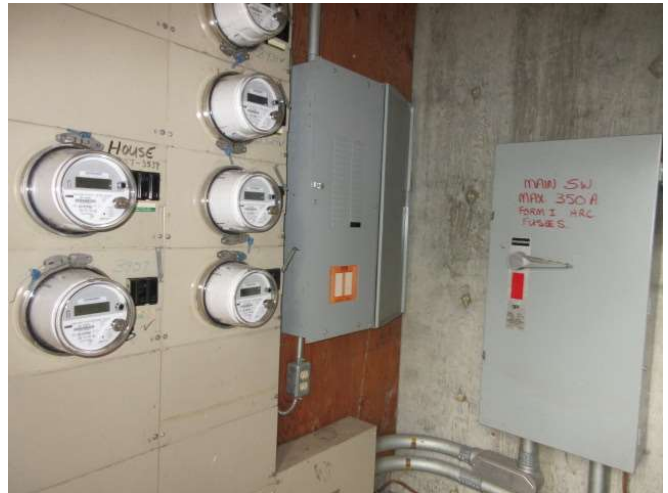
Photo 20: Typical electrical room.

We recommend that all electrical panels and major equipment be thermally scanned every few years to identify hot spots that require repair. The scans and related repairs found to be needed (minor tightening, etc.) are assumed to be an operating expense.

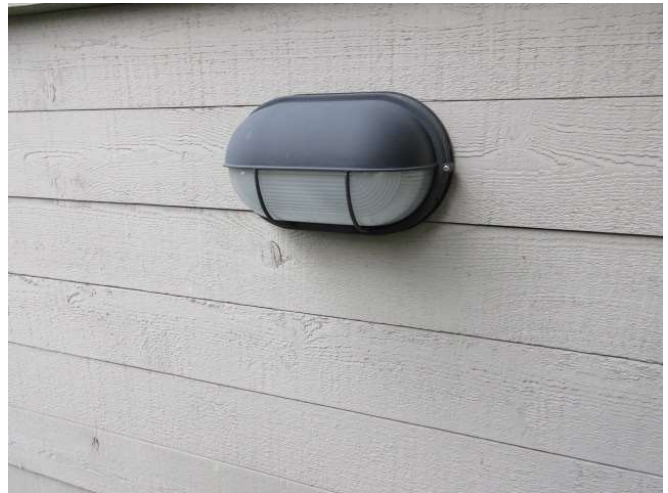
The lighting fixtures, where reviewed, are in serviceable condition. Exterior lighting levels were not measured as our review was completed during daylight.

Photo 21: Typical new lighting installed at the walkway along Arbutus Street.
