BC BUILDING SCIENCE

611 BENT COURT, NEW WESTMINSTER, B.C., V3M 1V3, TEL: 604-520-6456, FAX: 604-520-6496
BUILDING ENVELOPE & STRUCTURAL CONSULTANTS - WWW.BCBUILDINGSCIENCE.COM

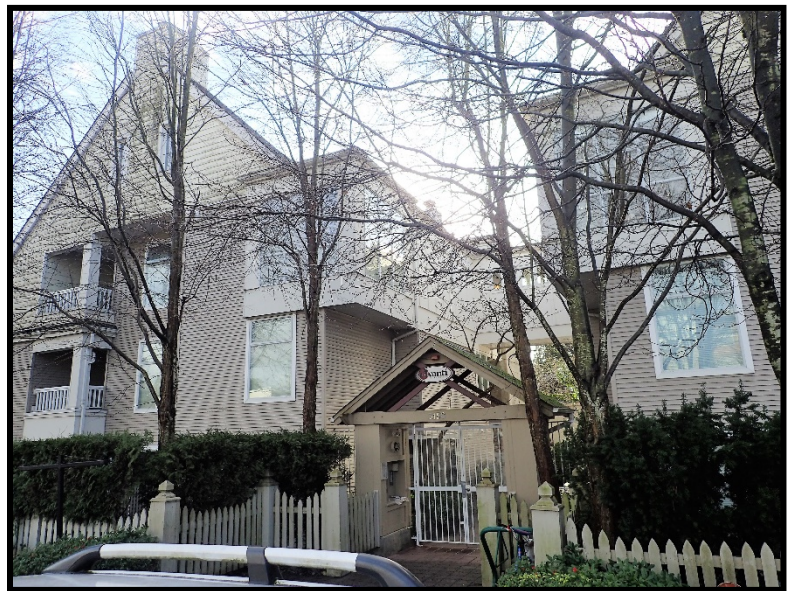
This report is prepared for the Owners, for the current Owners' information and may not be used or relied upon by any other person, unless that person is specifically named by us in this Agreement as a beneficiary of the Report, in which case the Report may also be used by the additional beneficiary we have named. You agree to maintain the confidentiality of the Report and reasonably protect the Report from distribution to any other person. If you directly or indirectly cause the Report to be distributed to any other person, you agree to indemnify, defend, and hold us harmless if any third party brings a claim against us relating to our inspection or the Report.

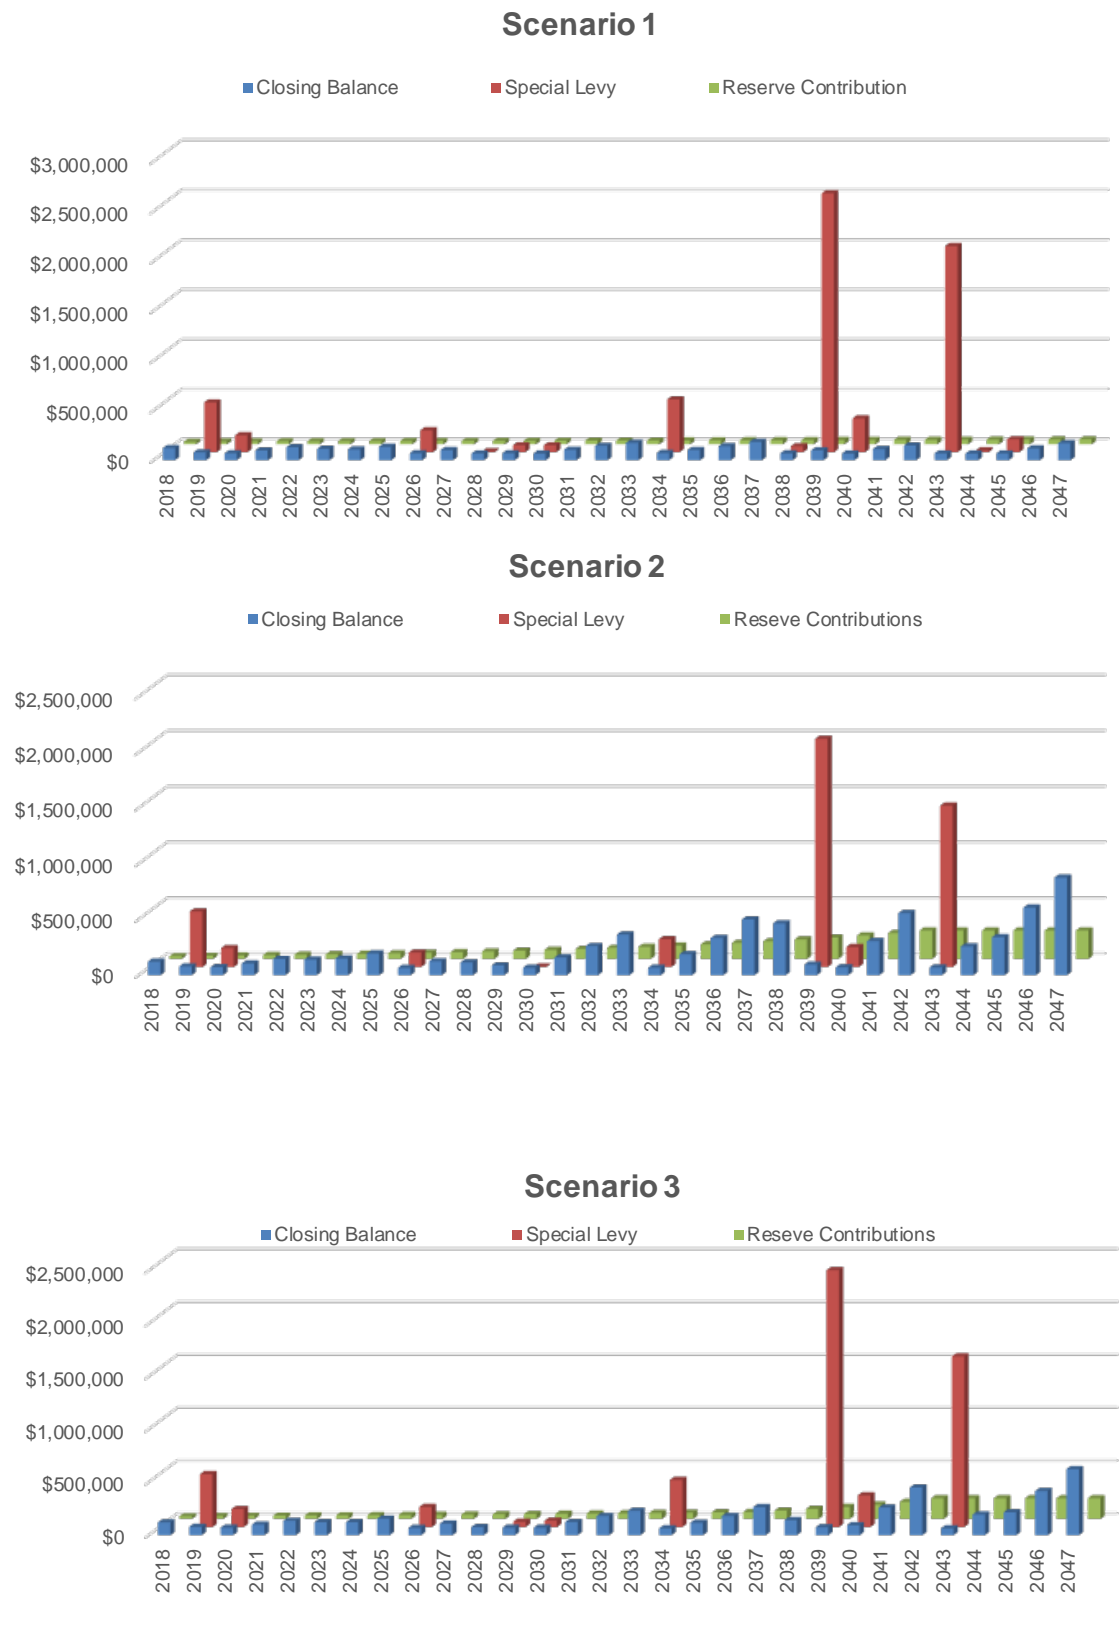
Below we provided financial projection summaries, prepared as recommended in the Financial Analysis section, including summary of the relevant cash flow and expenditures for the first five years based on the recommended Scenarios. Please note that the “Annual Increase” is only refer to the amount contributed each year to the reserve fund from the monthly common expenses. We recommend that interested readers go directly to the Financial Analysis section of this report for more detailed information.

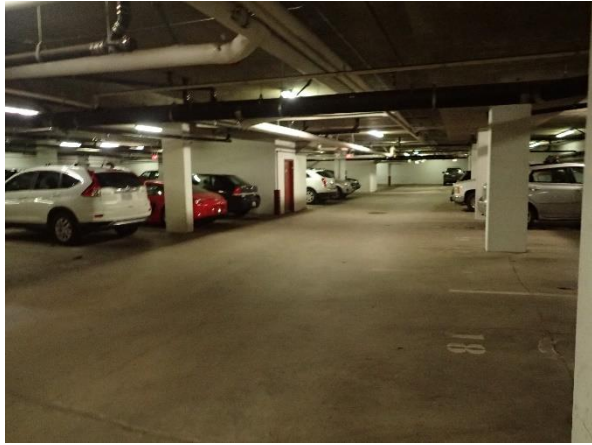
Physical Assessment:

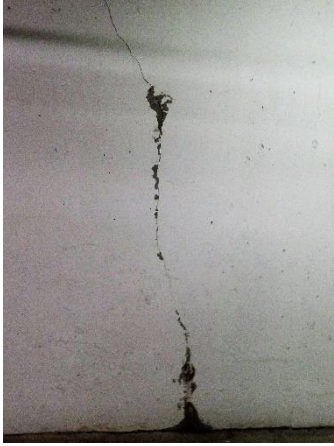
Photo 1: A crack noted in the concrete foundation wall at Stall #72. Monitor the crack and if widen repair as required.

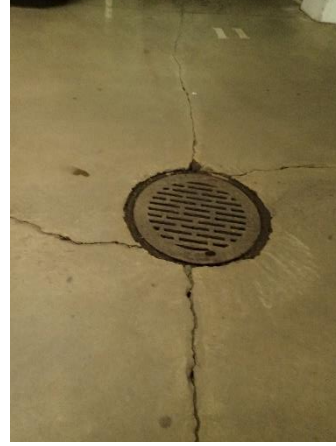
Photo 2: Noticeable cracks observed in slab on grade around the drainage that need to be repaired.

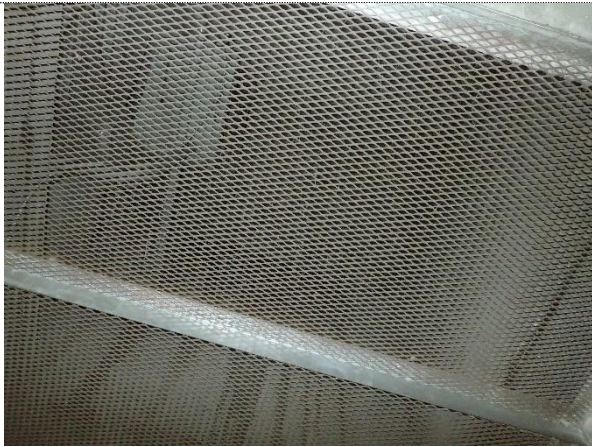
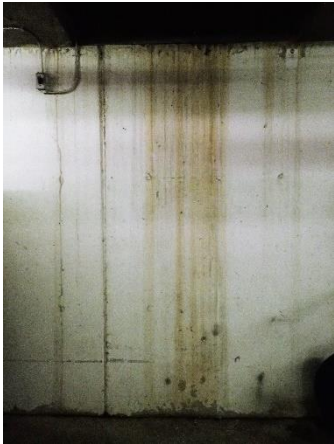
Photo 3: Staining noted on the concrete foundation wall at Stall #57 behind the parkade exhaust fan. Remove staining and monitor if reoccurs, repair as required.

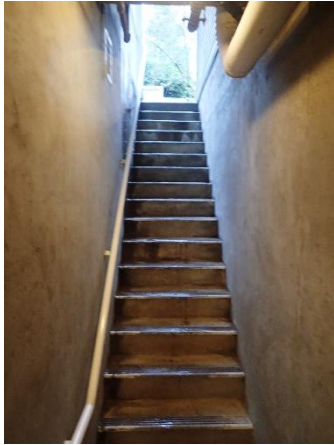
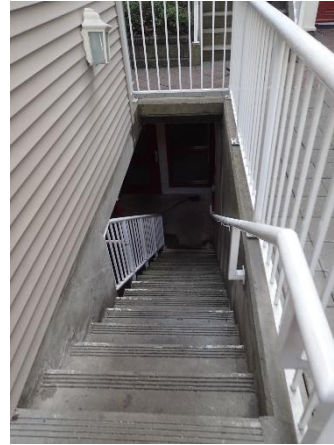
Physical Assessment:

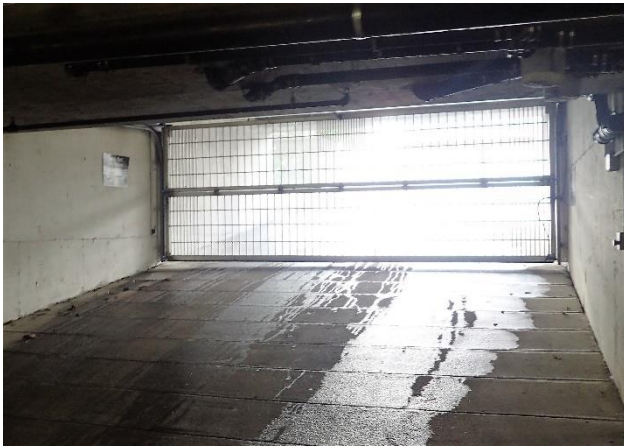
Physical Assessment:

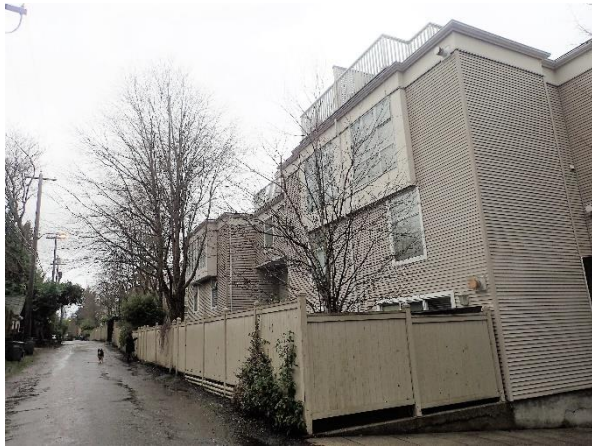
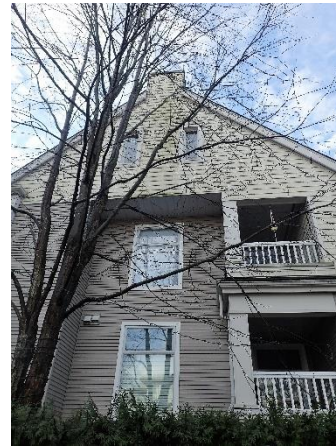
Physical Assessment:

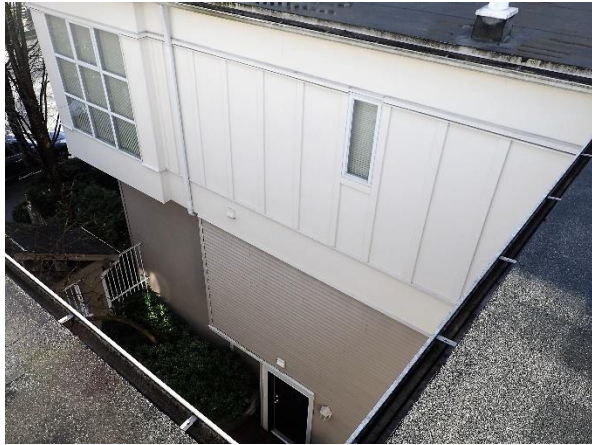
Physical Assessment:

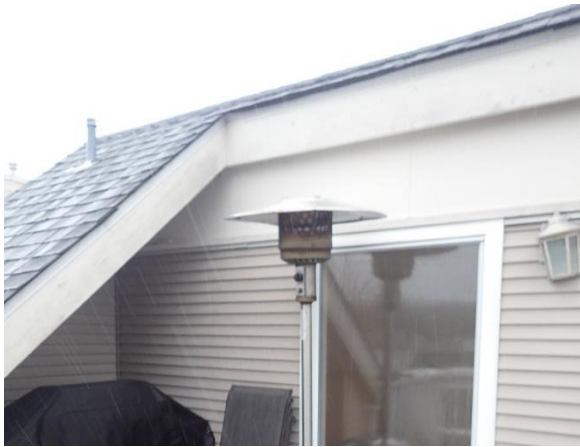
Physical Assessment:

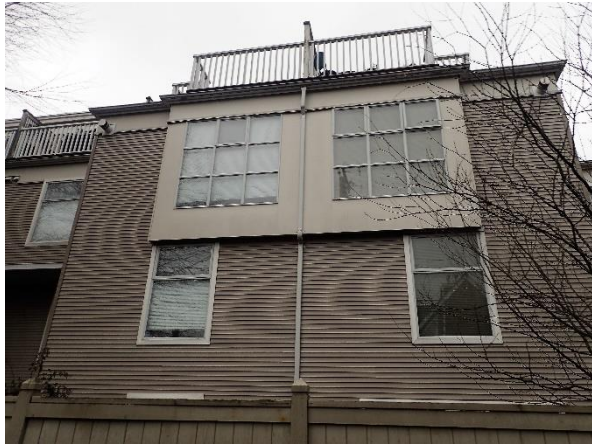
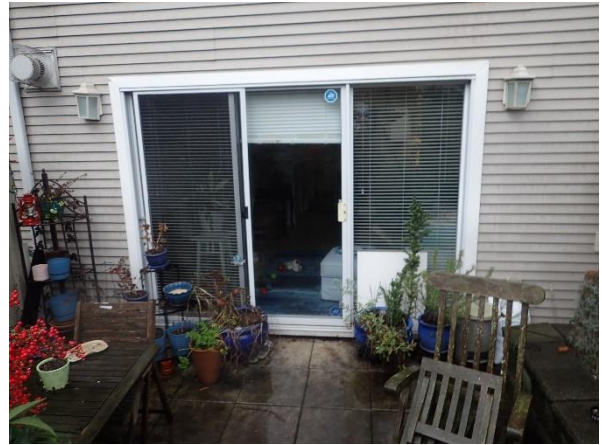
Physical Assessment:

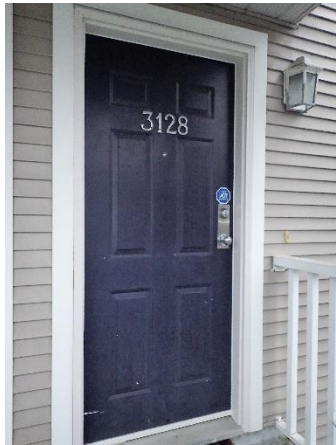
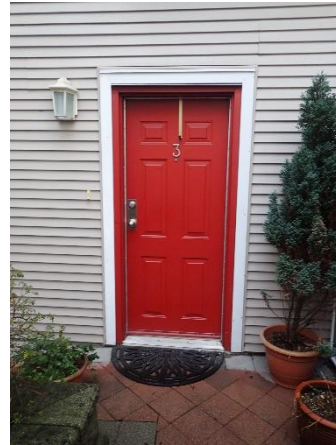
Physical Assessment:

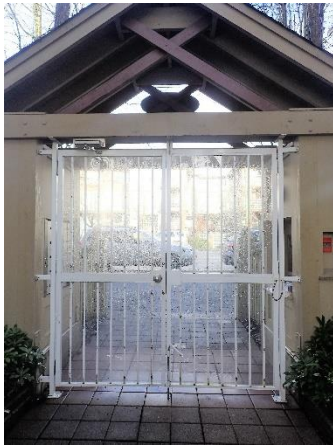
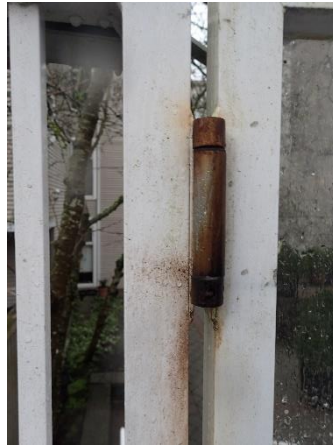
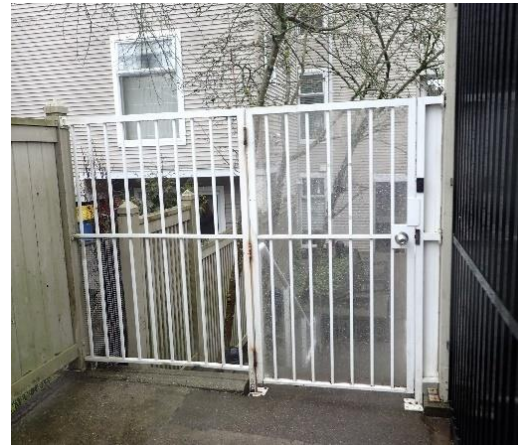
Physical Assessment:

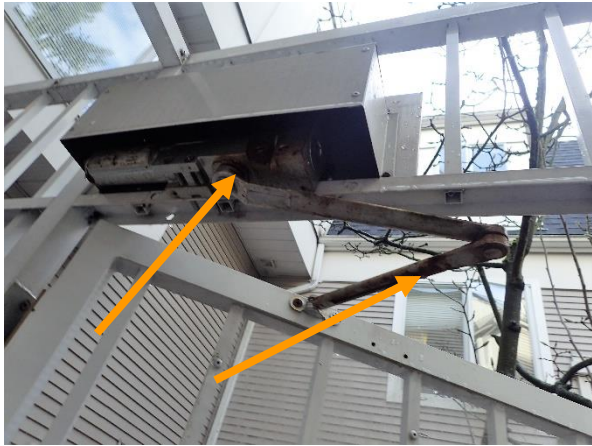
Photo 1: Corrosion observed on some elements of door control mechanism of a few entry gates.

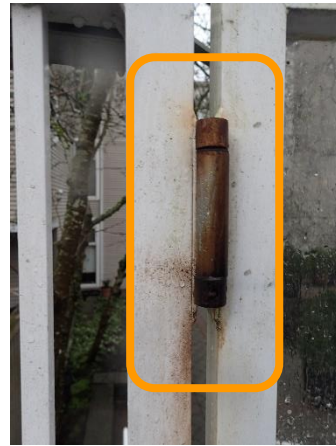
Photo 2: Corroded hinges noted at multiple locations.

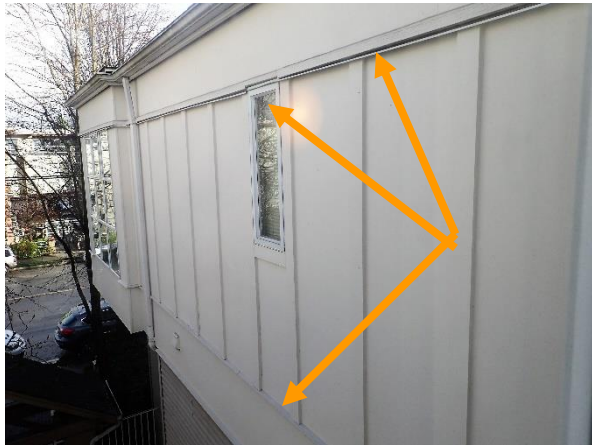
Physical Assessment:

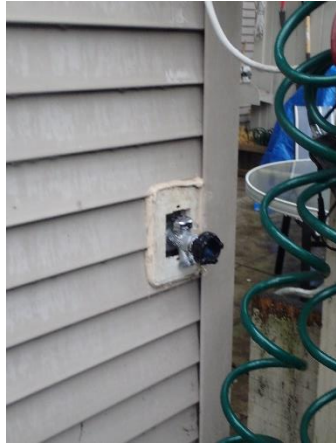
Physical Assessment:

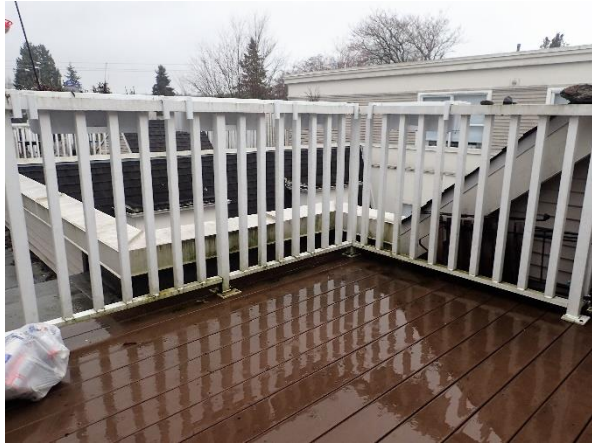
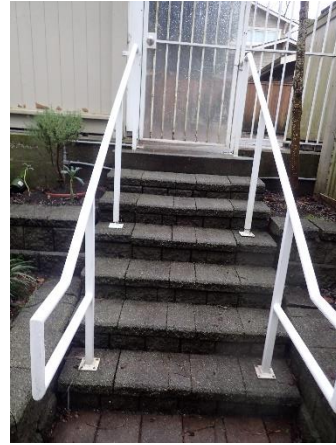
Physical Assessment:

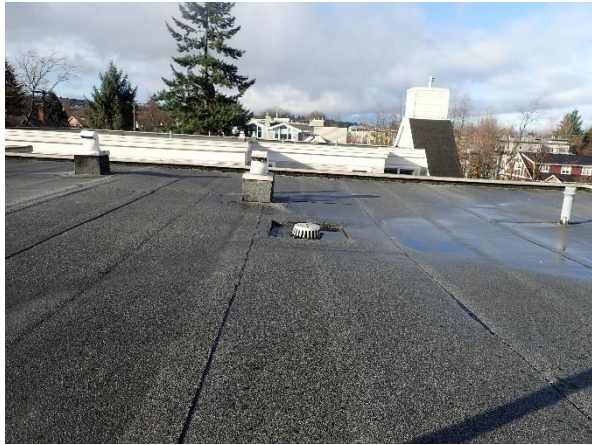
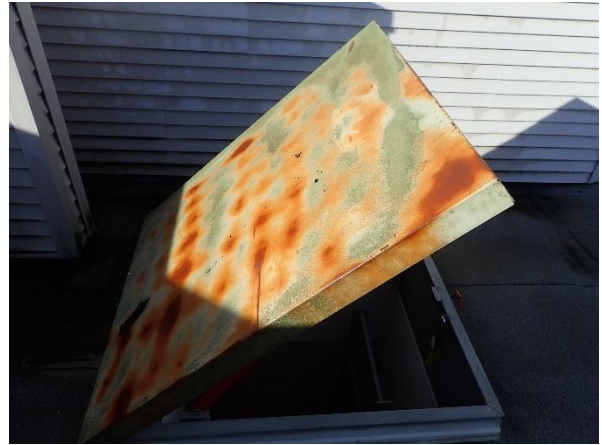
Physical Assessment:

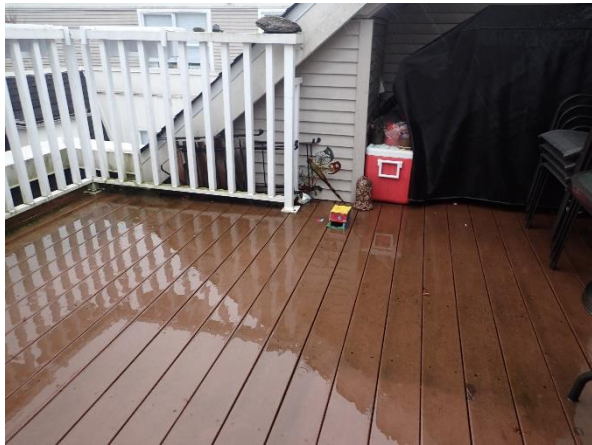
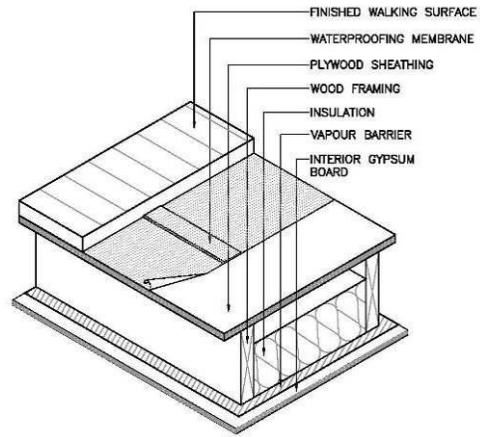
Physical Assessment:

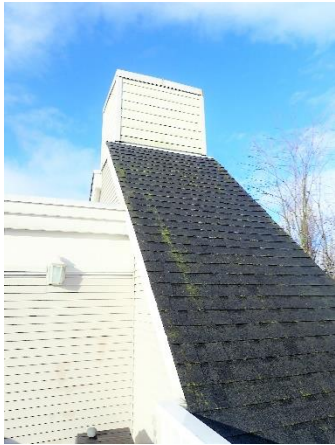
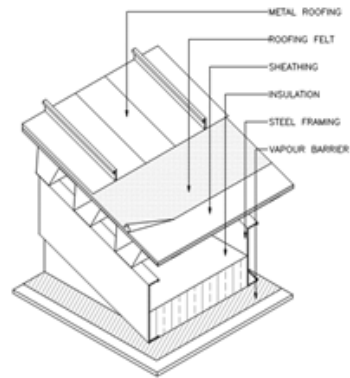
Physical Assessment:

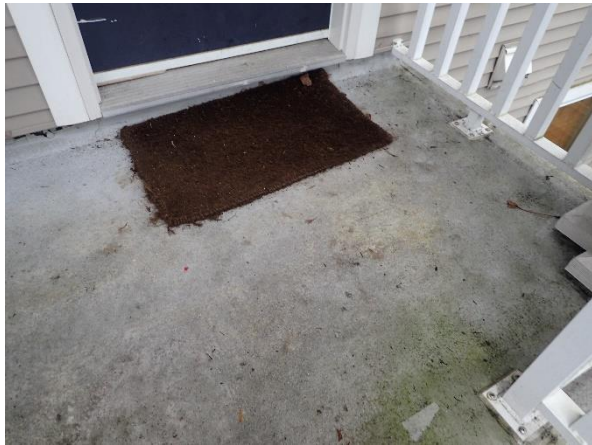
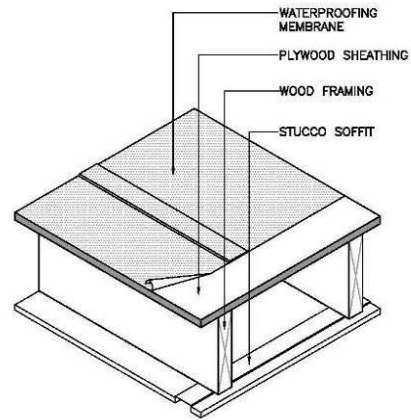
Physical Assessment:

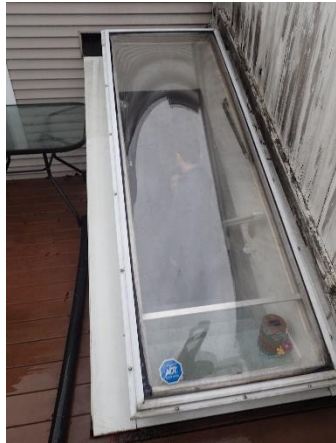
Physical Assessment:

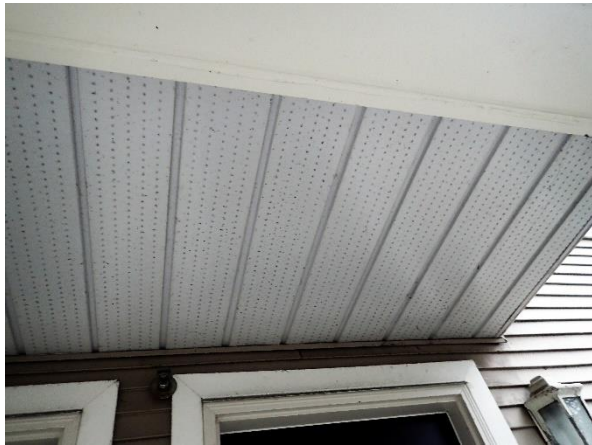
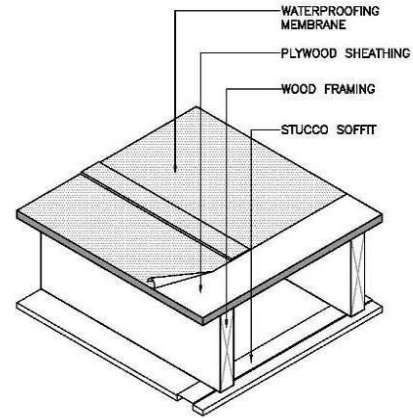
Physical Assessment:

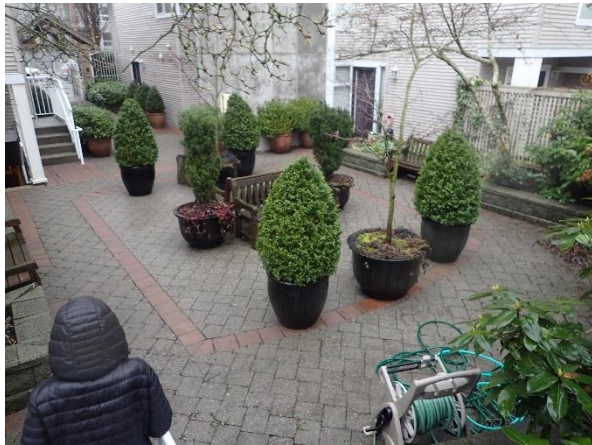
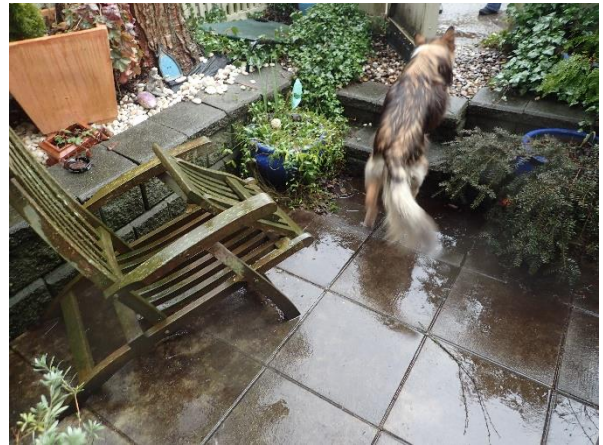
Physical Assessment:

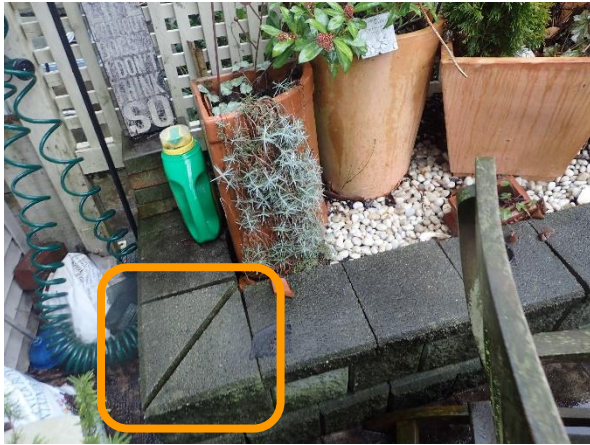
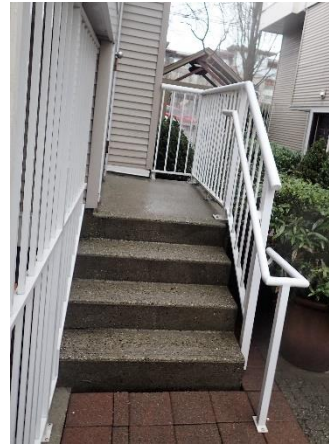
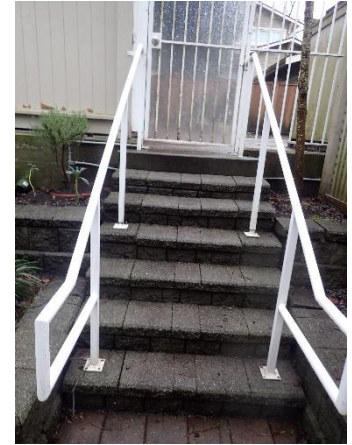
Physical Assessment:

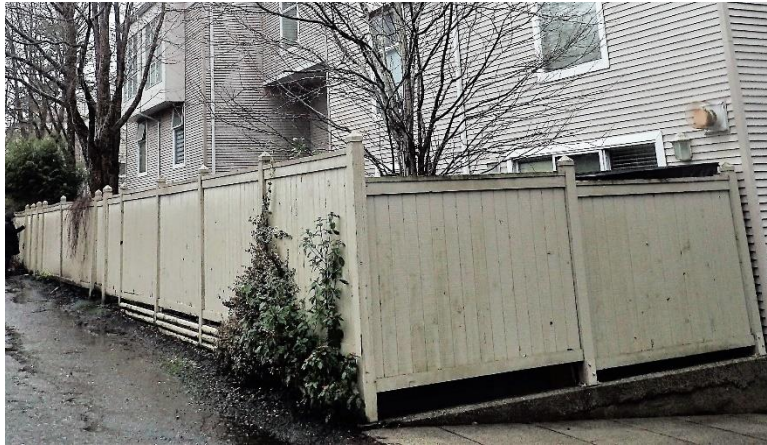
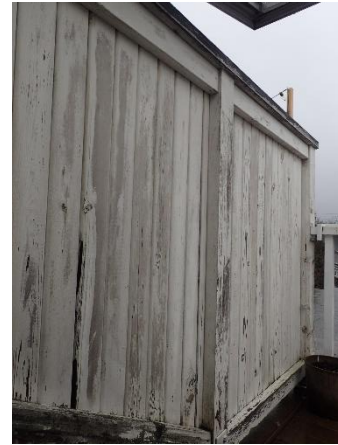
Physical Assessment:

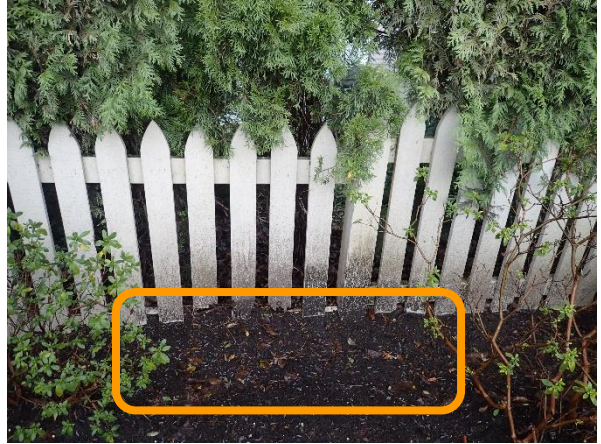
Photo 2: Gothic Picket Fences installed at front side of the property. A sample of damaged fencing at front side of the complex.

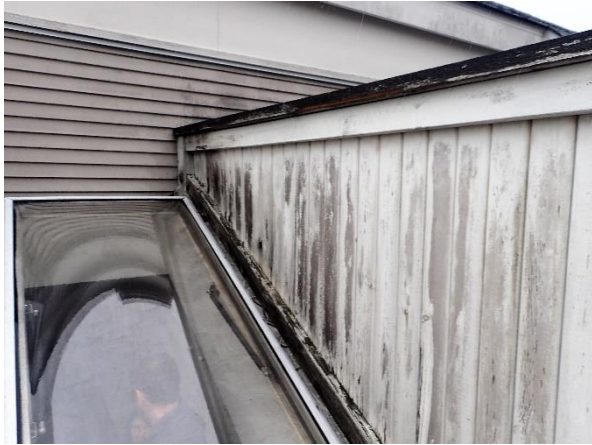
Photo 2: Sample of fade paint finishing, and decayed elements noted on fencing on the roof decks.

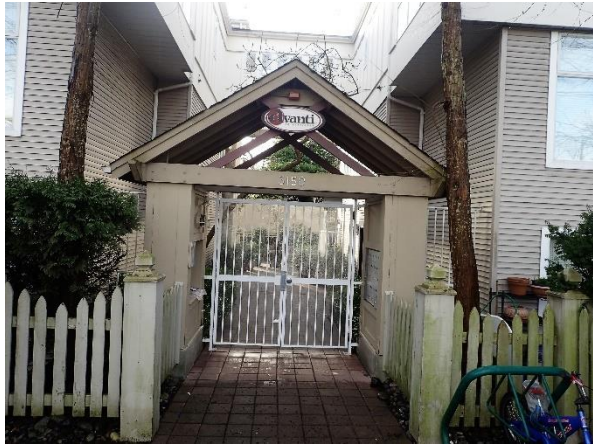
Physical Assessment:

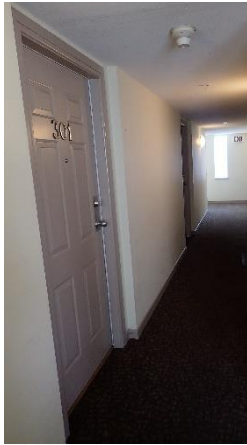
Physical Assessment:

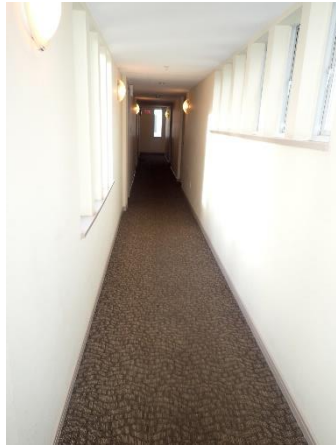
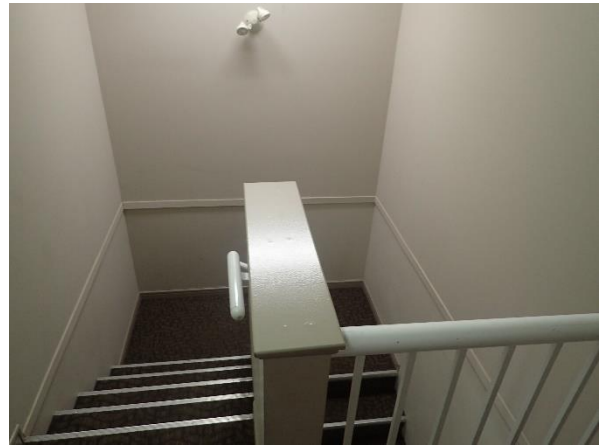
Physical Assessment:

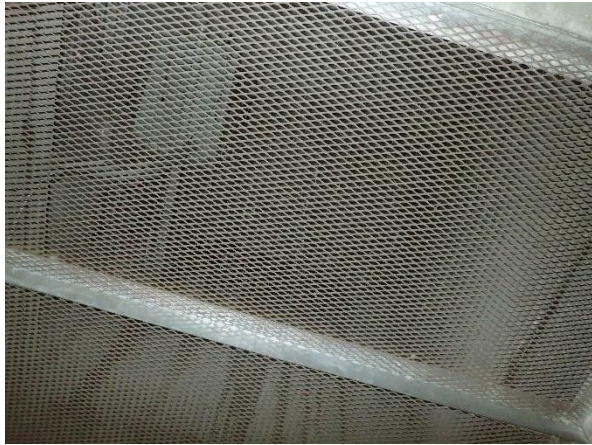
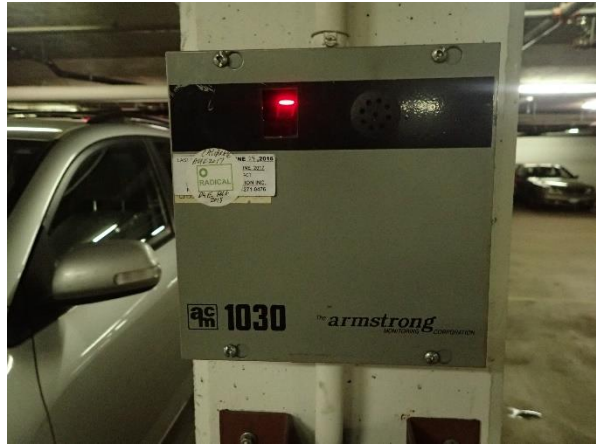
Physical Assessment:

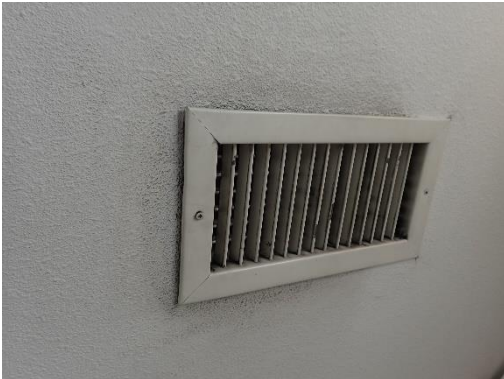
Physical Assessment:

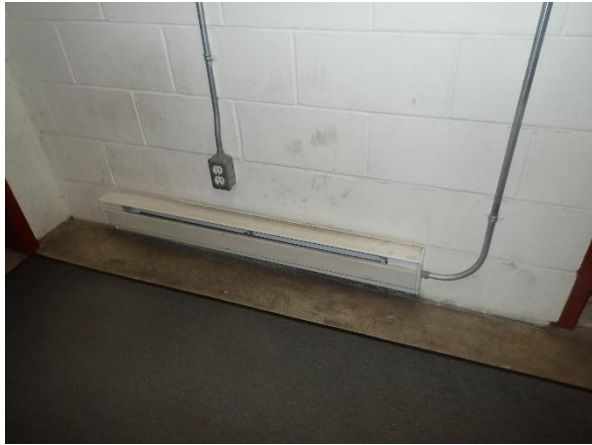
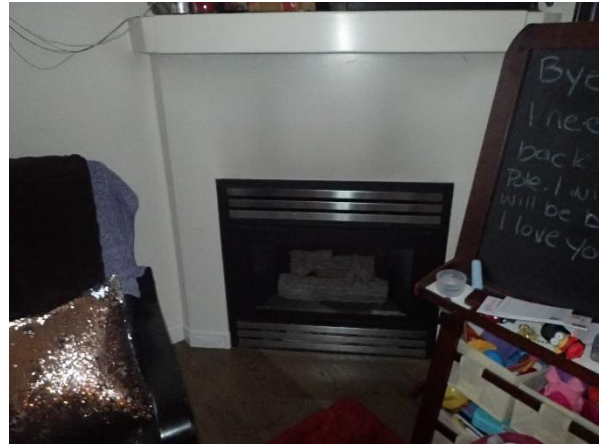
Physical Assessment:

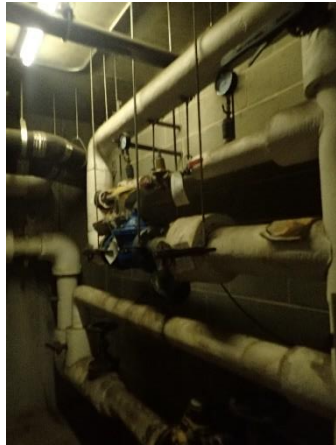
Physical Assessment:

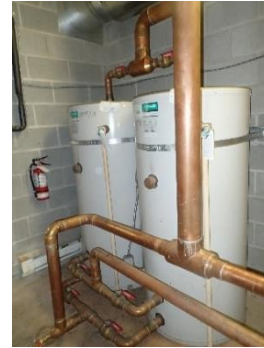
Physical Assessment:

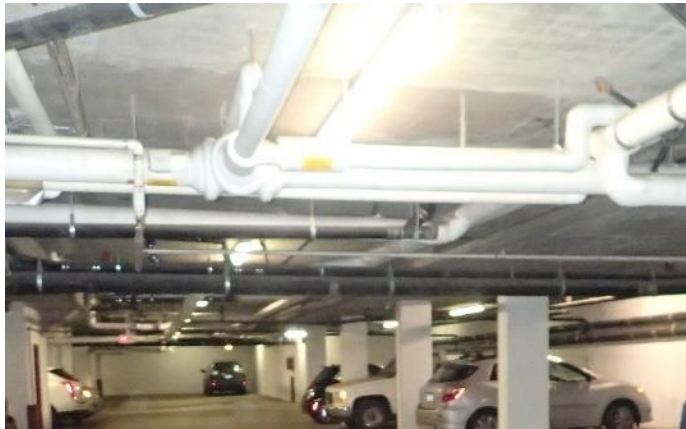
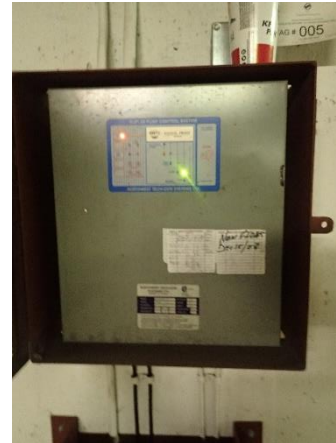
Physical Assessment:

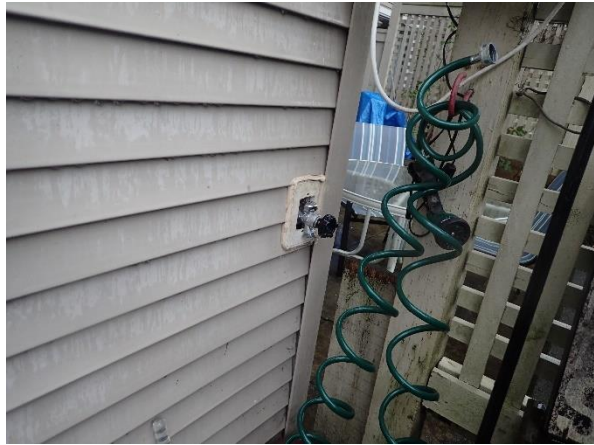
Physical Assessment:

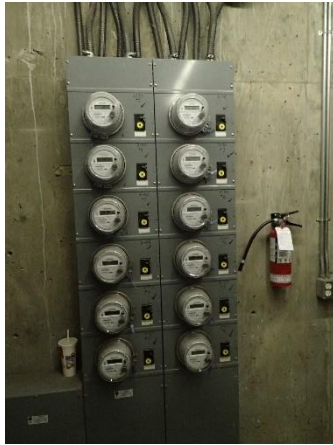
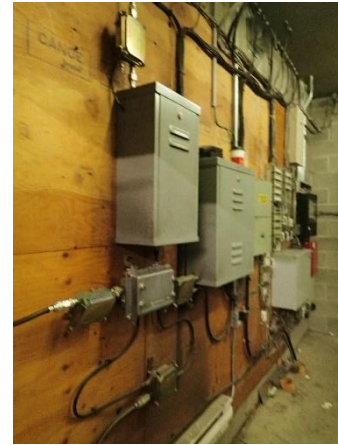
Physical Assessment:

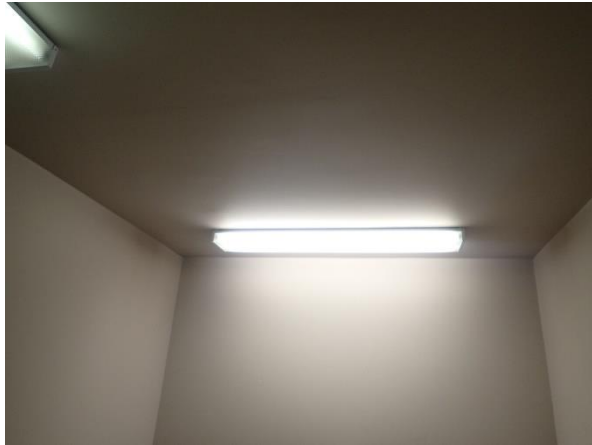
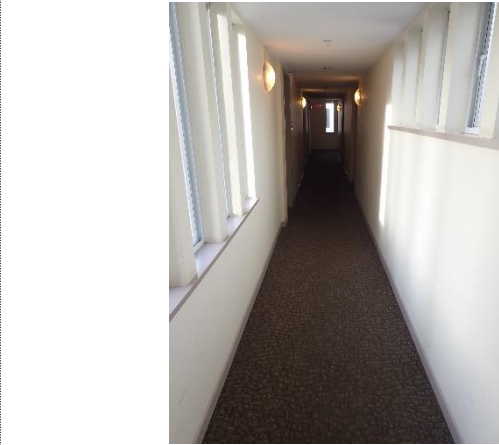
Physical Assessment:

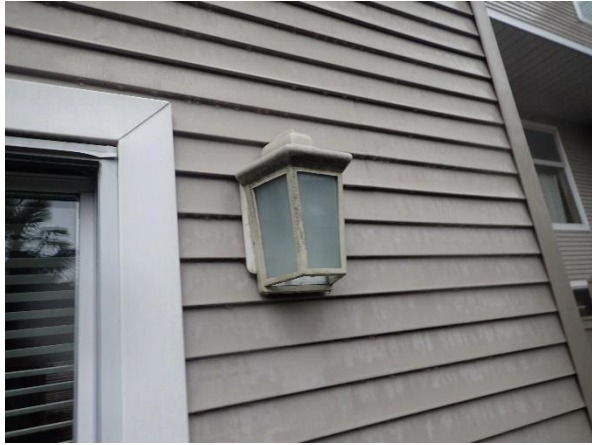
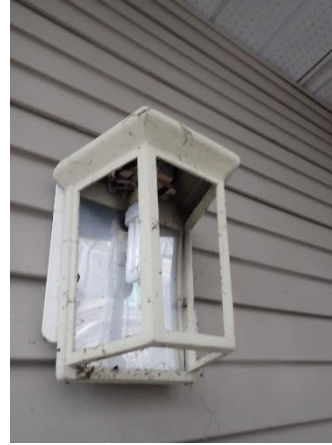
Physical Assessment:

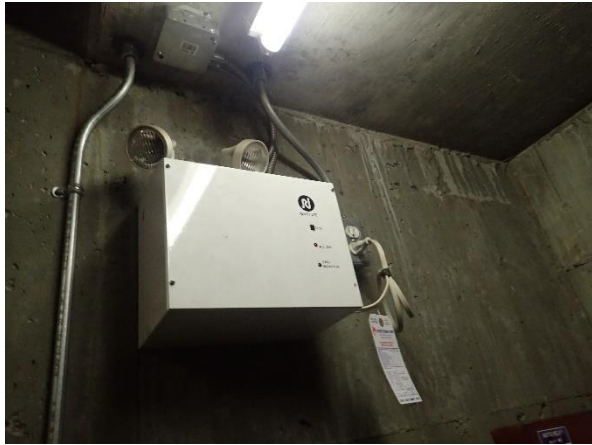
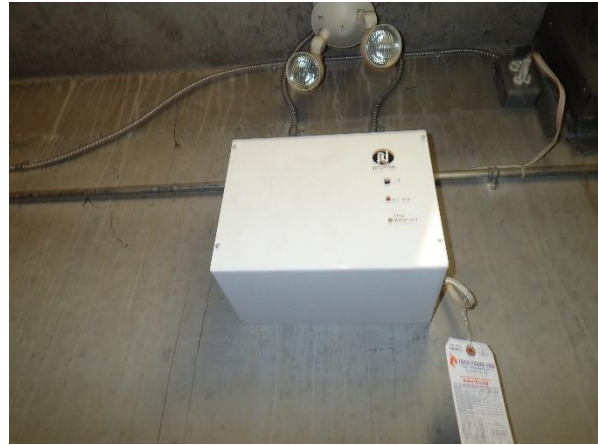
Physical Assessment:

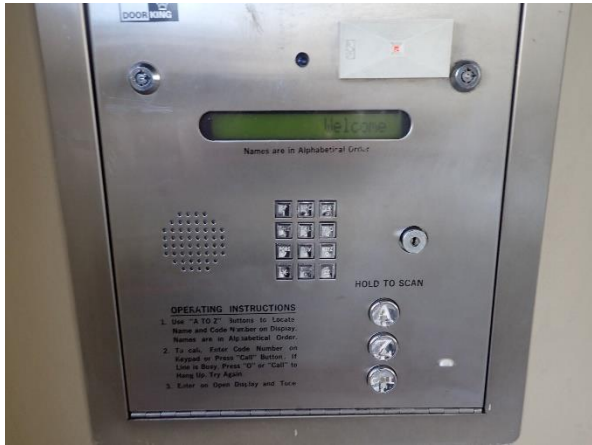
Physical Assessment:

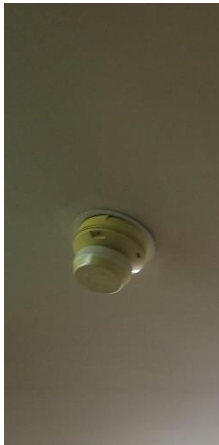
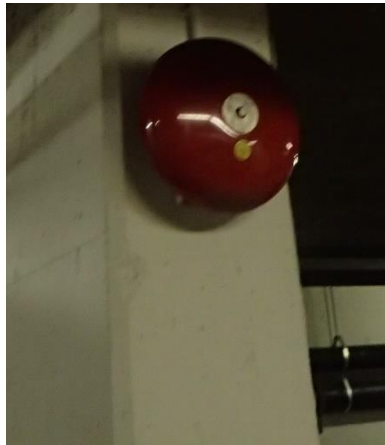
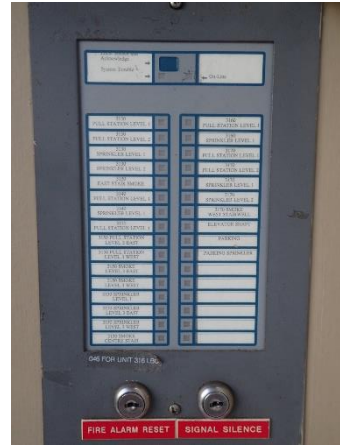
Physical Assessment:

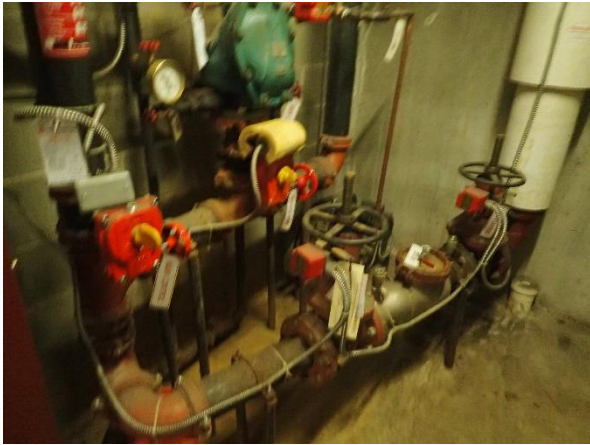
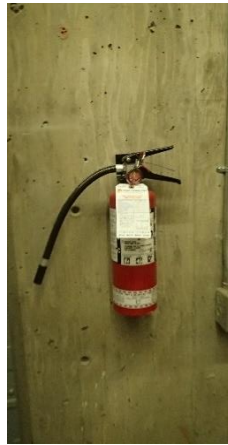
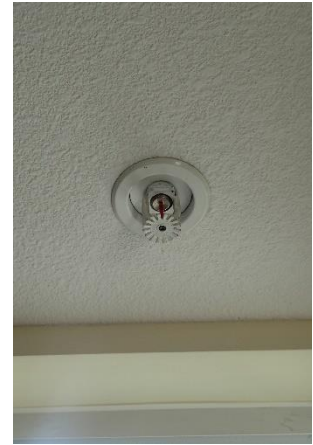
Physical Assessment:

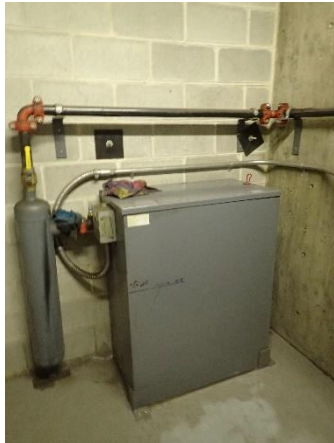
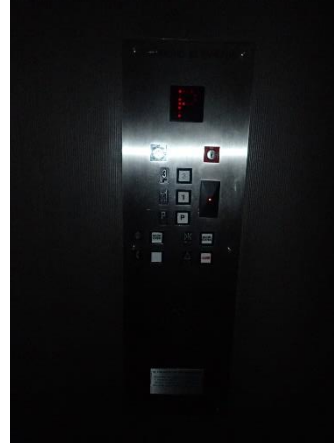
Physical Assessment:
