DEPRECIATION REPORT

AZURA ONE

1438 RICHARDS STREET
VANCOUVER, BC

DATE: **APRIL 9, 2021**

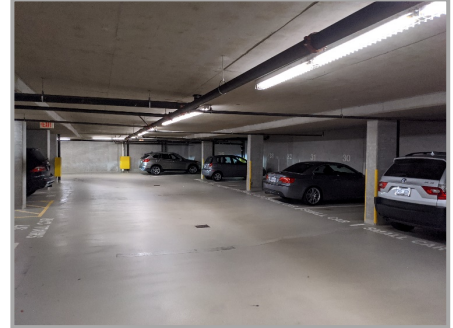
Location:	Below Building
Year Installed:	2004
Typical Service Life (yrs):	50
Effective Age (yrs):	16
Remaining Service Life (yrs):	34
Planned Renewal Date:	2054

Description: This component includes the 4-storey below-grade concrete parking structure and exposed concrete elements on the highrise structure.

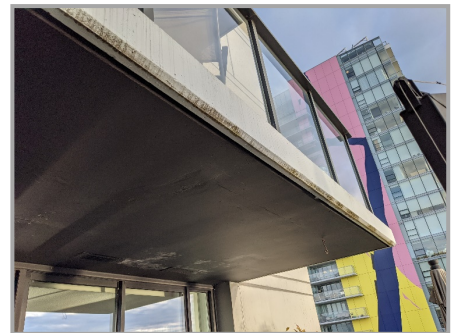
Location:	Balconies
Year Installed:	2004
Typical Service Life (yrs):	30
Effective Age (yrs):	16
Remaining Service Life (yrs):	14
Planned Renewal Date:	2034

Description: This component includes the metal balcony railings with glass panels. The guardrails are mounted on the surface of the balcony slabs and have sealant installed around the base plate.

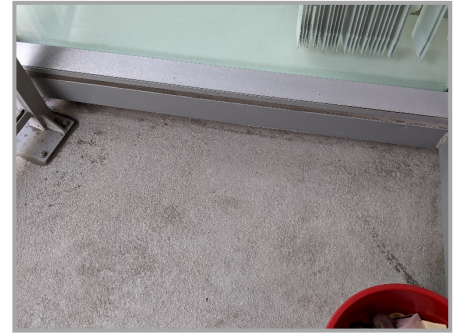
Location:	Highrise and Townhouse Balconies
Year Installed:	2010
Typical Service Life (yrs):	15
Effective Age (yrs):	6
Remaining Service Life (yrs):	9
Planned Renewal Date:	2029

Description: This component includes the liquid applied waterproofing membrane on the concrete balcony slabs. The waterproofing was observed to be applied up the walls as per best construction practices.

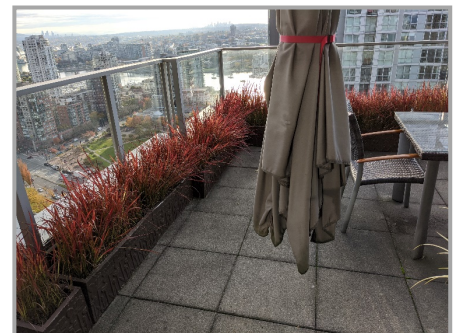
Location:	Penthouses
Year Installed:	2004
Typical Service Life (yrs):	30
Effective Age (yrs):	16
Remaining Service Life (yrs):	14
Planned Renewal Date:	2034

Description: This component includes the roof deck assemblies which typically consist of a waterproofing membrane covered by concrete pavers.

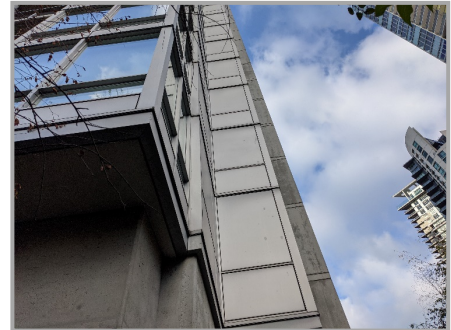
Location:	Exterior
Year Installed:	2004
Typical Service Life (yrs):	40
Effective Age (yrs):	16
Remaining Service Life (yrs):	24
Planned Renewal Date:	2044

Description: This component includes the metal panel cladding around the exterior of the high rise and townhouse buildings.

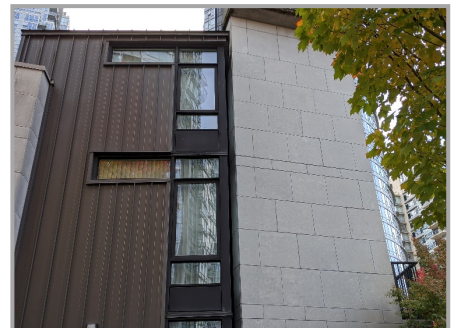
Location:	Townhouses
Year Installed:	2004
Typical Service Life (yrs):	40
Effective Age (yrs):	16
Remaining Service Life (yrs):	24
Planned Renewal Date:	2044

Description: This component includes the masonry tile on the townhouse building.

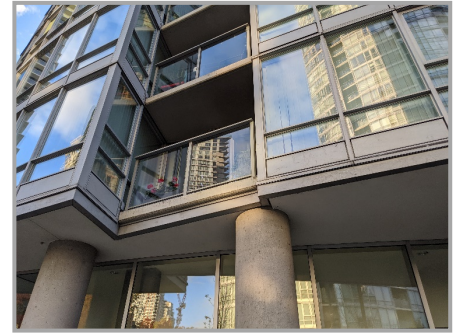
Location:	Highrise
Year Installed:	2004
Typical Service Life (yrs):	40
Effective Age (yrs):	16
Remaining Service Life (yrs):	24
Planned Renewal Date:	2044

Description: This component includes the window-wall assemblies which consist of aluminium framed double IGU windows.

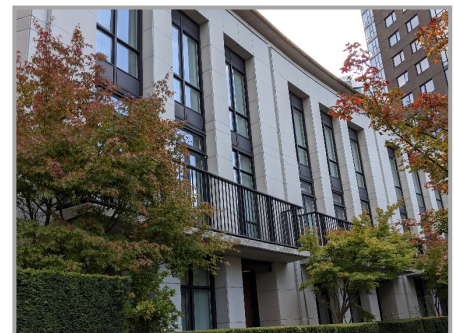
Location:	Highrise and Townhouses
Year Installed:	2004
Typical Service Life (yrs):	40
Effective Age (yrs):	16
Remaining Service Life (yrs):	24
Planned Renewal Date:	2044

Description: This component includes the aluminium framed double IGU punched windows on the highrise and townhouses.

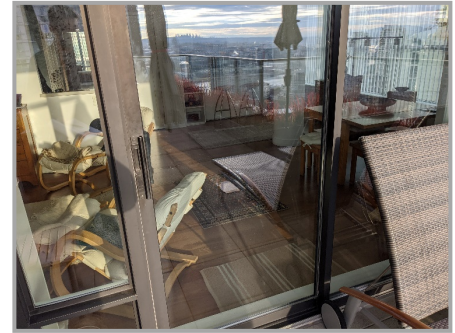
Location:	Highrise and Townhouses
Year Installed:	2004
Typical Service Life (yrs):	40
Effective Age (yrs):	16
Remaining Service Life (yrs):	24
Planned Renewal Date:	2044

Description: This component includes the aluminium framed sliding doors on the highrise balconies and townhouse patios. The sliding doors are generally protected by an overhang.

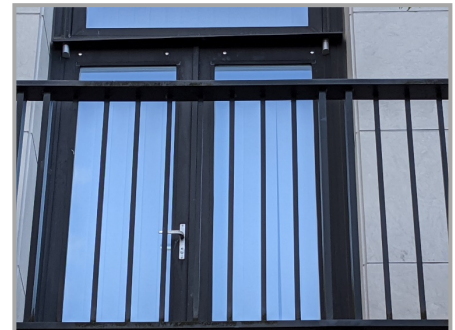
Location:	Townhouse Balconies
Year Installed:	2004
Typical Service Life (yrs):	40
Effective Age (yrs):	16
Remaining Service Life (yrs):	24
Planned Renewal Date:	2044

Description: This component includes the swing doors at the townhouse balconies.

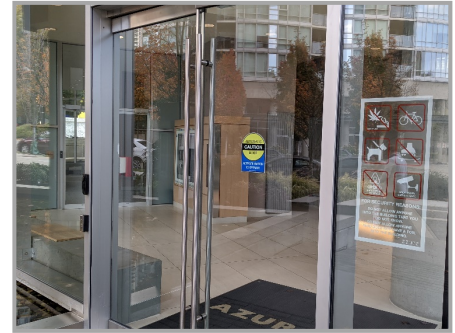
Location:	Main Entrance
Year Installed:	2004
Typical Service Life (yrs):	40
Effective Age (yrs):	16
Remaining Service Life (yrs):	24
Planned Renewal Date:	2044

Description: This component includes the metal framed glass panel main entrance doors for the highrise building.

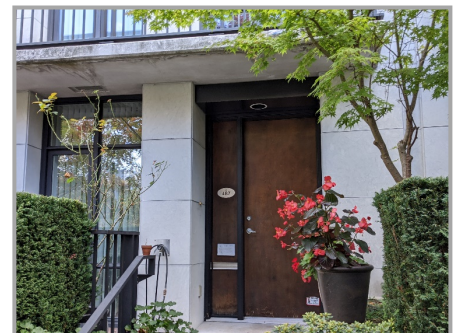
Location:	Townhouses
Year Installed:	2004
Typical Service Life (yrs):	25
Effective Age (yrs):	16
Remaining Service Life (yrs):	9
Planned Renewal Date:	2029

Description: This component includes the solid wood core townhouse entrance swing doors.

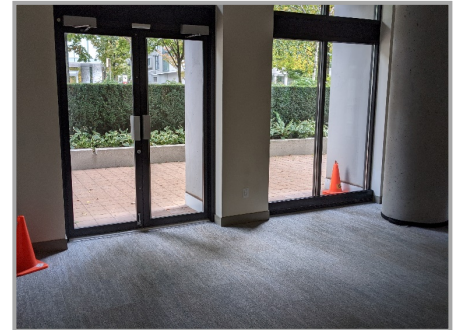
Location:	Throughout Highrise
Year Installed:	2004
Typical Service Life (yrs):	30
Effective Age (yrs):	16
Remaining Service Life (yrs):	14
Planned Renewal Date:	2034

Description: This component includes the exterior service doors for the highrise building.

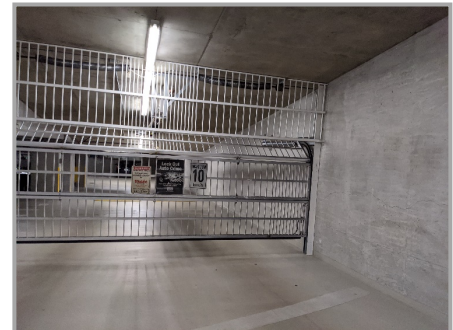
Location:	Parkade
Year Installed:	2004
Typical Service Life (yrs):	25
Effective Age (yrs):	16
Remaining Service Life (yrs):	9
Planned Renewal Date:	2029

Description: This component includes the metal picket overhead garage doors and their motor units.

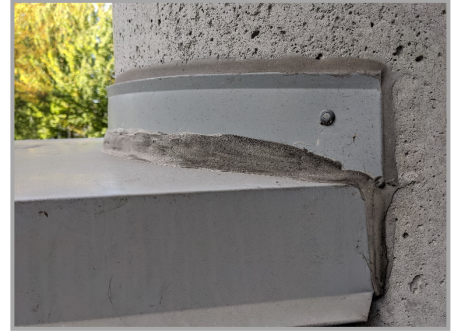
Location:	Throughout Complex
Year Installed:	2015
Typical Service Life (yrs):	10
Effective Age (yrs):	6
Remaining Service Life (yrs):	4
Planned Renewal Date:	2024

Description: This component includes the sealant installed around the vent penetrations, balcony baseplates, flashings, and cladding joints.

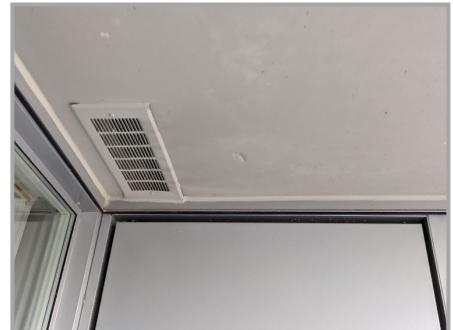
Location:	Balconies
Year Installed:	2015
Typical Service Life (yrs):	10
Effective Age (yrs):	6
Remaining Service Life (yrs):	4
Planned Renewal Date:	2024

Description: This component includes the elastomeric paint coating on the balcony soffits and the paint coating on the entrance canopy frame.

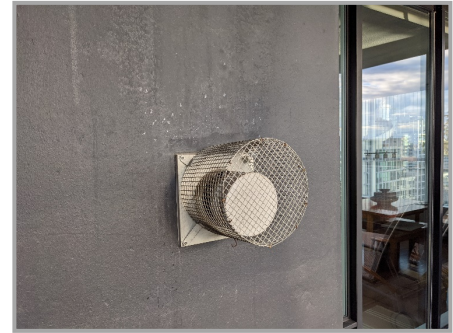
Location:	Exterior
Year Installed:	2004
Typical Service Life (yrs):	30
Effective Age (yrs):	16
Remaining Service Life (yrs):	14
Planned Renewal Date:	2034

Description: This component includes the fireplace vents at the townhouse building and at select highrise units.

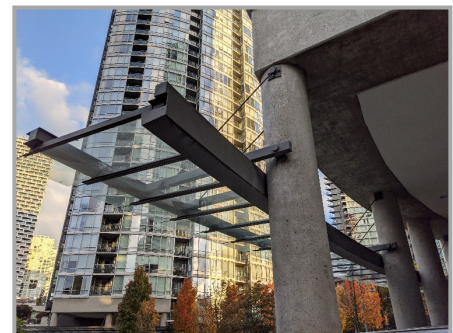
Location:	Highrise Entrance
Year Installed:	2004
Typical Service Life (yrs):	40
Effective Age (yrs):	16
Remaining Service Life (yrs):	24
Planned Renewal Date:	2044

Description: This component includes the metal framed glass panel canopy above the highrise main entrance.

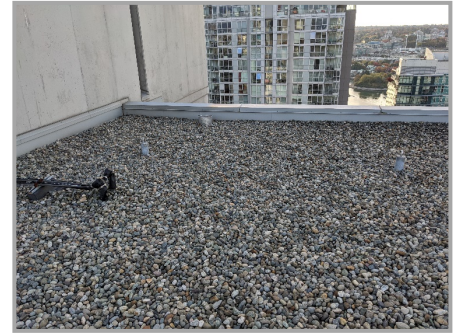
Location:	Highrise
Year Installed:	2004
Typical Service Life (yrs):	35
Effective Age (yrs):	16
Remaining Service Life (yrs):	19
Planned Renewal Date:	2039

Description: This component includes the inverted roof on the highrise structure. Inverted roofs typically consist of a waterproofing membrane covered by rigid insulation, filter fabric, and gravel ballast.

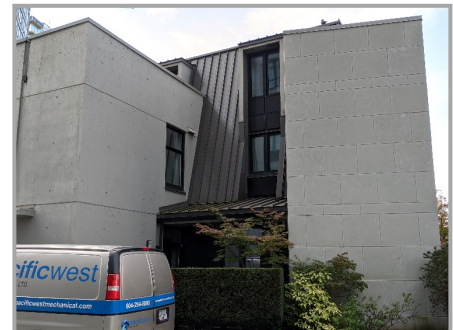
Location:	Townhouses
Year Installed:	2004
Typical Service Life (yrs):	40
Effective Age (yrs):	16
Remaining Service Life (yrs):	24
Planned Renewal Date:	2044

Description: This component includes the metal roofs on the townhouse buildings. Steep slope roof assemblies typically consist of sheathing, underlayment and eaves protection with asphalt shingles or metal panels protecting the assembly.

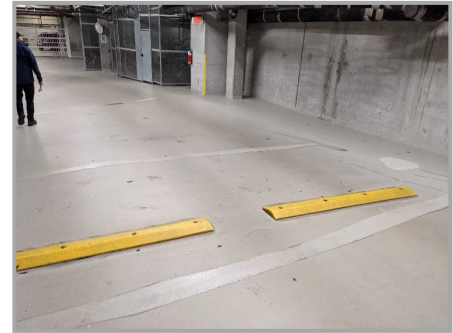
Location:	Parkade
Year Installed:	2004
Typical Service Life (yrs):	20
Effective Age (yrs):	16
Remaining Service Life (yrs):	4
Planned Renewal Date:	2024

Description: This component includes the elastomeric liquid applied waterproofing membrane installed on the suspended parkade slabs.
