BUILDING ENVELOPE CONDITION REVIEW

CONFERENCE PLAZA
438 SEYMOUR STREET, VANCOUVER, B.C.

Our File No.: R13-221

December 5, 2013

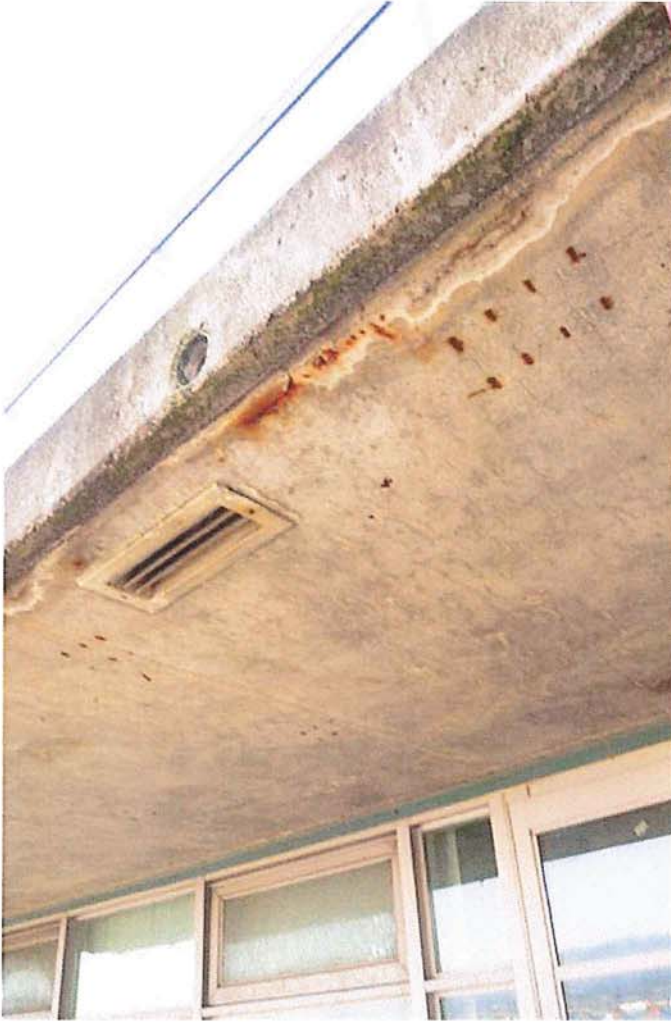
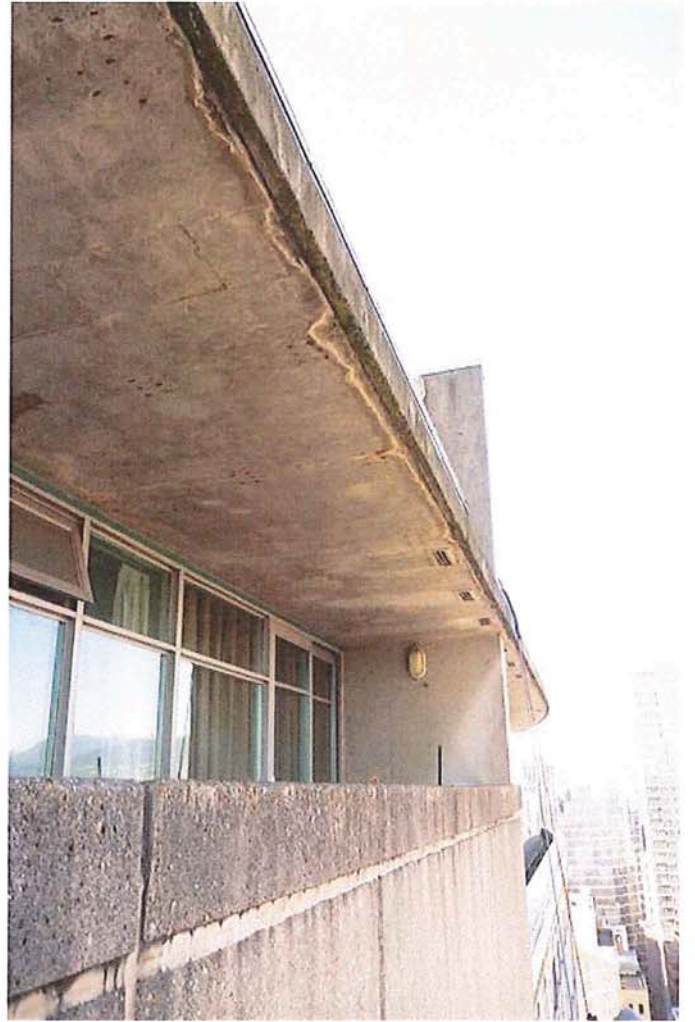
Photos No. 5 and 6

Description		Photos
3.2.1	Suspended concrete balcony slabs at Level 31 were noted to have exposed rebar at several locations as well as visible corrosion. Efflorescence staining was also visible.	5-8
3.2.2	Exposed rebar was observed at the underside of the Level 4 suspended concrete balcony slab on the north elevation	9
3.2.3	Spalling concrete was observed on the Level 4 deck which wraps around the residential tower on the west and south elevations	10-14
3.2.4	Efflorescence staining was typically noted at the embedded swing stage cable bypass sleeves.	15-18

Recommendation: Remove delaminated concrete in the spalled areas to a depth of 1" behind the exposed rebar. Saw cut the perimeter of the patches. Clean off the rebar corroded surface and coat with a corrosion inhibitor. Apply concrete patching material formulated for vertical applications.

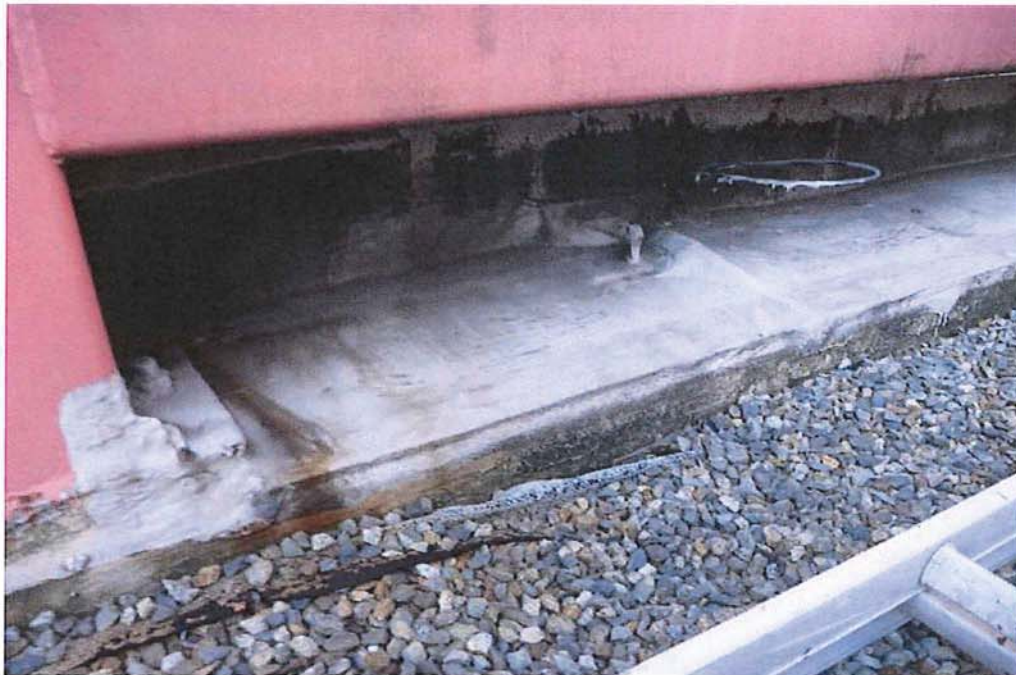
Photos No. 19 and 20

Description	Photos
3.3.1	A liquid-applied PMMA (polymethyl methacrylate) has been applied to the rooftop's steel structure column footings and the concrete curb on which the columns stand. In a few locations, large air pockets and minor delaminations were noted.	19-22

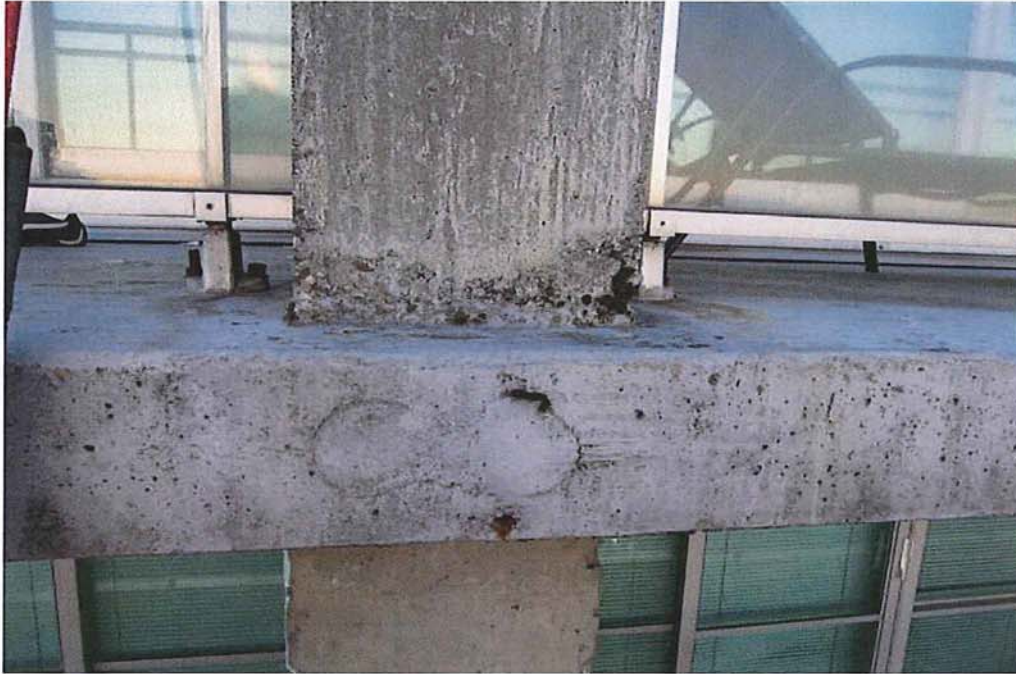
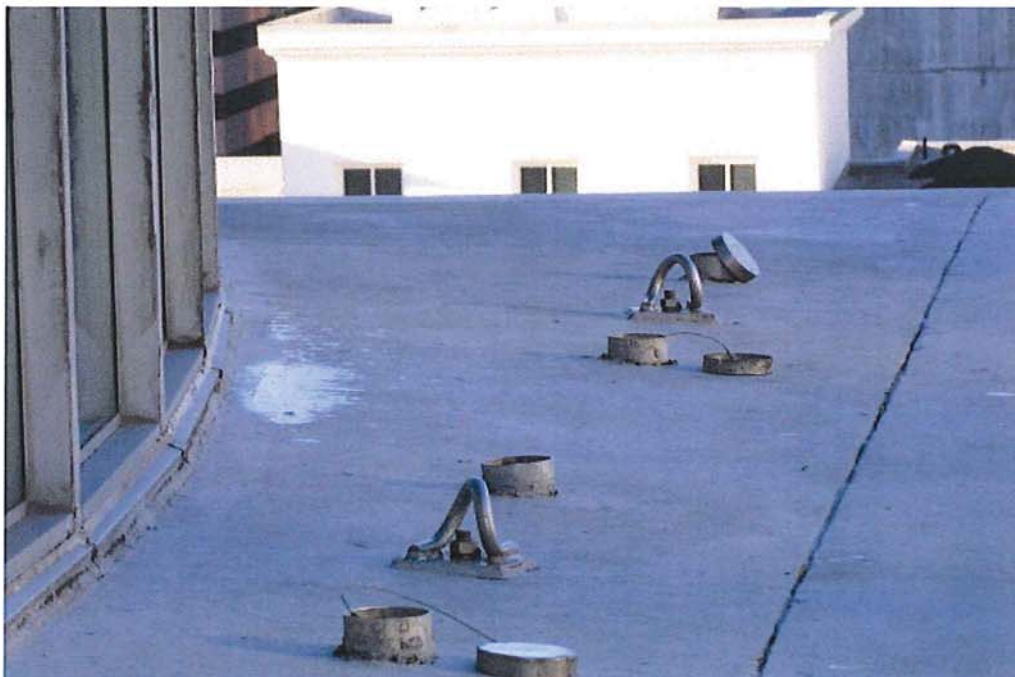
Photos No. 37 and 38

Description		Photos
3.4.1	The polyurethane traffic coating applied to the balconies and eyebrows was noted to be delaminating in several locations. Membrane up-legs and downlegs were observed to be inadequate in several locations. Concrete cracking was also observed in multiple locations.	36-37

3.4.2	Water ingress is apparent around the embedded swing stage cable bypass sleeves at both eyebrows. Some of the tethered caps were noted to be missing.	38-40

Recommendation: Apply a 1/2" fillet bead to the circumference of the top of the sleeve. At the underside of the sleeve, apply a 1/2" bead of sealant around the circumference, effectively acting as a drip-edge.

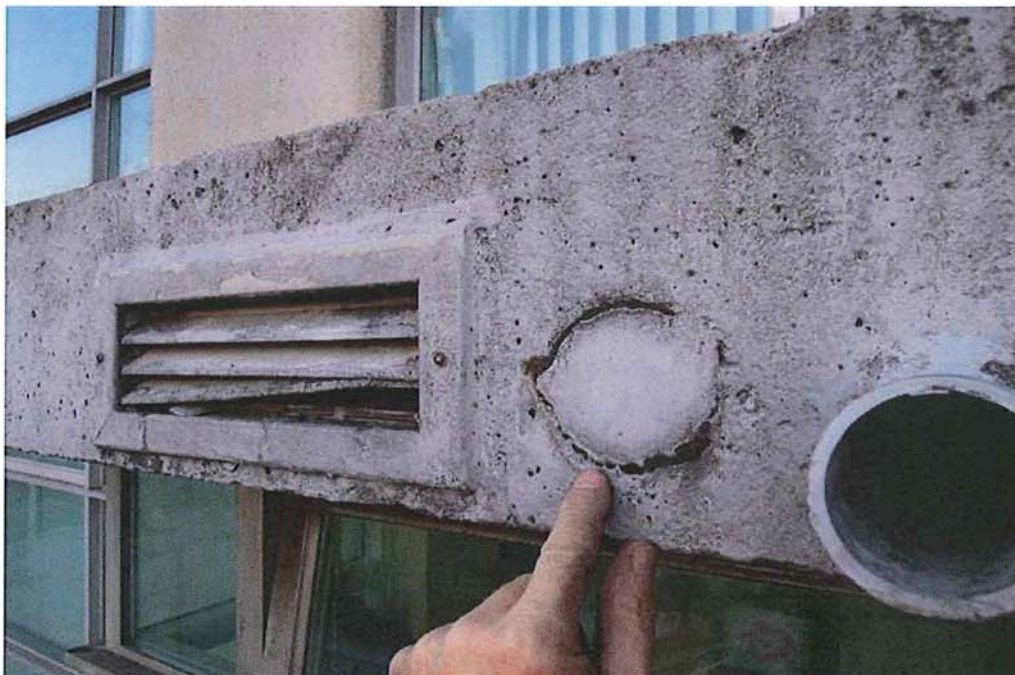
Photos No. 41 and 42

3.4.3	Concrete post tension cable grout plug sealant was observed to have failed on the south elevation at the Level 23 eyebrow.	41-42
3.4.4	Bolts and nuts for the guard rail mounting posts were observed to have surface corrosion throughout the building. It appears that the original hardware was galvanized steel.	43-45

Recommendation: Repair cracks larger than 1/16" by routing a 1/4" x 1/4" groove and then applying polyurethane sealant. Reseal grout plugs for all post tension cables with polyurethane sealant. Remove any delaminated polyurethane traffic coating. Provide a xylene wipe to all existing membrane to promote bonding of new membrane layer. Apply a new layer of polyurethane traffic coating base to coat to the delaminated areas and top coat to all surfaces.

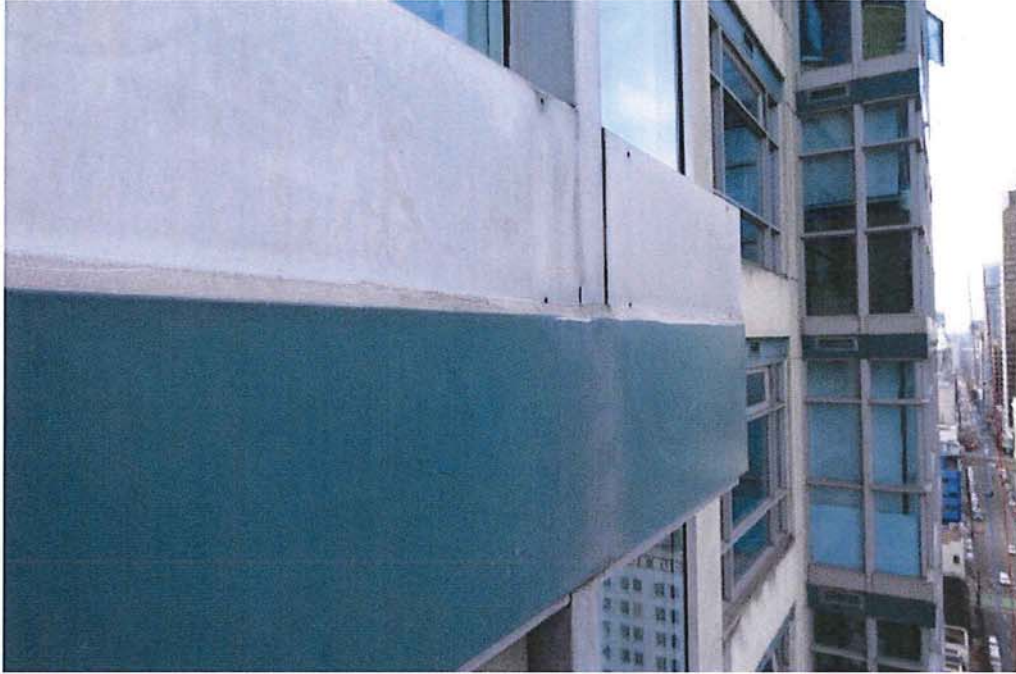
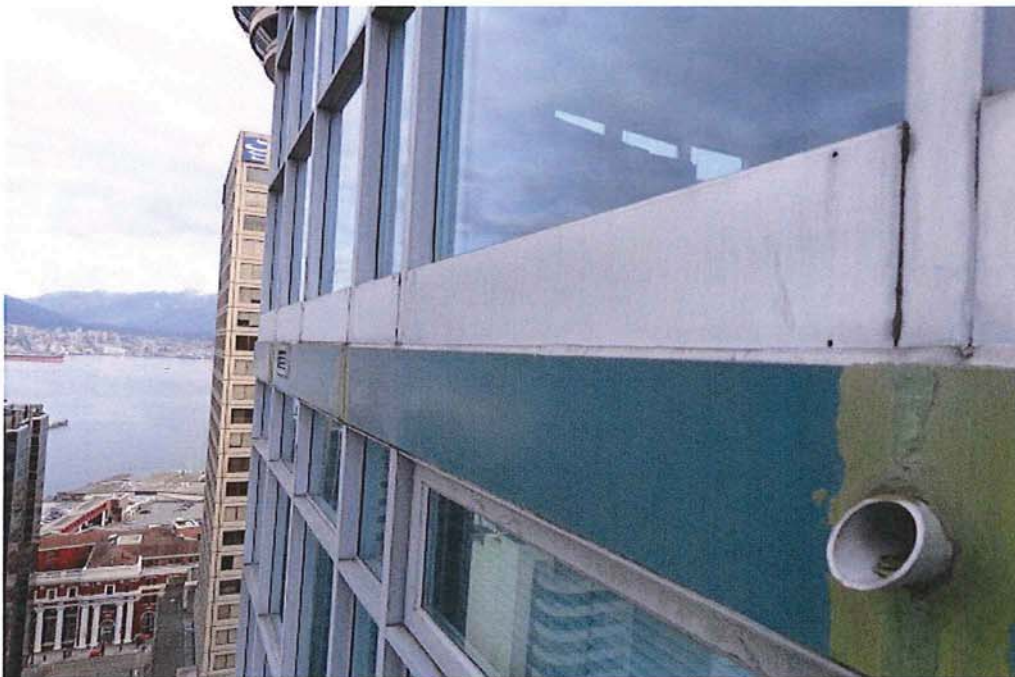
Photos No. 53 and 54

3.5.2	Recent applications of polyurethane sealant at window wall metal cladding panels appear to be performing well.	53-54
3.5.3	What appears to be the original polyurethane sealant is still present at many joints at the window wall metal cladding panels. Sealant was noted to be well aged and alligating throughout.	55-57

Recommendation: A global sealant renewal program should be completed for the high-rise residential tower at all locations which were not previously addressed during the 2005 – 2006 Exterior Sealant Renewal/Upgrading and Associated Work program.

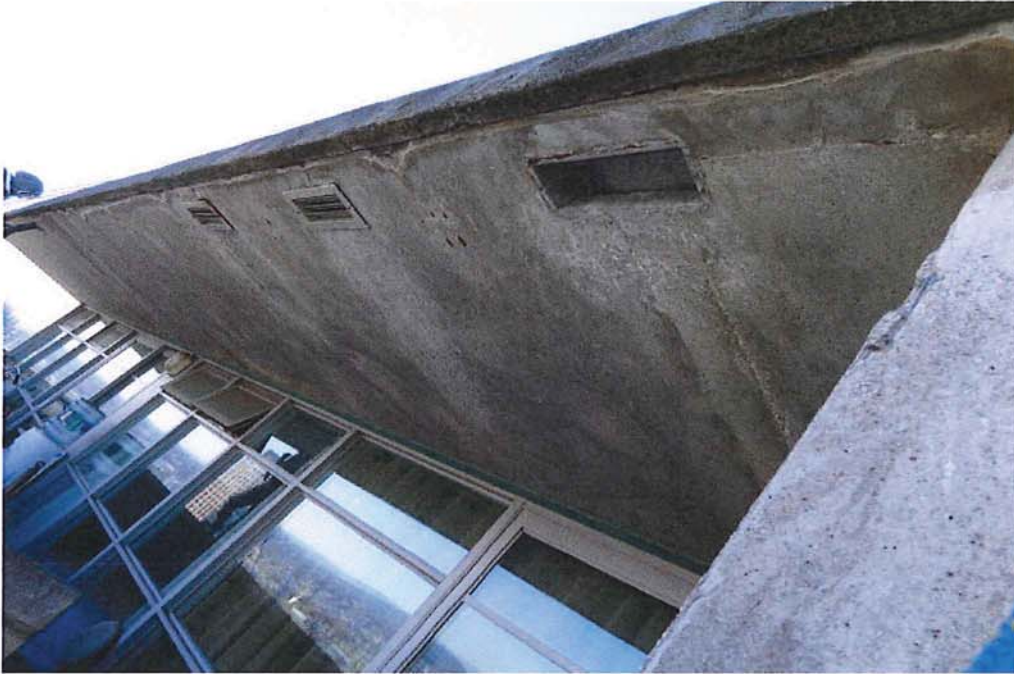
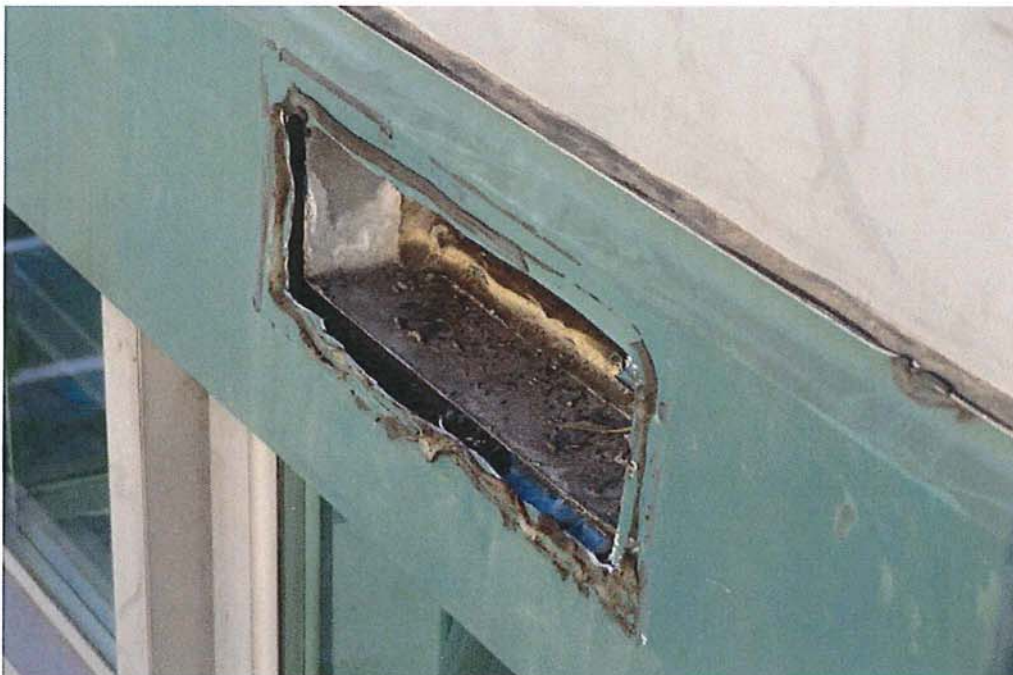
Photos No. 61 and 62

3.5.5	Air duct vent grills were noted to have issues of concern at: <ul style="list-style-type: none"> - Drop No. 1 – Level 30 and Level 6 vent grills were missing. Level 6 vent grill was located on Level 4's balcony - Drop No. 6 – Level 5 vent was loose and pulling away from the cladding 	61-63

Recommendation: Reinstate the missing or loose vent grills. During the course of any of the noted repair work, check all accessible grills to ensure that they are secure.

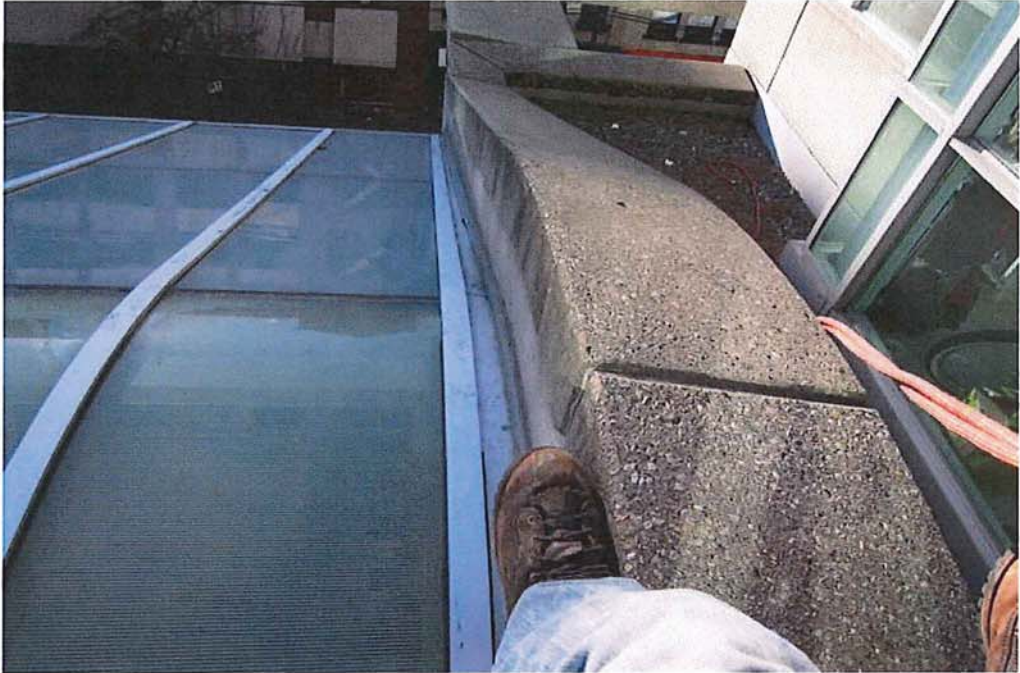
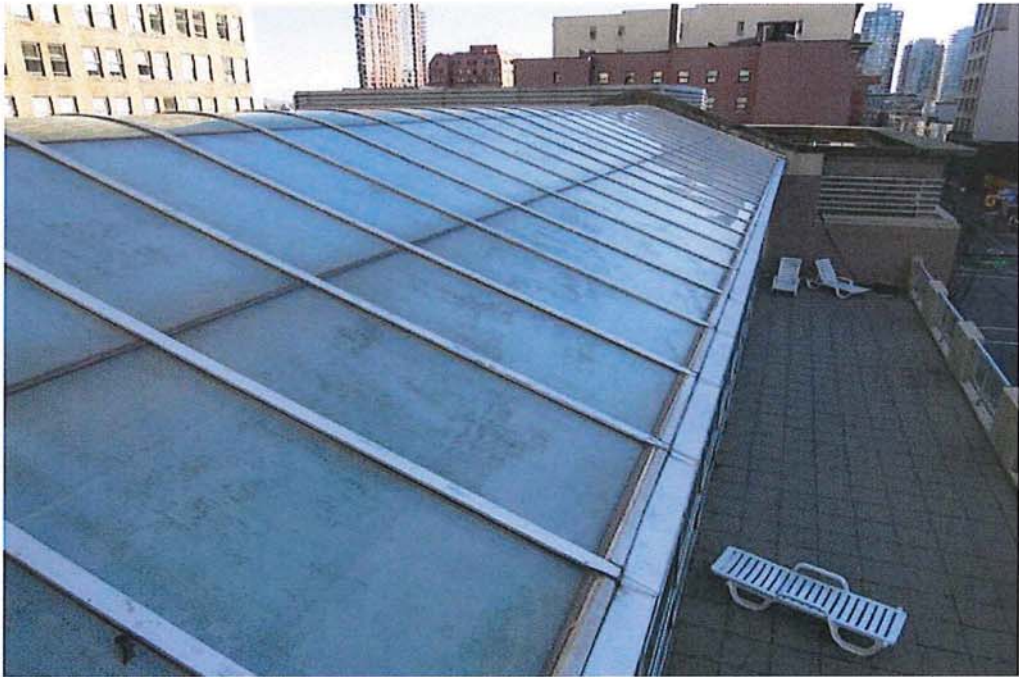
Photos No. 93 and 94

Description	Photos
3.7.1	The pool's pressure cap skylight roof system was noted to be in good condition. Sealant installed at IGU joints appears continuous. Where the skylight roof abuts the residential building the sealant applied to the gum-lip flashing also appears to be in good condition.	92-94
3.7.2	There were a few cracked glass panels on the south elevation's ground level skylight canopy.	95

4.14 **Recommendation:** Cracked IGU's and skylight canopy glass panels should be replaced. Repair damaged window hardware.

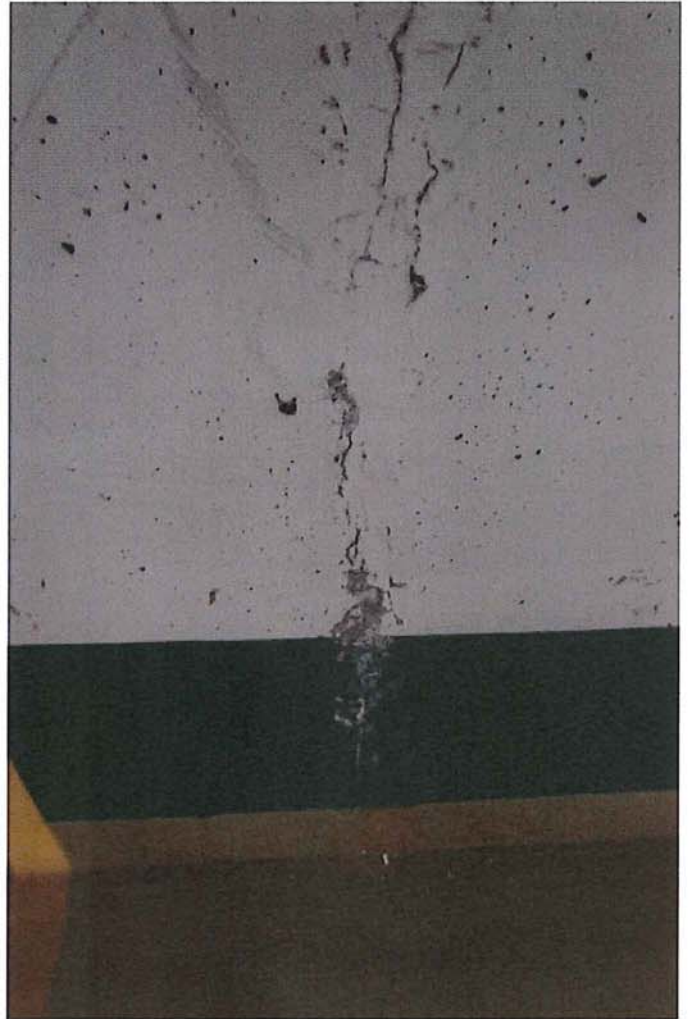
Photos No. 97 and 98

Description	Photos
3.8.1	Cracking and efflorescence staining was noted in several locations at the perimeter cast-in-place concrete walls at: <ul style="list-style-type: none"> - Stall No. 1, Stall No. 9, Stall No. 53, Stall No. 55, Stall No. 131, Stall No. 132, Stall No. 194, P3 Gate and Stall No. 208 	96-99

Recommendation: All cracks in the parkade perimeter walls showing efflorescence build-up and water staining should receive polyurethane crack injection.

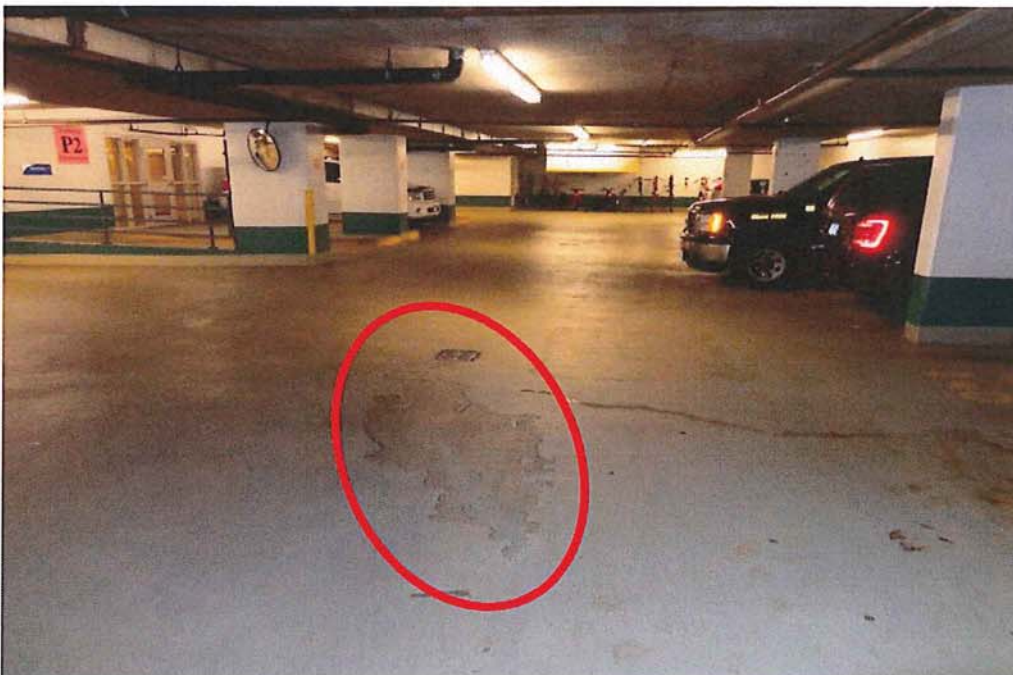
Photos No. 101 and 102

3.8.2	Polyurethane traffic coating membrane was observed to generally be in good condition with a few delaminated areas typically at the upper level parkade ramps and at the perimeter of parkade drains. Delaminations were specifically noted at or adjacent to: <ul style="list-style-type: none"> - Stall No. 6, P1 Ramp, P2 Ramp, Stall No. 78, Stall No. 91, Stall No. 100, Stall No. 104, Stall No. 124, P3 Ramp, the Pump Room on P3, Stall No. 151, Stall No. 193, Drain at P4 Ramp, Drain at P5 Ramp 	100-105

Recommendation: A targeted crack routing and membrane replacement program should be initiated for the parkade as part of a regular maintenance program. Visible cracks should be routed to 1/4" x 1/4" and any delaminated membrane should be removed. Polyurethane sealant should be applied to routed cracks. New polyurethane traffic coating should be applied to the targeted areas, including a base and top coat formulated for vehicular traffic applications.

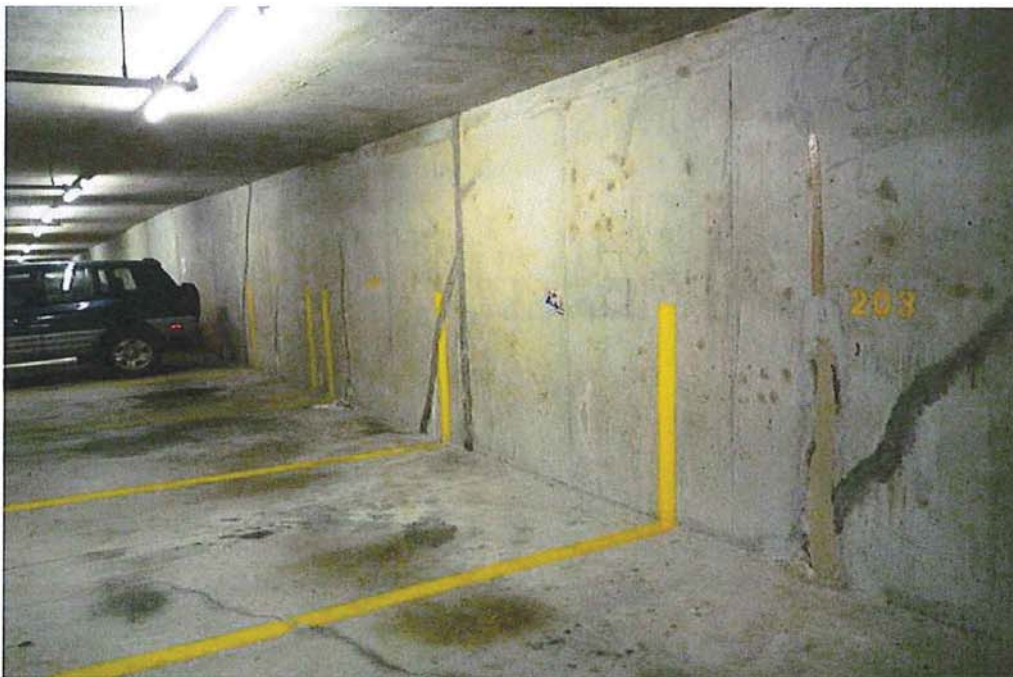
Photos No. 105 and 106

3.8.3	Previous crack injections have been completed throughout the parkade and have been observed to generally achieve success at limiting water ingress; however, some injections are still showing sign of ingress at: <ul style="list-style-type: none"> - Stall No. 34, Stall No. 195, Stall No. 205 and Stall No. 206 	106-108

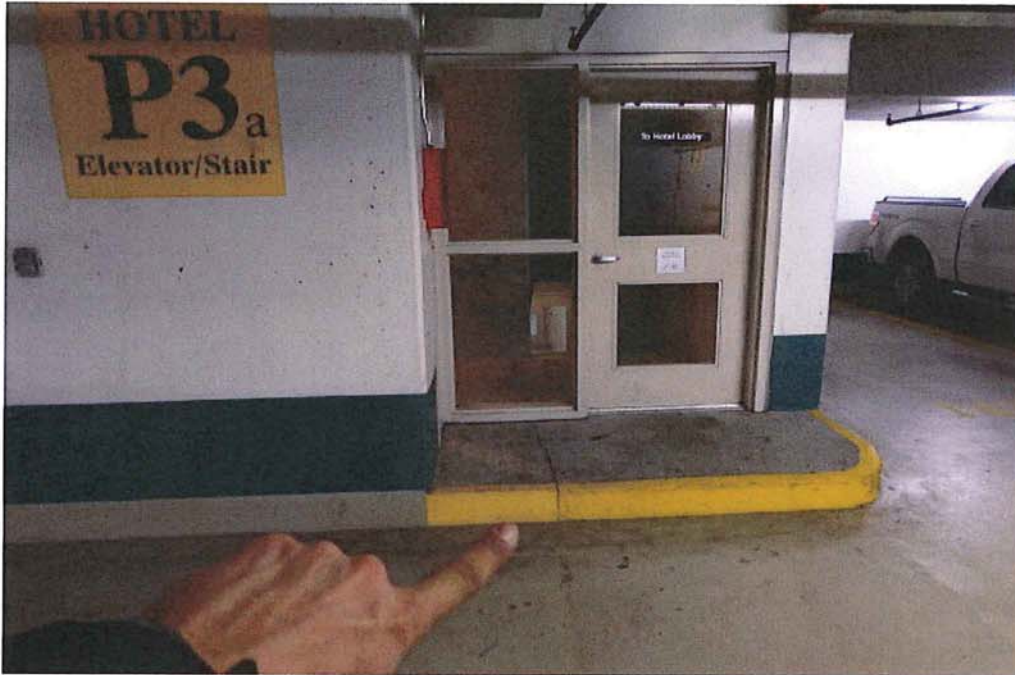
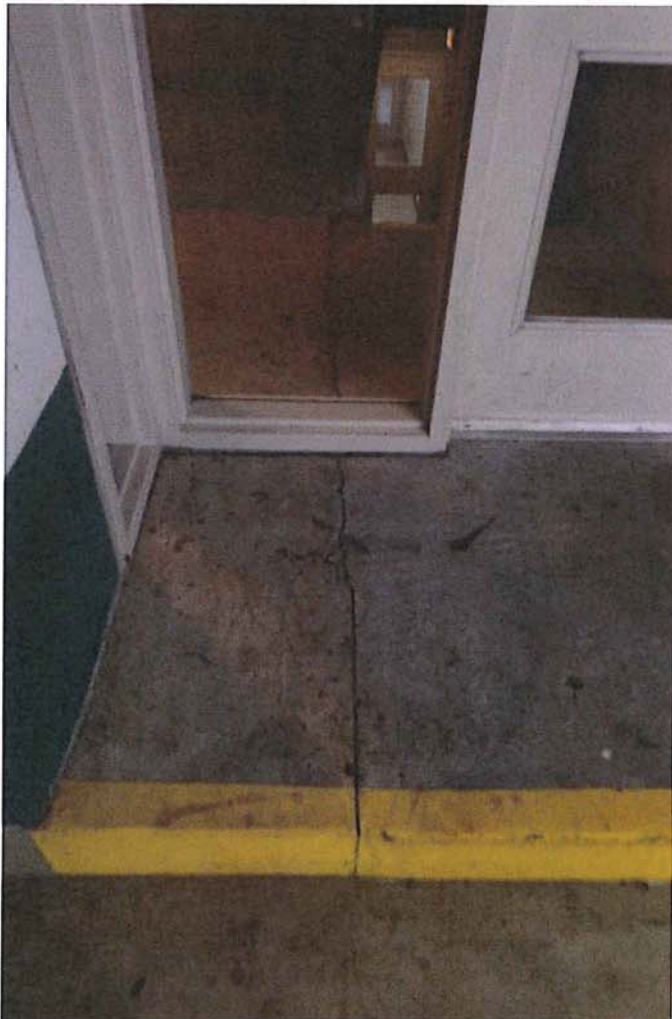
Photos No. 109 and 110

3.8.4	A crack was noted in the suspended slab at the Hotel stairway door at Level P3	109-110
3.8.5	Minor spalling concrete was noted at the slab-on-grade at Level P6	111

- 4.19 The crack in the suspended parkade slab located at the P3 hotel stairway could be related to concrete shrinkage of the parkade and stairway structures.

Recommendation: Monitor the crack by reviewing the width and the length regularly. If the crack is expanding a further structural review will be required. A movement joint should have been installed.

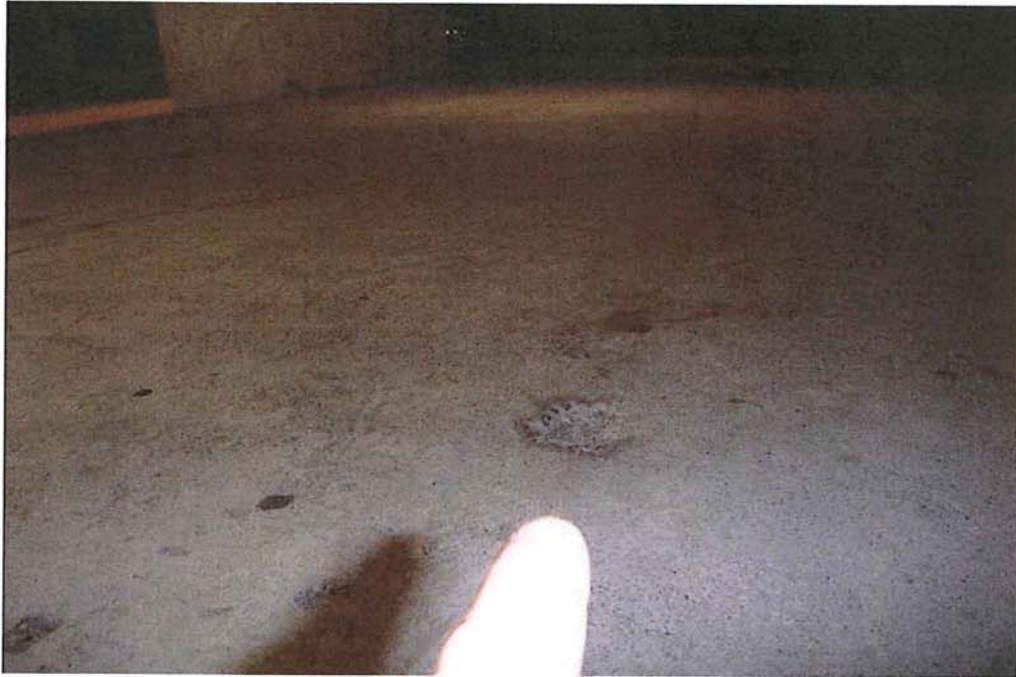
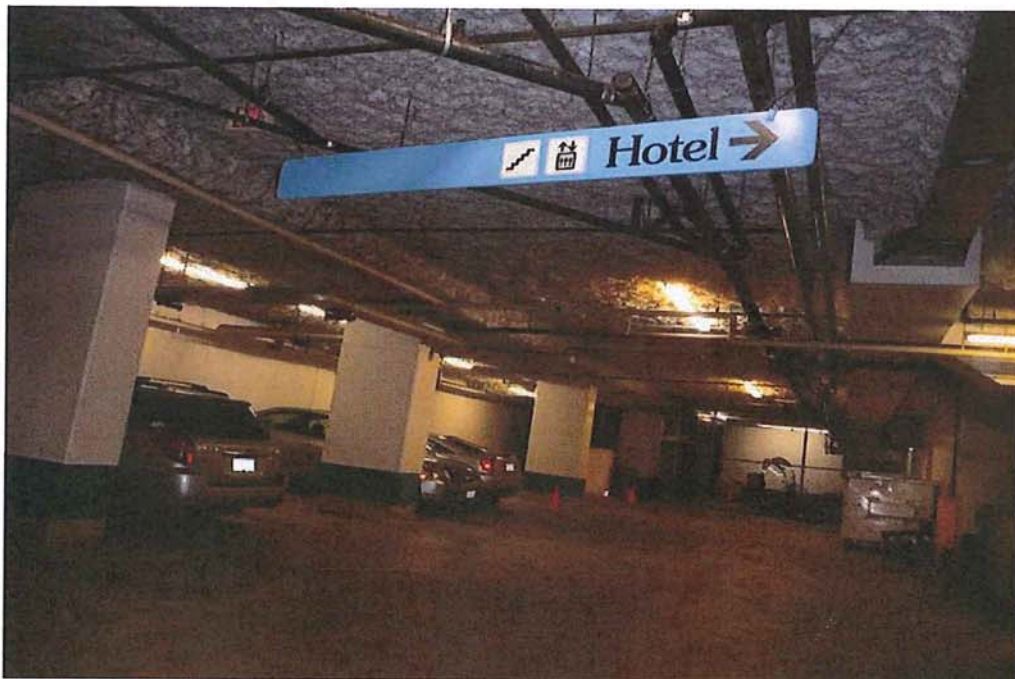
Photos No. 111 and 112

3.8.6	Sprayed fiberglass insulation was noted to be continuous for the building's footprint at the underside of the suspended floor slab.	112

- 4.20 Spalling concrete was observed at the slab-on-grade at P6. This is potentially a tripping hazard.

Recommendation: Repair spalling concrete with a concrete patching material.
