DEPRECIATION REPORT

BCS 2637 - "CORUS"
5989 WALTER GAGE ROAD
VANCOUVER, BC
YEAR 2013

January 30, 2013

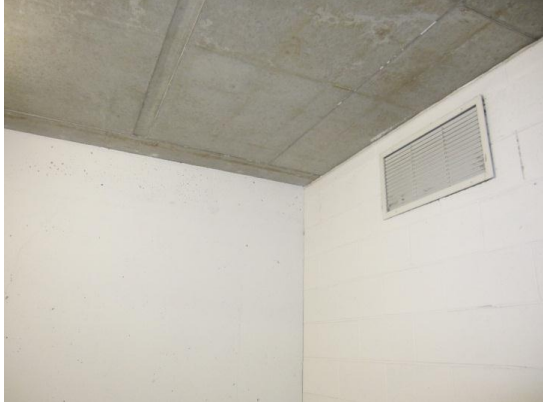
Component 1		Building - Structural and Architectural	Substructure and Underground Garage

Component Description	This component includes all below-grade portions of the building including footings, basement floors, walls, ceilings, columns, membrane, and expansion joints. These are typically poured concrete or masonry block.		
Reserve History	Year of Acquisition	2007	
	Description	Original to the building.	
Potential Deterioration	Potential deterioration includes water and road salt penetration of the surface of the concrete in the underground garage. Salt corrosion and water penetration of reinforcing rebar and freeze-thaw cycles could spall concrete in ceilings and walls in underground. Hydraulic pressure caused by poor drainage and settling could also cause concrete cracking. The membrane can be damaged by cracked concrete, wear and tear, and material breakdown due to age.		
Condition Analysis	Based upon a partial visual-inspection, this component appears to be in good condition for its age.

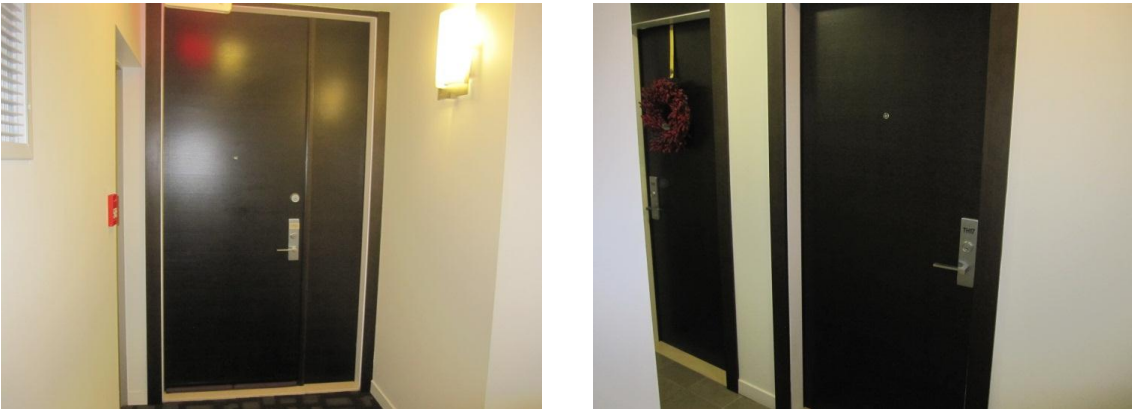
Component 2		Building - Structural and Architectural		Common Door Assemblies - Wood

Component Description	<p>Common door assemblies are generally manufactured or pre-hung fire-rated wood doors. These doors are manufactured to the standard fire prevention ratings of 20-minute, 45-minute, 60-minute, and 90-minute. Fire-rated doors are an integral part of not just the building’s passive fire-protection system but the building’s overall fire protection.</p>				
Reserve History	Year of Acquisition	2007			
	Description	Original to the building.			
Potential Deterioration	<p>Door hardware is subject to failure due to the constant usage in high traffic areas, such as busy corridors. Constant usage can lead to misalignment. Other common issues are holes or openings in the door assembly, improper gaps, and failure to latch.</p>				
Condition Analysis	<p>Based upon a partial visual-inspection, this component appears to be in good condition for its age.</p>

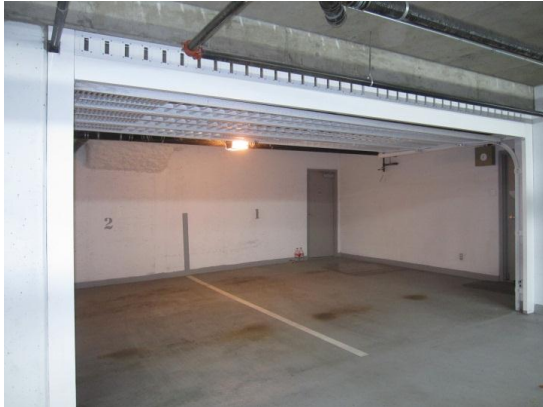
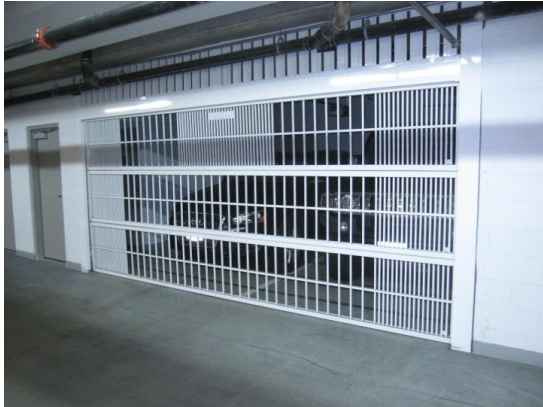
Component 4		Building - Structural and Architectural		Garage Door Assemblies - Metal

Component Description	Garage door assemblies may include single or double overhead wood / metal / fiberglass doors with automatic garage door openers, laser eye safety system and a pulley and spring system.				
Reserve History	Year of Acquisition	2007			
	Description	Original to the building.			
Potential Deterioration	Deterioration may occur from exposure to the sun and atmospheric chemicals. Physical impacts should be addressed when they occur.				
Condition Analysis	Based upon a partial visual-inspection, this component appears to be in good condition for its age.				
Life Cycle Analysis	Expected Lifespan	40 years			
	Effective Age	5 years			
	Remaining Lifespan	35 years			
Funding Analysis	Description	No money has been spent on this component to date.			
	Work	Removal and disposal of existing assembly, repairs or replacement as required. Appropriate safety precautions will be required.

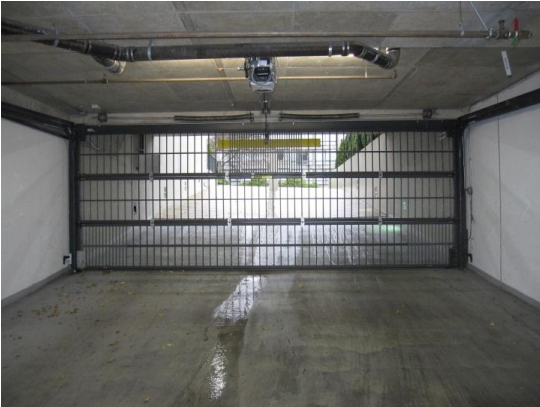
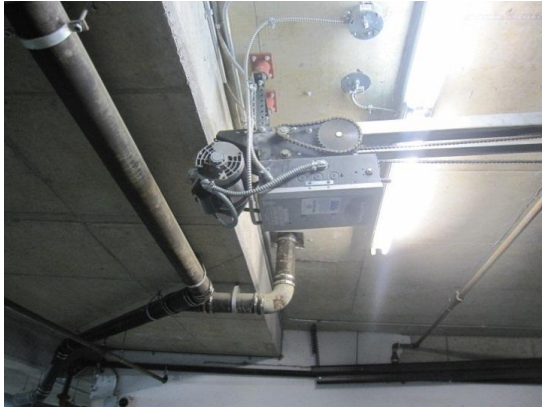
Component Description	A typical overhead door consists of several panels hinged together that roll along a system of tracks guided by rollers. Security gates are used to control vehicle access to specific areas. Gates are typically operated electronically, either by remote control or through some type of secure access system such as an intercom or card / fob reader.				
Reserve History	Year of Acquisition	2007			
	Description	Original to the building.			
Potential Deterioration	The track and rolling mechanism is subject to wear and tear from continuous use. Electronic failure of controls and access equipment. Mechanical failure of wheels or operator. Accidental collision or physical damage from shifts in building envelope. Exposure to the elements including corrosion.				
Condition Analysis	Based upon a partial visual-inspection, this component appears to be in good condition for its age.

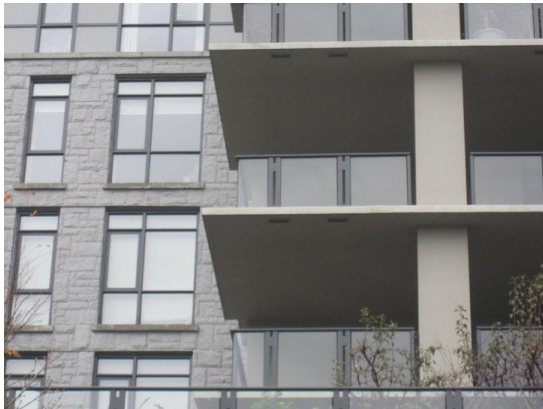
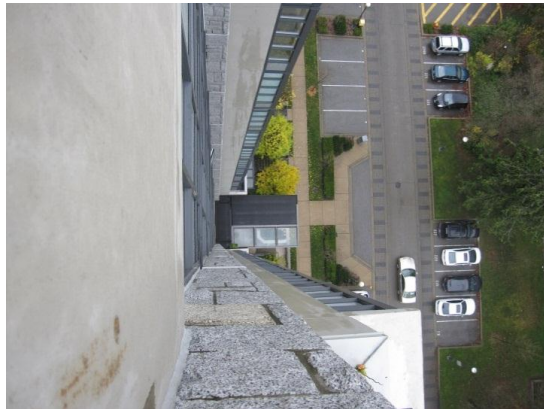
Component Description	Brick is primarily made from clay and shale which is then fired through a kiln at up to 2000 degrees. This process is called vitrification, which enables the clay particles to fuse together. Brick can last centuries and likely won't require patching or repairs for the first twenty-five years. Brick is a building material that has exceptional "thermal mass" properties. Thermal mass is the ability of a heavy, dense material to store heat and then slowly release it.				
Reserve History	Year of Acquisition	2007			
	Description	Original to the building.			
Potential Deterioration	Because bricks are porous – they expand or contract according to moisture levels and thermal influences – water is the principal cause of deterioration in brick at the building envelope. Mortar joint deterioration common. Water infiltration may cause staining and efflorescence, cracking/spalling/displacement, and deterioration in mortar joints.

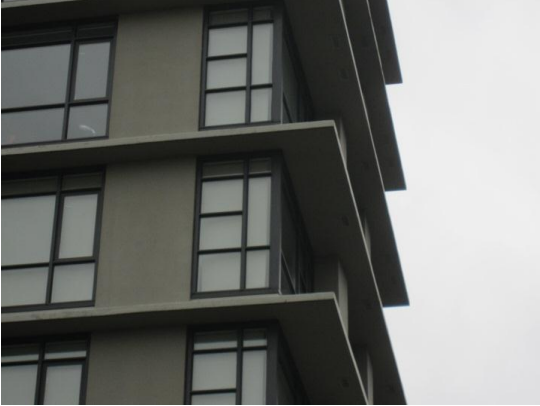
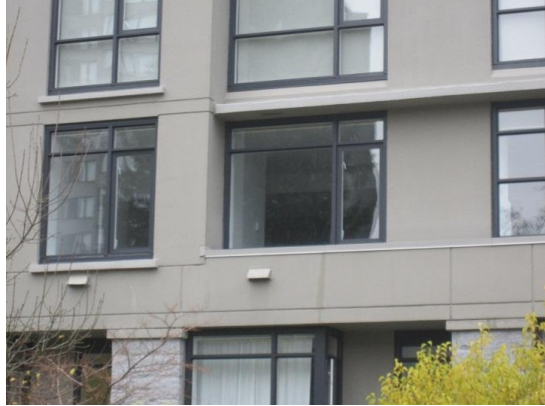
Component Description	Window walls are composed of vertical and horizontal metal framing members containing operable windows. These are nonbearing glass walls attached to the building's exterior structural frame.				
Reserve History	Year of Acquisition	2007			
	Description	Original to the building.			
Potential Deterioration	Windows are susceptible to the environment and weathering. Leaks can develop due to impact damage, seal deterioration, and improperly installed flashing.				
Condition Analysis	Based upon a partial visual-inspection, this component appears to be in good condition for its age.				
Life Cycle Analysis	Expected Lifespan	30 years			
	Effective Age	5 years			
	Remaining Lifespan	25 years			
Funding Analysis	Description	No money has been spent on this component to date.			
	Work	Removing and replacing the damaged window. Flashing and seal materials for trim. A budget equal to 30% of the estimated cost of the component is provided for periodic major repairs every 30 years.

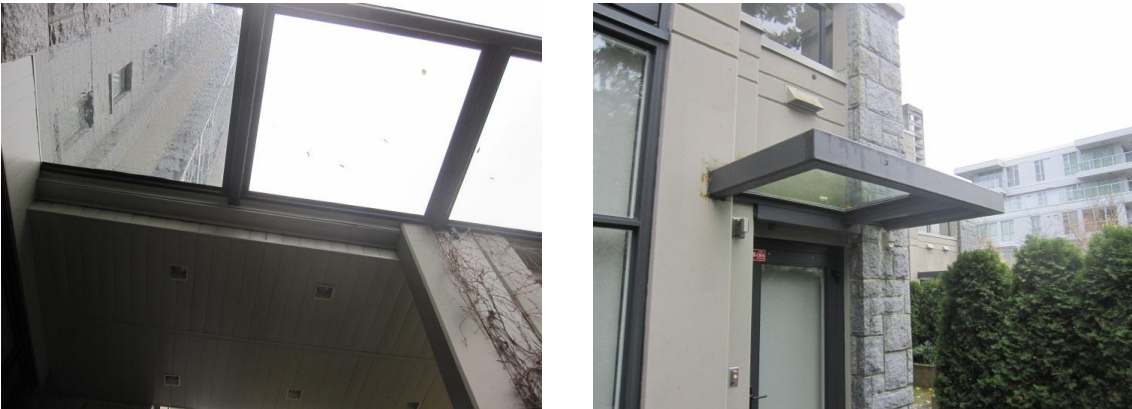
Component Description	<p>This component is a glass canopy system. The component consists of a metal support structure with glazing. These are affixed to the side of the building with metal fasteners and bolts. System includes sealant and gaskets for limiting moisture ingress.</p>		
Reserve History	Year of Acquisition	2007	
	Description	Original to the building.	
Potential Deterioration	<p>Physical impacts can break glass. Exposure to elements can undermine connectors and metal. Metal fatigue, seismic pressures and corrosion can affect structures stability. Seals and gaskets can deteriorate from UV light and exposure to elements.</p>		
Condition Analysis	<p>Based upon a partial visual-inspection, this component appears to be in good condition for its age.</p>		
Life Cycle Analysis	Expected Lifespan	30 years	
	Effective Age	5 years

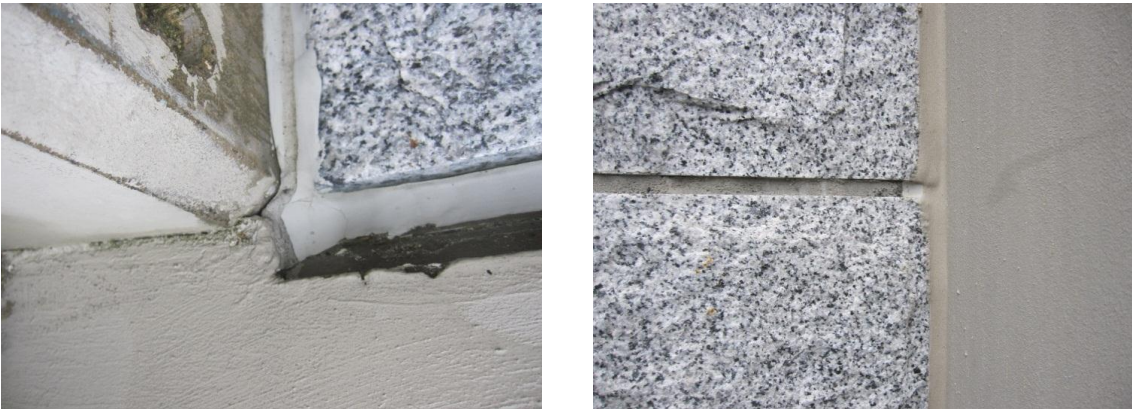
Component Description	<p>This component consists of all building caulking, silicone, weather-stripping, and polyurethane elastomeric sealant. It is applied around windows, exterior doors, roof flashing, rooftop equipment, and parapet walls. It would also include the sealant around moving components such as windows and doors.</p>				
Reserve History	Year of Acquisition	2007			
	Description	Original to the building.			
Potential Deterioration	<p>Sealants or gaskets can dry out and crack as a result of drying and thermal expansion / contraction. Caulking relies on flexibility to maintain seals between building materials and gradually succumbs to elements such as sunlight, rain, and temperature fluctuations. The caulking hardens and cracks allowing water penetration and heat loss.</p>				
Condition Analysis	<p>Based upon a partial visual-inspection, this component appears to be in good condition for its age.</p>

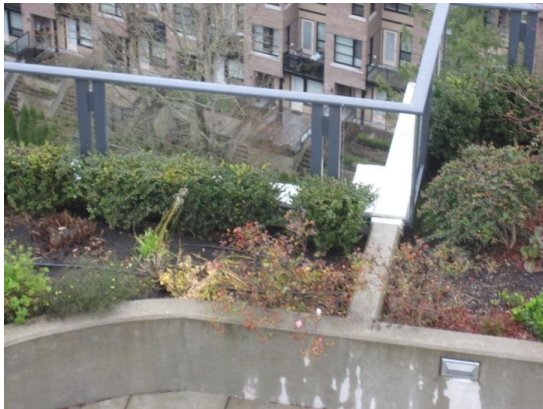
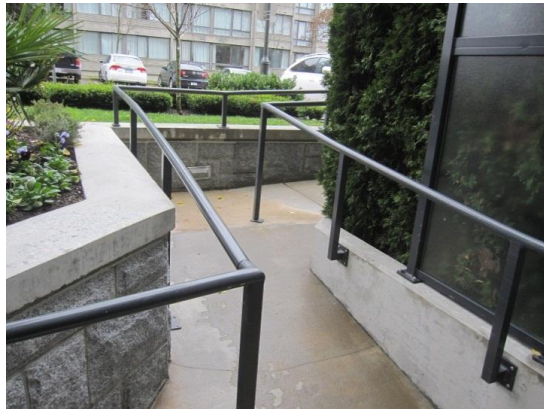
Component Description	Railings are an integral part of the building safety structure. Typical construction includes a rail system with posts bolted to the floor and wall.				
Reserve History	Year of Acquisition	2007			
	Description	Original to the building.			
Potential Deterioration	Railings can suffer from various deterioration, due primarily to exposure to the elements. Water can cause the metal to rust and weaken, penetration into concrete will weaken fasteners. Impacts can break glazing and dent metals. Railings can be replaced for aesthetic reasons.				
Condition Analysis	Based upon a partial visual-inspection, this component appears to be in good condition for its age.				
Life Cycle Analysis	Expected Lifespan	30 years			
	Effective Age	5 years			
	Remaining Lifespan	25 years			
Funding Analysis	Description	No money has been spent on this component to date.

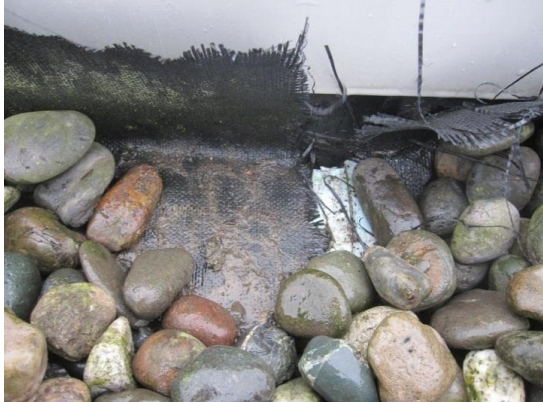
Component Description	<p>A roof system in which the principal roof covering is a single layer of flexible membrane often thermoset or thermoplastic. Thermoset membranes are compounded from synthetic rubber polymers, and the most commonly used polymers are EPDM, CSPE and Neoprene. Two of the most commonly-used thermoplastic single-ply membranes are PVC and TPO, both of them plastic-based materials.</p>				
Reserve History	Year of Acquisition	2007			
	Description	Original to the building.			
Potential Deterioration	<p>Roofing systems are susceptible to weather. Due to the thinner surface, these roof systems can be easily punctured. They have a relatively shorter life span than other roofing material and can be susceptible to water retention and seam failure.</p>				
Condition Analysis	<p>Based upon a partial visual-inspection, this component appears to be in good condition for its age.</p>

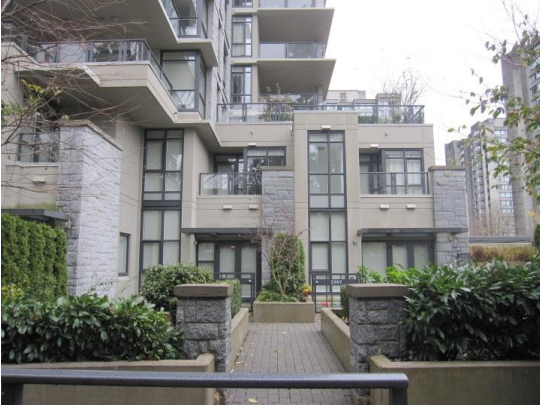
Component Description	This reserve item considers the preparation, priming, and painting of the exterior surfaces of the building. The type of paint which is suitable will be dependent on several factors, including the type of surface. Generally, applying the same type of paint as the original (e.g.. latex over latex or alkyd over alkyd) works best. Additionally, surface preparation, primer coats, and differing application methods must be considered.				
Reserve History	Year of Acquisition	2007			
	Description	Original to the building.			
Potential Deterioration	Includes exposure to the elements, such as wind, rain, snow, freeze-thaw cycles, and extreme temperature changes. UV light may deteriorate the paint and cause fading. Physical damage may occur from debris, vandalism, and impact damage.				
Condition Analysis	Based upon a partial visual-inspection, this component appears to be in good condition for its age.

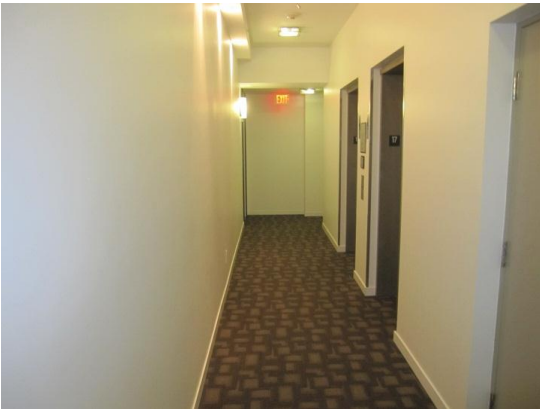
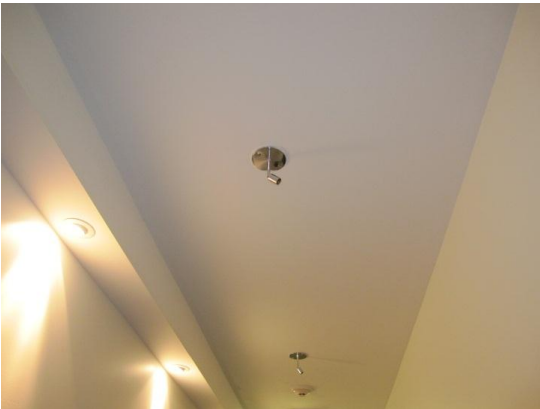
Component Description	This component refers to the common corridors inside the building. Component includes paint on walls and trim, and includes preparation for masking and finish. Interior latex paint is applied on common area walls and ceilings over a seal coat. Interior wood trim is painted with lacquer or gloss paint. Includes common side of doors. Excludes integrated construction unless noted. Excludes damage from repair work. Includes doors, casings, and trims as appropriate.				
Reserve History	Year of Acquisition	2007			
	Description	Original to the building.			
Potential Deterioration	Interior paint can deteriorate from UV sources, physical damage or water / moisture ingress. Repainting can also be done for aesthetic reasons.				
Condition Analysis	Based upon a partial visual-inspection, this component appears to be in good condition for its age.

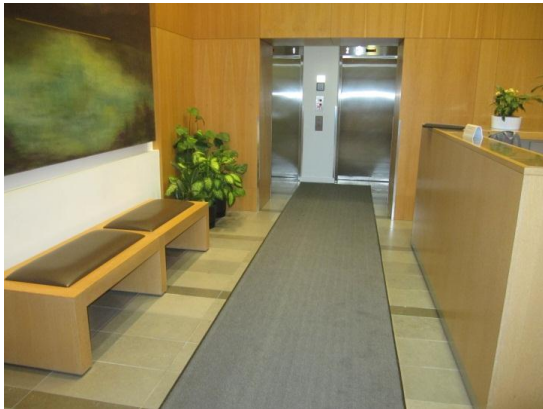
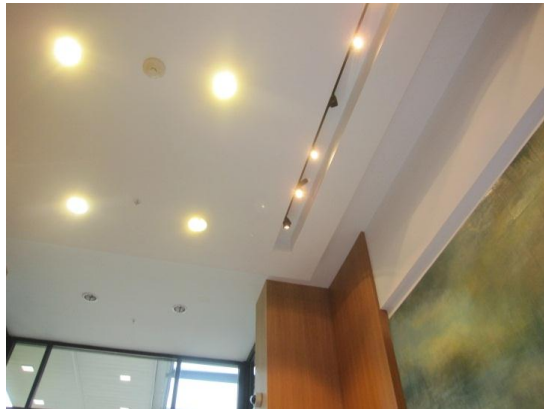
Component Description	This component comprises all of the reserve items and materials of the common lobby area(s), including flooring, wall finish, ceiling finish, fixtures, furnishings, and decorations.				
Reserve History	Year of Acquisition	2007			
	Description	Original to the building.			
Potential Deterioration	This component will typically experience wear and tear from owner and visitor use, which could include marking / damage to the wall surfaces including impact damage, damage to the flooring due to use, obsolescence of fixtures and furnishings due to diminished utility or dated design / aesthetics.				
Condition Analysis	Based upon a partial visual-inspection, this component appears to be in good condition for its age.				
Life Cycle Analysis	Expected Lifespan	22 years			
	Effective Age	5 years			
	Remaining Lifespan	17 years

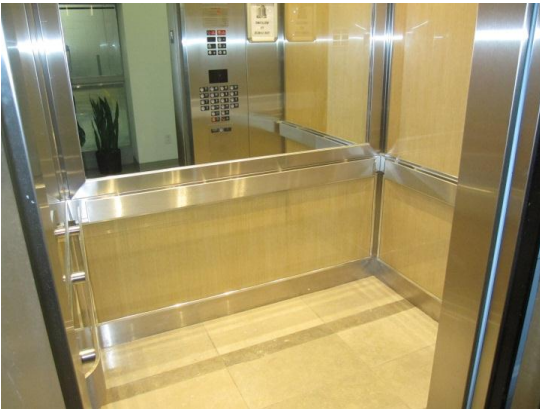
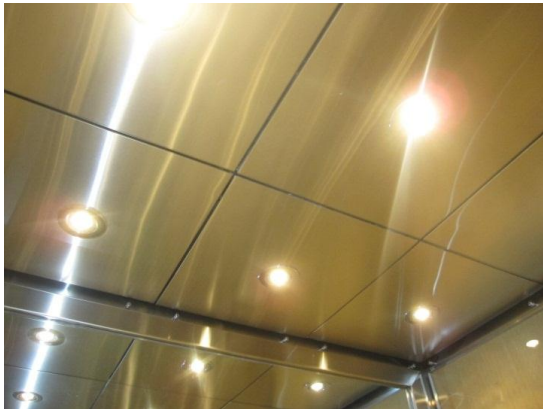
Component Description	This component covers the repair and replacement of the interior of the elevator cabs, including the flooring, wall panels, ceiling panels, ventilation fan, paint, light fixtures, and railings. This component does not include safety features, mechanical or electrical components within the elevator enclosure.				
Reserve History	Year of Acquisition	2007			
	Description	Original to the building.			
Potential Deterioration	The elevator cabs are most prone to impact damage caused by moving items in and out. Further damage is caused by wear and tear and vandalism. Most cab interiors are constructed of materials to allow for a certain resistance to deterioration of this type.				
Condition Analysis	Based upon a partial visual-inspection, this component appears to be in good condition for its age.

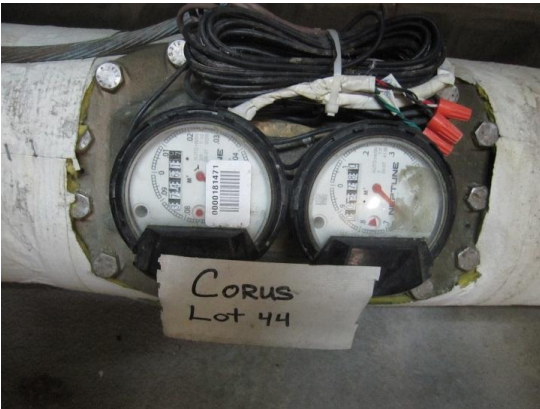
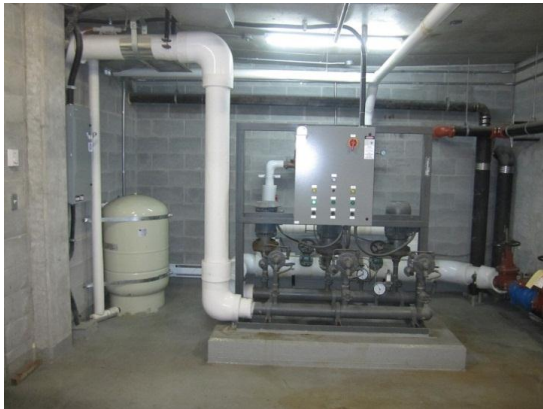
Component Description	Supply system to provide hot and cold water to the building via a main distribution system. Typically includes risers, branch lines, valves and backflow preventers. Backflow preventers are required on the main service and where irrigation and fire sprinkler systems connect to the water supply.				
Reserve History	Year of Acquisition	2007			
	Description	Original to the building.			
Potential Deterioration	Pinhole leaks at elbows. Contact between dissimilar metals can cause deleterious electrochemical reactions. Turbulence caused by improper bends and soldering can create leaks. Connections to fixtures can wear and break. Plastic resins can chemically change over time and become brittle. Vibration and stress can weaken joints. Valves can seize.				
Condition Analysis	Based upon a partial visual-inspection, this component appears to be in good condition for its age.

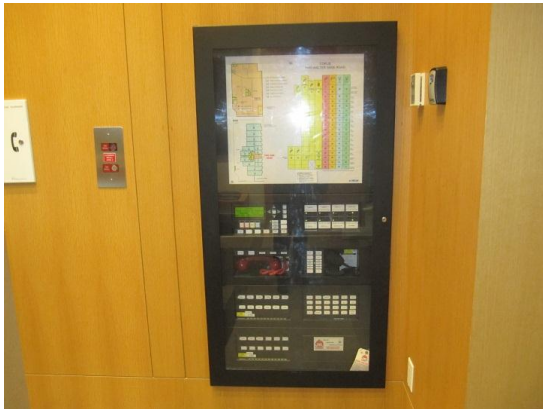
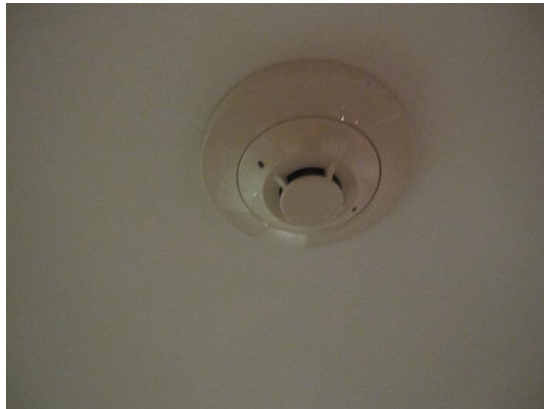
Component Description	An automatic fire alarm system is designed to detect fire by monitoring environmental changes associated with combustion. In general, a fire alarm system is classified as either automated, manual, or both. Automatic fire alarm systems are intended to notify the building occupants and emergency service responders in the event of a fire or other emergency. The system may include pull stations, enunciators, a fire panel, heat and smoke detectors, fire hoses, and fire extinguishers.				
Reserve History	Year of Acquisition	2007			
	Description	Original to the building.			
Potential Deterioration	Includes electrical failure, vandalism, and functional obsolescence. Exterior terminals will tend to have a shorter service life.				
Condition Analysis	Based upon a partial visual-inspection, this component appears to be in good condition for its age.
