DEPRECIATION REPORT

GEORGIA COURT
1823 EAST GEORGIA
VANCOUVER, B.C.

DATE: **NOVEMBER 4, 2015**

JRS PROJECT: VR14332

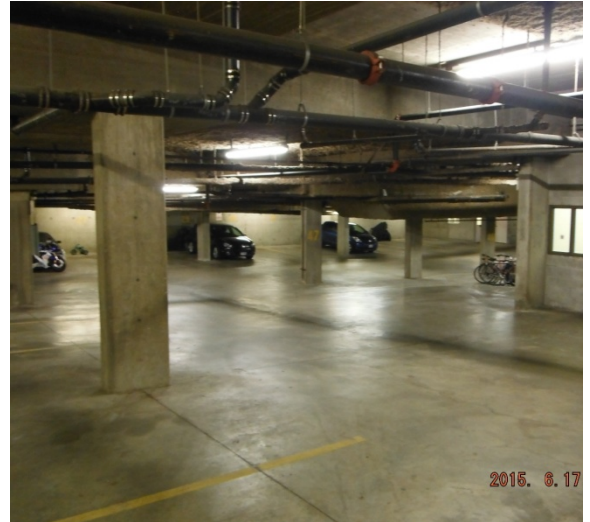
Location:	Parkade, Building Foundations
Year Installed:	1993
Typical Service Life (yrs):	50
Effective Age (yrs):	22
Remaining Service Life (yrs):	28
Planned Renewal Date:	2043

Description: The concrete structure consists of the parkade foundation walls, ceiling, and the exposed exterior foundation walls.

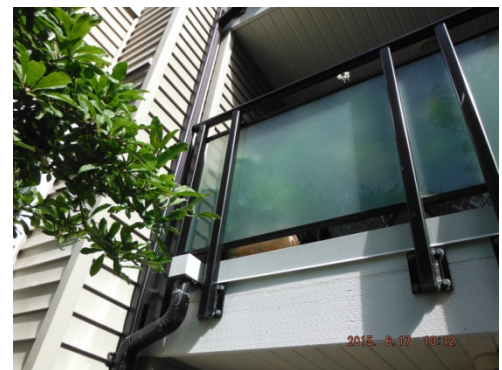
Balcony Guardrails

Location:	Balconies
Year Installed:	2009
Typical Service Life (yrs):	40
Effective Age (yrs):	6
Remaining Service Life (yrs):	34
Planned Renewal Date:	2049

Description: This component consists of the guardrails for the second, third, and fourth floor balconies.

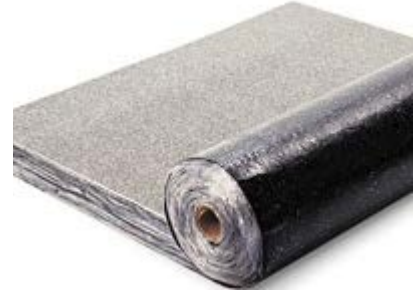
Location:	Balconies
Year Installed:	2009
Typical Service Life (yrs):	40
Effective Age (yrs):	6
Remaining Service Life (yrs):	34
Planned Renewal Date:	2049

Description: The balcony membrane assemblies were observed to be made up of a torch down 2-ply waterproofing membrane.

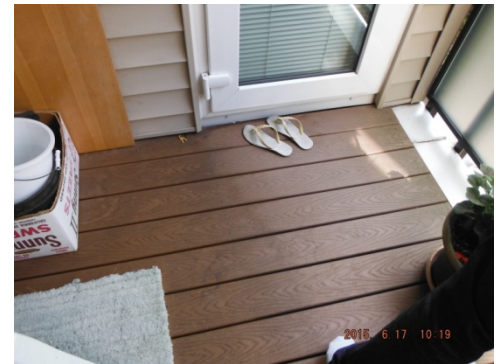
Location:	Balconies
Year Installed:	2009
Typical Service Life (yrs):	20
Effective Age (yrs):	6
Remaining Service Life (yrs):	14
Planned Renewal Date:	2029

Description: This component includes the wood planks on the balconies that sit on top of the balcony membrane assemblies.

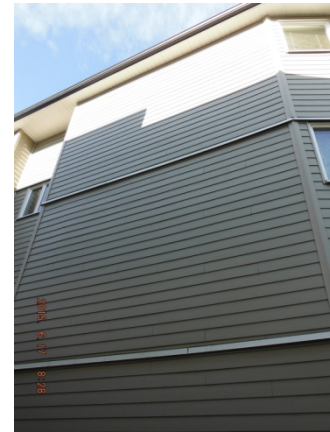
Location:	East Elevation
Year Installed:	2009
Typical Service Life (yrs):	40
Effective Age (yrs):	6
Remaining Service Life (yrs):	34
Planned Renewal Date:	2049

Description: A portion of the exterior wall on the east elevation was observed to be made up of fibre cement cladding.

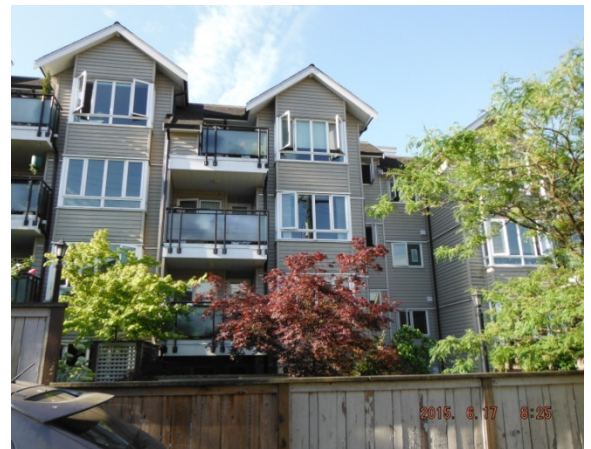
Location:	Exterior Walls
Year Installed:	2009
Typical Service Life (yrs):	40
Effective Age (yrs):	6
Remaining Service Life (yrs):	34
Planned Renewal Date:	2049

Description: The vinyl siding makes up a majority of the exterior walls throughout the building. The vinyl siding can be considered as a “rainscreen” assembly. This means it is constructed with a drainage cavity.

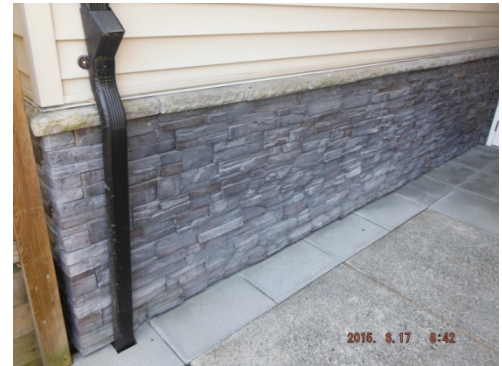
Location:	North and South Entrance
Year Installed:	2009
Typical Service Life (yrs):	30
Effective Age (yrs):	6
Remaining Service Life (yrs):	24
Planned Renewal Date:	2039

Description: Masonry stone cladding is used on the first level at the front and back entrance.

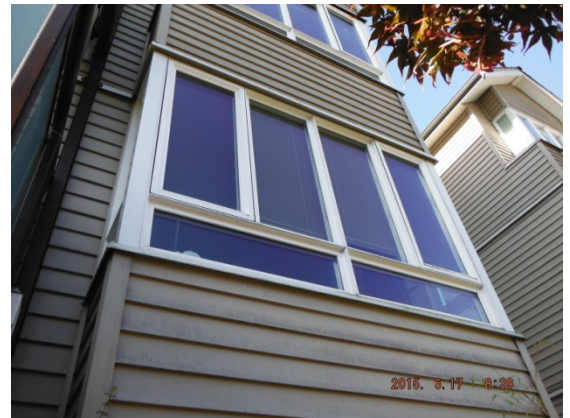
Location:	Building Exterior
Year Installed:	2009
Typical Service Life (yrs):	40
Effective Age (yrs):	6
Remaining Service Life (yrs):	34
Planned Renewal Date:	2049

Description: The window assemblies are double panes insulated glazing units (IGUs) with a vinyl frame.

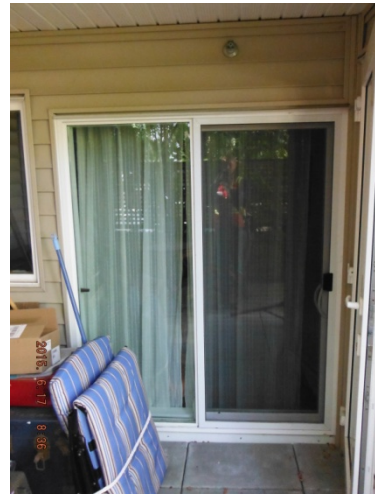
Location:	Balconies & Patios
Year Installed:	2009
Typical Service Life (yrs):	40
Effective Age (yrs):	6
Remaining Service Life (yrs):	34
Planned Renewal Date:	2049

Description: The sliding doors are vinyl framed, with double glazed IGUs.

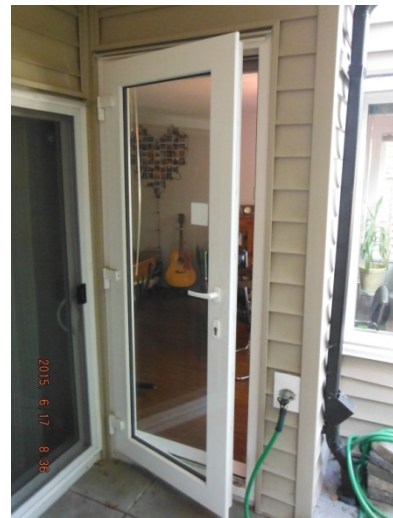
Location:	Balconies & Patios
Year Installed:	2009
Typical Service Life (yrs):	40
Effective Age (yrs):	6
Remaining Service Life (yrs):	34
Planned Renewal Date:	2049

Description: This component includes the exterior entrance doors located at balconies and the patios.

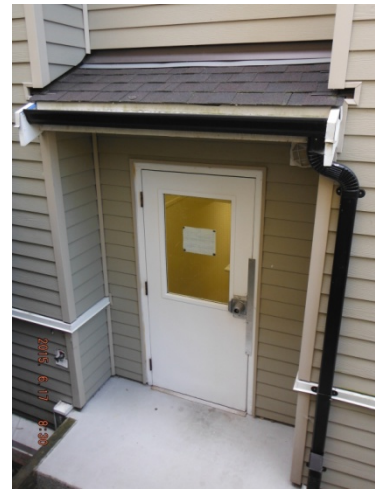
Location:	East, West and South Elevations
Year Installed:	1993
Typical Service Life (yrs):	40
Effective Age (yrs):	22
Remaining Service Life (yrs):	18
Planned Renewal Date:	2033

Description: This component includes the exterior entrance doors to the common areas of the building.

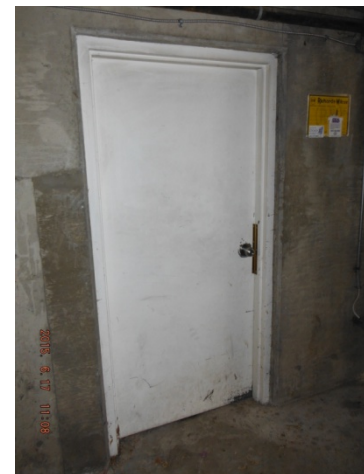
Location:	Parkade
Year Installed:	1993
Typical Service Life (yrs):	50
Effective Age (yrs):	22
Remaining Service Life (yrs):	28
Planned Renewal Date:	2043

Description: Metal clad service doors provide secure entry to utility rooms and building entrances.

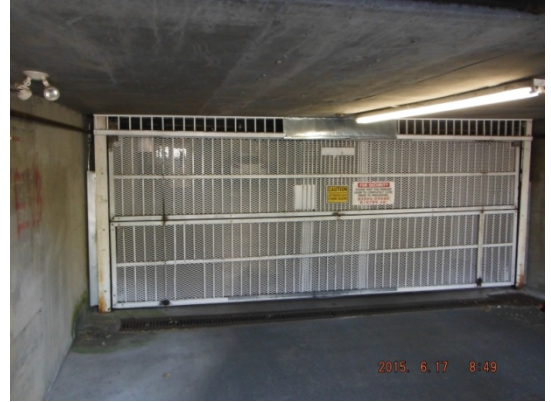
Location:	Parkade Entrance
Year Installed:	1993
Typical Service Life (yrs):	25
Effective Age (yrs):	19
Remaining Service Life (yrs):	6
Planned Renewal Date:	2021

Description: The parkade gate is comprised of metal panel sections connected by hinges. The gate rises along a track and is powered by a motor.

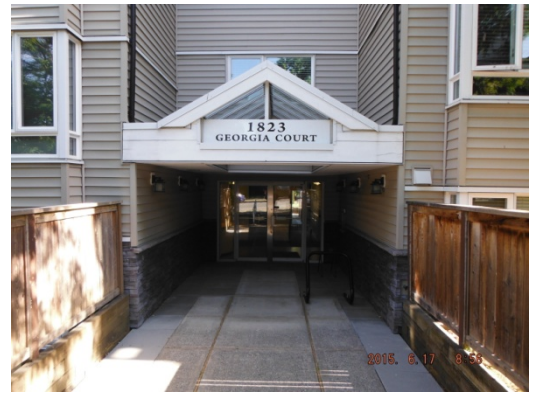
Location:	North Elevation
Year Installed:	2009
Typical Service Life (yrs):	20
Effective Age (yrs):	6
Remaining Service Life (yrs):	14
Planned Renewal Date:	2029

Description: This component consists of the skylights, low slope roof, and steep slope roof portion of the canopy at the front entrance.

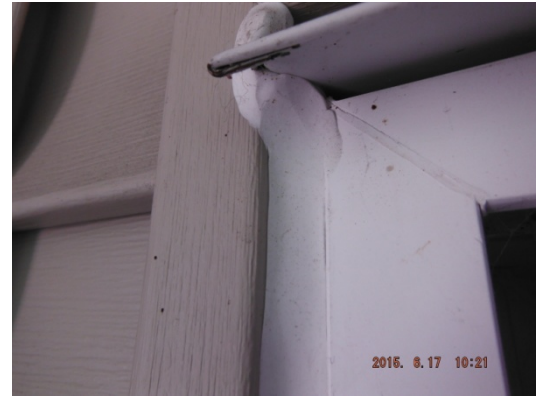
Location:	Window & Door Perimeters
Year Installed:	2009
Typical Service Life (yrs):	10
Effective Age (yrs):	6
Remaining Service Life (yrs):	4
Planned Renewal Date:	2019

Description: Sealant was observed around the windows and doors. Sealant is installed to allow for a continuous water shedding surface and to allow for movement between adjacent components.

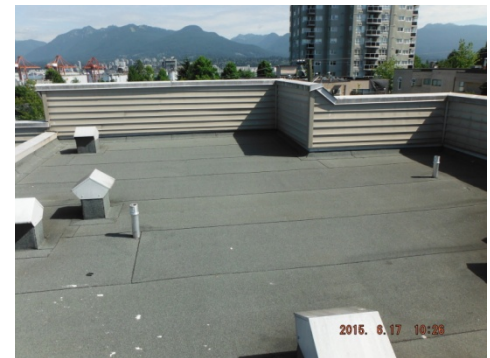
Location:	Flat Roof
Year Installed:	2009
Typical Service Life (yrs):	30
Effective Age (yrs):	6
Remaining Service Life (yrs):	24
Planned Renewal Date:	2039

Description: The low slope roofs consist of a torch on 2-ply membrane, flashings, ventilation, and roof drains.

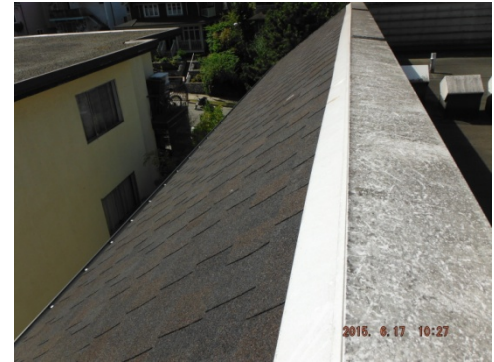
Location:	Pitched Roof
Year Installed:	2009
Typical Service Life (yrs):	30
Effective Age (yrs):	6
Remaining Service Life (yrs):	24
Planned Renewal Date:	2039

Description: Pitched roofing exists over all building sections and consists of asphaltic shingles.

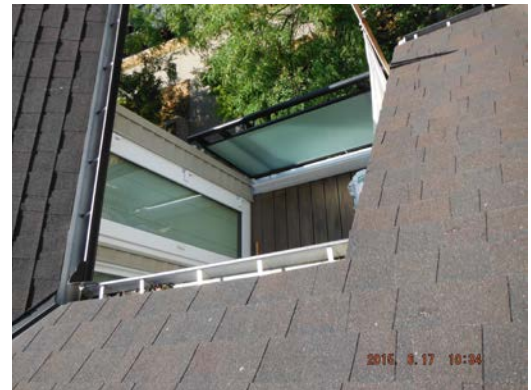
Location:	Building Exterior & Roof Edge
Year Installed:	2009
Typical Service Life (yrs):	15
Effective Age (yrs):	6
Remaining Service Life (yrs):	9
Planned Renewal Date:	2024

Description: The metal gutters and downspouts typically run around the roof perimeter and balconies and down the walls.

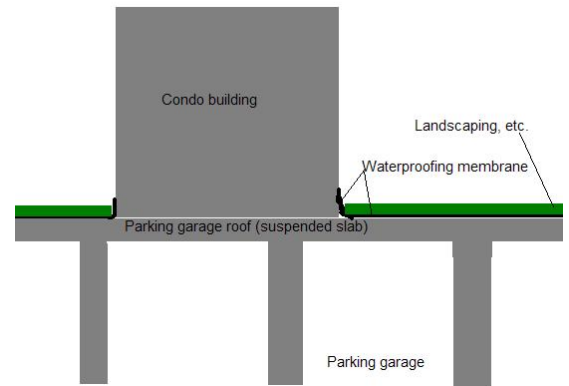
Location:	Underground, Above Parkade
Year Installed:	1993
Typical Service Life (yrs):	50
Effective Age (yrs):	22
Remaining Service Life (yrs):	28
Planned Renewal Date:	2043

Description: The below-grade membrane is applied to the horizontal surface of the parkade ceiling slab. The membrane is applied to help prevent water ingress into the concrete structure below.

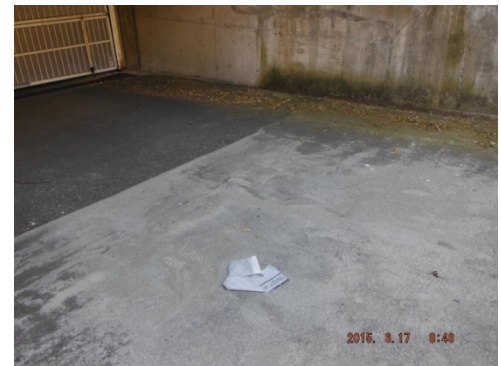
Location:	Parkade Sloped Entrance
Year Installed:	1993
Typical Service Life (yrs):	20
Effective Age (yrs):	15
Remaining Service Life (yrs):	5
Planned Renewal Date:	2020

Description: The parkade vehicular membrane is found only on the entrance ramp into the parkade. It is used to help protect the concrete structure in the parkade below it.

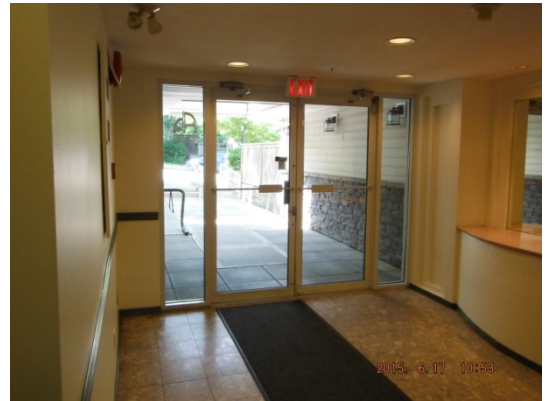
Location:	Main Entrance Interior
Year Installed:	20
Typical Service Life (yrs):	20
Effective Age (yrs):	15
Remaining Service Life (yrs):	5
Planned Renewal Date:	2020

Description: This asset includes wall and ceiling finishes, tile flooring, and decor pieces located in the building lobby.

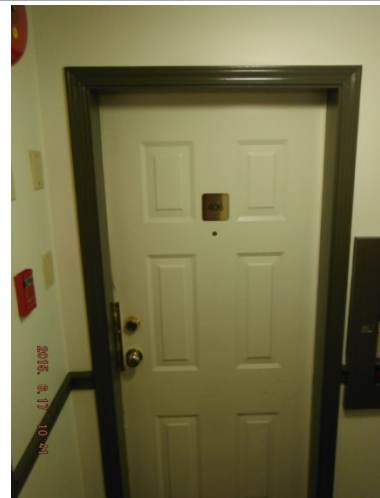
Location:	Suite Entry Doors
Year Installed:	1993
Typical Service Life (yrs):	50
Effective Age (yrs):	22
Remaining Service Life (yrs):	28
Planned Renewal Date:	2043

Description: This component includes unit entry doors.

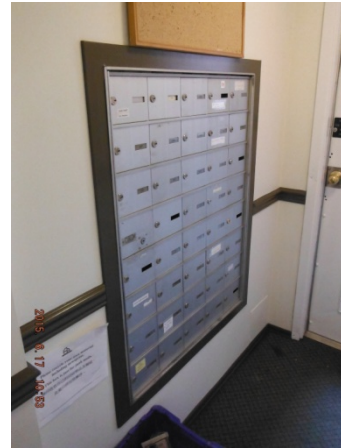
Location:	Main Entrance Interior
Year Installed:	1993
Typical Service Life (yrs):	30
Effective Age (yrs):	22
Remaining Service Life (yrs):	8
Planned Renewal Date:	2023

Description: The mailboxes are found in the lobby of the building on ground level.

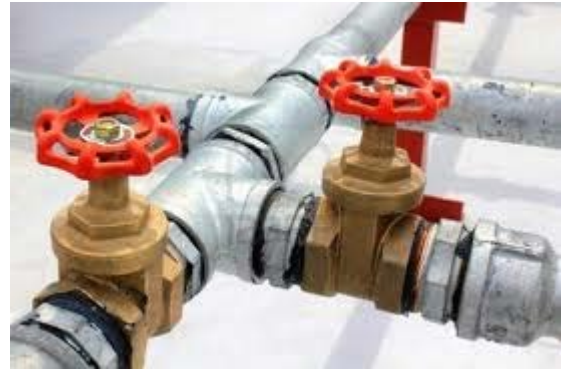
Location:	Shared and Common Walls
Year Installed:	1993
Typical Service Life (yrs):	30
Effective Age (yrs):	22
Remaining Service Life (yrs):	8
Planned Renewal Date:	2023

Description: The domestic water piping is located in shared and common walls throughout the building.

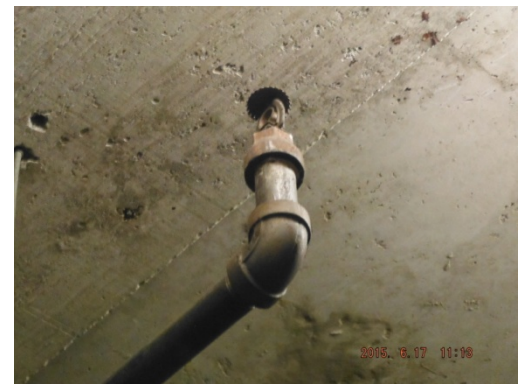
Location:	Parkade
Year Installed:	1993
Typical Service Life (yrs):	50
Effective Age (yrs):	22
Remaining Service Life (yrs):	28
Planned Renewal Date:	2043

Description: This physical asset includes sprinkler pipes and heads in the parkade.

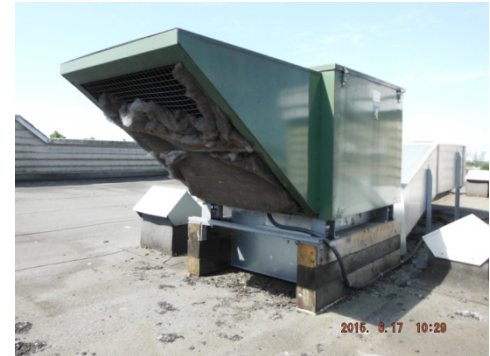
Location:	Flat Roof Top
Year Installed:	2011
Typical Service Life (yrs):	20
Effective Age (yrs):	4
Remaining Service Life (yrs):	16
Planned Renewal Date:	2031

Description: There is one make-up air unit that supplies heated air to the common hallways of the building.

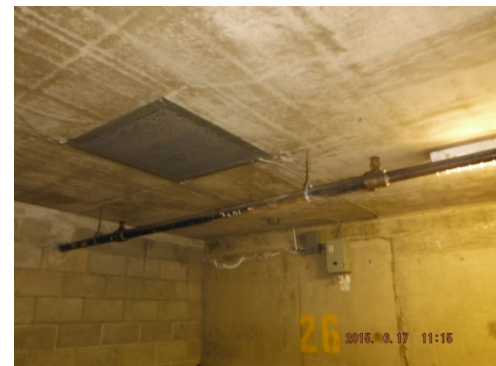
Location:	Parkade
Year Installed:	1993
Typical Service Life (yrs):	15
Effective Age (yrs):	10
Remaining Service Life (yrs):	5
Planned Renewal Date:	2020

Description: The parkade exhaust fan works to remove gases from the parkade area.

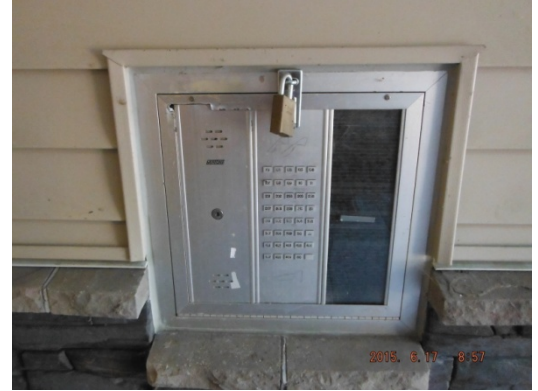
Description: The enterphone allows for secure access to the building.

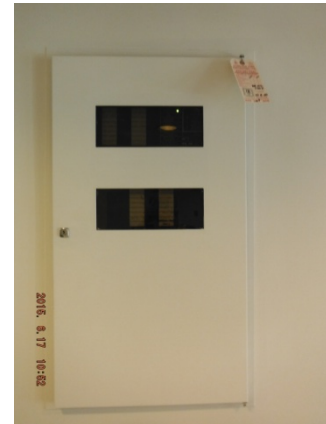
Description: This component includes the emergency lighting found throughout the building, as well as the fire alarm panel.

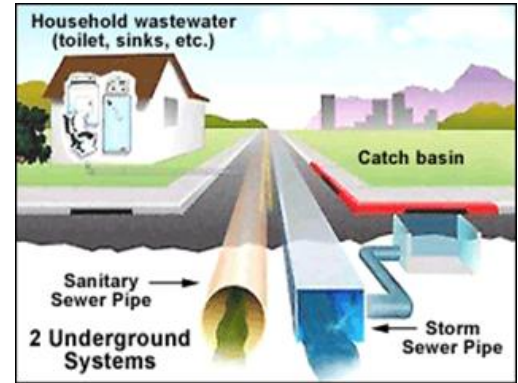
Description: This component includes building perimeter drainage, as well as underground piping running from city water supply to the building.

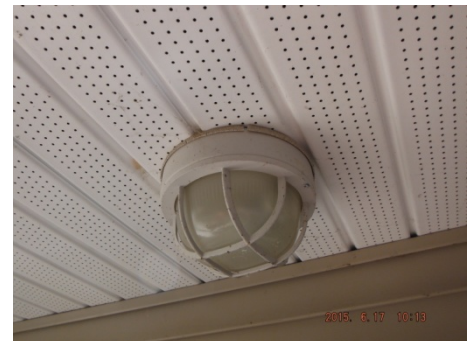
Description: The outdoor lighting includes wall and ceiling mounted fixtures featured at entry doors, garage doors, patios, and balconies.

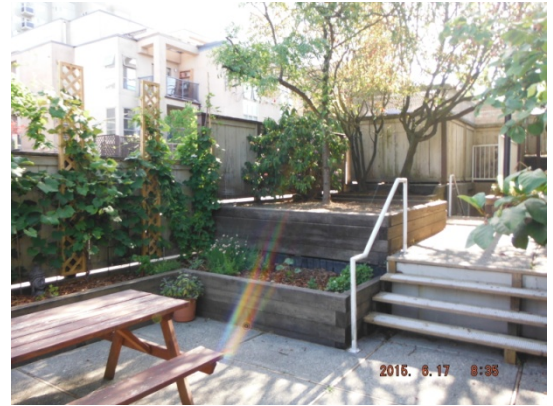
Description: The retaining walls are comprised of wood and include the planters.

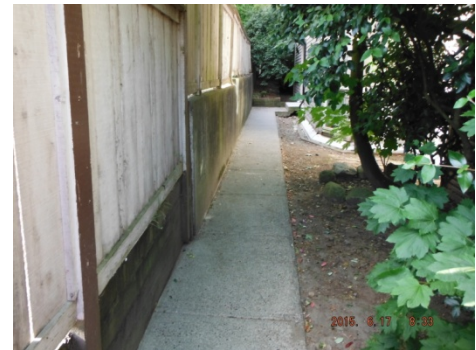
Description: The concrete retaining walls are found at the outdoor staircases and parkade entrance.

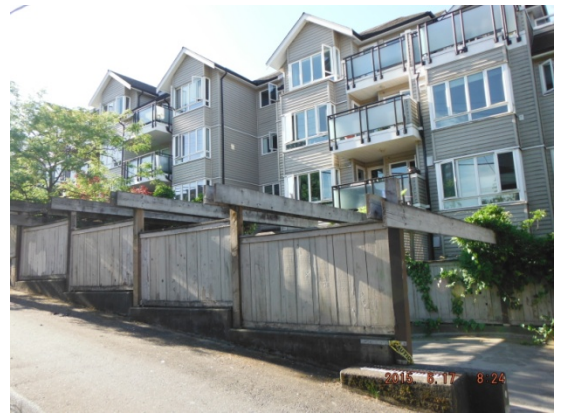
Description: The fencing is made up of wood and borders the ground level patios and the building.

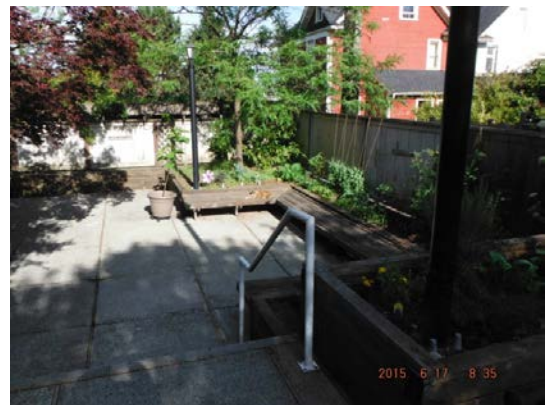
Description: The wooden benches are attached to the wood planters in the courtyard.

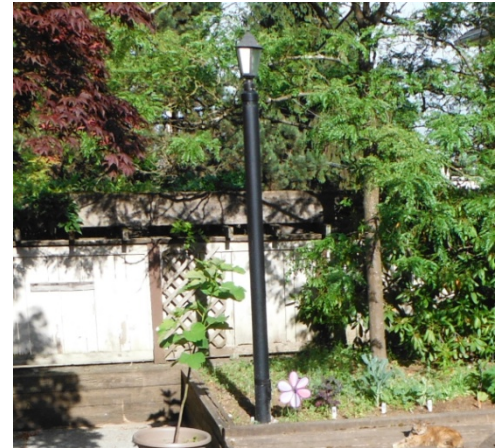
Description: The lamp posts are found in the courtyard on the backside of the building.

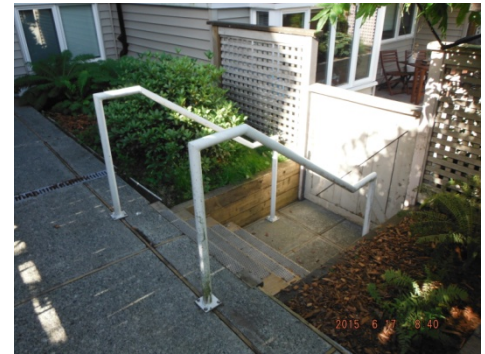
Description: The metal site railings are found at staircases surrounding the building.
