2018 DEPRECIATION REPORT
UPDATE (REVISED)
FOR
PACIFIC LANDMARK II,
930 CAMBIE STREET, VANCOUVER

June 19, 2019
Sense's Project No. 17A004A

EXECUTIVE SUMMARY

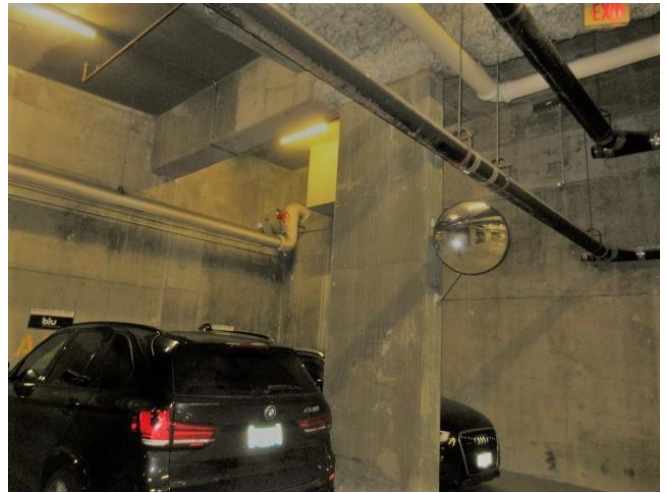
Most of the structural components are concealed from view. We noted no evidence of unusual settlement, displacement, or structural cracking in the areas reviewed.

Photo 1: Typical structural frame in the parking garage.

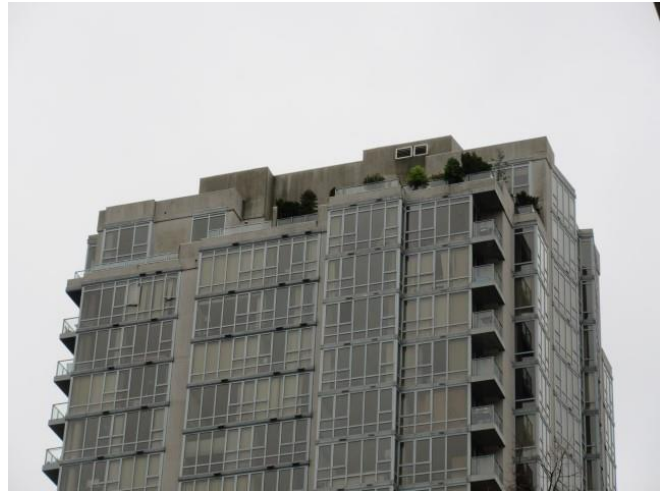
We did not access a suite with a balcony; however, based on past reports and our understanding, the balconies, pedestrian traffic coating, and guards are all in relatively good condition. The 2013 Depreciation Report indicated that guard fasteners are rusting and the finish to the guards is faded.

Photo 2: Typical balconies at corners of the building.

The projected expenditures allow for an evaluation of the condition of the balconies, to better develop a scope and timing of required maintenance and repairs in relation to the concrete, pedestrian coating, guard finishes and fasteners, etc. Pending this evaluation, the projected expenditures allow for periodic programs of re-coating of the balconies, including local repairs to the concrete and guard fasteners.

The balcony slabs should be checked regularly to identify and remove any loose concrete that may form at the slab edges or soffits. We assume this will be done as part of ongoing maintenance.

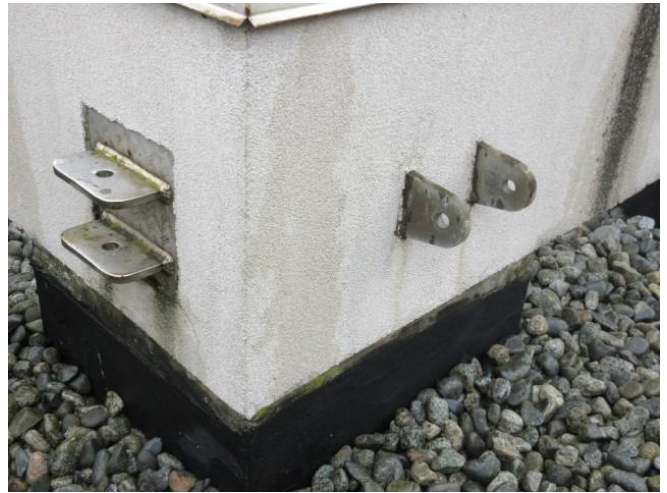
Photo 3: Typical roof anchors.

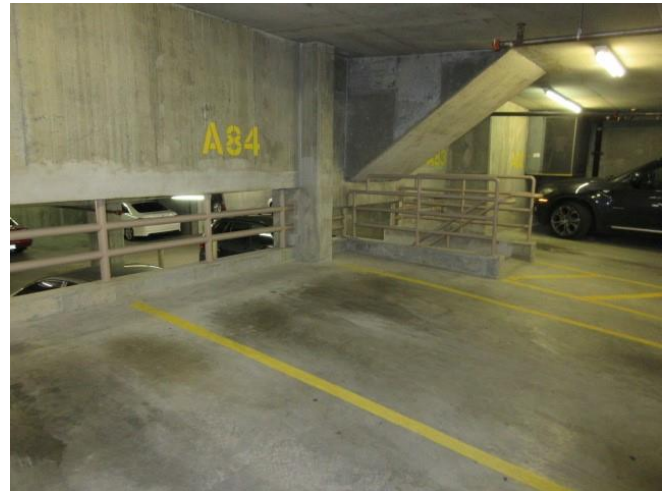
Photo 4: Typical parking garage.

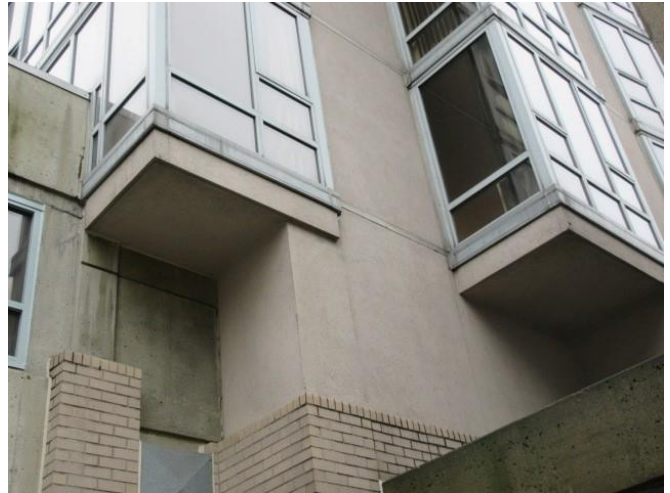
Photo 5: Typical exterior walls.

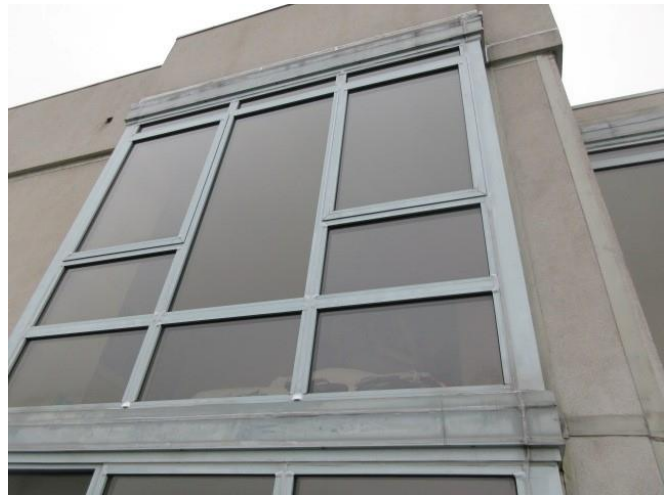
Photo 6: Typical window wall.

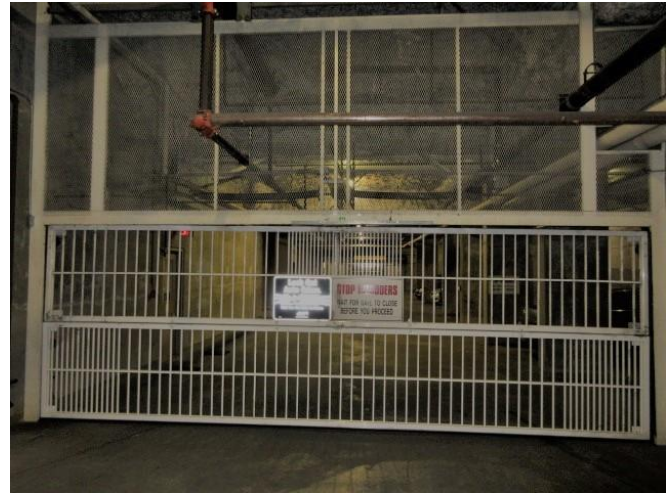
Photo 7: Door separating commercial and residential areas.

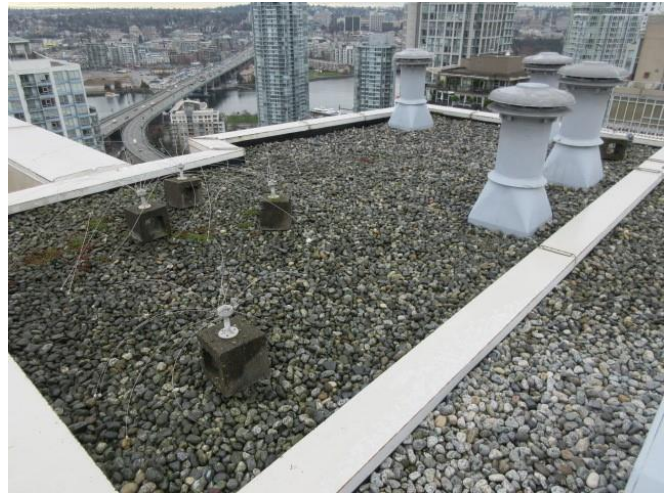
Photo 8: Mechanical penthouse roof.

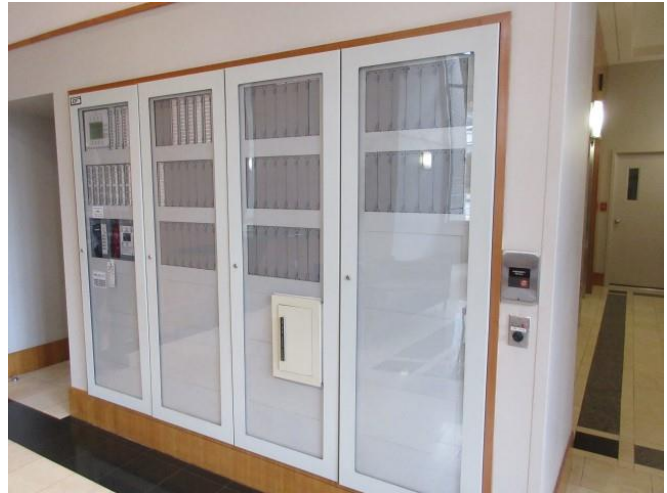
Photo 11: Fire alarm control panel.

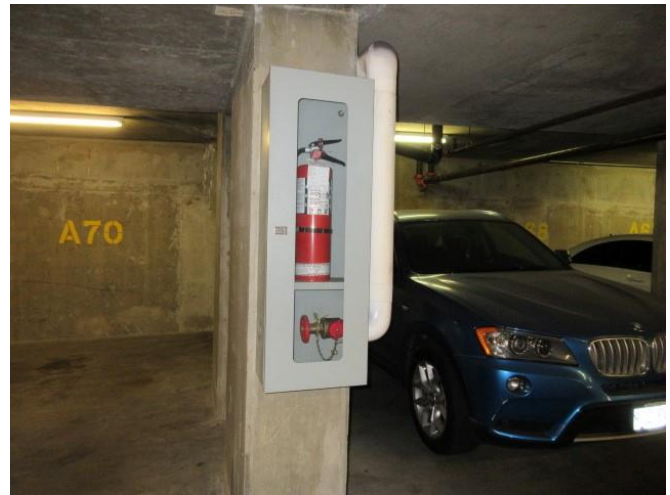
Photo 12: Typical fire extinguisher and hose connection.

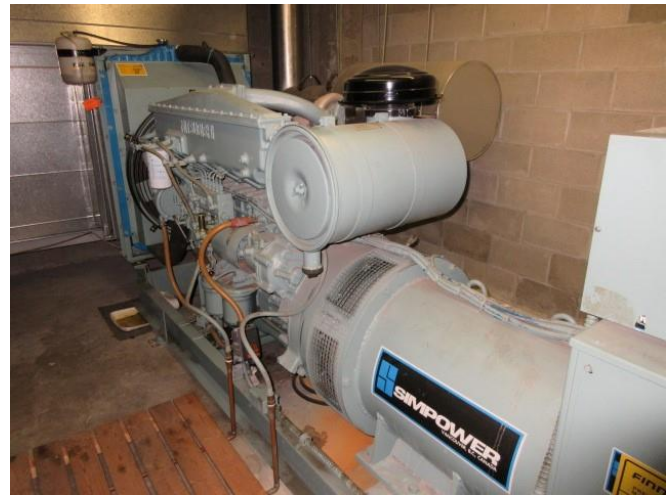
Photo 13: Emergency generator.

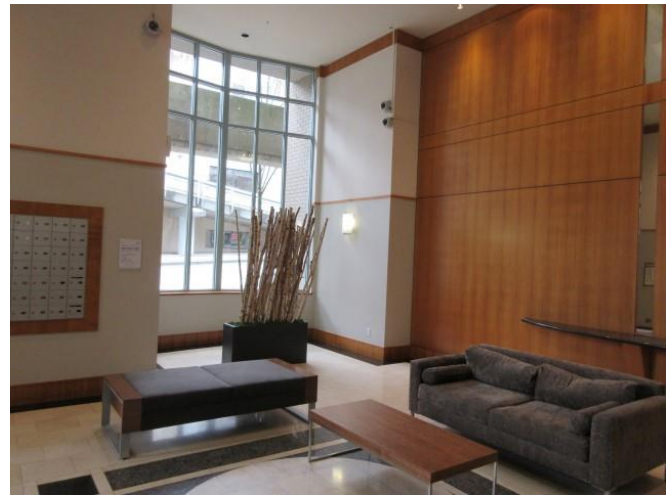
Photo 14: Main entrance lobby.

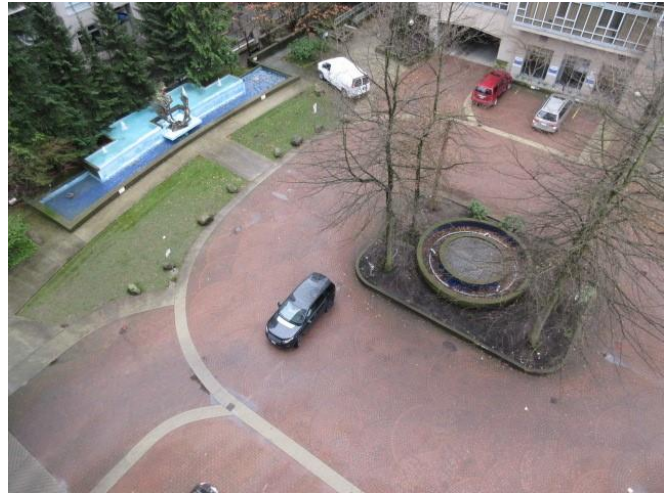
Photo 15: Entrance drive and water features.

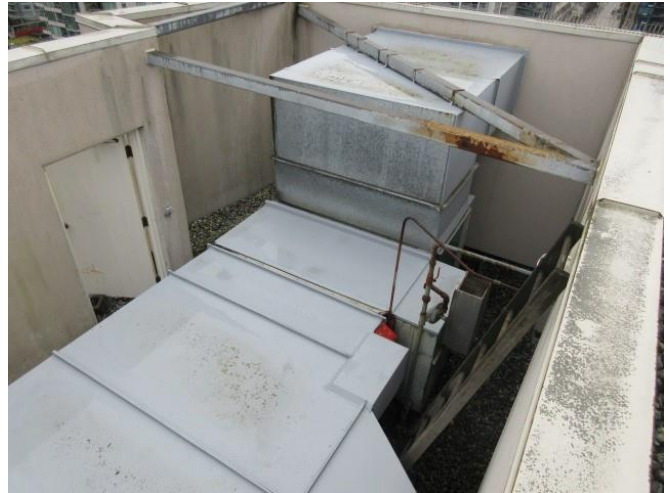
Photo 16: Roof-top make up air unit.

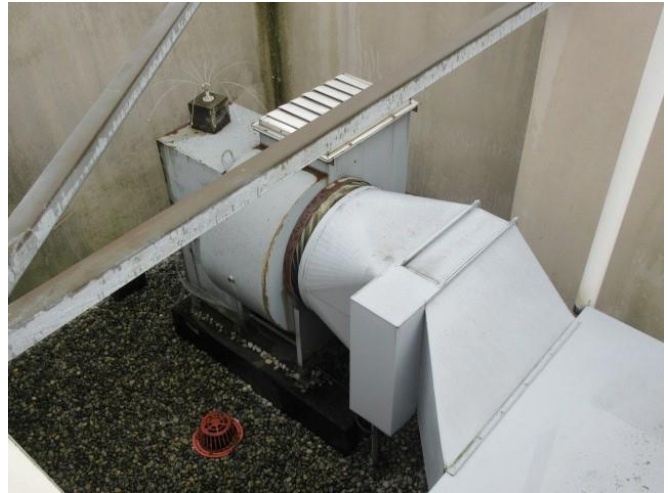
Photo 17: Smoke exhaust fan.

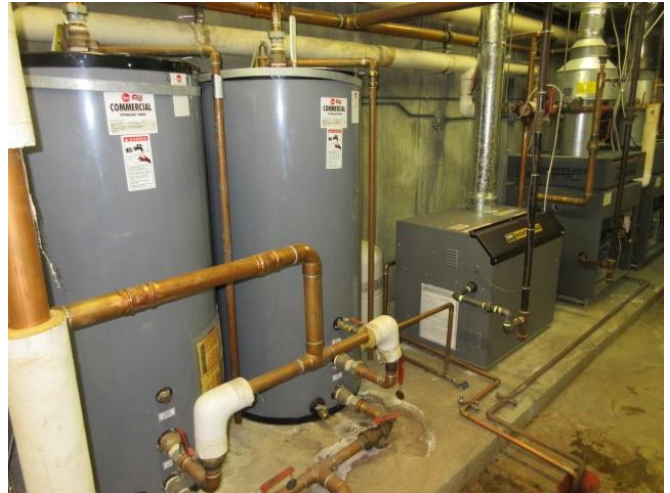
Photo 18: Typical domestic hot water boilers and storage tanks.

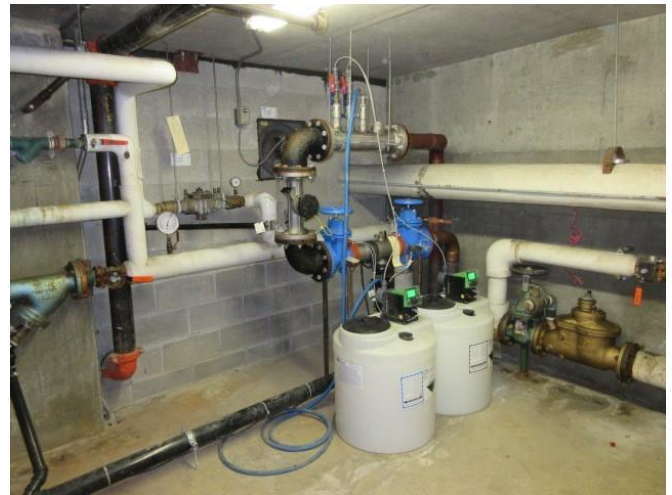
The Building Operator indicated that there had been frequent pin hole leaks in the distribution piping over the years, until the water started to be treated by Hytec in 2013. Since, there have been few occurrences of pinhole leaks, and where there have been leaks they have been on the recirculation lines.

Photo 19: Domestic water and Hytec equipment.

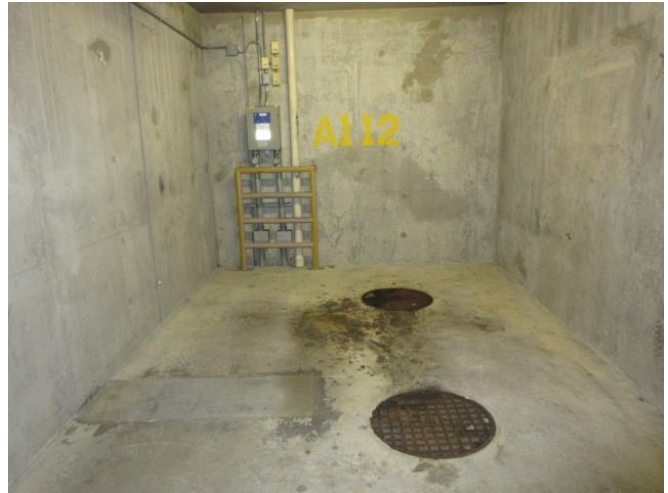
Photo 20: Typical storm sump controls.

The condition of the buried and concealed piping cannot be evaluated visually. We recommend that drains be flushed and scoped routinely. This maximizes the service life of the piping and help identify repair needs. We assume this will be done as part of ongoing maintenance.

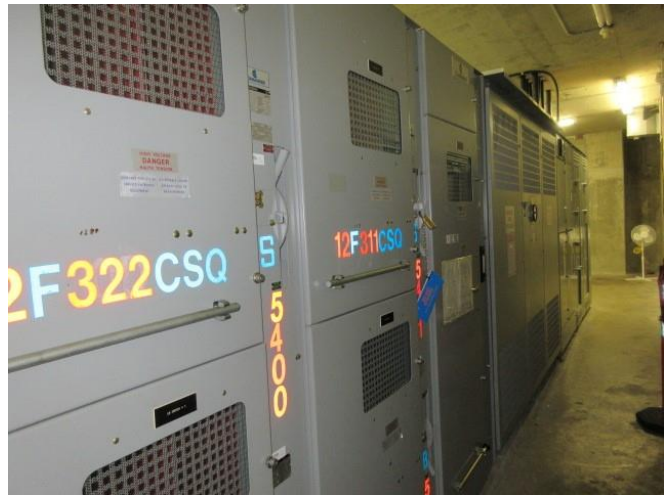
Photo 21: Main electrical equipment.

We recommend that all panels and equipment be thermally scanned every few years to identify hot spots that require repair. The scans, and related repairs found to be needed (assuming minor tightening, etc.) are assumed to be an operating expense.

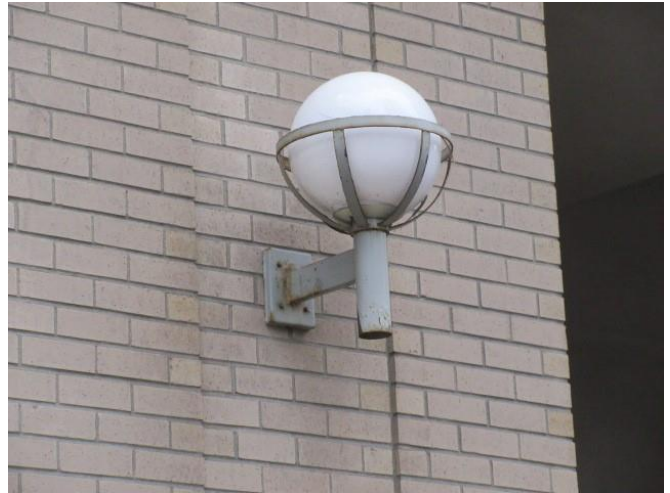
Photo 22: Typical exterior lighting.

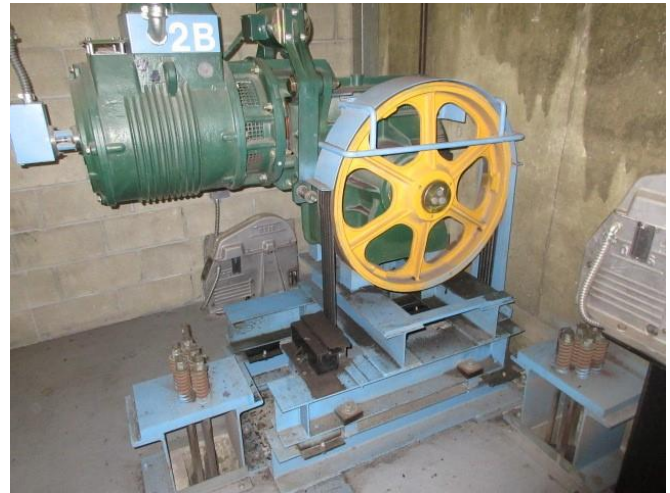
Photo 23: Typical elevator machine.

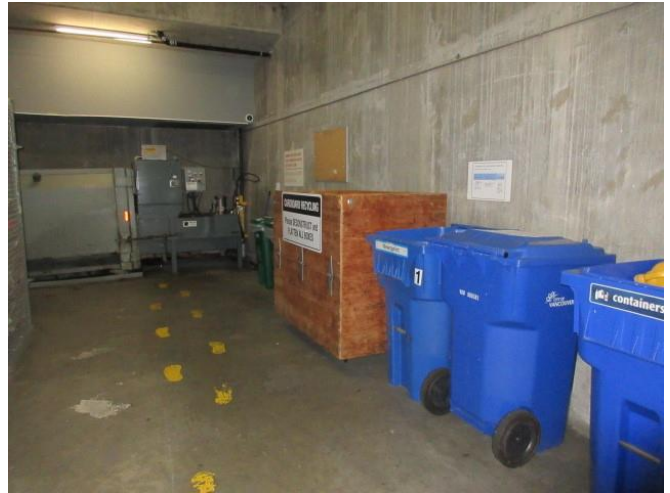
Photo 24: Garbage room with compactor and recycle bins.

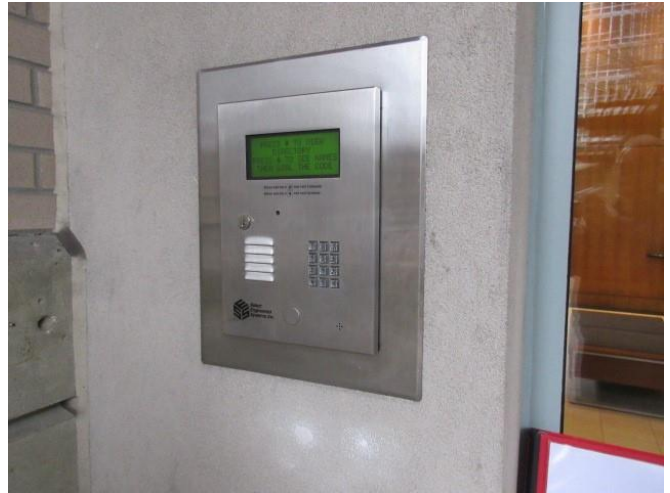
Photo 25: Enterphone panel.
