## Depreciation Report

### Robinson Tower Strata Corporation LMS 1902

488 Helmcken Street, Vancouver, British Columbia

January 22, 2014

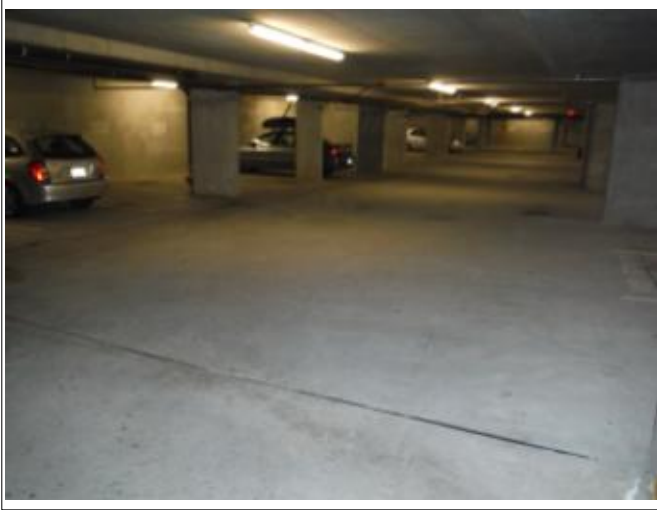
SS01

| Row | COMPONENT | | CONDITION ASSESSMENT | | | RECOMMENDATION | | | LIFE CYCLE DATA | | | | | |
|---|---|---|---|---|---|---|---|---|---|---|---|---|---|---|
| 2 | A1010 Standard Foundations-concrete | Slab on Grade/ P3 | P3 parkade floor is a slab on grade and it is in good condition. Photo #SS01. | Good | 1995 | The slab on grade is expected to last the life of the building with regular maintenance. No anticipated capital expenses; however a regular allowance to address cracking is recommended. | Repair Allowance | 3 | 19 | 5 | 1 | 1 | N | \$2,000 |

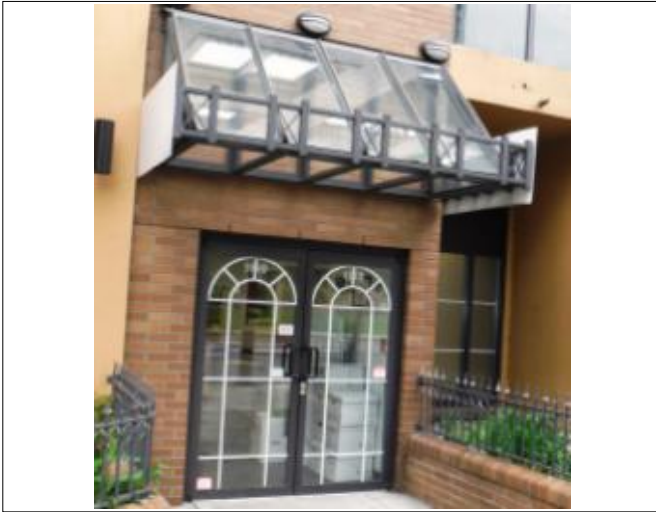
BE14

| Row | COMPONENT | | CONDITION ASSESSMENT | | | RECOMMENDATION | | | LIFE CYCLE DATA | | | | | |
|---|---|---|---|---|---|---|---|---|---|---|---|---|---|---|
| 26 | B2030 Exterior Doors Storefront | Commercial Units /Entry Doors | Each commercial unit has an aluminum framed double glazed storefront entry door. Photo #BE14. A few commercial units replaced the entry unit in the past. | Good | Varied | Replace original ones at end of expected service life. Repair included in sliding units repair allowance. | Renewal | 3 | N/A | 35 | 15 | 1 | Y | \$29,000 |

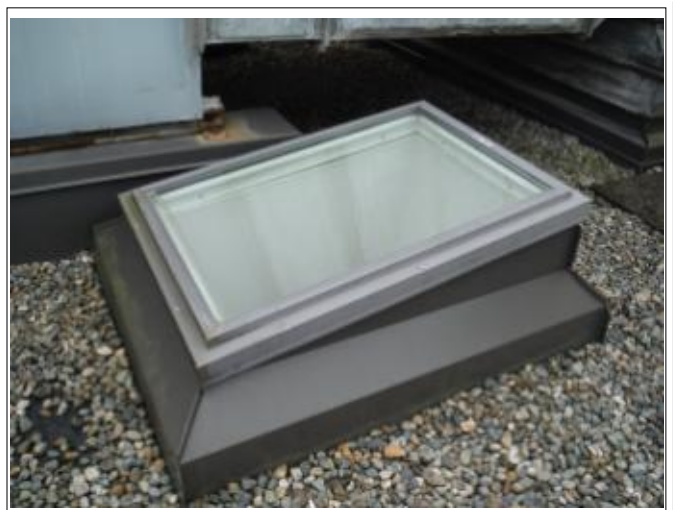
RS09

| Row | COMPONENT | | CONDITION ASSESSMENT | | | RECOMMENDATION | | | LIFE CYCLE DATA | | | | | |
|---|---|---|---|---|---|---|---|---|---|---|---|---|---|---|
| 36 | B3010 Roof Coverings | Skylights/ Penthouse Units | Aluminum framed skylights are installed at penthouse units. They appear in good condition. Photo #RS09. | Good | 1995 | Replace skylights at end of expected service life. | Renewal | 3 | 19 | 25 | 6 | 1 | N | \$4,000 |

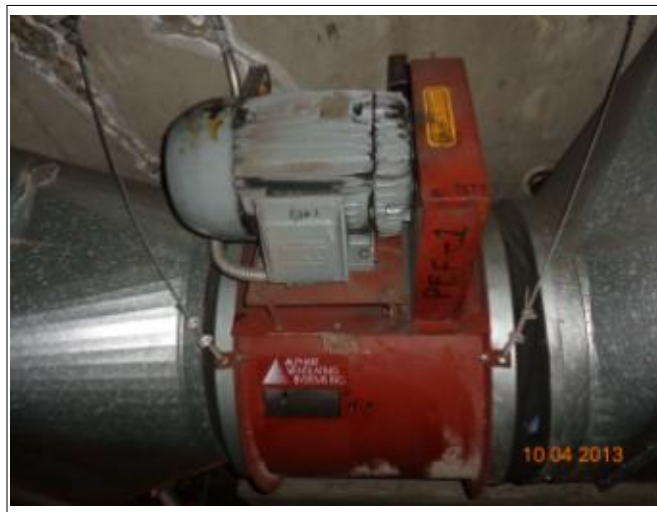
MS11

| Row | COMPONENT | | CONDITION ASSESSMENT | | | RECOMMENDATION | | | LIFE CYCLE DATA | | | | | |
|---|---|---|---|---|---|---|---|---|---|---|---|---|---|---|
| 74 | D303007 HVAC, Exhaust System | Parkade / Exhaust Fans | Primary parkade exhaust is provided by 2 large capacity (15 HP) vane-axial exhaust fans (photos #MS11 & M12). One unit's motor was replaced in 2007. | Fair | 1995 | Replace or refurbish at end of expected service life. Costs spread over 2 years after the statistical median service life. | Renewal | 3 | 19 | 20 | 5 | 1 | N | \$17,000 |

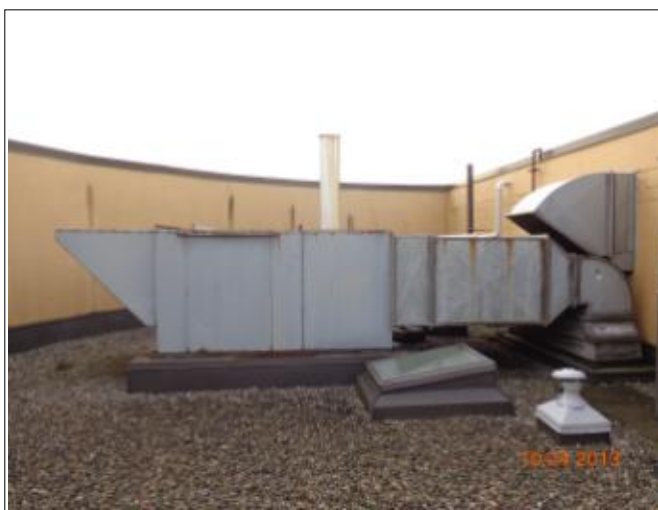
MS14

| Row | COMPONENT | | CONDITION ASSESSMENT | | | RECOMMENDATION | | | LIFE CYCLE DATA | | | | | |
|---|---|---|---|---|---|---|---|---|---|---|---|---|---|---|
| 77 | D304008 HVAC, Air Handling Units | Rooftop / Makeup Air Unit | The corridors, lobby and parkade stairs for this building is ventilated by a gas-fired make-up air unit (photo #MS14). The make-up air unit is provided with an indirect gas burner module, which tempers the outside air when necessary, and a fan sized for 9,000 CFM; no cooling is provided. | Fair | 1995 | Perform manufacturer's recommended service and maintenance (by mechanical maintenance contractor); replace at end of expected service life. | Renewal | 3 | 19 | 20 | 3 | 1 | Y | \$32,000 |

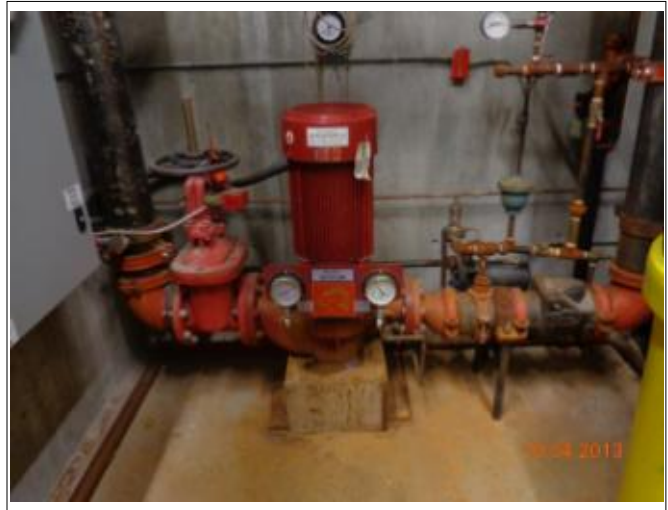
MS17

| Row | COMPONENT | | CONDITION ASSESSMENT | | | RECOMMENDATION | | | LIFE CYCLE DATA | | | | | |
|---|---|---|---|---|---|---|---|---|---|---|---|---|---|---|
| 81 | D401002 Sprinkler Water Supply Equipment and Piping | Fire Pump Room / Fire Pump | The wet sprinkler system includes an electric driven fire pump, fire pump controller, and jockey pump (photo #MS17). The components are in good condition. | Good | 1995 | Ensure that components and system are inspected, maintained, and tested per NFPA 20 and 25. Electric fire pumps run during tests and emergency situations only, as such, a well maintained fire pump system should last in excess of 30 years. Replacement of system after 30 years is assumed. | Renewal | 3 – Renewal | 19 | 30 | 11 | 1 | N | \$27,000 |

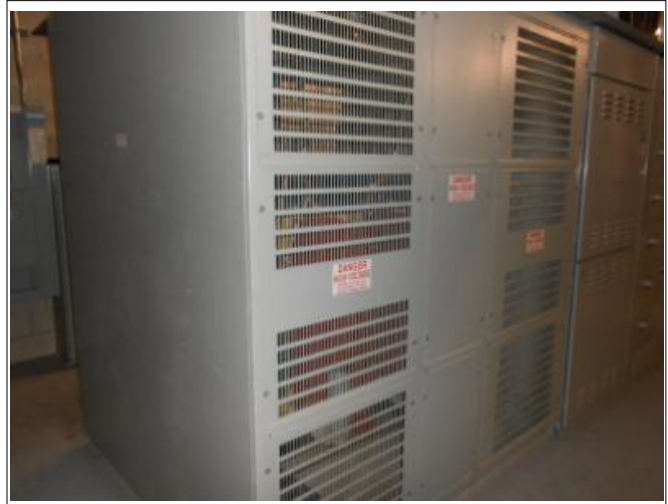
ES02

| Row | COMPONENT | | CONDITION ASSESSMENT | | | RECOMMENDATION | | | LIFE CYCLE DATA | | | | | |
|---|---|---|---|---|---|---|---|---|---|---|---|---|---|---|
| 86 | D5010 - Electrical Service and Distribution | Main High-voltage Transformer | 1000 kVA 12.5kV input step down transformer with 120/208V secondary output. Manufactured by Hummond located in the main electrical room. photo #ES02. The transformer winding temperature was noted to be approximately 70deg.C which is well below the alarm point for transformers of this type. Photo #ES03. Expenses are to be shared between commercial and residential part of the strata. | Good | 1995 | With proper maintenance may survive age of the building. Regular cleaning (every 5 years) and infrared scanning is recommended. Replace transformer at the end of service life. | Renewal | 4 | 19 | 30 | 11 | 1 | Y | \$105,000 |

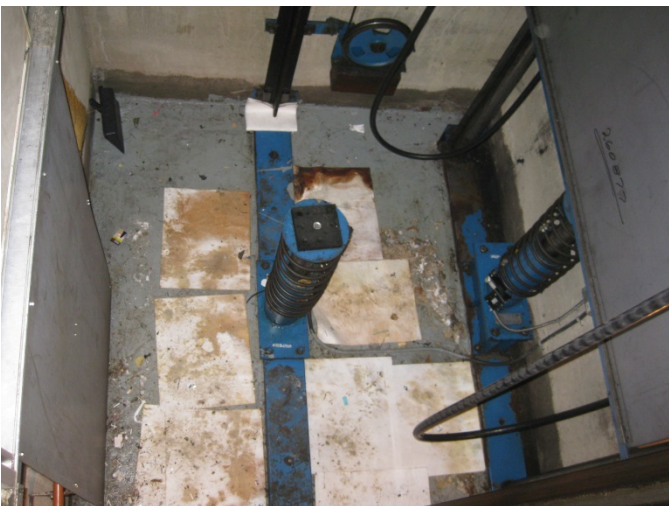
**Figure 6 – Elevator Pit – Car 1 (note absorbent pads)**
