To The Owners, Strata Plan BCS3818
c/o Mr. John Trotter, Senior Strata Manager
FirstService Residential
700 - 200 Granville Street
Vancouver BC V6C 1S4

Site Visit: June 11, 2019
Submitted September 12, 2019
by
RDH Building Science Inc.
#400-4333 Still Creek Drive,
Burnaby BC V5C 6S6

RDH Building Science Inc. (RDH) was retained by The Owners, Strata Plan BCS3818 (the Owners) to prepare a Second Depreciation Report Update (the Report) for the building known as Brook at the Village (the Air Space Parcel - ASP), which is located at 181 West 1st Avenue, Vancouver, BC. The parkade is shared with an adjoining building located at 151 West 1st Avenue (the Remainder). Please note that the Remainder is not included in this Report. In addition, the Owners own a share of the off-site Amenity Facility, which is also not included in this Report. The Report considers the common property and limited common property components (the Assets) that the Strata Corporation is solely responsible to maintain, repair, and replace.

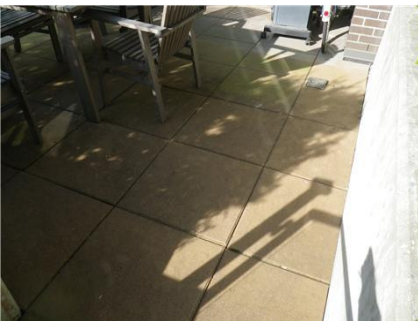
Encl 03 - Protected Liquid-Applied (Hot Rubber) Podium Membrane

Patios and areas above the parking garage.

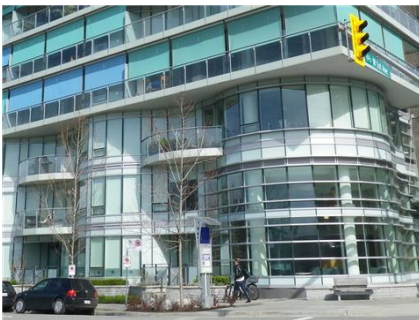
Encl 08 - Curtain Wall

First three floors of the north and west building elevations.

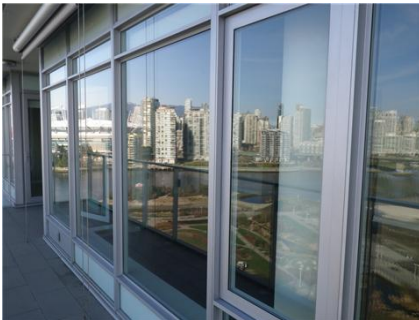
Encl 09 - Aluminum Framed Window

All building elevations.

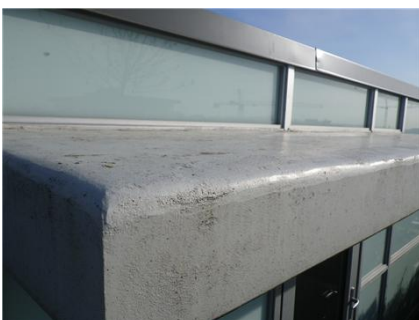
Encl 12 - Concrete Eyebrows

Concrete overhangs throughout the building.

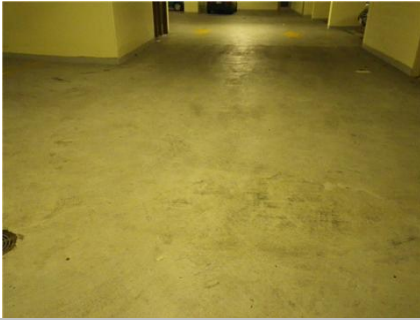
Encl 17 - Parkade Suspended Concrete Slab with Traffic-bearing Membrane

P1 parkade, storage rooms, and service rooms.

- Encl 17 Parkade Suspended Concrete Slab with Traffic-Bearing Membrane – Prepare concrete surface and re-apply traffic-bearing membrane. Frequency will depend on traffic volume and other factors.
- Encl 08 & 09 Curtain Wall and Aluminum Framed Windows – Cyclical replacement of insulating glazing units (IGUs), as required. An allowance has been included on a two-year cycle.

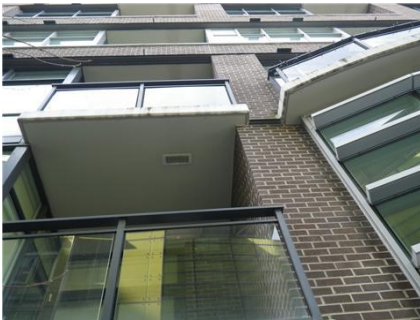
Encl 19 - General & Inspections

All elevations and all levels of the building.

- Encl 19 General & Inspections – Commission a Building Enclosure Condition Assessment (BECA) to confirm the remaining service life of Assets, such as the eyebrow membranes, the parkade traffic membrane, and sealant. The assessment should be completed in advance of the various building enclosure renewals to assist with the planning process.
- Encl 12 Concrete Eyebrows – Prepare and re-apply membrane top coat.
- Encl 20 Sealant – Replace sealants at interfaces between building enclosure assemblies, and at penetrations through assemblies.

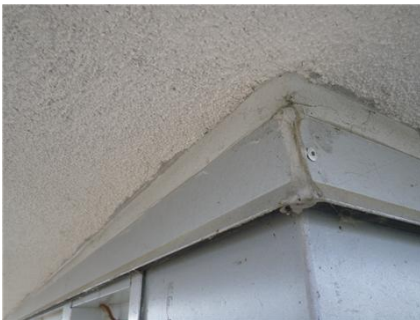
Encl 20 - Sealant

Interfaces and service penetrations at the exterior walls, roofs and other locations.
