DEPRECIATION REPORT

LMS 4410 — “Chez Victoria”

5555 Victoria Drive

The subject property was visually inspected on September 16, 2019. The consultant reviewed building plans, financial documents, AGM minutes, governing documents, and consulted with the client to identify undocumented repair work, learn about latent defects that are causing problems, assess risk tolerance, and determine the client’s short-term intentions regarding reserve fund work.

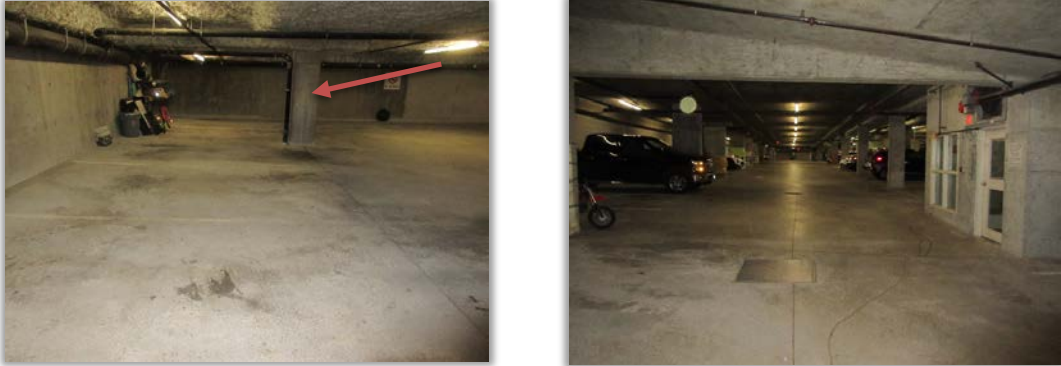
Description	This component accounts for major repairs to the below-grade portions of the property. This includes the foundation walls and parkade: the footings, basement floors, walls, parkade ceilings, columns, and courtyard membrane.		
	Quantity	1,225 LF	
	Current Job Cost	\$99,173	
Condition Analysis	Based on a partial visual inspection, this component appears to be in average condition for its age. No major deficiencies were noted or reported at the time of inspection.		
Reserve History	Year of Acquisition	2000	
	Work Completed	None noted or reported	
	Dollars Spent	N/A	
Life Cycle Analysis	Expected Lifespan	35 years (Budget Provision)	
	Effective Age	19 years	
	Remaining Lifespan	16 years	
Funding Analysis	Work	Non-structural cracks can sometimes be injected with a sealant. We have budgeted for periodic structural stabilization work, spot replacement of damaged concrete, underdrain repairs, waterproofing, and membrane replacement. This includes excavation and compacted backfilling.

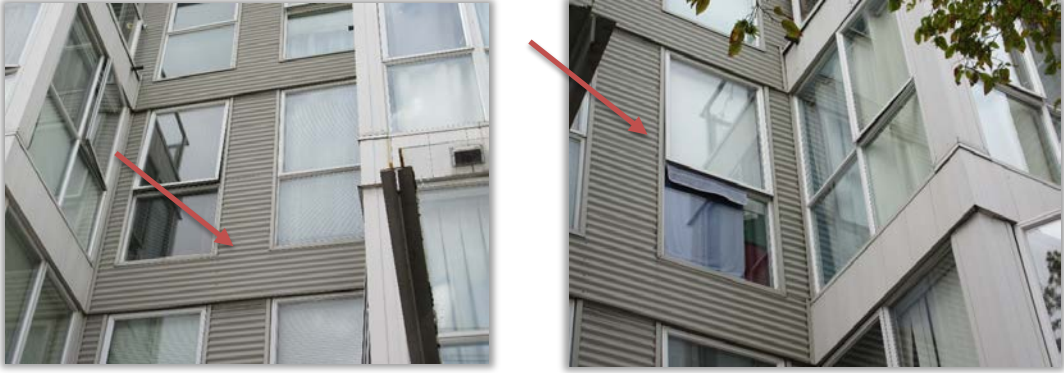
Description	<p>This component accounts for the metal siding envelope system. This system includes the building frame, sheathing, building paper, insulation, and metal siding.</p> <table border="1" style="width: 100%; border-collapse: collapse;"> <tr> <td style="background-color: #e0e0e0; padding: 2px;">Quantity</td> <td style="padding: 2px;">5,200 SF</td> </tr> <tr> <td style="background-color: #e0e0e0; padding: 2px;">Current Job Cost</td> <td style="padding: 2px;">\$39,652</td> </tr> </table>		Quantity	5,200 SF	Current Job Cost	\$39,652		
Quantity	5,200 SF							
Current Job Cost	\$39,652							
Condition Analysis	<p>Based on a partial visual inspection, this component appears to be in average condition for its age. No major deficiencies were noted or reported at the time of inspection.</p>							
Reserve History	<table border="1" style="width: 100%; border-collapse: collapse;"> <tr> <td style="background-color: #e0e0e0; padding: 2px;">Year of Acquisition</td> <td style="padding: 2px;">2000</td> </tr> <tr> <td style="background-color: #e0e0e0; padding: 2px;">Work Completed</td> <td style="padding: 2px;">None noted or reported</td> </tr> <tr> <td style="background-color: #e0e0e0; padding: 2px;">Dollars Spent</td> <td style="padding: 2px;">N/A</td> </tr> </table>		Year of Acquisition	2000	Work Completed	None noted or reported	Dollars Spent	N/A

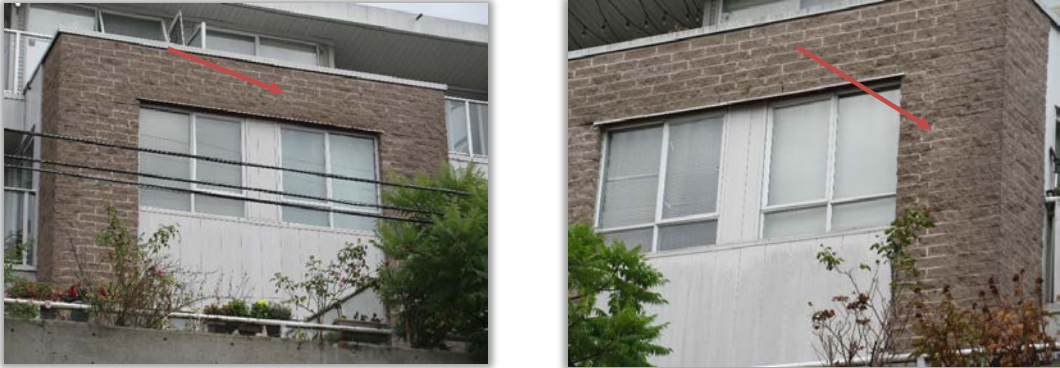
Description	This component accounts for the structural brick wall system. This system includes the brick wall, backer rod and sealant for the control joints, as well as the shelf-angles and flashing.	
	Quantity	3,500 SF
	Current Job Cost	\$13,423
Condition Analysis	Based on a partial visual inspection, this component appears to be in average condition for its age. No major deficiencies were noted or reported at the time of inspection. Some evidence of efflorescence noted on bricks.	
Reserve History	Year of Acquisition	2000
	Work Completed	None noted or reported
	Dollars Spent	N/A
Life Cycle Analysis	Expected Lifespan	25 years (Budget Provision)
	Effective Age	19 years
	Remaining Lifespan	6 years
Funding Analysis	Work	Re-point bricks: clean and clear loose mortar, replace damaged bricks, install new mortar, then tool to a concave surface to draw water away from the bricks.

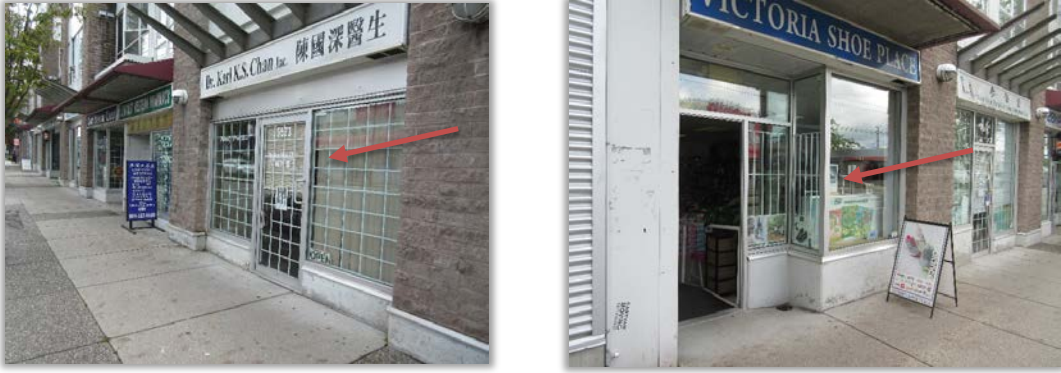
Description	This component accounts for the non-structural exterior commercial storefront assembly. This includes the metal frame, insulated glass units, caulking, and storefront doors with standard hardware.	
	Quantity	350 SF
	Current Job Cost	\$22,684
Condition Analysis	Based on a partial visual inspection, this component appears to be in average condition for its age. No major deficiencies were noted or reported at the time of inspection. Some areas are showing minor impact damage, however this does not appear to have compromised the area.	
Reserve History	Year of Acquisition	2000
	Work Completed	None noted or reported
	Dollars Spent	N/A
Life Cycle Analysis	Expected Lifespan	25 years
	Effective Age	19 years
	Remaining Lifespan	6 years
Funding Analysis	Work	Remove and dispose of damaged storefront sections. Spot repairs to any damaged tube framing. Install new window walls with new caulking, work-site clean up, and any special safety preparation and precautions as required. Window wall systems may require re-caulking before the windows fail.

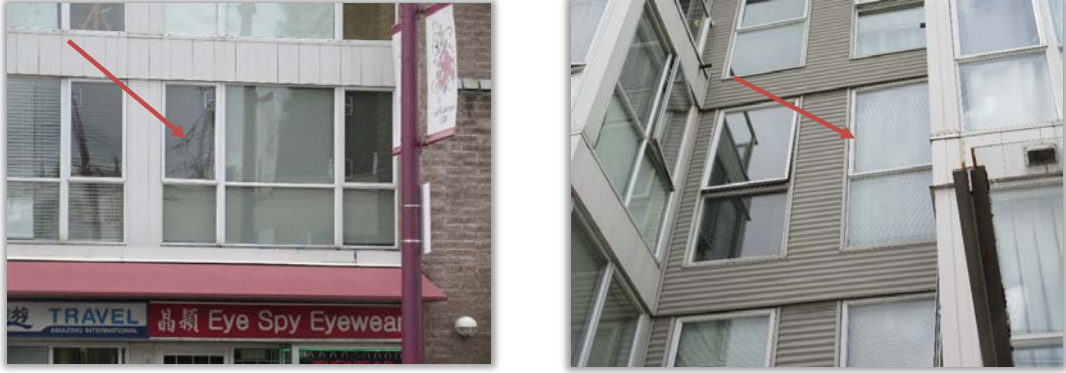
Description	This component accounts for the exterior aluminum-frame windows. This includes the frame, hardware, casing, and aluminum windows.	
	Quantity	277 Windows
	Current Job Cost	\$166,452
Condition Analysis	Based on a partial visual inspection, this component appears to be in average condition for its age. No major deficiencies were noted or reported at the time of inspection. Gate and motor were in working order at time of inspection.	
Reserve History	Year of Acquisition	2000
	Work Completed	None noted or reported
	Dollars Spent	N/A
Life Cycle Analysis	Expected Lifespan	30 years (Budget Provision)
	Effective Age	19 years
	Remaining Lifespan	11 years
Funding Analysis	Work	Remove and dispose of damaged window assemblies, repairs to or replacement of the frame, casing, and hardware as required, and installation of new windows. Appropriate safety preparation and precautions as required.

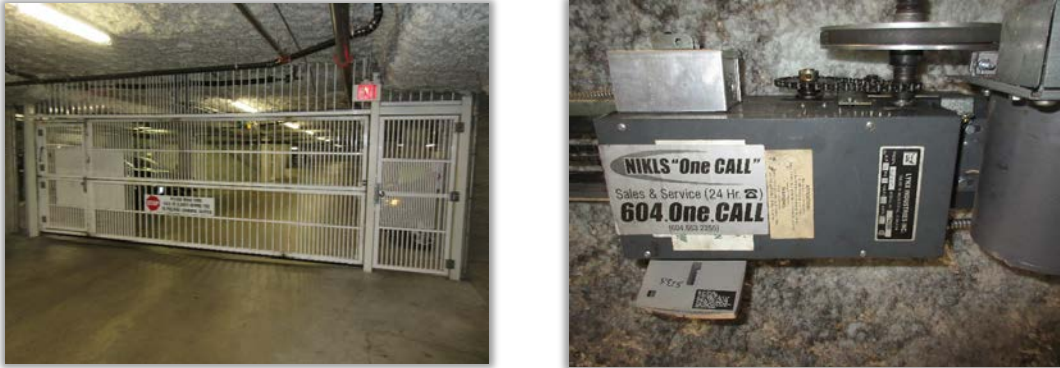
Description	<p>This component accounts for the parkade's entrance gate. This excludes the remote openers but includes the gate, operating mechanism, tracks, rollers, and associated hardware.</p> <table border="1" style="width: 100%; border-collapse: collapse;"> <tr> <td style="background-color: #e0e0e0; width: 20%;">Quantity</td> <td>5 Openings</td> </tr> <tr> <td style="background-color: #e0e0e0;">Current Job Cost</td> <td>\$22,352</td> </tr> </table>		Quantity	5 Openings	Current Job Cost	\$22,352
Quantity	5 Openings					
Current Job Cost	\$22,352					
Condition Analysis	<p>Based on a partial visual inspection, this component appears to be in average condition for its age. No major deficiencies were noted or reported at the time of inspection.</p>					
Reserve History	Year of Acquisition	2000				
	Work Completed	None noted or reported				
	Dollars Spent	N/A				
Life Cycle Analysis	Expected Lifespan	22 years (Budget Provision)				
	Effective Age	19 years				
	Remaining Lifespan	3 years				
Funding Analysis	Work	Remove and replace damaged metal door components as required.				
	Budget	A budget equal to 50% of the estimated total cost is provided for significant expenditures every 22 years.				
Potential Deterioration	<p>Includes impact damage, wear-and-tear, electronic failure, mechanical failure, and water damage. Contributing factors include physical damage, debris accumulation, subsurface shifting, and damage from environmental factors such as extreme temperature changes, rain, snow, wind, and sun exposure.</p>					
Suggested Maintenance	<p>Regular visual inspection of the door and tracks/rollers. Lubricate and clean as required.</p>

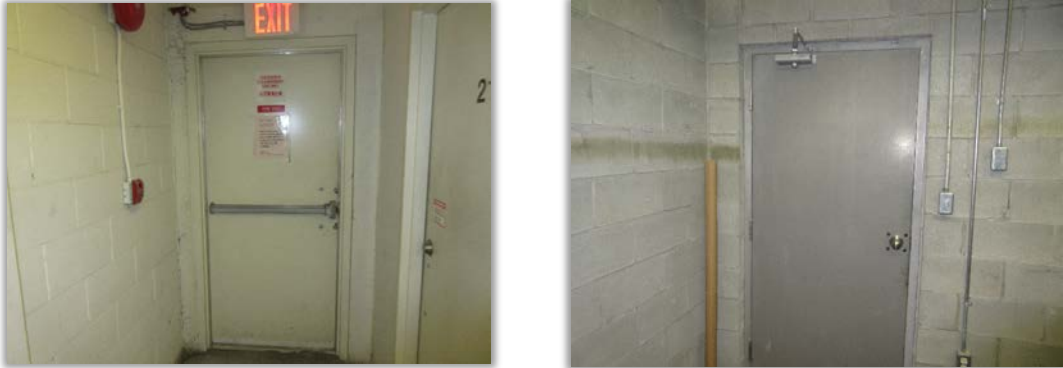
Description	<p>This component accounts for the common-element exterior doors. This includes the doors and all associated hardware.</p> <table border="1" style="width: 100%; border-collapse: collapse;"> <tr> <td style="background-color: #e0e0e0; padding: 2px;">Quantity</td> <td style="padding: 2px;">41 Openings</td> </tr> <tr> <td style="background-color: #e0e0e0; padding: 2px;">Current Job Cost</td> <td style="padding: 2px;">\$5,002</td> </tr> </table>		Quantity	41 Openings	Current Job Cost	\$5,002		
Quantity	41 Openings							
Current Job Cost	\$5,002							
Condition Analysis	<p>Based on a partial visual inspection, this component appears to be in average condition for its age. No major deficiencies were noted or reported at the time of inspection.</p>							
Reserve History	<table border="1" style="width: 100%; border-collapse: collapse;"> <tr> <td style="background-color: #e0e0e0; padding: 2px;">Year of Acquisition</td> <td style="padding: 2px;">2000</td> </tr> <tr> <td style="background-color: #e0e0e0; padding: 2px;">Work Completed</td> <td style="padding: 2px;">None noted or reported</td> </tr> <tr> <td style="background-color: #e0e0e0; padding: 2px;">Dollars Spent</td> <td style="padding: 2px;">N/A</td> </tr> </table>		Year of Acquisition	2000	Work Completed	None noted or reported	Dollars Spent	N/A

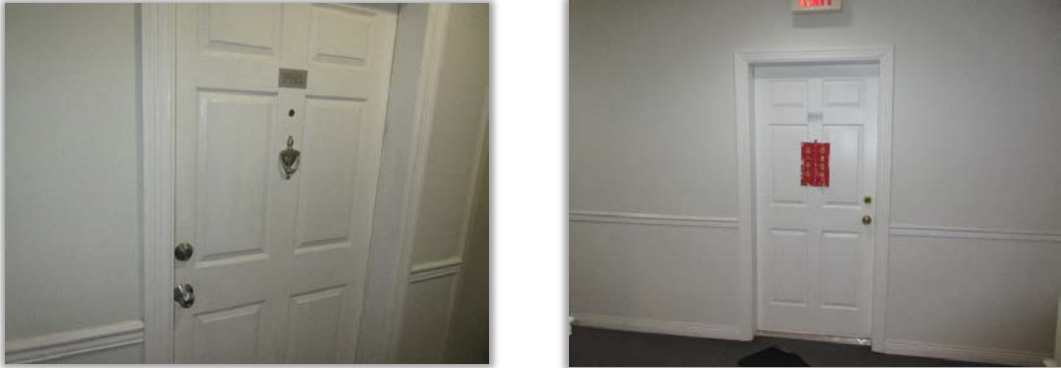
Description	<p>This component accounts for the common-element interior wooden doors. This includes the doors, frames, and all associated hardware.</p> <table border="1" style="width: 100%; border-collapse: collapse;"> <tr> <td style="background-color: #e0e0e0; padding: 2px;">Quantity</td> <td style="padding: 2px;">78 Openings</td> </tr> <tr> <td style="background-color: #e0e0e0; padding: 2px;">Current Job Cost</td> <td style="padding: 2px;">\$16,410</td> </tr> </table>		Quantity	78 Openings	Current Job Cost	\$16,410		
Quantity	78 Openings							
Current Job Cost	\$16,410							
Condition Analysis	<p>Based on a partial visual inspection, this component appears to be in average condition for its age. No major deficiencies were noted or reported at the time of inspection. Some doors are showing wear, but this is considered cosmetic.</p>

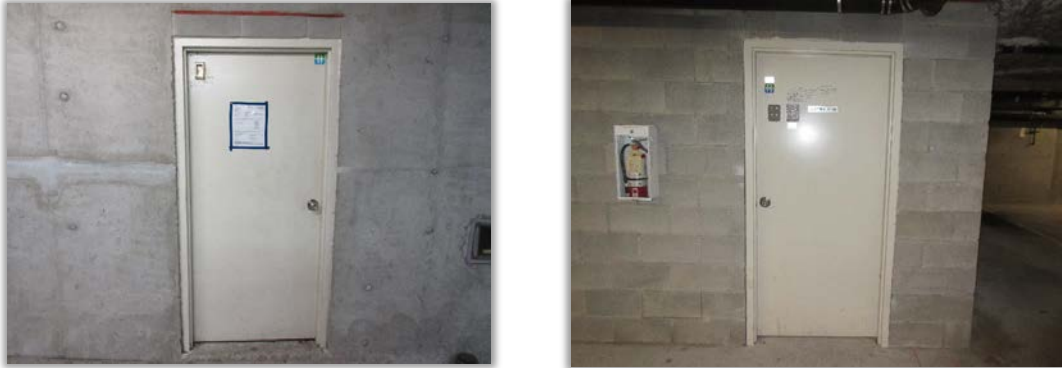
Description	<p>This component accounts for the common-element interior metal doors. This includes the doors, frames, and all associated hardware.</p> <table border="1" style="width: 100%; border-collapse: collapse;"> <tr> <td style="background-color: #e0e0e0; padding: 2px;">Quantity</td> <td style="padding: 2px;">24 Openings</td> </tr> <tr> <td style="background-color: #e0e0e0; padding: 2px;">Current Job Cost</td> <td style="padding: 2px;">\$5,597</td> </tr> </table>		Quantity	24 Openings	Current Job Cost	\$5,597		
Quantity	24 Openings							
Current Job Cost	\$5,597							
Condition Analysis	<p>Based on a partial visual inspection, this component appears to be in average condition for its age. No major deficiencies were noted or reported at the time of inspection.</p>							
Reserve History	<table border="1" style="width: 100%; border-collapse: collapse;"> <tr> <td style="background-color: #e0e0e0; padding: 2px;">Year of Acquisition</td> <td style="padding: 2px;">2000</td> </tr> <tr> <td style="background-color: #e0e0e0; padding: 2px;">Work Completed</td> <td style="padding: 2px;">None noted or reported</td> </tr> <tr> <td style="background-color: #e0e0e0; padding: 2px;">Dollars Spent</td> <td style="padding: 2px;">N/A</td> </tr> </table>		Year of Acquisition	2000	Work Completed	None noted or reported	Dollars Spent	N/A

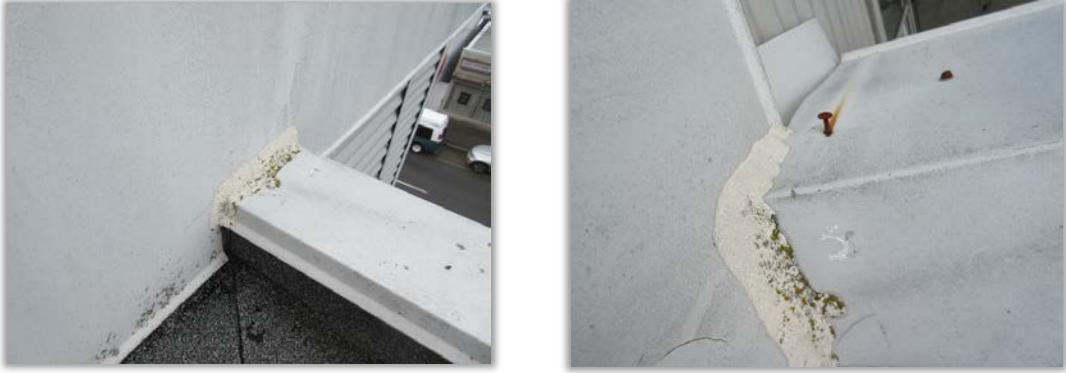
Description	This component accounts for the common-element caulking found around the windows, exterior doors, and some trim.	
	Quantity	800 LF
	Current Job Cost	\$2,146
Condition Analysis	Based on a partial visual inspection, this component appears to be in fair condition for its age. No major deficiencies were noted or reported at the time of inspection. Caulking should be checked regular, there are areas where dirt and mould are gathering.	
Reserve History	Year of Acquisition	2000
	Work Completed	None noted or reported
	Dollars Spent	N/A
Life Cycle Analysis	Expected Lifespan	12 years (Budget Provision)
	Effective Age	8 years
	Remaining Lifespan	4 years
Funding Analysis	Work	Remove and replace failed caulking as required. Appropriate safety preparation and precautions as required.
	Budget	A budget equal to 50% of the estimated total cost is provided for significant expenditures every 12 years.

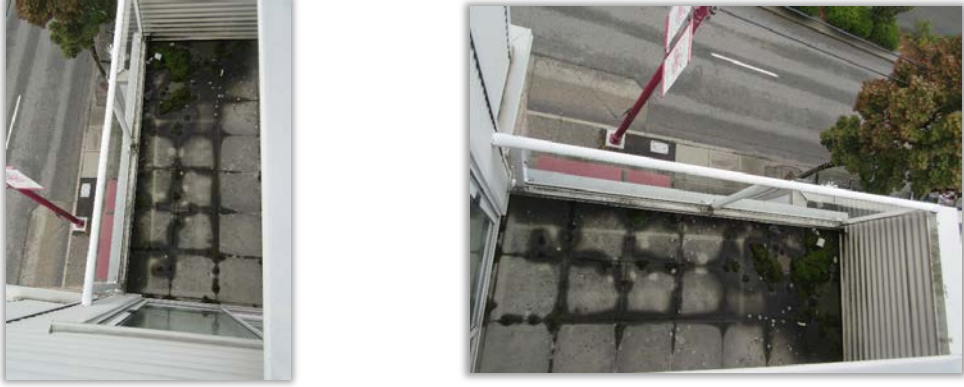
Description	This component accounts for the common-element balcony structure. This includes sounding, marking, cutting, removing concrete to expose the rebar, reinforcing, bonding the rebar, placing concrete, consolidating, screening, floating, finishing, and spraying a curing compound.	
	Quantity	4,235 SF
	Current Job Cost	\$82,400
Condition Analysis	Based on a partial visual inspection, this component appears to be in average condition for its age. No major deficiencies were noted or reported at the time of inspection. There was a buildup of debris on several balconies. These areas should be cleared regularly.	
Reserve History	Year of Acquisition	2000
	Work Completed	None noted or reported
	Dollars Spent	N/A
Life Cycle Analysis	Expected Lifespan	40 years
	Effective Age	19 years
	Remaining Lifespan	21 years
Funding Analysis	Work	Remove and dispose of existing assembly, repairs or replacement as required. Appropriate safety preparation and precautions as required.

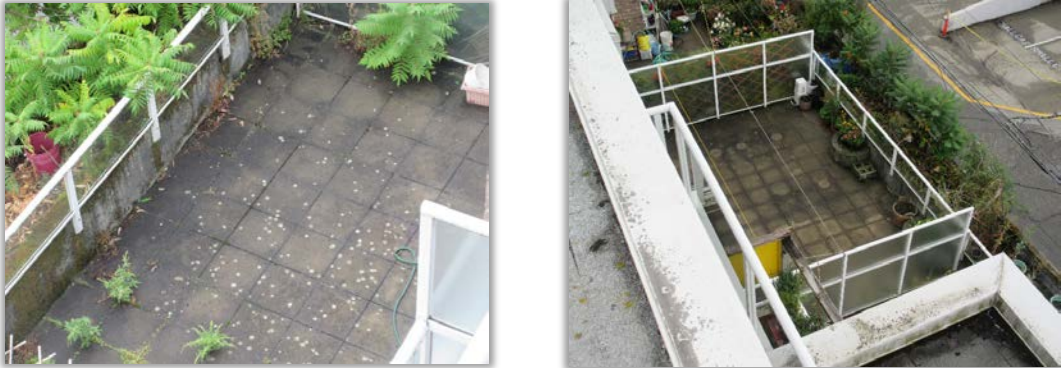
Description	This component accounts for the roof deck system over occupied living space. This includes an allowance for repairs as necessary to the structural roof decking, insulation, roof membrane system, flashing, concrete block supports, and concrete blocks.	
	Quantity	4,310 SF
	Current Job Cost	\$34,428
Condition Analysis	Based on a partial visual inspection, this component appears to be in average condition for its age. No major deficiencies were noted or reported at the time of inspection.	
Reserve History	Year of Acquisition	2000
	Work Completed	None noted or reported
	Dollars Spent	N/A
Life Cycle Analysis	Expected Lifespan	20 years (Budget Provision)
	Effective Age	15 years
	Remaining Lifespan	5 years
Funding Analysis	Work	Remove pavers and supports. Remove and dispose of roof membrane system, insulation, and damaged roof decking components. Repair the structural roof decking as required. Install and taper roof deck insulation boards. Install new roof membrane system. Install concrete blocks and supports, using salvageable material if possible.

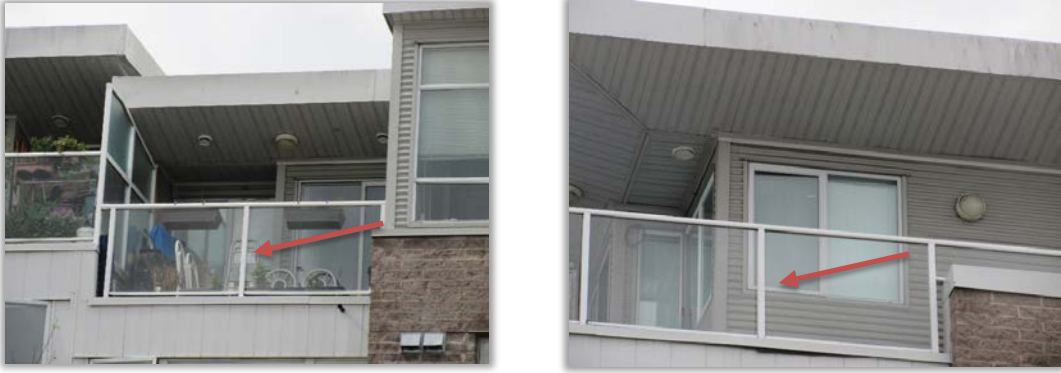
Description	This component accounts for the common-element balcony railing systems, including all associated fasteners and hardware.	
	Quantity	800 LF
	Current Job Cost	\$65,645
Condition Analysis	Based on a partial visual inspection, this component appears to be in average condition for its age. No major deficiencies were noted or reported at the time of inspection.	
Reserve History	Year of Acquisition	2000
	Work Completed	None noted or reported
	Dollars Spent	N/A
Life Cycle Analysis	Expected Lifespan	25 years (Budget Provision)
	Effective Age	15 years
	Remaining Lifespan	10 years
Funding Analysis	Work	Remove and replace failed balcony railings. Appropriate safety preparation and precautions as required.
	Budget	A budget equal to 50% of the estimated total cost is provided for significant expenditures every 25 years.
Potential Deterioration	Includes breakage, water damage, loosening of fasteners, wear-and-tear, and aesthetic degradation. Contributing factors include physical damage, debris accumulation, and environmental factors such as extreme temperature changes, rain, snow, wind, and sun exposure.

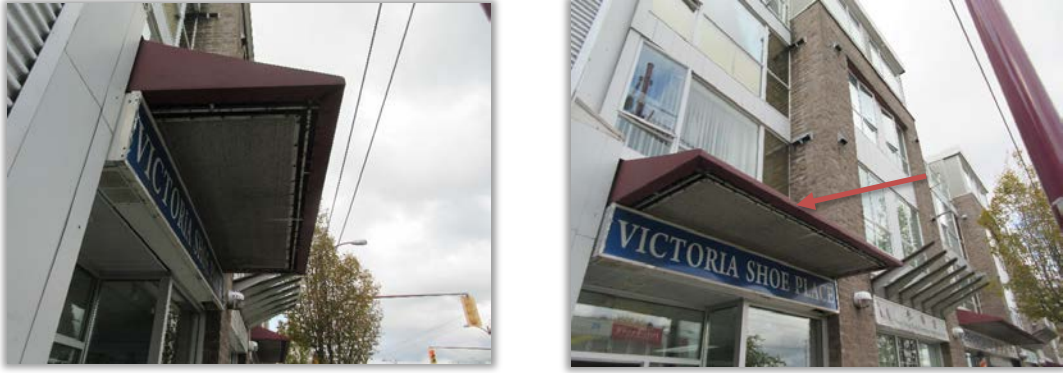
Description	This component accounts for the fabric canopy system. This includes the fabric, frame, and associated hardware.	
	Quantity	15 Canopies
	Current Job Cost	\$10,662
Condition Analysis	Based on a partial visual inspection, this component appears to be in average condition for its age. No major deficiencies were noted or reported at the time of inspection.	
Reserve History	Year of Acquisition	2000
	Work Completed	None noted or reported
	Dollars Spent	N/A
Life Cycle Analysis	Expected Lifespan	18 years (Budget Provision)
	Effective Age	12 years
	Remaining Lifespan	6 years
Funding Analysis	Work	Remove and replace existing canopy assembly. The entire system can be replaced, the fabric can be replaced, or the fabric can be repaired.
	Budget	A budget equal to 33% of the estimated total cost is provided for significant expenditures every 18 years.
Potential Deterioration	Includes impact damage, tearing, corrosion, fastener failure, and water damage. Contributing factors include physical damage, wear-and-tear, and environmental factors such as extreme temperature changes, rain, snow, wind, and sun exposure.

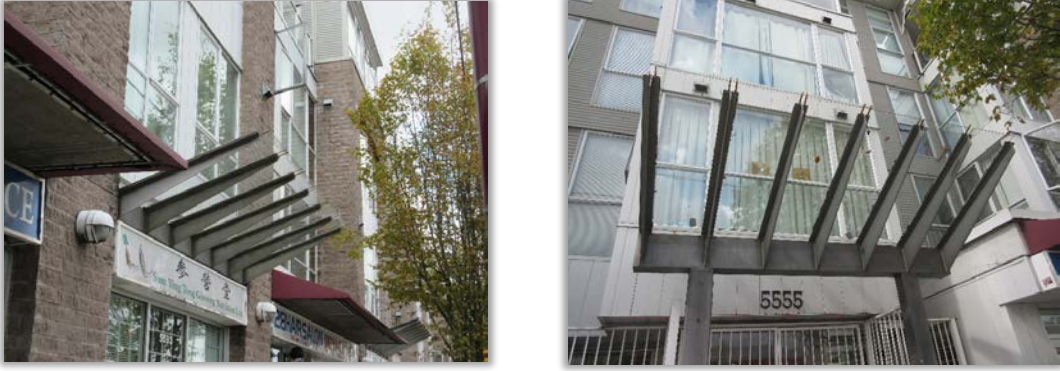
Description	<p>This component accounts for the metal canopy system. This includes the canopy, frame, and associated hardware.</p> <table border="1" style="width: 100%; border-collapse: collapse;"> <tr> <td style="background-color: #e0e0e0; width: 20%;">Quantity</td> <td>9 Canopies</td> </tr> <tr> <td style="background-color: #e0e0e0;">Current Job Cost</td> <td>\$19,635</td> </tr> </table>		Quantity	9 Canopies	Current Job Cost	\$19,635		
Quantity	9 Canopies							
Current Job Cost	\$19,635							
Condition Analysis	<p>Based on a partial visual inspection, this component appears to be in average condition for its age. No major deficiencies were noted or reported at the time of inspection.</p>							
Reserve History	<table border="1" style="width: 100%; border-collapse: collapse;"> <tr> <td style="background-color: #e0e0e0; width: 20%;">Year of Acquisition</td> <td>2000</td> </tr> <tr> <td style="background-color: #e0e0e0;">Work Completed</td> <td>None noted or reported</td> </tr> <tr> <td style="background-color: #e0e0e0;">Dollars Spent</td> <td>N/A</td> </tr> </table>		Year of Acquisition	2000	Work Completed	None noted or reported	Dollars Spent	N/A

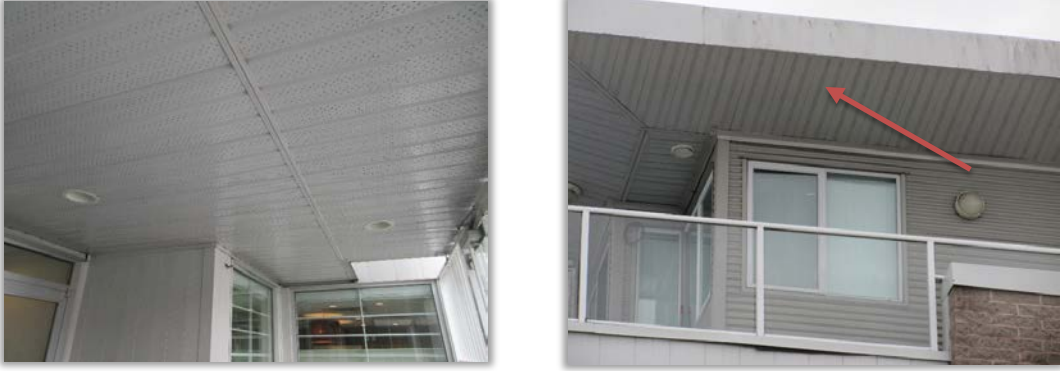
Description	This component accounts for the soffits, also known as the eaves.	
	Quantity	5,390 SF
	Current Job Cost	\$6,943
Condition Analysis	Based on a partial visual inspection, this component appears to be in average condition for its age. No major deficiencies were noted or reported at the time of inspection.	
Reserve History	Year of Acquisition	2000
	Work Completed	None noted or reported
	Dollars Spent	N/A
Life Cycle Analysis	Expected Lifespan	30 years (Budget Provision)
	Effective Age	10 years
	Remaining Lifespan	20 years
Funding Analysis	Work	Remove and replace damaged soffits. Appropriate safety preparation and precautions as required.
	Budget	A budget equal to 15% of the estimated total cost is provided for significant expenditures every 30 years.
Potential Deterioration	Includes impact damage, heat damage, water damage, fading, warping, and cracking. Contributing factors include physical damage and environmental factors such as extreme temperature changes, rain, snow, and wind exposure.

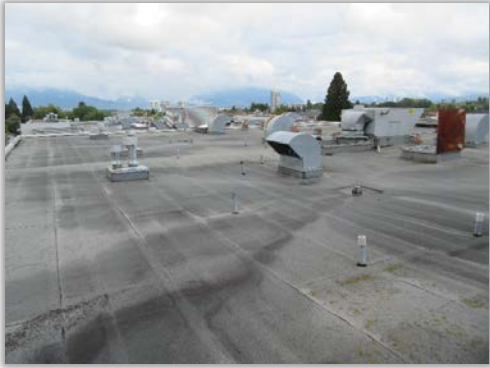
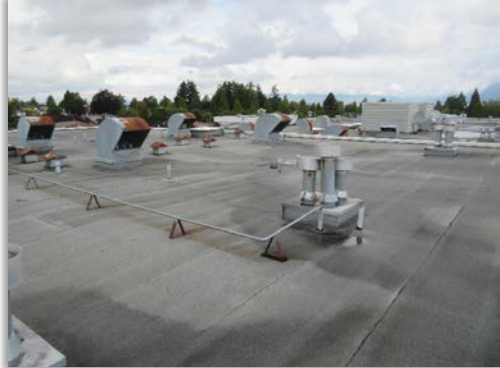
</div>								
Description	<p>This component accounts for the modified bituminous membrane roofing system. This includes the cap sheet, base sheet, insulation, flashing, and an allowance for replacement of roof-openings such as vents.</p> <table border="1" style="width: 100%; border-collapse: collapse;"> <tr> <td style="background-color: #e0e0e0; padding: 2px;">Quantity</td> <td style="padding: 2px;">23,100 SF</td> </tr> <tr> <td style="background-color: #e0e0e0; padding: 2px;">Current Job Cost</td> <td style="padding: 2px;">\$384,782</td> </tr> </table>		Quantity	23,100 SF	Current Job Cost	\$384,782		
Quantity	23,100 SF							
Current Job Cost	\$384,782							
Condition Analysis	<p>Based on a partial visual inspection, this component appears to be in average condition for its age. No major deficiencies were noted or reported at the time of inspection. There are areas of discoloration and water pooling. Due to the age, regular inspections are recommended.</p>

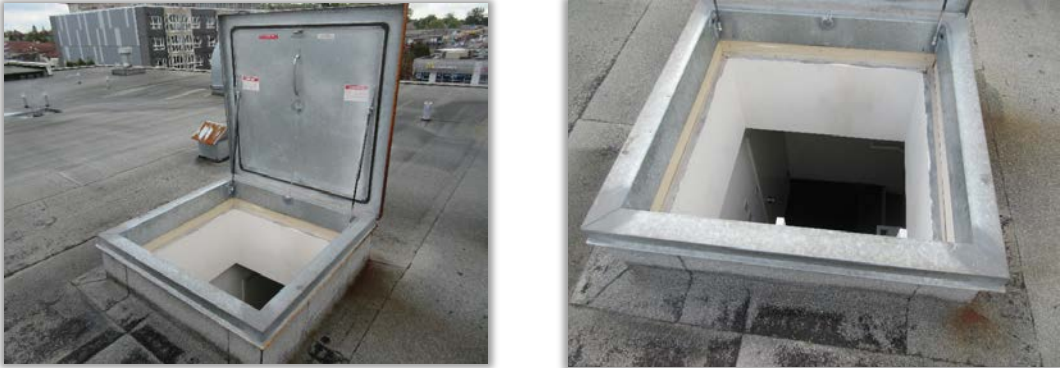
Description	This component accounts for the roof access hatch. This includes the cover, hatch, curb, and insulation.	
	Quantity	2 Hatches
	Current Job Cost	\$3,826
Condition Analysis	Based on a partial visual inspection, this component appears to be in average condition for its age. No major deficiencies were noted or reported at the time of inspection.	
Reserve History	Year of Acquisition	2000
	Work Completed	None noted or reported
	Dollars Spent	N/A
Life Cycle Analysis	Expected Lifespan	30 years
	Effective Age	18 years
	Remaining Lifespan	12 years
Funding Analysis	Work	Remove and replace existing hatch assembly. Appropriate safety preparation and precautions as required.
	Budget	We have allowed for a full replacement of this component every 30 years.
Potential Deterioration	Includes impact damage, corrosion, seal/curb deterioration, hinge/spring deterioration, opening-mechanism failure, and water damage. Contributing factors include physical damage, wear-and-tear, and environmental factors such as extreme temperature changes, rain, snow, wind, and sun exposure.

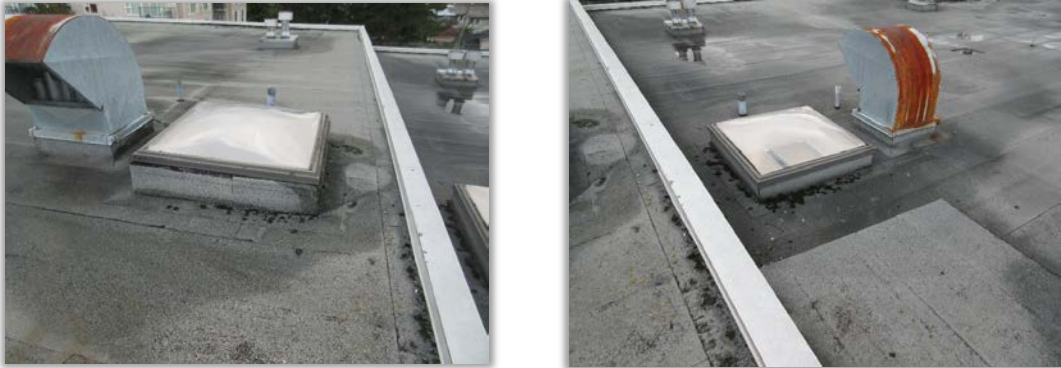
Description	This component accounts for the skylight systems, including the skylight units, curbs, and associated hardware.	
	Quantity	9 Each
	Current Job Cost	\$8,762
Condition Analysis	Based on a partial visual inspection, this component appears to be in average condition for its age. No major deficiencies were noted or reported at the time of inspection.	
Reserve History	Year of Acquisition	2000
	Work Completed	None noted or reported
	Dollars Spent	N/A
Life Cycle Analysis	Expected Lifespan	30 years
	Effective Age	19 years
	Remaining Lifespan	11 years
Funding Analysis	Work	Remove and replace existing skylight assembly. Take care to pull back roofing flashing and material. Appropriate safety preparation and precautions as required.
	Budget	We have allowed for a full replacement of this component every 30 years.
Potential Deterioration	Includes impact damage, cracking, failed seals, mechanism failure, and water damage. Contributing factors include physical damage, seal deterioration, wear-and-tear, and environmental factors such as extreme temperature changes, rain, snow, wind, and sun exposure.

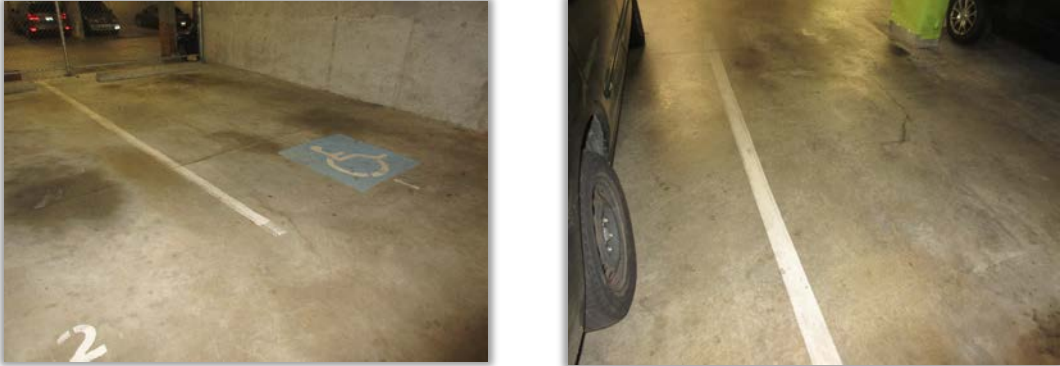
Description	This component accounts for the common-element pavement markings.		
	Quantity	121 Stalls	
	Current Job Cost	\$1,660	
Condition Analysis	Based on a visual inspection, this component appears to be in average condition for its age. No major deficiencies were noted or reported at the time of inspection.		
Reserve History	Year of Acquisition	2000	
	Work Completed	None noted or reported	
	Dollars Spent	N/A	
Life Cycle Analysis	Expected Lifespan	4 years	
	Effective Age	1 year	
	Remaining Lifespan	3 years	
Funding Analysis	Work	Repaint existing markings as required or desired.	
	Budget	We have allowed for a full replacement of this component every 4 years.	
Potential Deterioration	Includes chipping, fading, and obfuscation. Contributing factors include wear-and-tear, impact damage, debris accumulation, chemical damage (particularly from de-icing chemicals), and environmental factors such as temperature changes, rain, snow, wind, and sun exposure.

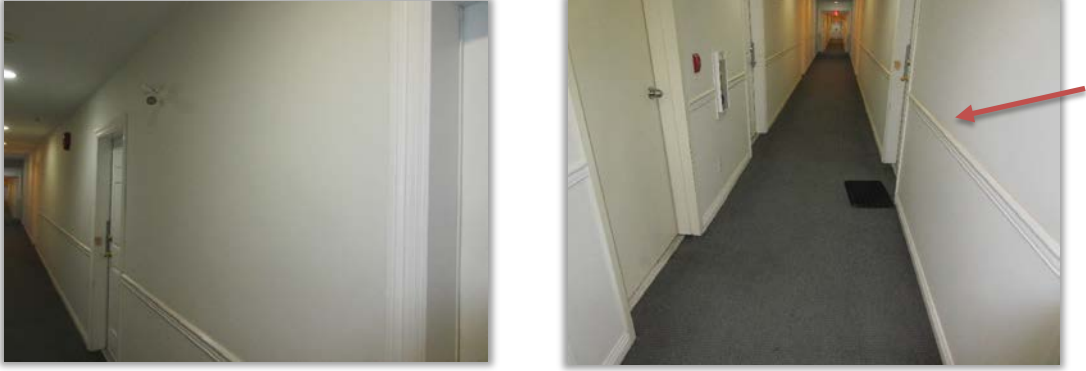
Description	This component accounts for the interior paint finish.	
	Quantity	31,700 SF
	Current Job Cost	\$74,269
Condition Analysis	Based on a visual inspection, this component appears to be in average condition for its age. No major deficiencies were noted or reported at the time of inspection.	
Reserve History	Year of Acquisition	2000
	Work Completed	None noted or reported
	Dollars Spent	N/A
Life Cycle Analysis	Expected Lifespan	16 years
	Effective Age	10 years
	Remaining Lifespan	6 years
Funding Analysis	Work	Surface preparation, painting, and clean-up.
	Budget	We have allowed for a full replacement of this component every 16 years.
Potential Deterioration	Includes impact damage, stains, markings, fading, and water damage. Contributing factors include physical damage, wear-and-tear, and environmental factors such as temperature changes, humidity, and sun exposure. Painting may also be done for aesthetic reasons.

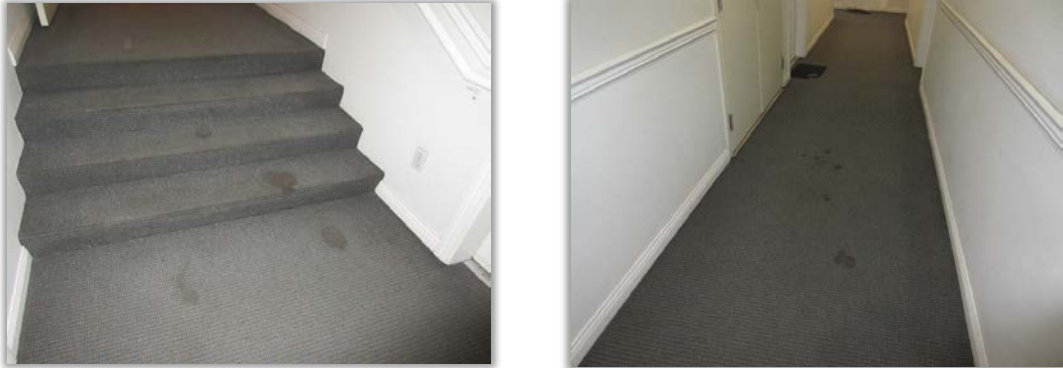
Description	This component accounts for the interior common-area carpet flooring.	
	Quantity	4,300 SF
	Current Job Cost	\$39,560
Condition Analysis	Based on a visual inspection, this component appears to be in fair condition for its age. A number of areas where stained and showing signs of wear.	
Reserve History	Year of Acquisition	2009
	Work Completed	None noted or reported
	Dollars Spent	N/A
Life Cycle Analysis	Expected Lifespan	15 years
	Effective Age	10 years
	Remaining Lifespan	5 years
Funding Analysis	Work	Remove and replace the damaged carpet or the entire carpet, including the carpet pad, depending on the extent and cause of the damage.
	Budget	We have allowed for a full replacement of this component every 15 years.
Potential Deterioration	Includes fading, matting, colour-loss, wear-and-tear, wrinkles, ripples, stains, burns, strong odors, and lack of padding support. Contributing factors include physical damage, water damage, spills, debris accumulation, and damage from environmental factors such as temperature changes, humidity, and sun exposure. Carpet may also be replaced for aesthetic reasons.

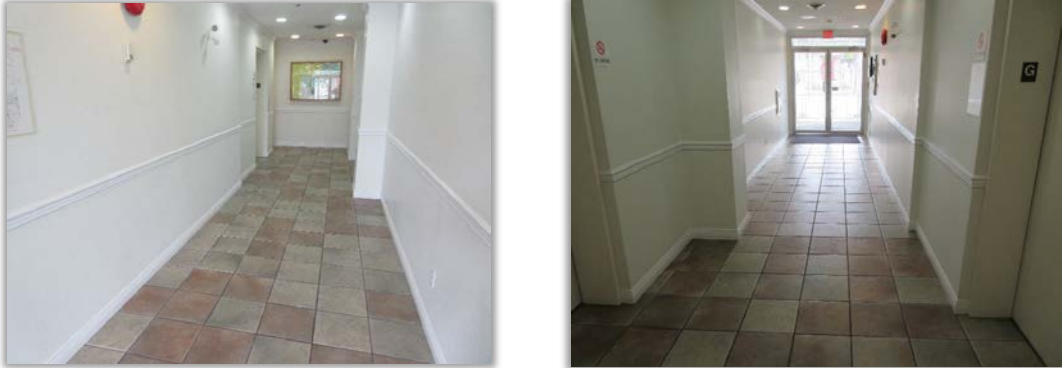
Description	<p>This component accounts for periodic renovations to the common-area lobby. This includes the flooring, lighting, finish, furniture, and décor.</p> <table border="1" style="width: 100%; border-collapse: collapse;"> <tr> <td style="background-color: #e0e0e0; padding: 2px;">Quantity</td> <td style="padding: 2px;">265 SF</td> </tr> <tr> <td style="background-color: #e0e0e0; padding: 2px;">Current Job Cost</td> <td style="padding: 2px;">\$6,225</td> </tr> </table>		Quantity	265 SF	Current Job Cost	\$6,225		
Quantity	265 SF							
Current Job Cost	\$6,225							
Condition Analysis	<p>Based on a visual inspection, this component appears to be in average condition for its age. No major deficiencies were noted or reported at the time of inspection.</p>							
Reserve History	<table border="1" style="width: 100%; border-collapse: collapse;"> <tr> <td style="background-color: #e0e0e0; padding: 2px;">Year of Acquisition</td> <td style="padding: 2px;">2019</td> </tr> <tr> <td style="background-color: #e0e0e0; padding: 2px;">Work Completed</td> <td style="padding: 2px;">Lobby was repainted in 2019.</td> </tr> <tr> <td style="background-color: #e0e0e0; padding: 2px;">Dollars Spent</td> <td style="padding: 2px;">\$2,483 + \$861 reported.</td> </tr> </table>		Year of Acquisition	2019	Work Completed	Lobby was repainted in 2019.	Dollars Spent	\$2,483 + \$861 reported.

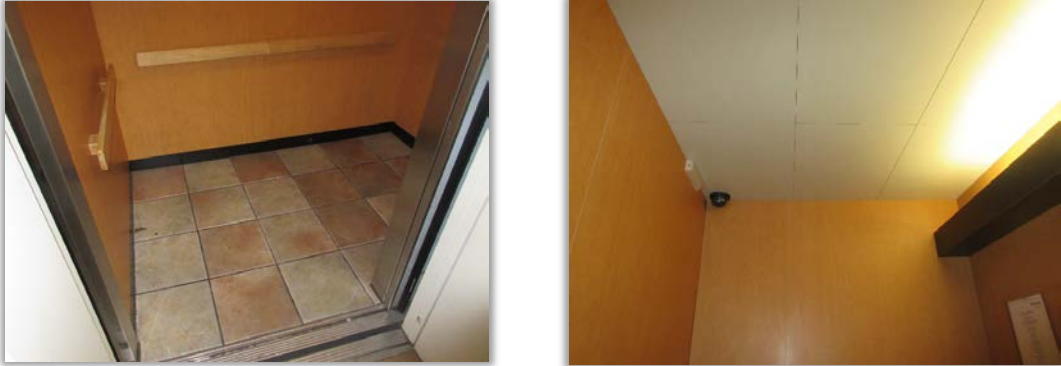
Description	<p>This component accounts for periodic renovations to the interior of the elevator cabs. This includes the flooring, wall panels, ceiling, lighting, and railings. This component does not include safety features or mechanical/electrical components within the elevator enclosure.</p> <table border="1" style="width: 100%; border-collapse: collapse;"> <tr> <td style="background-color: #e0e0e0; padding: 2px;">Quantity</td> <td style="padding: 2px;">2 Cabs</td> </tr> <tr> <td style="background-color: #e0e0e0; padding: 2px;">Current Job Cost</td> <td style="padding: 2px;">\$12,771</td> </tr> </table>		Quantity	2 Cabs	Current Job Cost	\$12,771		
Quantity	2 Cabs							
Current Job Cost	\$12,771							
Condition Analysis	<p>Based on a visual inspection, this component appears to be in average condition for its age. No major deficiencies were noted or reported at the time of inspection.</p>

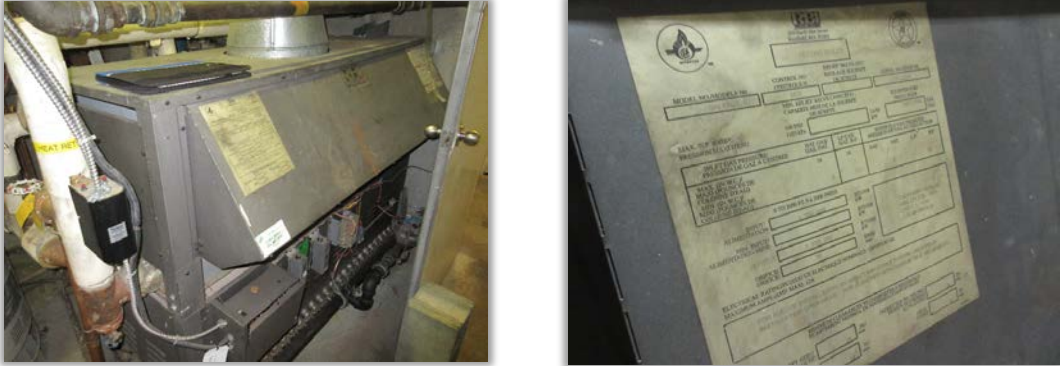
Description	This component accounts for the natural gas boiler. This includes the insulating jacket, standard controls, burner, safety controls, breech, trim, fittings, and valves. This excludes the piping and the rest of the heating distribution system, which is accounted for separately in this report.	
	Quantity	1 Boiler
	Current Job Cost	\$20,894
Condition Analysis	Based on a partial visual inspection, this component appears to be in average condition for its age. No major deficiencies were noted or reported at the time of inspection. The boiler is an RBI Water Heater, Model #HBN 1260E-029, Serial #110022356	
Reserve History	Year of Acquisition	2017
	Work Completed	Boiler relief valve was replaced in 2016, boiler replaced in 2017
	Dollars Spent	\$2,754 & \$15,195
Life Cycle Analysis	Expected Lifespan	25 years
	Effective Age	1year
	Remaining Lifespan	24 years

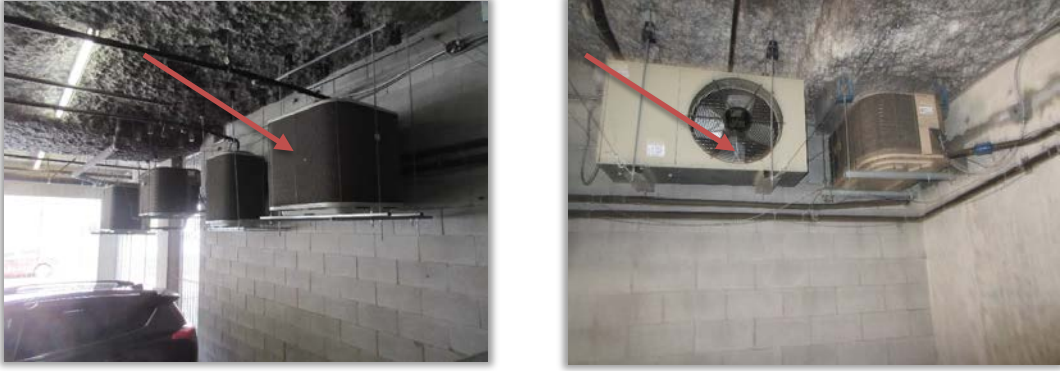
Description	This component accounts for the common-element heat pump. This includes the compressor, heat exchangers, valves, controller, filter, sensors, and associated components. This excludes the refrigerant piping and Air Handling Units, which are accounted for separately in this report.	
	Quantity	19 Systems
	Current Job Cost	\$89,628
Condition Analysis	Based on a partial visual inspection, this component appears to be in average condition for its age. No major deficiencies were noted or reported at the time of inspection.	
Reserve History	Year of Acquisition	2000
	Work Completed	None noted or reported
	Dollars Spent	N/A
Life Cycle Analysis	Expected Lifespan	17 years
	Effective Age	14 years
	Remaining Lifespan	3 years
Funding Analysis	Work	Remove and replace the failing unit. Small repairs and replacements are expected towards the end of the unit's life.
	Budget	We have allowed for a full replacement of this component every 17 years.

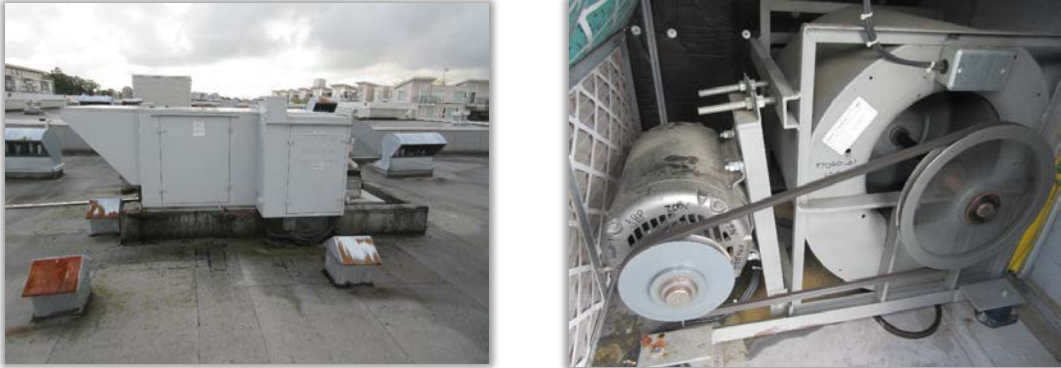
Description	This component accounts for the Rooftop Unit (RTU). This includes the AC system, heating system, and ventilation system all contained in the same rooftop cabinet. This does not include the ductwork system, which is accounted for in the HVAC distribution component.	
	Quantity	2 Units
	Current Job Cost	\$89,628
Condition Analysis	Based on a partial visual inspection, this component appears to be in average condition for its age. No major deficiencies were noted or reported at the time of inspection. Make is EngA. Model DJE40/O, Serial #S57060-MUA (1 / 2)	
Reserve History	Year of Acquisition	2017
	Work Completed	Strata allocated \$62k in 2017 for replacement
	Dollars Spent	\$54,875 quoted by PML
Life Cycle Analysis	Expected Lifespan	20 years (Budget Provision)
	Effective Age	1year
	Remaining Lifespan	19 years
Funding Analysis	Work	Remove and replace the failing boiler.

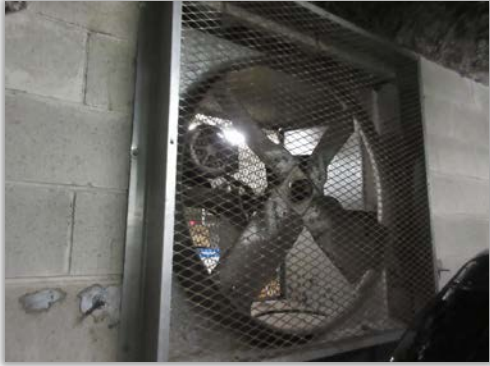
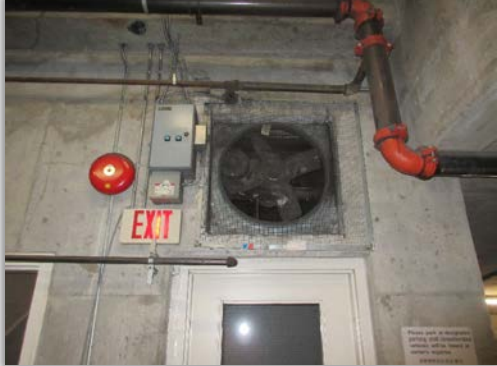
</div>		
Description	This component accounts for the parkade exhaust fans.	
	Quantity	1 System
	Current Job Cost	\$5,743
Condition Analysis	Based on a partial visual inspection, this component appears to be in average condition for its age. No major deficiencies were noted or reported at the time of inspection. It was assumed the fan was operational.	
Reserve History	Year of Acquisition	2016
	Work Completed	Repairs to the system in 2016
	Dollars Spent	\$555
Life Cycle Analysis	Expected Lifespan	15 years (Budget Provision)
	Effective Age	1year
	Remaining Lifespan	14 years
Funding Analysis	Work	Remove and replace the failed fan parts as required.
	Budget	A budget equal to 50% of the estimated total cost is provided for significant expenditures every 15 years.
Potential Deterioration	Includes corrosion, high operating costs, air leakage, motor failure, fan failure, and controls failure. Contributing factors include wear-and-tear, physical damage, frequent start-ups, overheating, debris accumulation, and environmental factors such as extreme temperatures and humidity.

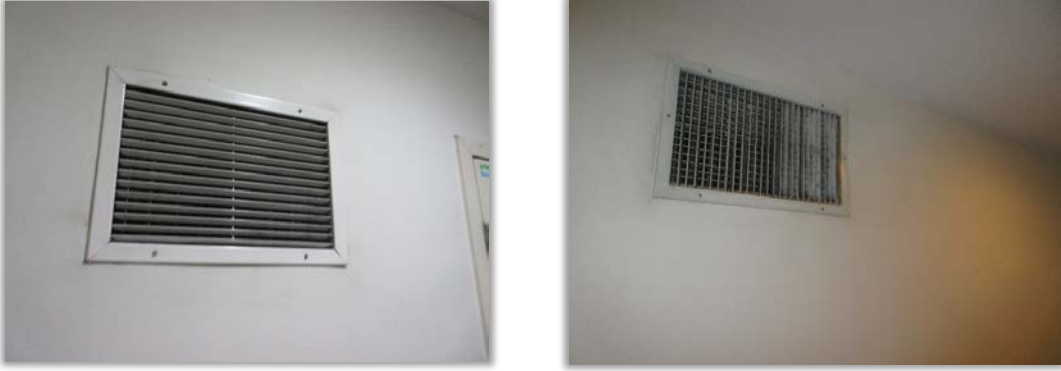
Description	This component accounts for the HVAC distribution system. This includes the plenum, ductwork, duct connections, GRDs (grilles, registers, and diffusers), and thermostats.	
	Quantity	2 Systems
	Current Job Cost	\$14,523
Condition Analysis	We were not able to visually inspect this component. No major deficiencies were reported at the time of inspection, so we assume it to be in average condition for its age.	
Reserve History	Year of Acquisition	2000
	Work Completed	None noted or reported
	Dollars Spent	N/A
Life Cycle Analysis	Expected Lifespan	30 years (Budget Provision)
	Effective Age	10 years
	Remaining Lifespan	20 years
Funding Analysis	Work	Remove and replace ductwork, GRDs, and thermostats as required.
	Budget	A budget equal to 25% of the estimated total cost is provided for significant expenditures every 30 years.
Potential Deterioration	Includes failed seams, corrosion, noisy operation, and debris accumulation. Contributing factors include wear-and-tear, vibration, condensation, blockages, thermal stress, insufficient maintenance, and environmental factors such as temperature changes and humidity.

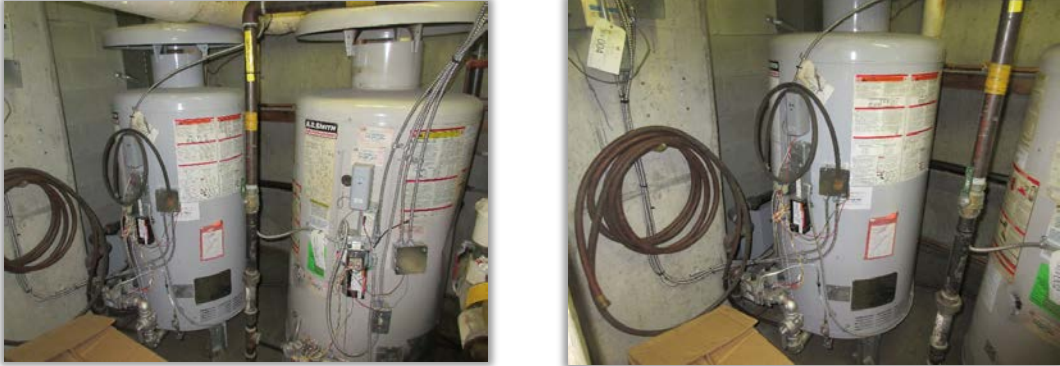
Description	This component accounts for the common-element water heaters. This includes the tanks, heating components, and controls. This excludes the piping, fittings, valves, and vents, which are accounted for separately in the Domestic Water Distribution component.	
	Quantity	2 Tanks
	Current Job Cost	\$20,344
Condition Analysis	Based on a partial visual inspection, this component appears to be in average condition for its age. No major deficiencies were noted or reported at the time of inspection. The tanks are AEO Smith. Serial #3634M002878 & 1616M000102	
Reserve History	Year of Acquisition	2016
	Work Completed	None noted or reported
	Dollars Spent	N/A
Life Cycle Analysis	Expected Lifespan	12 years
	Effective Age	1year
	Remaining Lifespan	11 years
Funding Analysis	Work	Remove and replace the failing water heater.
	Budget	We have allowed for a full replacement of this component every 12 years.

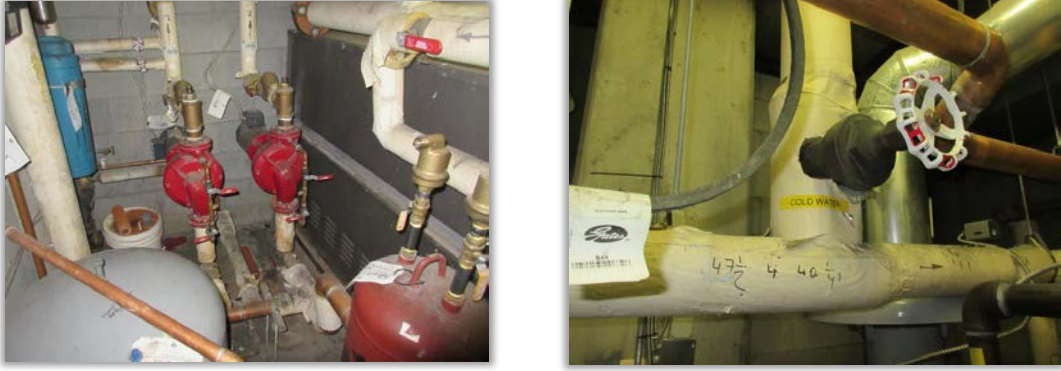
Description	This component accounts for the interior common-element domestic water distribution system. This includes risers, pumps, branch lines, valves, and backflow preventers for both the supply and removal of hot and cold water.	
	Quantity	1 System
	Current Job Cost	\$109,498
Condition Analysis	We were not able to visually inspect this component. No major deficiencies were reported at the time of inspection, so we assume it to be in average condition for its age.	
Reserve History	Year of Acquisition	2000
	Work Completed	None noted or reported
	Dollars Spent	N/A
Life Cycle Analysis	Expected Lifespan	25 years (Budget Provision)
	Effective Age	16 years
	Remaining Lifespan	9 years
Funding Analysis	Work	Notify residents of work scope, disruption, and timeline. Access relevant areas while causing minimal damage. Replace damaged water supply components (usually with PEX) or, if water damage is frequent and severe, repipe most or all of the property to prevent further damage from occurring. Test system. Repair any damage and clean work areas.

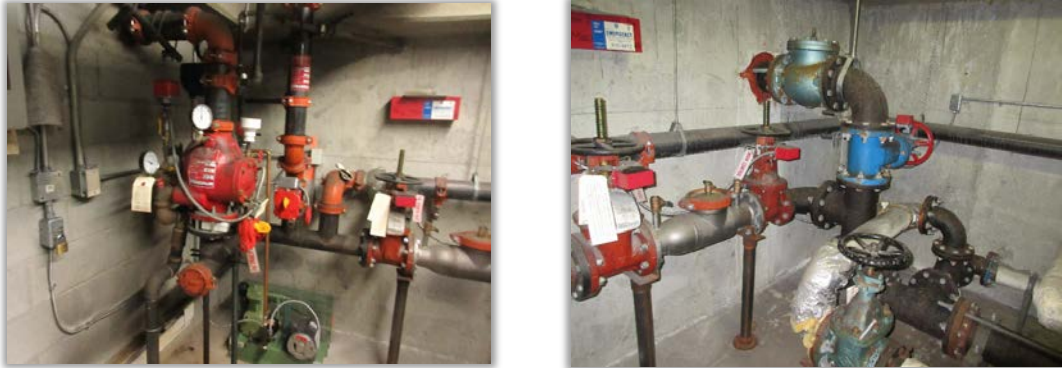
Description	This component accounts for the wet sprinkler system. This includes piping, pipe tees, valves, alarms, sprinkler heads, connections, and associated components.	
	Quantity	1 System
	Current Job Cost	\$58,088
Condition Analysis	Based on a partial visual inspection, this component appears to be in average condition for its age. No major deficiencies were noted or reported at the time of inspection. Labels indicate regular inspection undertaken by Fire Department.	
Reserve History	Year of Acquisition	2000
	Work Completed	Air compressor replaced in 2017
	Dollars Spent	\$2,575
Life Cycle Analysis	Expected Lifespan	35 years (Budget Provision)
	Effective Age	10 years
	Remaining Lifespan	25 years
Funding Analysis	Work	Inspect and test system regularly to comply with local regulations. Do all work as required or recommended by the inspector. Remove and replace failing components.
