DEPRECIATION REPORT

LMS 4410 — “Chez Victoria”

5555 Victoria Drive

The subject property was visually inspected on September 16, 2019. The consultant reviewed building plans, financial documents, AGM minutes, governing documents, and consulted with the client to identify undocumented repair work, learn about latent defects that are causing problems, assess risk tolerance, and determine the client’s short-term intentions regarding reserve fund work.

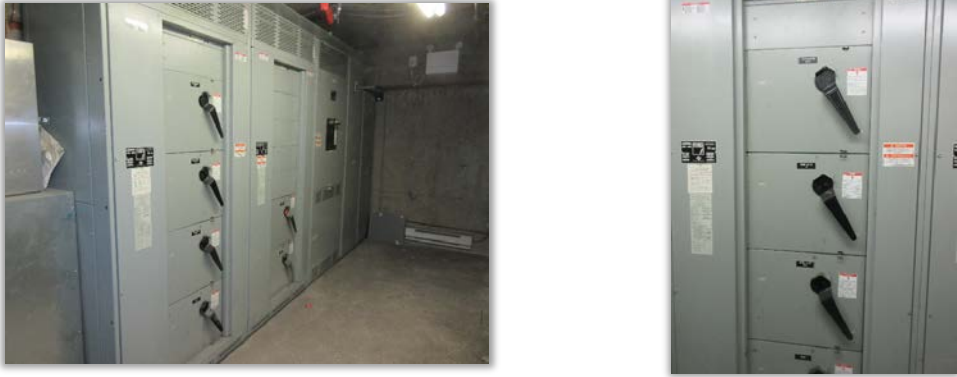
Description	This component accounts for the common-element electrical service and distribution system. This includes wiring, service panels, breakers, switches, receptacles, and various electrical accessories.	
	Quantity	1 System
	Current Job Cost	\$50,091
Condition Analysis	Based on a partial visual inspection, this component appears to be in average condition for its age. No major deficiencies were noted or reported at the time of inspection.	
Reserve History	Year of Acquisition	2000
	Work Completed	None noted or reported
	Dollars Spent	N/A
Life Cycle Analysis	Expected Lifespan	30 years (Budget Provision)
	Effective Age	16 years
	Remaining Lifespan	14 years
Funding Analysis	Work	Remove and replace the various electrical components as required or desired.
	Budget	A budget equal to 15% of the estimated total cost is provided for significant expenditures every 30 years.

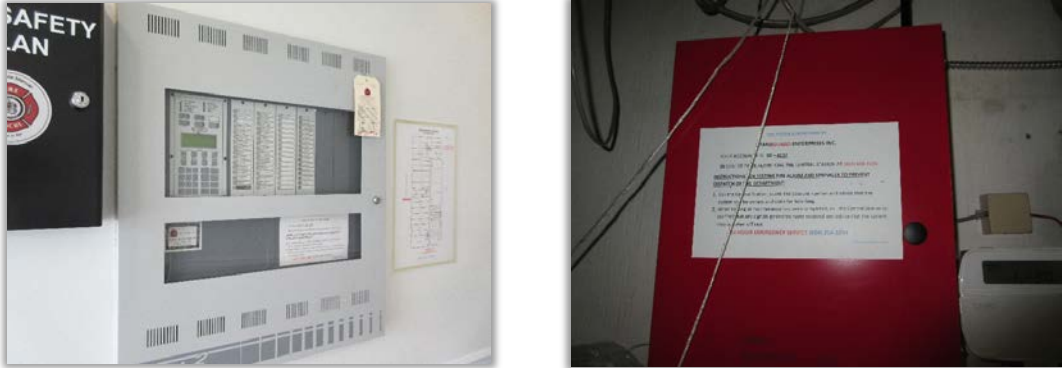
Description	This component accounts for the fire detection and notification system. This includes initiating devices, relays, conduits, wiring, panels, and fire equipment.	
	Quantity	1 System
	Current Job Cost	\$5,009
Condition Analysis	Based on a partial visual inspection, this component appears to be in average condition for its age. No major deficiencies were noted or reported at the time of inspection.	
Reserve History	Year of Acquisition	2000
	Work Completed	None noted or reported
	Dollars Spent	N/A
Life Cycle Analysis	Expected Lifespan	15 years (Budget Provision)
	Effective Age	10 years
	Remaining Lifespan	5 years
Funding Analysis	Work	Repair or replace the various components as required or recommended by qualified fire inspectors.
	Budget	A budget equal to 20% of the estimated total cost is provided for significant expenditures every 15 years.
Potential Deterioration	Includes component failure, wire degradation, electrical failure, impact damage, and functional obsolescence. Contributing factors include wear-and-tear, usage, debris accumulation, corrosion, physical damage, technological improvements, building code changes, and environmental factors such as extreme temperatures, humidity, and ventilation.

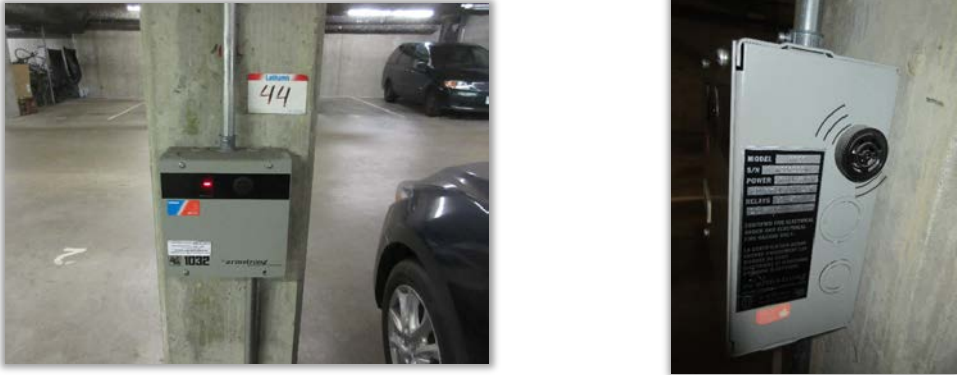
Description	This component accounts for the common-element gas sensors.	
	Quantity	5 Sensors
	Current Job Cost	\$4,552
Condition Analysis	Based on a partial visual inspection, this component appears to be in average condition for its age. No major deficiencies were noted or reported at the time of inspection.	
Reserve History	Year of Acquisition	2000
	Work Completed	None noted or reported
	Dollars Spent	N/A
Life Cycle Analysis	Expected Lifespan	7 years
	Effective Age	4 years
	Remaining Lifespan	3 years
Funding Analysis	Work	Remove and replace the expiring gas sensors.
	Budget	We have allowed for a full replacement of this component every 7 years.
Potential Deterioration	Includes fuel cell deterioration due to wear-and-tear. Gas sensors should be replaced before their expiration date.	
Suggested Maintenance	Regular testing of the sensors. Inspect and replace as required.

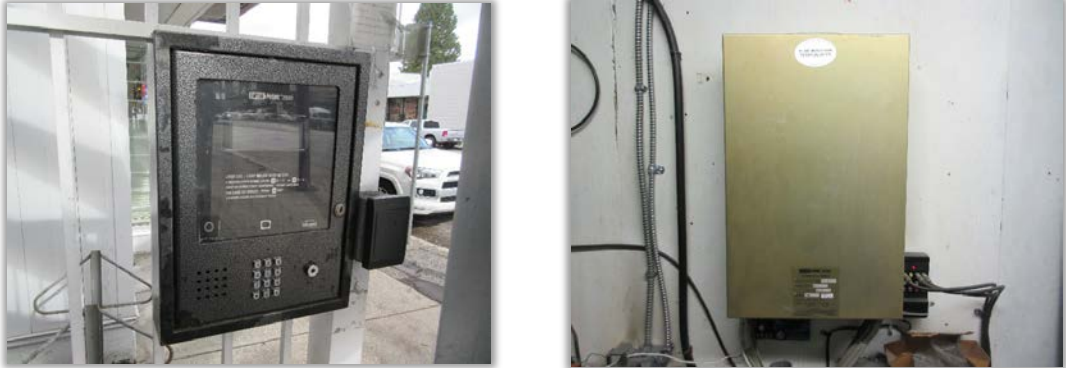
Description	<p>This component accounts for the common-element access entry system. This includes the intercom terminal and door-release system.</p> <table border="1" style="width: 100%; border-collapse: collapse;"> <tr> <td style="background-color: #e0e0e0; width: 20%;">Quantity</td> <td>1 System</td> </tr> <tr> <td style="background-color: #e0e0e0;">Current Job Cost</td> <td>\$18,125</td> </tr> </table>		Quantity	1 System	Current Job Cost	\$18,125		
Quantity	1 System							
Current Job Cost	\$18,125							
Condition Analysis	<p>Based on a partial visual inspection, this component appears to be in average condition for its age. No major deficiencies were noted or reported at the time of inspection.</p>							
Reserve History	<table border="1" style="width: 100%; border-collapse: collapse;"> <tr> <td style="background-color: #e0e0e0; width: 20%;">Year of Acquisition</td> <td>2016</td> </tr> <tr> <td style="background-color: #e0e0e0;">Work Completed</td> <td>System upgraded in 2016 by Blue Mountain Tech.</td> </tr> <tr> <td style="background-color: #e0e0e0;">Dollars Spent</td> <td>Intercom unit replacement estimated at \$6,200</td> </tr> </table>		Year of Acquisition	2016	Work Completed	System upgraded in 2016 by Blue Mountain Tech.	Dollars Spent	Intercom unit replacement estimated at \$6,200

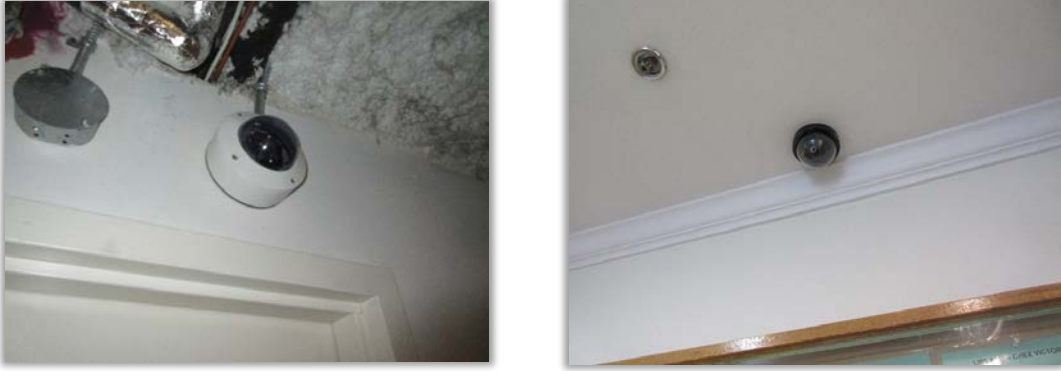
Description	This component accounts for the surveillance system. This includes the cameras, software, and hardware.	
	Quantity	1 System
	Current Job Cost	\$2,504
Condition Analysis	Based on a partial visual inspection, this component appears to be in average condition for its age. No major deficiencies were noted or reported at the time of inspection.	
Reserve History	Year of Acquisition	2018
	Work Completed	New system installed in 2018/2019
	Dollars Spent	N/A
Life Cycle Analysis	Expected Lifespan	7 years (Budget Provision)
	Effective Age	1year
	Remaining Lifespan	6 years
Funding Analysis	Work	Remove and replace the surveillance components as required or desired.
	Budget	A budget equal to 75% of the estimated total cost is provided for significant expenditures every 7 years.
Potential Deterioration	Includes impact damage, electrical failure, component degradation, and functional obsolescence. Contributing factors include wear-and-tear, physical damage, corrosion, technological improvements, and environmental factors such as extreme temperatures, rain, snow, wind, and sun exposure.

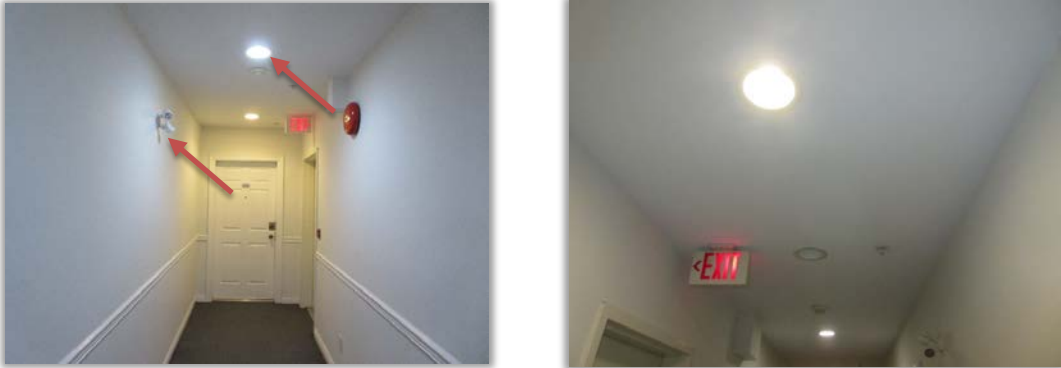
Description	This component accounts for the interior common-area lighting. This includes the fixtures and a small allowance for box and wiring costs.	
	Quantity	200 Lights
	Current Job Cost	\$33,983
Condition Analysis	Based on a visual inspection, this component appears to be in average condition for its age. No major deficiencies were noted or reported at the time of inspection.	
Reserve History	Year of Acquisition	2000
	Work Completed	None noted or reported
	Dollars Spent	N/A
Life Cycle Analysis	Expected Lifespan	25 years (Budget Provision)
	Effective Age	19 years
	Remaining Lifespan	6 years
Funding Analysis	Work	Remove and replace failed lighting components as required or desired.
	Budget	A budget equal to 60% of the estimated total cost is provided for significant expenditures every 25 years.
Potential Deterioration	Includes impact damage, electrical component failure, and water damage. Contributing factors include physical damage, power surges, usage, and damage from environmental factors such as temperature changes and humidity. Fixtures may also be replaced due to functional obsolescence or for aesthetic reasons.

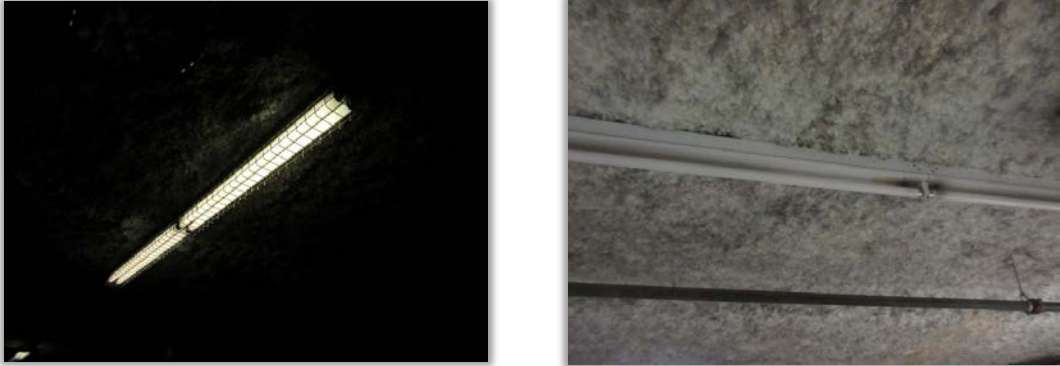
Description	This component accounts for the lighting in the underground parking area. This includes the fixtures and a small allowance for box and wiring costs.	
	Quantity	97 Lights
	Current Job Cost	\$10,151
Condition Analysis	Based on a visual inspection, this component appears to be in average condition for its age. No major deficiencies were noted or reported at the time of inspection.	
Reserve History	Year of Acquisition	2000
	Work Completed	None noted or reported
	Dollars Spent	N/A
Life Cycle Analysis	Expected Lifespan	20 years (Budget Provision)
	Effective Age	15 years
	Remaining Lifespan	5 years
Funding Analysis	Work	Remove and replace failed lighting components as required or desired.
	Budget	A budget equal to 50% of the estimated total cost is provided for significant expenditures every 20 years.
Potential Deterioration	Includes impact damage, electrical component failure, and water damage. Contributing factors include physical damage, power surges, usage, and damage from environmental factors such as temperature changes and humidity. Fixtures may also be replaced due to functional obsolescence or for aesthetic reasons.

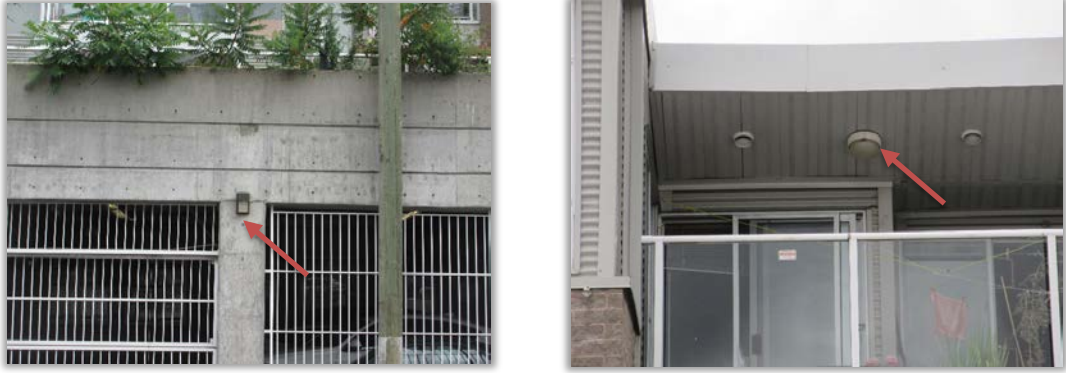
Description	This component accounts for the common-element exterior lighting. This includes the fixtures and a small allowance for box and wiring costs.	
	Quantity	150 Lights
	Current Job Cost	\$3,323
Condition Analysis	Based on a visual inspection, this component appears to be in average condition for its age. No major deficiencies were noted or reported at the time of inspection.	
Reserve History	Year of Acquisition	2000
	Work Completed	None noted or reported
	Dollars Spent	N/A
Life Cycle Analysis	Expected Lifespan	20 years (Budget Provision)
	Effective Age	15 years
	Remaining Lifespan	5 years
Funding Analysis	Work	Remove and replace failed lighting components as required or desired.
	Budget	A budget equal to 15% of the estimated total cost is provided for significant expenditures every 20 years.
Potential Deterioration	Includes impact damage, electrical component failure, and water damage. Contributing factors include physical damage, power surges, usage, and damage from environmental factors such as extreme temperature changes, rain, snow, wind, and sun exposure. Fixtures may also be replaced due to functional obsolescence or for aesthetic reasons.

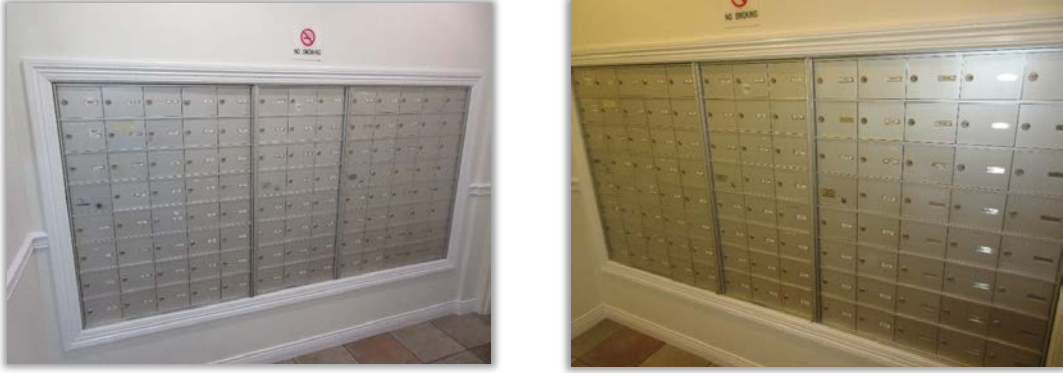
Description	This component accounts for the mailboxes.	
	Quantity	104 Mailboxes
	Current Job Cost	\$5,193
Condition Analysis	Based on a partial visual inspection, this component appears to be in average condition for its age. No major deficiencies were noted or reported at the time of inspection.	
Reserve History	Year of Acquisition	2000
	Work Completed	None noted or reported
	Dollars Spent	N/A
Life Cycle Analysis	Expected Lifespan	30 years (Budget Provision)
	Effective Age	15 years
	Remaining Lifespan	15 years
Funding Analysis	Work	Remove and replace the failed mailboxes.
	Budget	A budget equal to 50% of the estimated total cost is provided for significant expenditures every 30 years.
Potential Deterioration	Includes impact damage and corrosion. Contributing factors include physical damage, wear-and-tear, and environmental factors such as temperature changes and humidity.

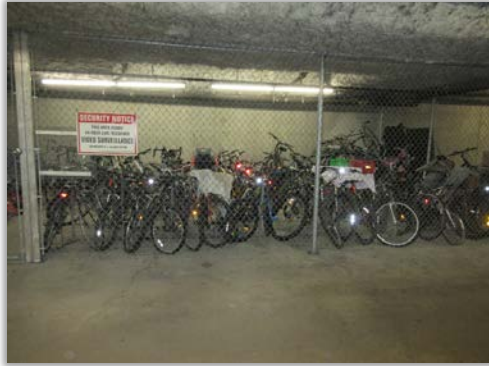
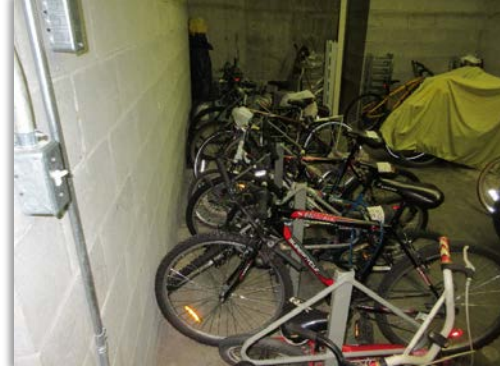
Description	This component accounts for the bicycle racks.	
	Quantity	124 Bikes
	Current Job Cost	\$5,199
Condition Analysis	Based on a visual inspection, this component appears to be in average condition for its age. No major deficiencies were noted or reported at the time of inspection.	
Reserve History	Year of Acquisition	2000
	Work Completed	None noted or reported
	Dollars Spent	N/A
Life Cycle Analysis	Expected Lifespan	20 years (Budget Provision)
	Effective Age	10 years
	Remaining Lifespan	10 years
Funding Analysis	Work	Remove and replace the failing bicycle racks.
	Budget	A budget equal to 50% of the estimated total cost is provided for significant expenditures every 20 years.
Potential Deterioration	Includes impact damage, loosening of fasteners, and corrosion. Contributing factors include physical damage, wear-and-tear, and environmental factors such as temperature changes and humidity.	
Suggested Maintenance	Regular inspection of the bicycle racks for deterioration. Tighten fasteners, clean, and repair as required.

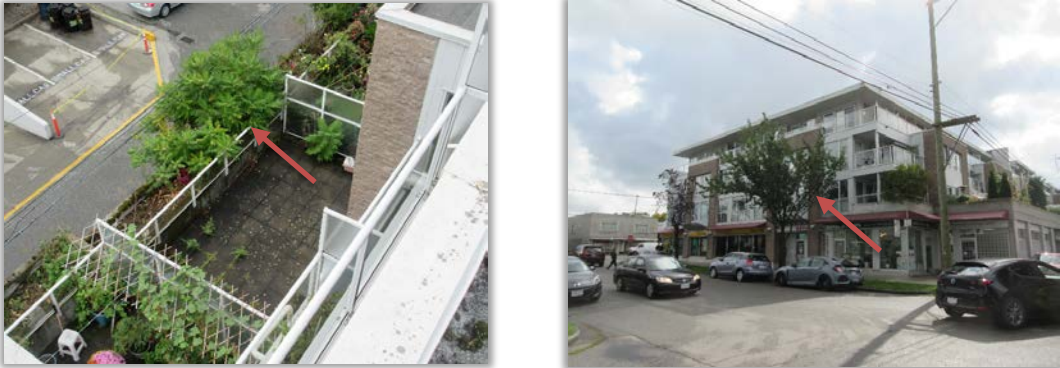
Description	This component accounts for the common-element landscaping. This excludes any routine maintenance that is covered by the operating fund.	
	Quantity	1 Allowace
	Current Job Cost	\$1,559
Condition Analysis	Based on a partial visual inspection, this component appears to be in good condition. No major deficiencies were noted or reported at the time of inspection.	
Reserve History	Year of Acquisition	2000
	Work Completed	None noted or reported
	Dollars Spent	N/A
Life Cycle Analysis	Expected Lifespan	5 years (Budget Provision)
	Effective Age	1 year
	Remaining Lifespan	4 years
Funding Analysis	Work	Regrade as necessary. Replace or repair dead and damaged vegetation. Top up beds. Change landscaping for aesthetic purposes.
	Budget	A budget equal to 10% of the estimated total cost is provided for significant expenditures every 5 years.
Potential Deterioration	Includes poor grading, impact damage, and wear-and-tear. Contributing factors include physical damage, subsurface shifting, debris accumulation, lack of maintenance, and environmental factors such as extreme temperature changes, rain, snow, wind, and sun exposure.

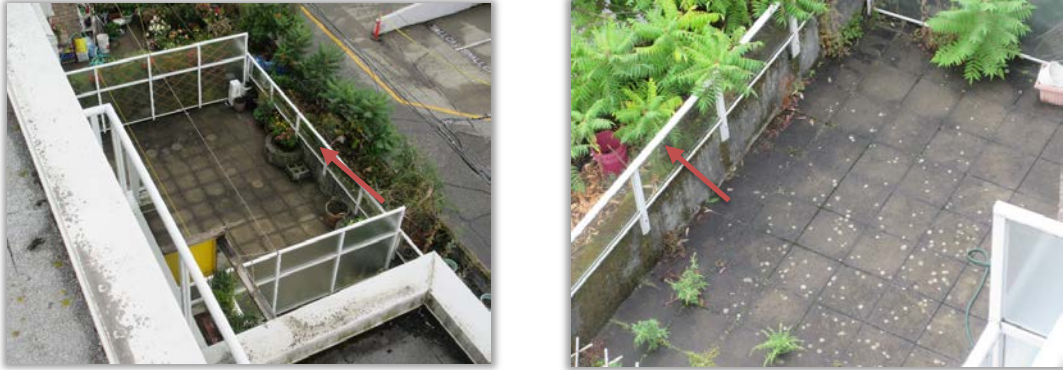
Description	This component accounts for the common-element exterior metal railings.	
	Quantity	310 LF
	Current Job Cost	\$9,020
Condition Analysis	Based on a visual inspection, this component appears to be in average condition for its age. No major deficiencies were noted or reported at the time of inspection.	
Reserve History	Year of Acquisition	2000
	Work Completed	None noted or reported
	Dollars Spent	N/A
Life Cycle Analysis	Expected Lifespan	30 years (Budget Provision)
	Effective Age	15 years
	Remaining Lifespan	15 years
Funding Analysis	Work	Remove and replace railing as required or desired.
	Budget	A budget equal to 25% of the estimated total cost is provided for significant expenditures every 30 years.
Potential Deterioration	Includes impact damage, breakage, corrosion, wear-and-tear, and leaning. Contributing factors include physical damage, subsurface shifting, debris accumulation, lack of maintenance, and environmental factors such as extreme temperature changes, rain, snow, wind, and sun exposure.
