To The Owners, Strata Plan BCS528  
c/o Mr. Ylya Malek, Property Manager  
Rancho Management Services  
Unit 600 - 1190 Hornby St  
Vancouver BC V6Z 2K5

Site Visit: June 20, 2017  
Submitted: April 11, 2018 by  
RDH Building Science Inc.  
224 West 8th Avenue  
Vancouver BC V5Y 1N5

RDH Building Science Inc. (RDH) was retained by The Owners, Strata Plan BCS528 (the Owners) to prepare a Depreciation Report Update (the Report) for the building known as Domus, which is located at 1055 Homer Street, Vancouver, BC. The Report considers the common property and limited common property components (the Assets) that the Strata Corporation is responsible to maintain, repair and replace.

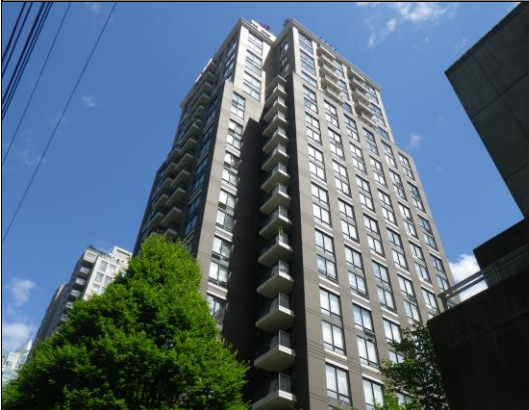
Figure 2.1 Elevation photograph of Domus

Date of first occupancy (approximate)	2003
	Approximate gross floor area, including the parkade (ft <sup>2</sup> )	208,000
	Total area of Unit Entitlement	12,020
	Stories above grade	27
	Total number of strata lots	135

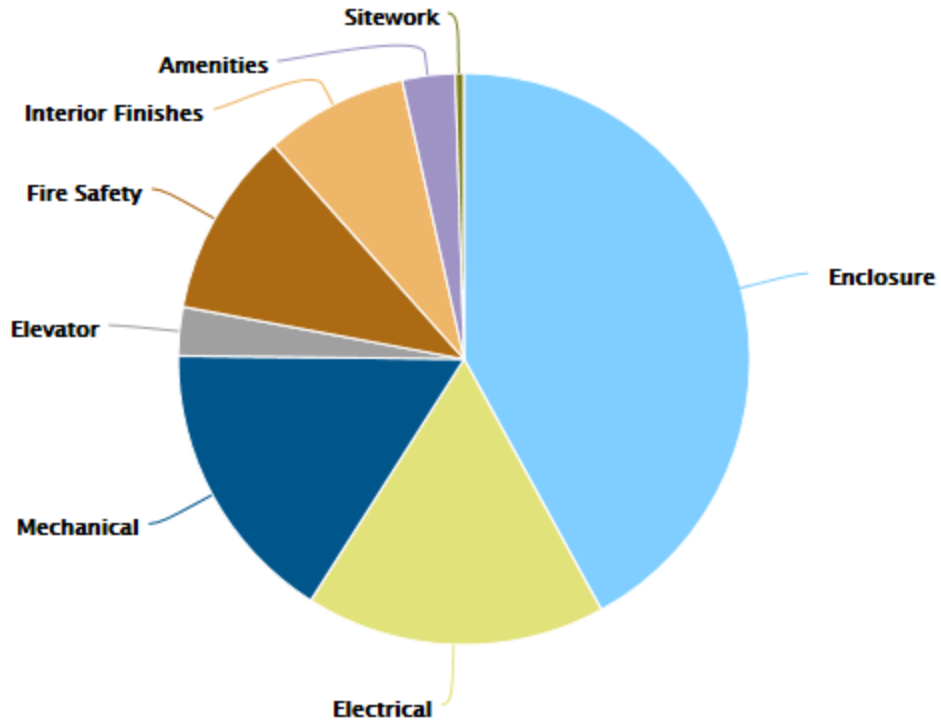
Figure 4.1 Distribution of estimated capital expenditures over 10 years by system.

Approximately 10% of the Strata Corporation’s capital expenditures will occur in the next 10 years. The distribution of estimated capital expenditures over the next 10 years is shown in Figure 4.1 below.

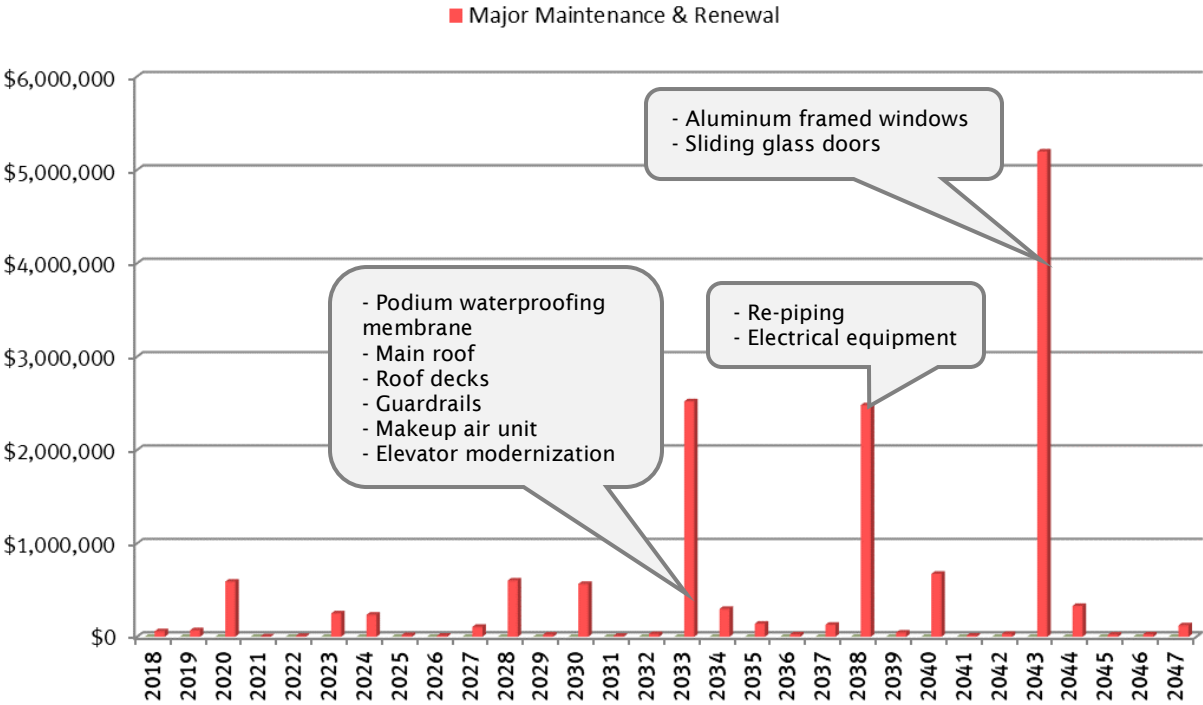
Figure 5.1 Strategic Forecast (30 Years), showing the approximate timing and value of some key capital expenditures.

Estimated major maintenance and renewal costs over the next 30 years are shown on the graph below (Figure 5.1). The red bars represent the estimated value of capital costs.

Each bar on the graph represents a collection of different major maintenance and renewal activities, each with different values. The labels on the graph summarize significant renewal expenditures forecast for

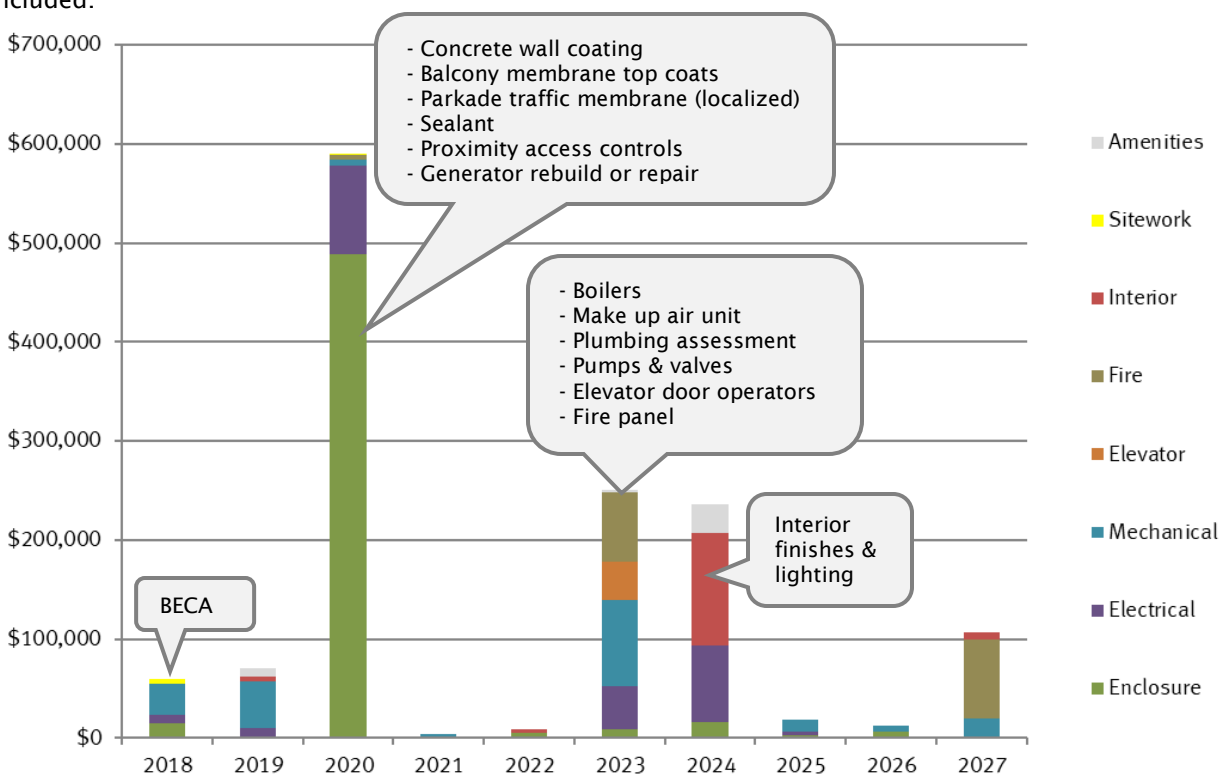
Figure 5.2 Tactical Forecast (10 years), showing the approximate timing and value of some key capital expenditures.

The bars indicate the years in which an event (or bundle of events) is most likely to occur as well as the total magnitude of major maintenance and renewal costs for that year and the costs broken down by system. Labels summarize renewals and major maintenance activities forecast for that year. The soft costs associated with project implementation, such as site access, design, contract administration, are not included.

The tactical plan above represents one of many possible approaches to planning major maintenance and renewal activities. The Strata Corporation can use this initial plan as a tool, a starting point to identify probable projects, priorities and strategies. The actual cost, timing, and scope of projects will be determined by the Strata Corporation and may be reflected in updates to the Depreciation Report.

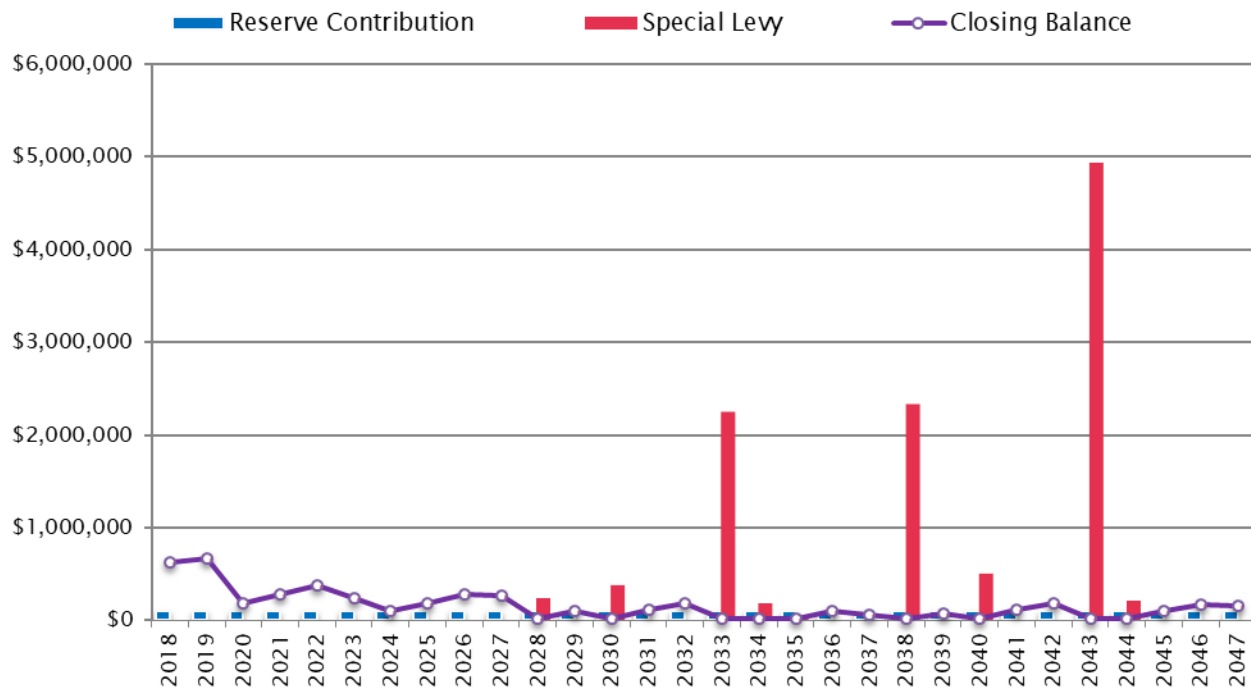
Figure 6.1 CRF balance, contribution and special levies based on the previous funding.

The graph below shows the annual contribution to the CRF, the closing balance of the CRF, and the size of the special levies forecast for the next 30 years.

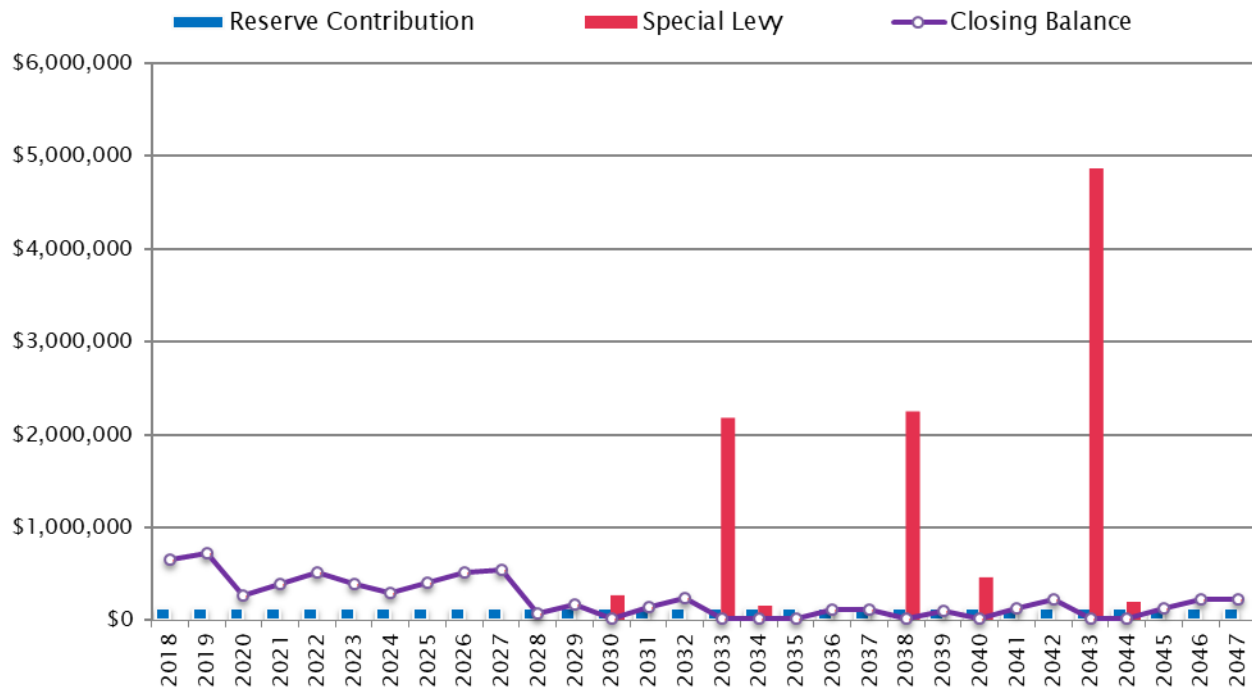
Figure 6.2 CRF balance, contribution and special levies based on the current funding.

The graph below shows the annual contribution to the CRF, the closing balance of the CRF, and the size of the special levies forecast for the next 30 years.

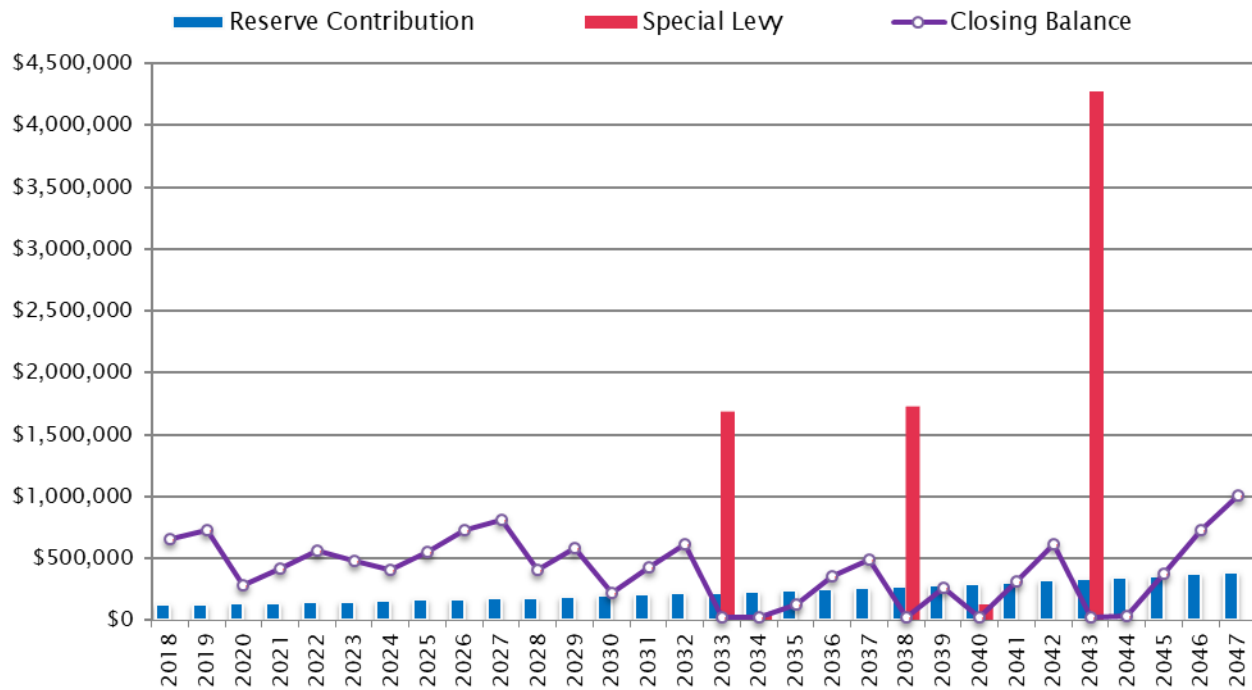
Figure 6.3 CRF balance, contribution and special levies based on the alternative funding scenario.

The alternative funding scenario eliminates most of the smaller levies, but it is not adequate to offset all the special levies over the 30-year planning horizon. The graph below shows the annual contribution to the CRF, the closing balance of the CRF, and the size of the special levies forecast for the next 30 years.

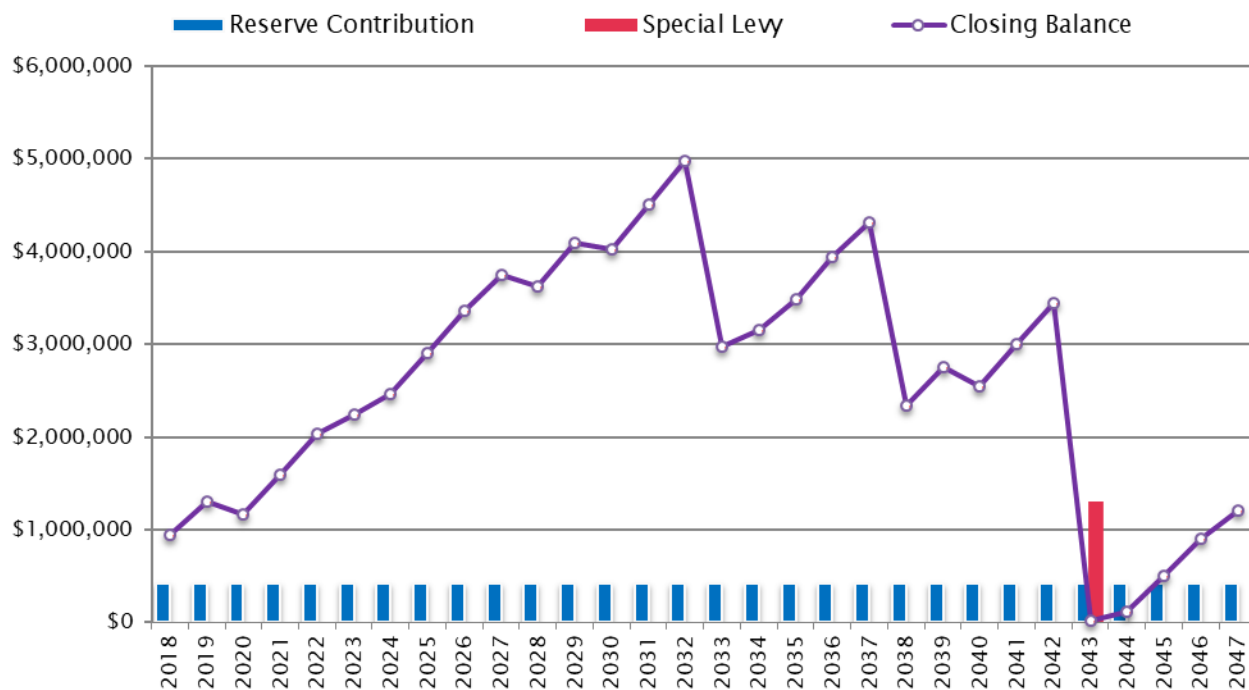
Figure 6.4 CRF balance, contribution and special levies based on a Progressive Reserve calculation.

The Progressive Reserve would offset all but one special levy over the 30-year planning horizon. The graph below shows the annual contribution to the CRF, the closing balance of the CRF, and the size of the special levies forecast for the next 30 years.

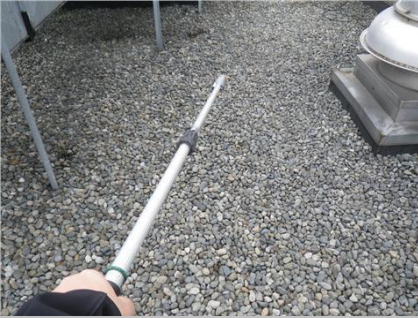
**Encl 01 - Protected SBS Membrane Roof with Ballast**

Main low-sloped roof.

Service Life: 30  
Installed Year: 2003  
Chronological Age: 15  
Effective Age: 15  
Next Renewal Year: 2033

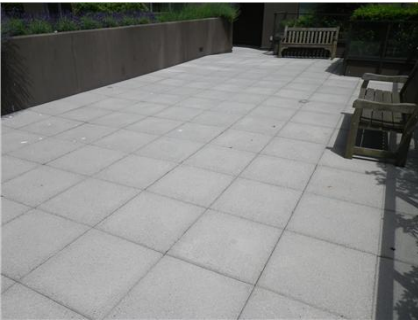
**Encl 02 - Protected SBS Membrane Deck with Traffic-Bearing Surface**

Decks from level 4 to the penthouse.

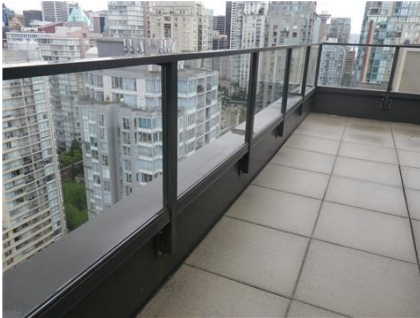
**Encl 04 - Guardrail Glazed Aluminum**

Deck and balcony perimeters.

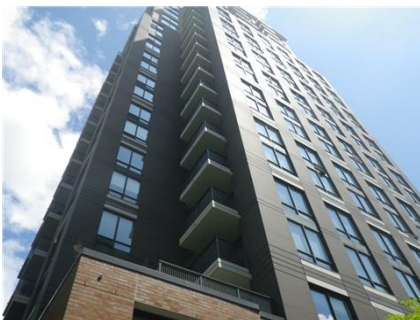
**Encl 06 - Coated Concrete Wall**

All levels and elevations.

- Encl 06 Coating on Exterior Concrete – Plan to reapply the protective coating of the exterior concrete walls, including preparation of the concrete substrate and localized repairs of delaminated or spalled concrete.

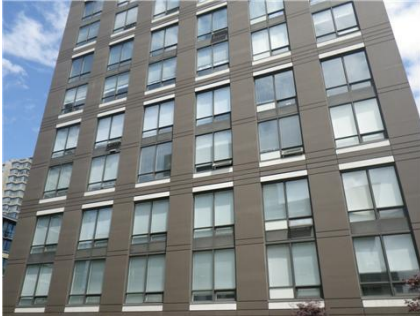
**Encl 08 - Aluminum Framed Window**

All levels and elevations.

- Encl 08 Aluminum Framed Window – Allowance to replace failed insulated glazing units (IGUs) with condensation or misting between the panes of glass, as required. An allowance is shown every two years; however, the exact number will vary from year to year.

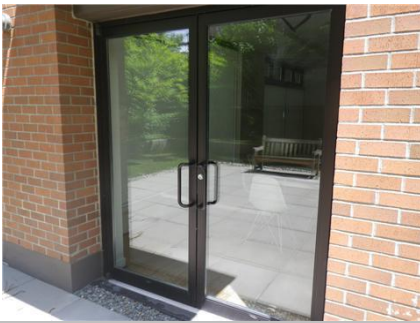
**Encl 09 - Aluminum Frame Glazed Swing Door**

Various decks.

Service Life: 25  
Installed Year: 2003  
Chronological Age: 15  
Effective Age: 15  
Next Renewal Year: 2028

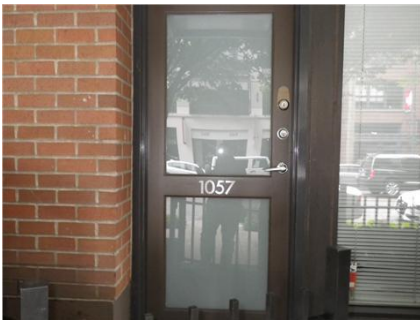
**Encl 10 - Wood Swing Door**

Townhouse entry doors.

Service Life: 25  
Installed Year: 2003  
Chronological Age: 15  
Effective Age: 15  
Next Renewal Year: 2028

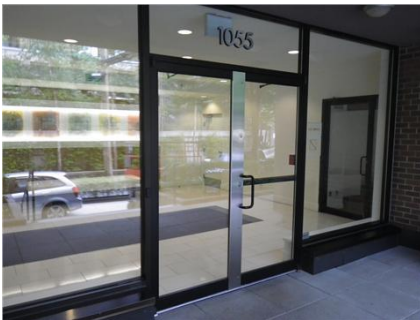
**Encl 11 - Aluminum Frame Lobby Door**

West and east lobby entrances.

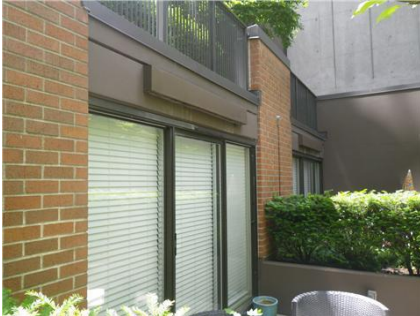
**Encl 12 - Aluminum Framed Sliding Glass Door**

Various balconies and decks.

Service Life: 40  
Installed Year: 2003  
Chronological Age: 15  
Effective Age: 15  
Next Renewal Year: 2043

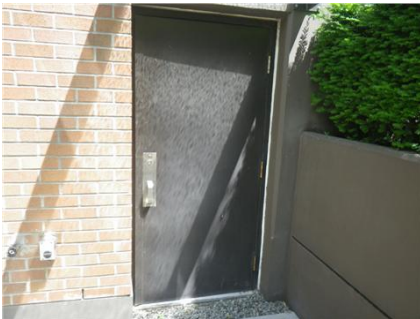
**Encl 13 - Steel Swing Door**

Emergency exit doors.

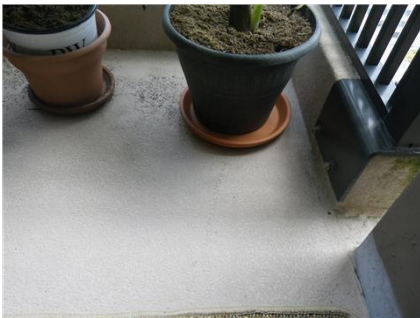
**Encl 14 - Exposed Urethane Balcony Membrane**

Balcony surfaces.

- Encl 14 Balcony Urethane Membranes – Plan for localized repairs and re-application of the balcony membrane top coats, as required.
- Encl 17 Parkade Traffic Membrane – Prepare parkade suspended slab surfaces and locally repair and reapply traffic-bearing membrane in high-traffic areas, as required.

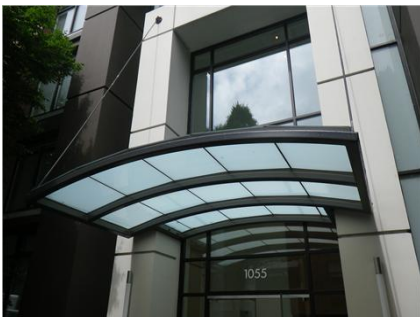
**Encl 15 - Metal Frame and Glass Canopy**

Adjacent to west and east lobby entrances.

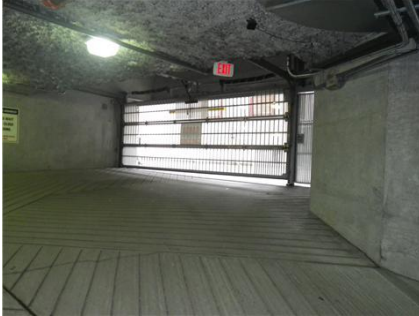
**Encl 16 - Open-grid Overhead Parkade Gate**

Parkade entrances.

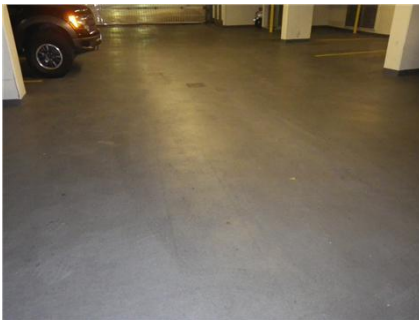
**Encl 17 - Parking Slab with Traffic-bearing Membrane**

Parkade levels P0 to P1.

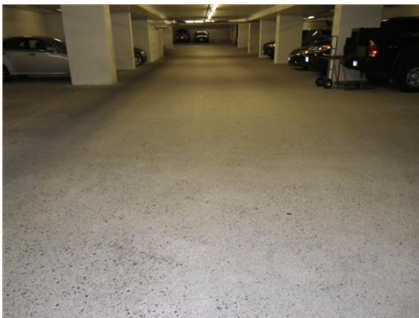
**Encl 18 - Slab-on-Grade**

Parkade level P2.

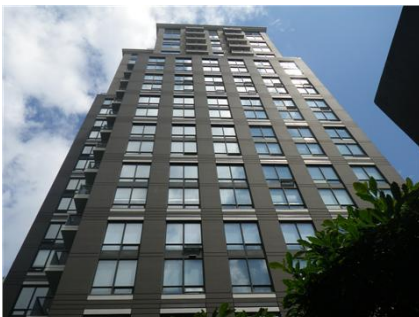
**Encl 19 - General & Inspections**

All levels and elevations.

- Encl 19 General & Inspections – Commission a building enclosure condition assessment (BECA) to confirm the remaining service life of assets such as the at-grade (podium) waterproofing membranes, concrete coatings, sealant, and balconies. The assessment should be completed in advance of recoating, balcony and sealant renewals to assist with the planning process.

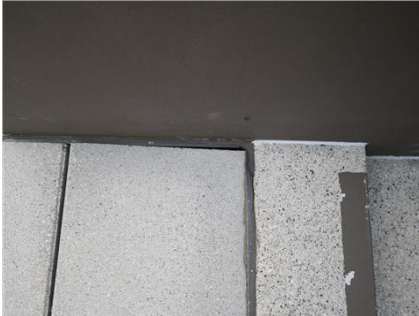
**Encl 20 - Sealant**

Around building enclosure details and penetrations.

- Encl 20 Sealant – Plan to replace sealants at interfaces between building enclosure assemblies, and at penetrations through assemblies. The sealant renewals should be coordinated with the concrete coating renewals.

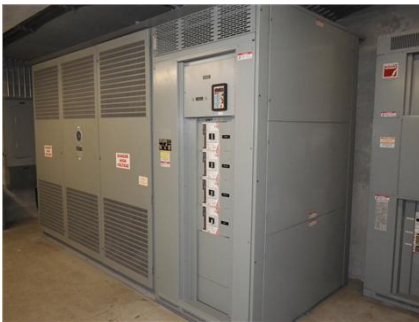
**Elec 01 - Unit Substation**

Main electrical room in parkade level P1 by stall #112.

- Elec 01, 02, and 04 Electrical Distribution Equipment – Conduct infrared thermography, ultrasonic scanning, and cleaning of the main components of the electrical distribution equipment to detect hidden hazards (every 3 to 5 years).
- Elec 03 Emergency Generator – Consider a rebuild of the emergency generator, as required.
- Elec 08 Proximity Access Controls – Anticipate the modernization of components of the door access control system, excluding field wiring, as may be required by technological obsolescence.

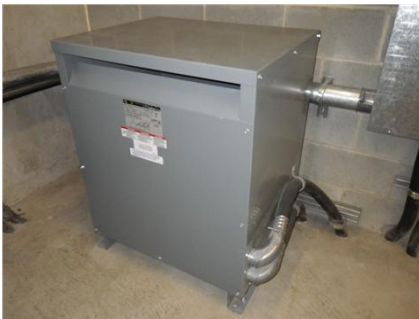
**Elec 02 - Distribution Transformer - Interior**

Electrical room in parkade level P1 by stall #89 and emergency distribution room by stall #130.

Service Life: 40  
Installed Year: 2003  
Chronological Age: 15  
Effective Age: 15  
Next Renewal Year: 2043

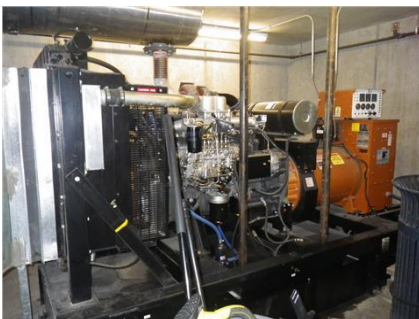
**Elec 03 - Emergency Generator**

Emergency generator room in parkade level P1 by stall #60.

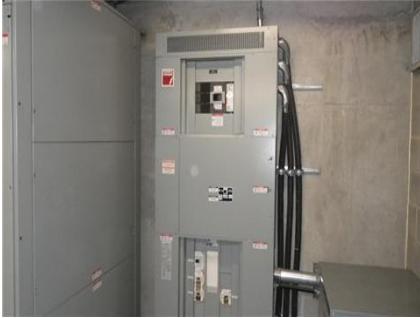
**Elec 04 - Electrical Distribution**

Electrical rooms throughout.

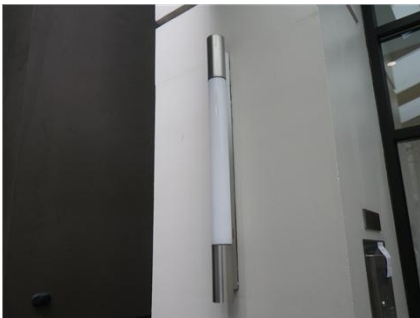
**Elec 05 - Exterior Light Fixtures**

Mounted to exterior walls, soffits, and posts.

- Elec 05 & 06 Interior and Exterior Lighting - Consider the replacement of interior and exterior light fixtures, as required.

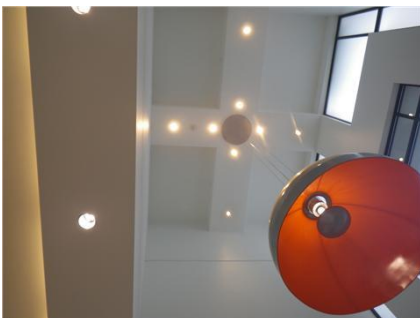
**Elec 06 - Interior Light Fixtures**

Hallways, amenity rooms, service rooms, and throughout the parkade.

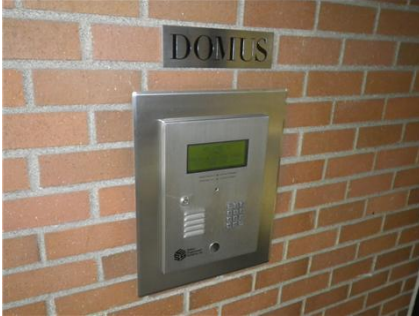
**Elec 07 - Enterphone System**

Lobby and parkade entrances.

Service Life: 25  
Installed Year: 2003  
Chronological Age: 15  
Effective Age: 15  
Next Renewal Year: 2028

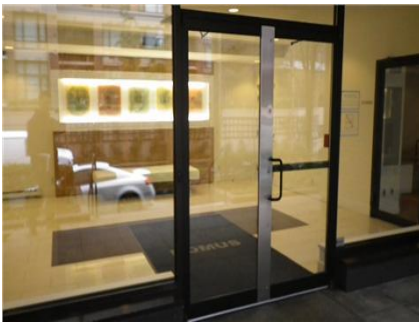
**Elec 08 - Proximity Access Control**

Access to common areas.

Service Life: 12  
Installed Year: 2003  
Chronological Age: 15  
Effective Age: 10  
Next Renewal Year: 2020

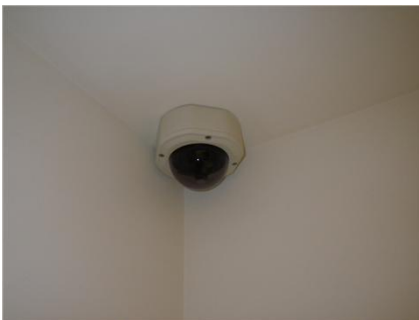
**Elec 09 - Security Surveillance**

Throughout the building.

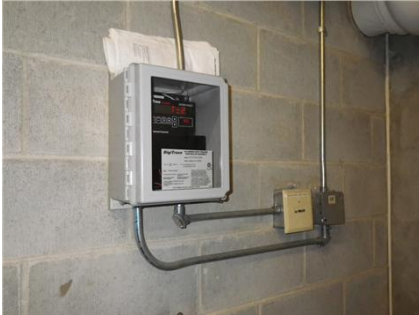
**Mech 01 - Heat Tracing - Freeze Protection**

Throughout the parkade.

Service Life:	15
Installed Year:	2011
Chronological Age:	7
Effective Age:	7
Next Renewal Year:	2026

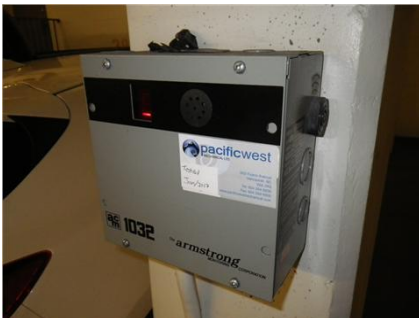
**Mech 02 - Gas Detection - Parking Garage**

Throughout the parkade.

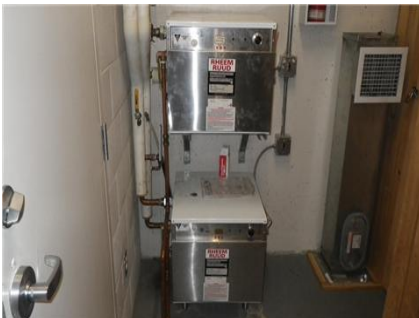
**Mech 03 - Tankless Instantaneous Heater - DHW - Electric**

Storage locker room, level 2.

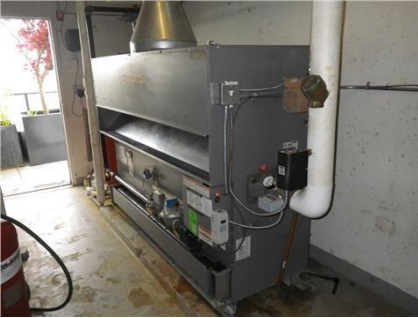
**Mech 05 - Boiler - DHW - Heating - Gas Fired**

Rooftop mechanical room.

Service Life: 14  
Installed Year: 2009  
Chronological Age: 9  
Effective Age: 9  
Next Renewal Year: 2023

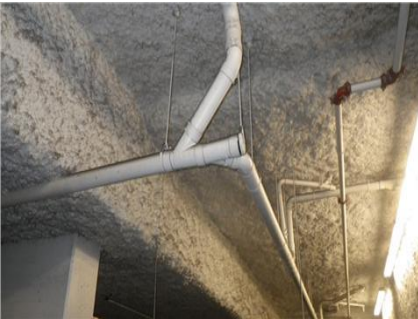
**Mech 06 - Drainage - Sanitary**

Connected to waste fixtures throughout.

Service Life: 50  
Installed Year: 2003  
Chronological Age: 15  
Effective Age: 15  
Next Renewal Year: 2053

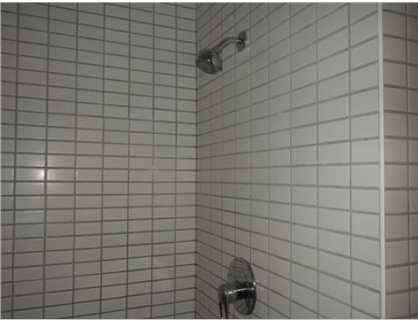
**Mech 07 - Fixtures - Showers**

Amenity change rooms.

Service Life: 25  
Installed Year: 2003  
Chronological Age: 15  
Effective Age: 15  
Next Renewal Year: 2028

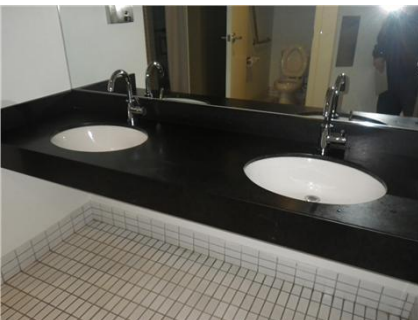
**Mech 08 - Fixtures - Taps & Sinks**

Amenity changerooms.

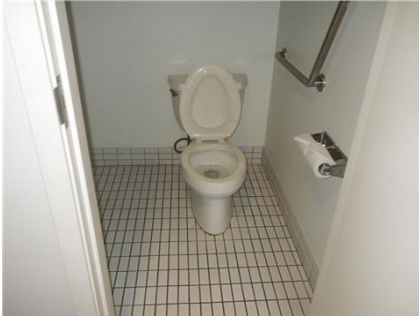
**Mech 09 - Fixtures - Toilets**

Amenity changerooms.

Service Life: 20  
Installed Year: 2003  
Chronological Age: 15  
Effective Age: 15  
Next Renewal Year: 2023

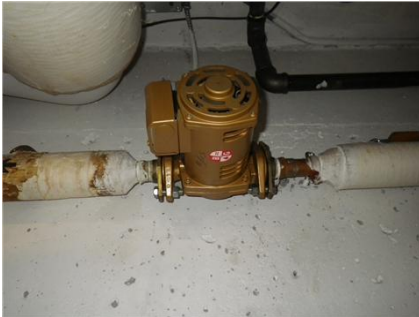
**Mech 10 - Pump - DHW - Circulation and Recirculation**

Rooftop mechanical room.

Service Life: 10  
Installed Year: 2009  
Chronological Age: 9  
Effective Age: 9  
Next Renewal Year: 2019

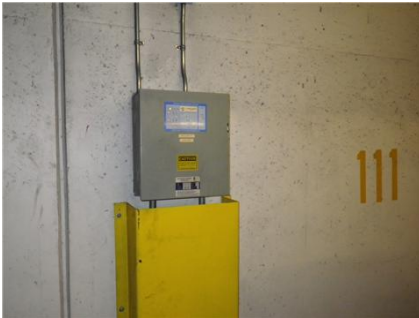
**Mech 11 - Pumps - Sanitary Lift and Control Panel**

Parkade level P2.

Service Life: 15  
Installed Year: 2013  
Chronological Age: 5  
Effective Age: 5  
Next Renewal Year: 2028

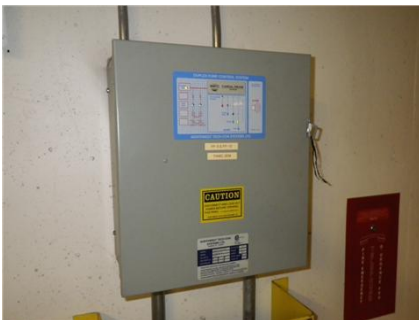
**Mech 12 - Pumps - Storm Lift and Control Panel**

Parkade level P2.

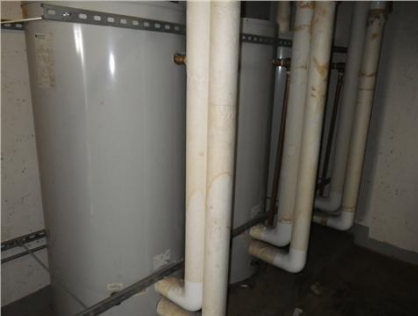
**Mech 13 - Tank - DHW - Storage**

Rooftop mechanical room.

Service Life: 8  
Installed Year: 2009  
Chronological Age: 9  
Effective Age: 7  
Next Renewal Year: 2019

- Mech 13 Hot Water Storage Tanks – Anticipate the cyclical renewal of domestic hot water storage tanks, as required.
- Mech 17 Domestic Booster Pumps – Plan for the replacement of the domestic booster pumps and motor control panel, as required.
- Mech 22 & 26 Fan Coil & Condensing Units – Anticipate the cyclical replacement of split system air conditioning unit fan coils and components of the condensing units, as required.

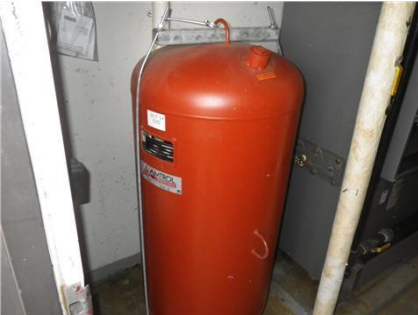
**Mech 14 - Tank - Expansion -DHW - Diaphragm**

Rooftop mechanical room.

Service Life: 20  
Installed Year: 2009  
Chronological Age: 9  
Effective Age: 9  
Next Renewal Year: 2029

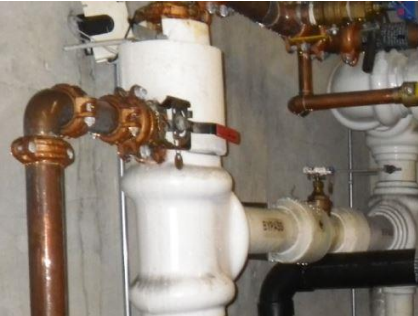
**Mech 15 - Piping - Domestic Water Distribution**

Connected to supply fixtures throughout.

Service Life: 28  
Installed Year: 2003  
Chronological Age: 15  
Effective Age: 8  
Next Renewal Year: 2038

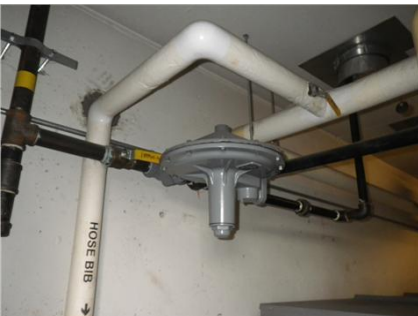
**Mech 16 - Piping - Gas Distribution**

Connected to gas fixtures throughout.

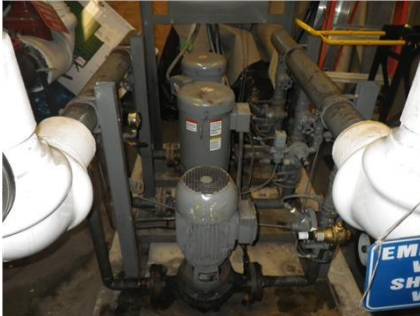
**Mech 17 - Pump - Domestic Water Booster**

Water entry room in parkade level P1 by stall #50.

Service Life: 14  
Installed Year: 2003  
Chronological Age: 15  
Effective Age: 14  
Next Renewal Year: 2018

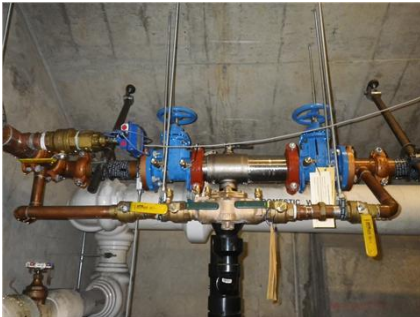
**Mech 18 - Valves - Cross Connection & Backflow Prevention**

Water entry room in parkade level P1 by stall #50 and sprinkler room, level P2, by stall #122.

Service Life: 20  
Installed Year: 2003  
Chronological Age: 15  
Effective Age: 15  
Next Renewal Year: 2023

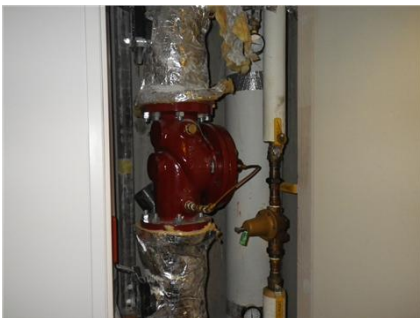
**Mech 19 - Valves - Plumbing Flow Control and Directional**

Water entry room in parkade level P1 by stall #50 and sprinkler room, level P2, by stall #122.

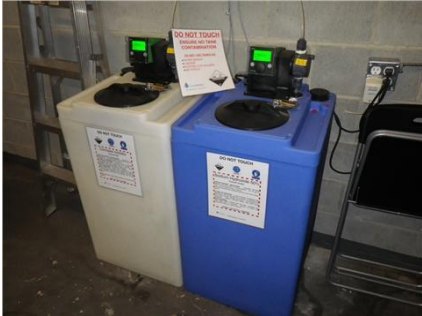
**Mech 20 - 1ClearWater Domestic Water Treatment Equipment [PLACEHOLDER]**

Parkade water entry room.

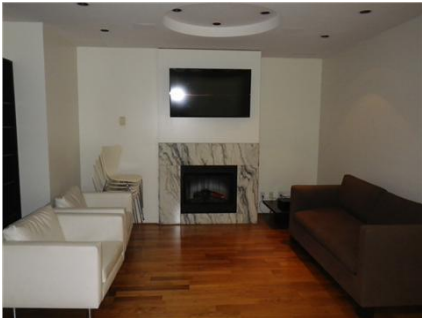
**Mech 21 - Fireplace - Electric**

Amenity lounge.

Service Life: 30  
Installed Year: 2003  
Chronological Age: 15  
Effective Age: 15  
Next Renewal Year: 2033

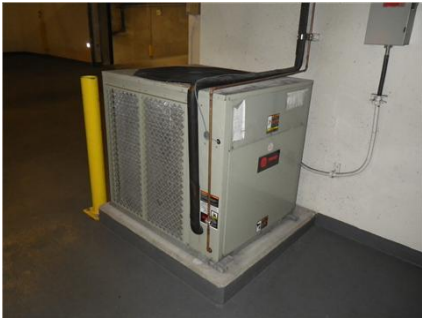
**Mech 22 - Condensing Unit - Outdoor Section - Split System**

Parkade and penthouse suites.

Lennox heat pump outdoor units, 5 tons cooling capacity and associated indoor fan coil units for forced air conditioning and heating.

Service Life: 15  
Installed Year: 2003  
Chronological Age: 15  
Effective Age: 14  
Next Renewal Year: 2019

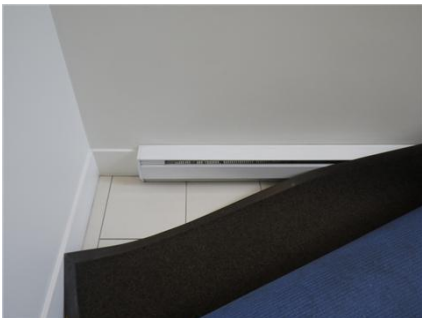
**Mech 23 - Baseboard - Electric**

Service and amenity rooms.

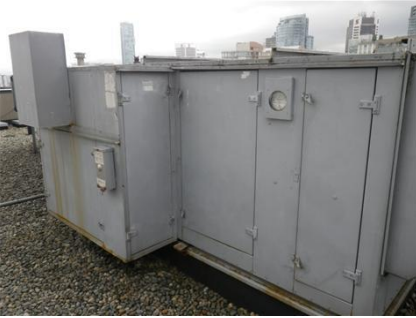
**Mech 24 - Outdoor Air Handler - Makeup Air - Gas**

Roof.

Engineered Air, DJ-100-0, outdoor rooftop unit, belt-driven, centrifugal fan with natural gas fired heating to supply tempered make-up air to the interior spaces. Capacity 800,000 max BTU input, 640,000 max BTU output; 10,550 CFM.

Service Life: 30  
Installed Year: 2003  
Chronological Age: 15  
Effective Age: 15  
Next Renewal Year: 2033

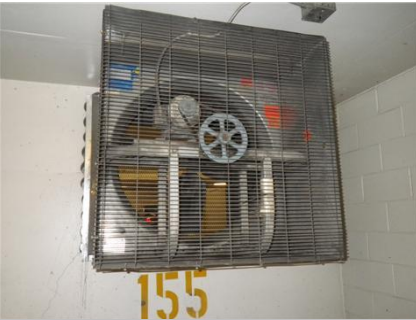
**Mech 25 - Exhaust Fan - Parkade - Propellor**

Parkade.

Service Life: 20  
Installed Year: 2003  
Chronological Age: 15  
Effective Age: 15  
Next Renewal Year: 2023

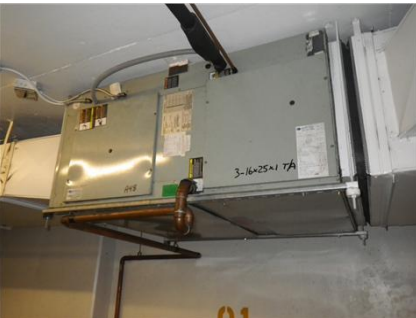
**Mech 26 - Indoor Air handler - Fan Coil Unit - AC**

Parkade.

Lennox direct expansion air-conditioning, ceiling suspended fan coil unit with ducted system for air conditioning.

Service Life: 15  
Installed Year: 2003  
Chronological Age: 15  
Effective Age: 14  
Next Renewal Year: 2019

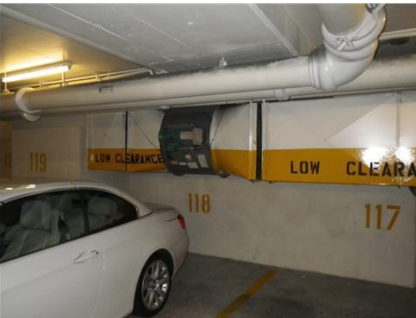
**Mech 27 - Exhaust Fan Parkade - Inline**

Parkade.

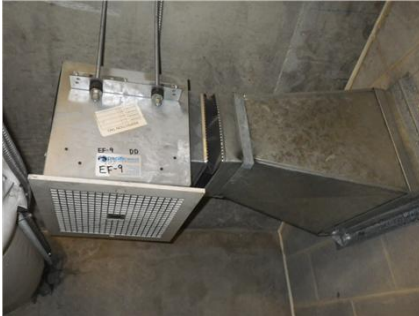
**Mech 28 - Exhaust Fan - Small Service - Cabinet**

Service and storage rooms.

Cook, direct drive fans, ceiling and cabinet fans, and centrifugal inline blower fans.

Service Life: 12  
Installed Year: 2003  
Chronological Age: 15  
Effective Age: 12  
Next Renewal Year: 2018

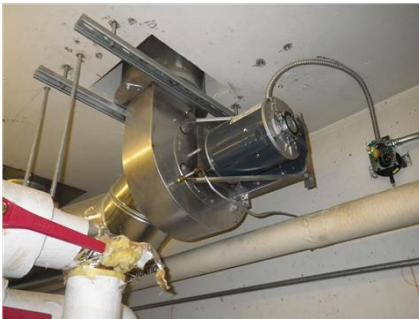
**Mech 29 - Gas Appliance Powerventer Draft Fan**

Rooftop mechanical rooms.

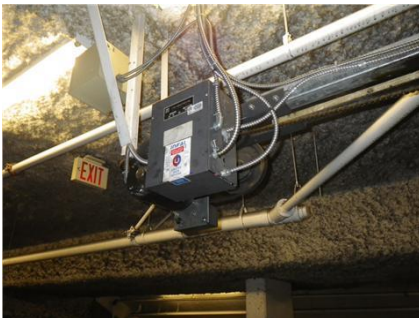
**Mech 30 - Overhead Gate Motor**

Parkade entrance gates.

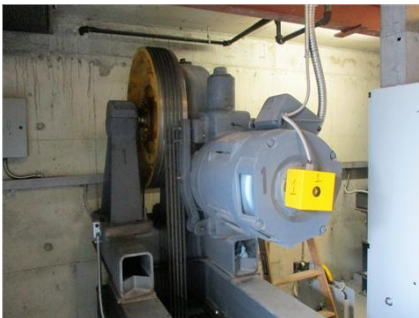
**Elev 01 - Traction Elevators, Overhead Geared**

Elevator machine room at roof level.

Single speed side opening doors, round plastic car and hall pushbuttons, one (1) stainless steel car operating panel per car, ECI 1000 door operators, infrared light curtain door protection, stainless steel doors and front return, plastic laminate walls with mirror on rear walls, stainless steel ceiling, tile flooring, tubular stainless steel handrails on all non-access walls, firefighter's emergency operation, standby power provisions, hands-free voice communication device, no seismic provisions.

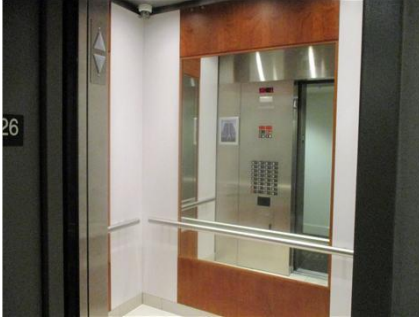
**Elev 02 - Elevator Cabs & Hoistway**

Elevator cab interior, fixture, and hoistway.

- Elev 02 Elevator Cabs & Hoistway - Plan for the replacement of the elevator door operators, as per the recommendations of the elevator review.

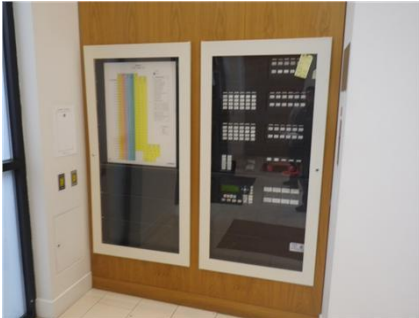
**Fire 01 - Fire Alarm Panel**

Lobbies.

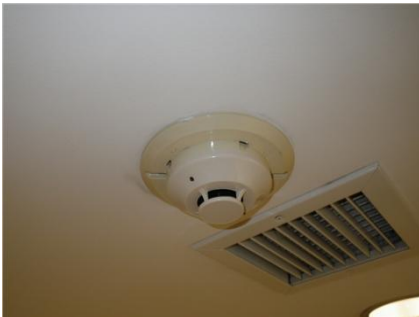
**Fire 02 - Fire Detection & Alarm**

Throughout all common areas.

Smoke detectors, heat detectors, flow switches, tamper switches, horns, pull stations and other fixed apparatus field devices to detect fire and smoke conditions and initiate timely response.

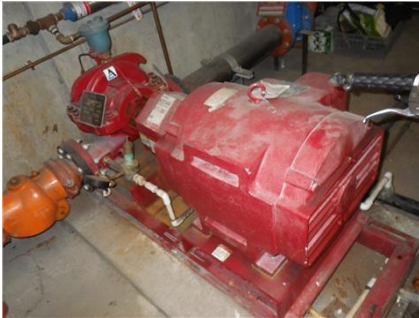
**Fire 03 - Fire & Jockey Pump**

Sprinkler room in parkade level P2, by stall #122.

Service Life: 30  
Installed Year: 2003  
Chronological Age: 15  
Effective Age: 15  
Next Renewal Year: 2033

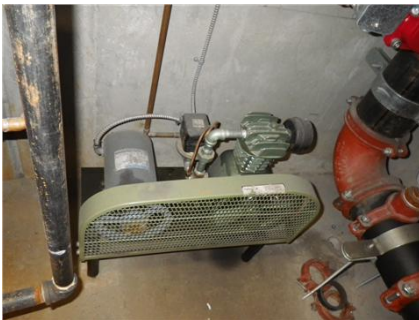
**Fire 04 - Dry Sprinkler Compressor**

Sprinkler room in parkade level P2, by stall #122.

Service Life: 14  
Installed Year: 2003  
Chronological Age: 15  
Effective Age: 1  
Next Renewal Year: 2031

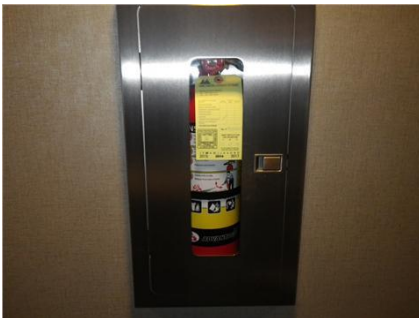
**Fire 05 - Portable Fire Extinguisher**

Throughout all common areas.

Service Life: 24  
Installed Year: 2003  
Chronological Age: 15  
Effective Age: 15  
Next Renewal Year: 2027

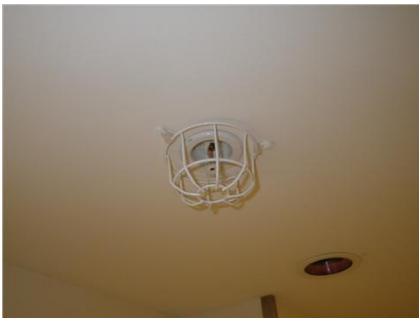
**Fire 06 - Sprinkler & Standpipe - Wet**

Throughout interior common areas.

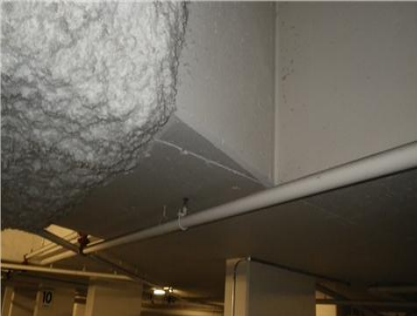
**Fire 07 - Sprinkler System - Dry**

Throughout the parkade.

Service Life: 100  
Installed Year: 2003  
Chronological Age: 15  
Effective Age: 15  
Next Renewal Year: 2103

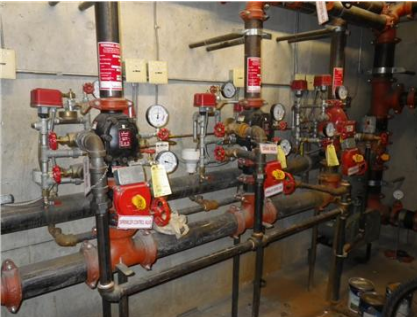
**Fire 08 - Sprinkler Valve Assembly - Dry**

Sprinkler room in parkade level P2, by stall #122.

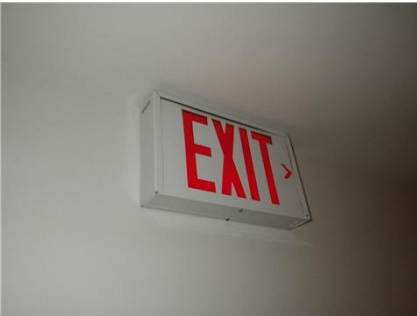
**Fire 09 - Emergency Egress Equipment**

Throughout all common areas.

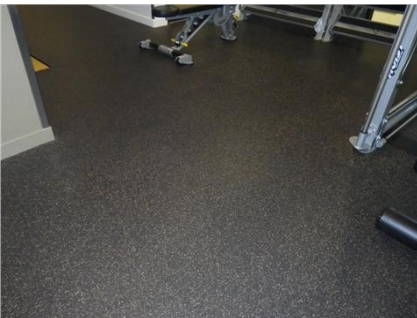
**Finish 01 - Rubber Sports Flooring**

Fitness room.

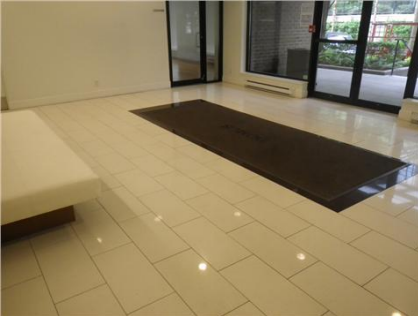
**Finish 02 - Floor Tile**

Lobbies and amenity changerooms.

Service Life: 40  
Installed Year: 2003  
Chronological Age: 15  
Effective Age: 15  
Next Renewal Year: 2043

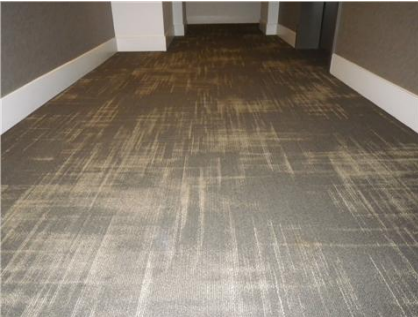
**Finish 03 - Sheet Carpet**

Hallways.

Service Life: 10  
Installed Year: 2014  
Chronological Age: 4  
Effective Age: 4  
Next Renewal Year: 2024

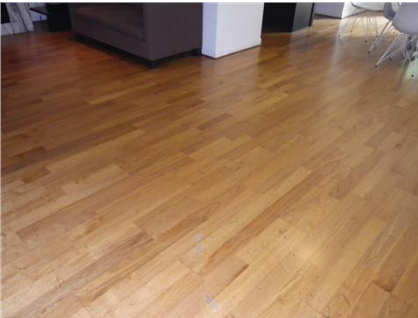
**Finish 04 - Wood Laminate Flooring**

Amenity lounge and portion of fitness room.

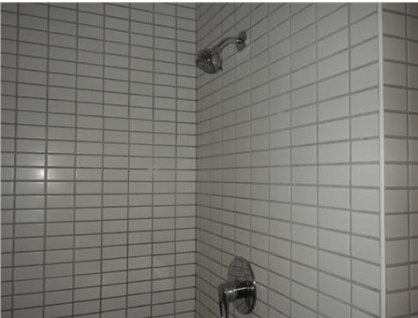
**Finish 05 - Ceramic Tile**

Amenity changerooms.

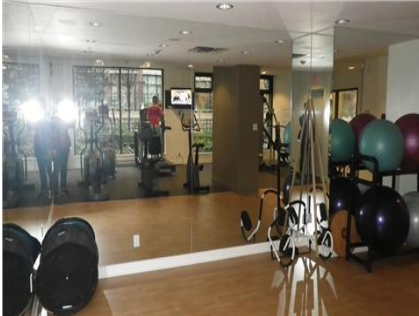
**Finish 06 - Mirror**

Fitness room wall.

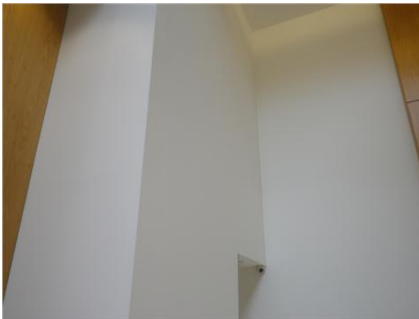
**Finish 07 - Paint**

Lobbies, amenity rooms, and a portion of hallways.

- Finish 03 Carpet - Plan for the replacement of carpet flooring throughout all common areas.
- Finish 04 Wood Laminate Flooring - Plan for the renewal of the wood laminate flooring.
- Finish 07 Paint - Plan to repaint interior common areas in coordination with other interior finish renewals. Interior finish renewals are considered aesthetic in nature and will be scheduled at the discretion of the strata corporation.

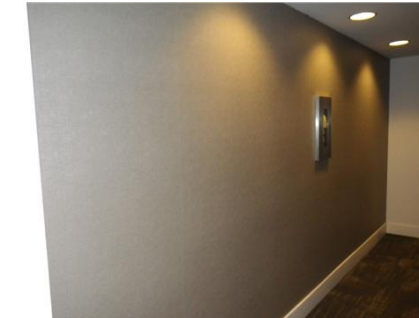
**Finish 08 - Wallpaper Covering**

Hallways.

Decorative wallpaper sheet covering adhered to substrate sheathing. Wallpaper scheduled to be replaced in 2014.

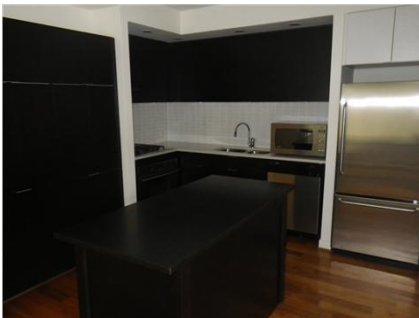
**Finish 09 - Carpentry and Millwork**

Amenity lounge.

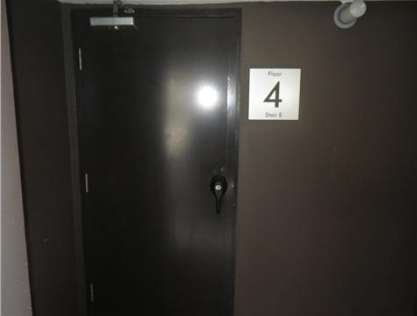
**Finish 10 - Interior Swing Door - General**

Throughout the building.

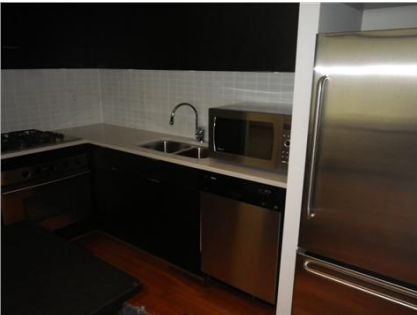
**Amen 01 - Domestic Appliances**

Amenity lounge.

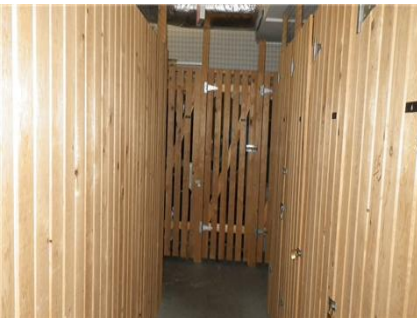
**Amen 02 - Wood Storage Locker**

Storage rooms.

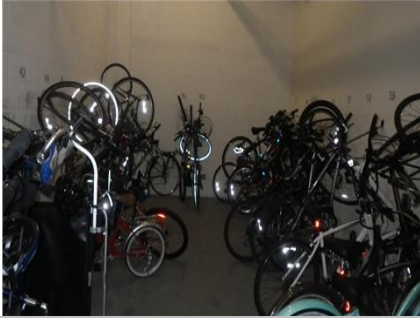
**Amen 03 - Bicycle Rack**

Bike rooms within the parkade.

Service Life: 30  
Installed Year: 2003  
Chronological Age: 15  
Effective Age: 15  
Next Renewal Year: 2033

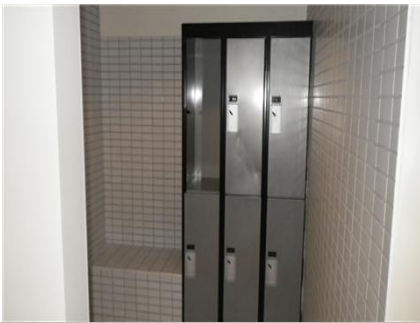
**Amen 04 - Metal Storage Locker**

Amenity changerooms.

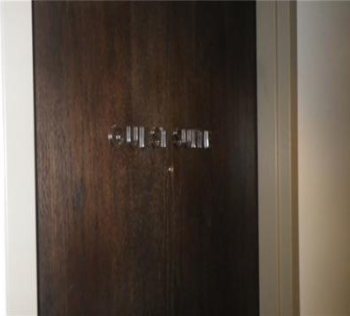
**Amen 07 - Guest Suite**

Level four.

Service Life: 10  
Installed Year: 2014  
Chronological Age: 4  
Effective Age: 4  
Next Renewal Year: 2024

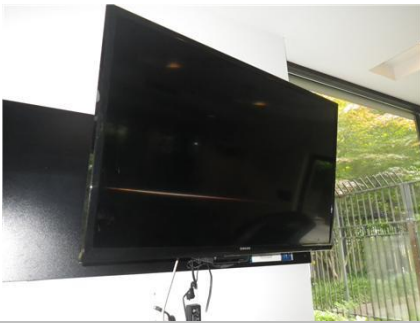
**Amen 08 - Audio Visual Equipment**

Fitness room.

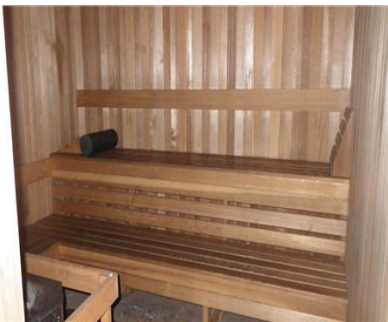
**Amen 09 - Dry Sauna**

Fitness room.

Service Life: 20  
Installed Year: 2003  
Chronological Age: 15  
Effective Age: 14  
Next Renewal Year: 2024

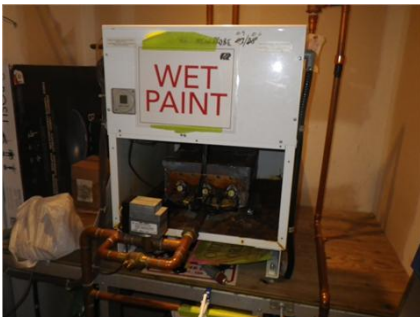
**Amen 10 - Steam Generator**

Mechanical closet in fitness room.

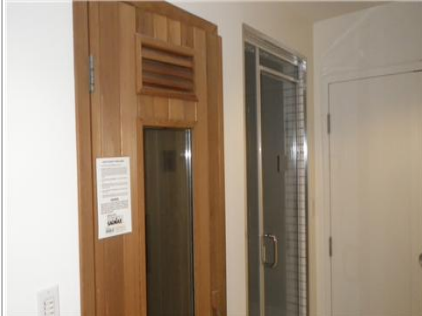
**Amen 11 - Steam Room**

Fitness room.

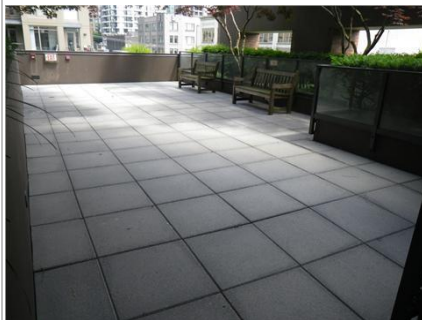
**Site 02 - Concrete Unit Paving**

Decks, terraces and breeze ways.

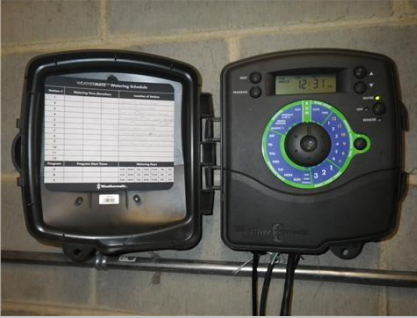
**Site 04 - Irrigation System**

Throughout landscaped areas. Controller in water entry room in parkade level P1 bystall #150.

Service Life: 15  
Installed Year: 2003  
Chronological Age: 15  
Effective Age: 15  
Next Renewal Year: 2018
