To The Owners, Strata Plan BCS528  
c/o Mr. Ylya Malek, Property Manager  
Rancho Management Services  
Unit 600 - 1190 Hornby St  
Vancouver BC V6Z 2K5

Site Visit: June 20, 2017  
Submitted: April 11, 2018 by  
RDH Building Science Inc.  
224 West 8th Avenue  
Vancouver BC V5Y 1N5

RDH Building Science Inc. (RDH) was retained by The Owners, Strata Plan BCS528 (the Owners) to prepare a Depreciation Report Update (the Report) for the building known as Domus, which is located at 1055 Homer Street, Vancouver, BC. The Report considers the common property and limited common property components (the Assets) that the Strata Corporation is responsible to maintain, repair and replace.

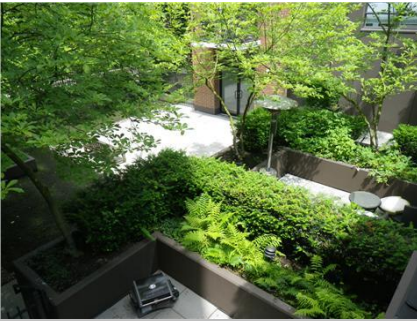
**Site 05 - Soft Landscaping**

Various locations throughout the site.
