DEPRECIATION REPORT

VAS 495—"Oasis"
2234 Prince Albert Street
Vancouver, BC
2021

February 2, 2021

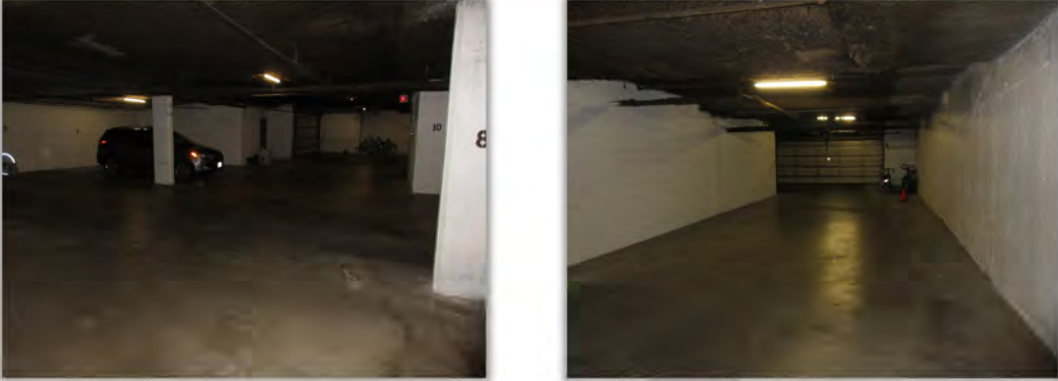
Description	This component accounts for major repairs to the below-grade portions of the property. This includes the foundation walls and parkade: the footings, basement floors, walls, parkade ceilings, columns, and courtyard membrane.	
	Quantity	360 LF
	Current Job Cost	\$38,823
Condition Analysis	Based on a partial visual inspection, this component appears to be in average condition for its age. No major deficiencies were noted or reported at the time of inspection.	
Reserve History	Year of Acquisition	1977
	Work Completed	None noted or reported
	Dollars Spent	N/A
Life Cycle Analysis	Expected Lifespan	35 years (Budget Provision)
	Effective Age	24 years
	Remaining Lifespan	11 years
Funding Analysis	Work	Non-structural cracks can sometimes be injected with a sealant. We have budgeted for periodic structural stabilization work, spot replacement of damaged concrete, underdrain repairs, waterproofing, and membrane replacement. This includes excavation and compacted backfilling.

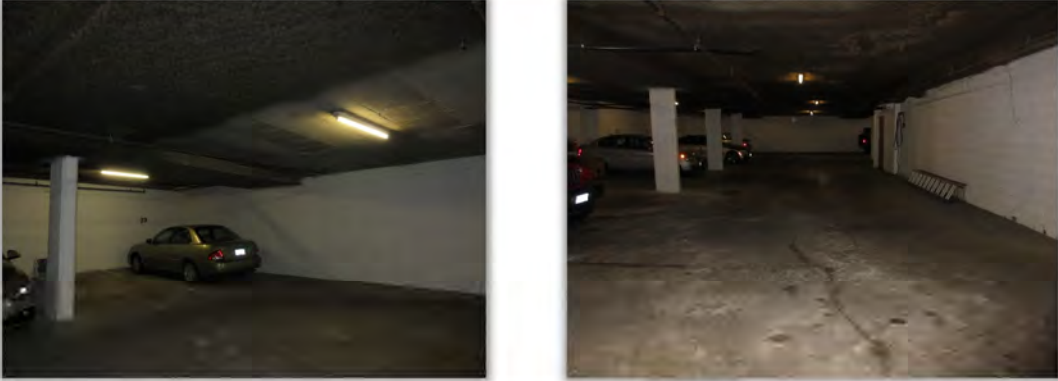
Description	A roof system in which the principal roof covering is a single layer of flexible membrane often thermoset or thermoplastic. Thermoset membranes are compounded from synthetic rubber polymers, and the most commonly used polymers are EPDM, CSPE and Neoprene. Two of the most commonly-used thermoplastic single-ply membranes are PVC and TPO, both of them plastic-based materials.	
	Quantity	2,800 SF
	Current Job Cost	\$37,733
Condition Analysis	Based on a partial visual inspection, this component appears to be in average to good overall condition based upon the date of replacement. Water penetration is not appearing in the parkade ceiling below the membrane, the remainder of the membrane should be replaced within a few years.	
Reserve History	Year of Acquisition	2005
	Work Completed	The south side membrane of the parkade was replaced in 2005.

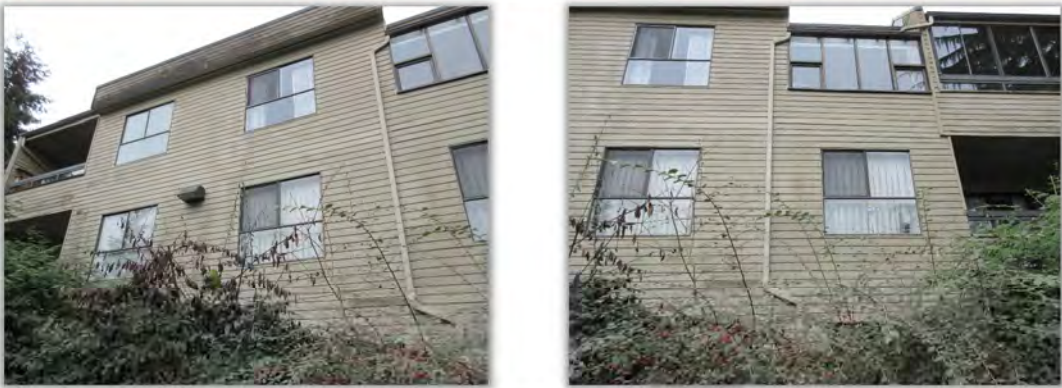
Description	This component accounts for the wood siding envelope system. This system includes the studs, sheathing, building paper, insulation, and wood siding.	
	Quantity	7,500 SF
	Current Job Cost	\$72,163
Condition Analysis	Based on a partial visual inspection, this component appears to be in average condition for its age. No major deficiencies were noted or reported at the time of inspection.	
Reserve History	Year of Acquisition	1977
	Work Completed	Siding on the east wall was replaced in 2018 involving units 102, 103, 202, 203, 302 and 303.
	Dollars Spent	Approximately \$30,970 was spent in 2019 on the repairs.
Life Cycle Analysis	Expected Lifespan	35 years (Budget Provision)
	Effective Age	22 years
	Remaining Lifespan	13 years
Funding Analysis	Work	Remove and dispose of cracked or rotting wood boards. Repair damaged studs and sheathing. Replace building paper and insulation as needed. Install new wood siding, work-site clean up, and any special safety preparation and precautions as required.

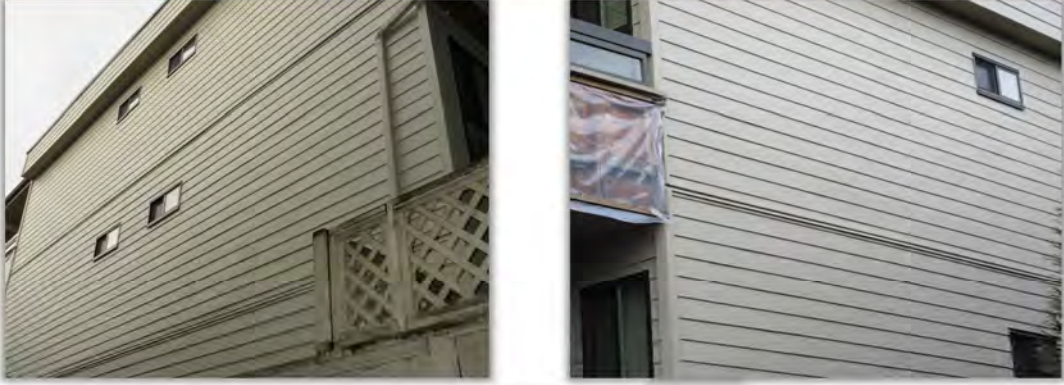
Description	This component accounts for the composite siding system. This system includes the building frame, sheathing, building paper, insulation, and the composite siding.	
	Quantity	1,200 SF
	Current Job Cost	\$13,229
Condition Analysis	Based on a partial visual inspection, this component appears to be in good condition for its age. No major deficiencies were noted or reported at the time of inspection.	
Reserve History	Year of Acquisition	2018
	Work Completed	None noted or reported
	Dollars Spent	N/A
Life Cycle Analysis	Expected Lifespan	40 years (Budget Provision)
	Effective Age	2 years
	Remaining Lifespan	38 years
Funding Analysis	Work	Remove and dispose of all or damaged composite siding. Repair damaged building frame and sheathing. Replace building paper and insulation as needed. Install new composite system, work-site clean up, and any special safety preparation and precautions as required.

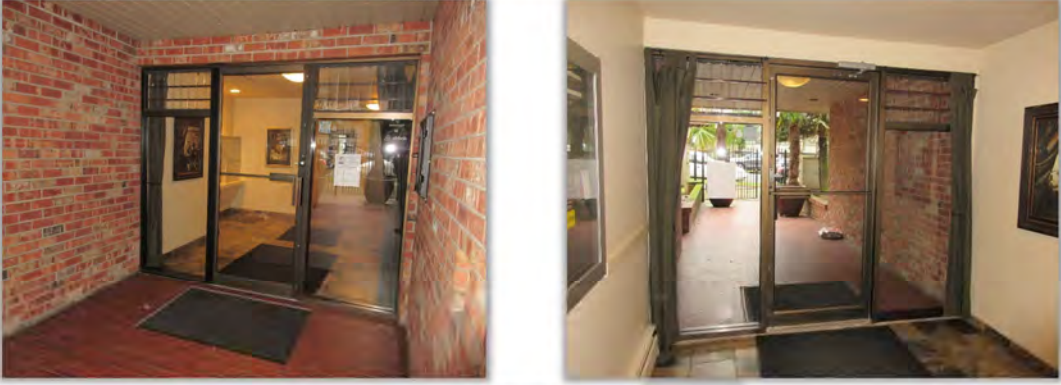
Description	This component accounts for the non-structural exterior commercial storefront assembly. This includes the metal frame, insulated glass units, caulking, and storefront doors with standard hardware.	
	Quantity	100 SF
	Current Job Cost	\$4,503
Condition Analysis	Based on a partial visual inspection, this component appears to be in average condition for its age. No major deficiencies were noted or reported at the time of inspection.	
Reserve History	Year of Acquisition	1977
	Work Completed	None noted or reported
	Dollars Spent	N/A
Life Cycle Analysis	Expected Lifespan	25 years
	Effective Age	15 years
	Remaining Lifespan	10 years
Funding Analysis	Work	Remove and dispose of damaged storefront sections. Spot repairs to any damaged tube framing. Install new window walls with new caulking, work-site clean up, and any special safety preparation and precautions as required. Window wall systems may require re-caulking before the windows fail.

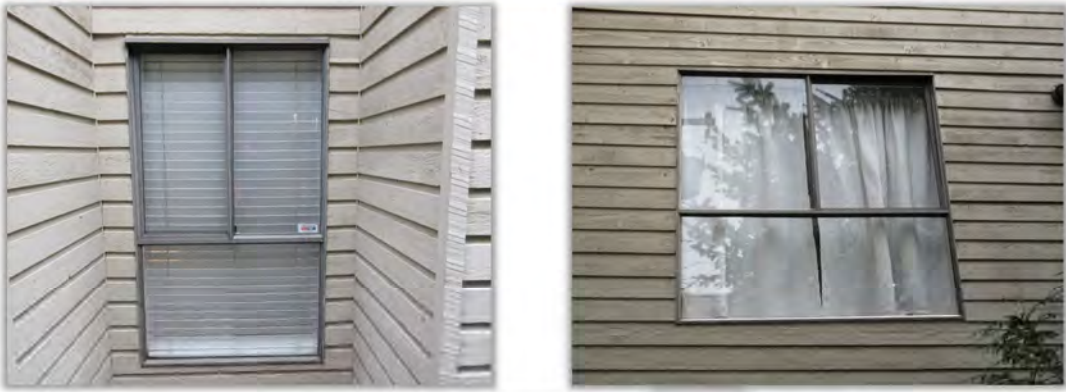
Description	This component accounts for the exterior aluminum-frame windows. This includes the frame, hardware, casing, and aluminum windows.		
	Quantity	34 Windows	
	Current Job Cost	\$25,514	
Condition Analysis	Based on a partial visual inspection, this component appears to be in average condition for its age. No major deficiencies were noted or reported at the time of inspection.		
Reserve History	Year of Acquisition	1977	
	Work Completed	New bathroom and other windows were installed in the east side unit during the wood siding replacement.	
	Dollars Spent	Approximately \$ 7,070 was spent on the replacement in 2019.	
Life Cycle Analysis	Expected Lifespan	30 years (Budget Provision)	
	Effective Age	18 years	
	Remaining Lifespan	12 years	
Funding Analysis	Work	Remove and dispose of damaged window assemblies, repairs to or replacement of the frame, casing, and hardware as required, and installation of new windows. Appropriate safety preparation and precautions as required.

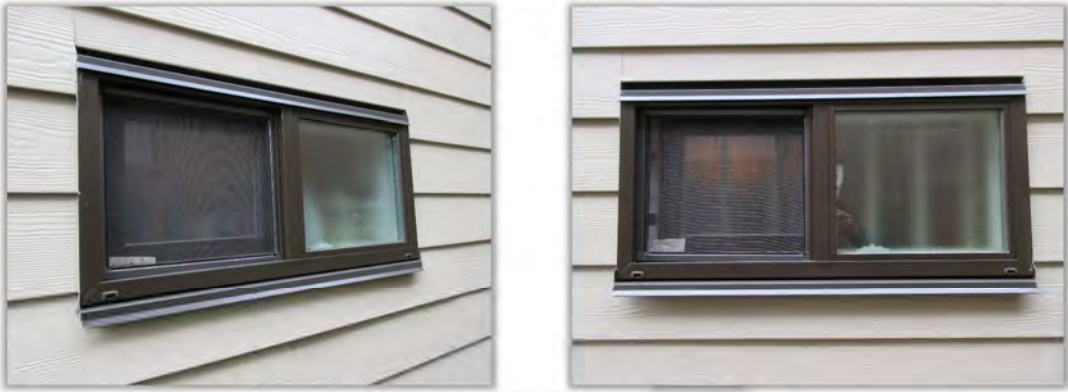
Description	This component accounts for the exterior vinyl-frame windows. This includes the frame, hardware, casing, caulking, and vinyl windows.	
	Quantity	6 Windows
	Current Job Cost	\$1,310
Condition Analysis	Based on a partial visual inspection, this component appears to be in average condition for its age. No major deficiencies were noted or reported at the time of inspection.	
Reserve History	Year of Acquisition	2018
	Work Completed	None noted or reported
	Dollars Spent	N/A
Life Cycle Analysis	Expected Lifespan	35 years (Budget Provision)
	Effective Age	1 year
	Remaining Lifespan	34 years
Funding Analysis	Work	Remove and dispose of damaged window assemblies, repairs to or replacement of the frame, casing, and hardware as required, and installation of new windows. Appropriate safety preparation and precautions as required.
	Budget	A budget equal to 50% of the estimated total cost is provided for significant expenditures every 35 years.

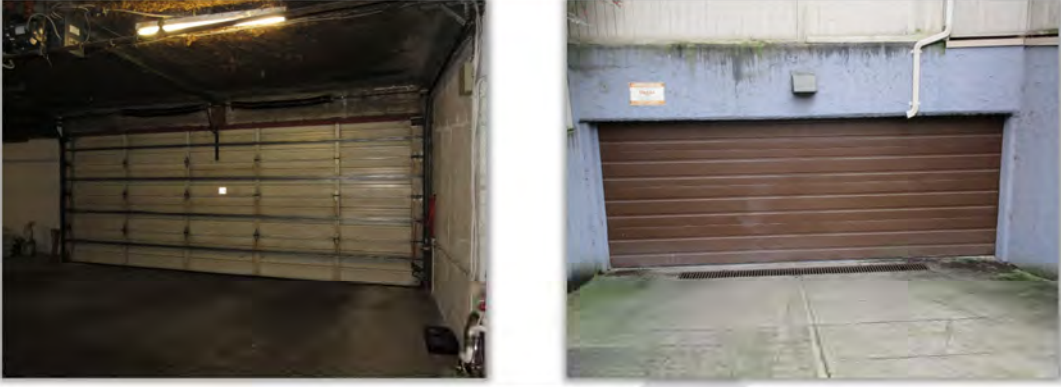
Description	<p>This component accounts for the parkade's entrance gate. This excludes the remote openers but includes the gate, operating mechanism, tracks, rollers, and associated hardware.</p> <table border="1" style="width: 100%; border-collapse: collapse;"> <tr> <td style="background-color: #e0e0e0; padding: 2px;">Quantity</td> <td style="padding: 2px;">1 Opening</td> </tr> <tr> <td style="background-color: #e0e0e0; padding: 2px;">Current Job Cost</td> <td style="padding: 2px;">\$8,941</td> </tr> </table>		Quantity	1 Opening	Current Job Cost	\$8,941		
Quantity	1 Opening							
Current Job Cost	\$8,941							
Condition Analysis	<p>Based on a partial visual inspection, this component appears to be in average condition for its age. No major deficiencies were noted or reported at the time of inspection.</p>							
Reserve History	<table border="1" style="width: 100%; border-collapse: collapse;"> <tr> <td style="background-color: #e0e0e0; padding: 2px;">Year of Acquisition</td> <td style="padding: 2px;">1977</td> </tr> <tr> <td style="background-color: #e0e0e0; padding: 2px;">Work Completed</td> <td style="padding: 2px;">None noted or reported</td> </tr> <tr> <td style="background-color: #e0e0e0; padding: 2px;">Dollars Spent</td> <td style="padding: 2px;">N/A</td> </tr> </table>		Year of Acquisition	1977	Work Completed	None noted or reported	Dollars Spent	N/A

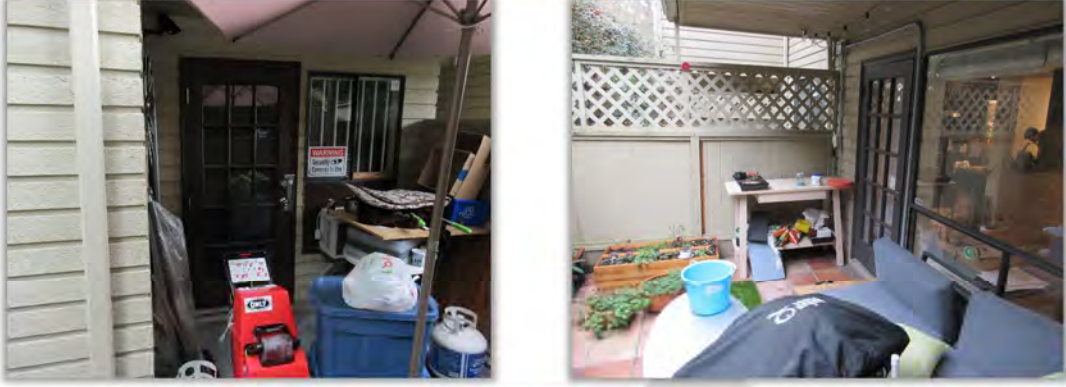
Description	This component accounts for the common-element exterior French doors. This includes the doors, glass lites, frames, and all associated hardware. Each two-door system is counted as one opening for the purposes of this report.	
	Quantity	2 Openings
	Current Job Cost	\$872
Condition Analysis	Based on a partial visual inspection, this component appears to be in average condition for its age. No major deficiencies were noted or reported at the time of inspection.	
Reserve History	Year of Acquisition	1977
	Work Completed	None noted or reported
	Dollars Spent	N/A
Life Cycle Analysis	Expected Lifespan	30 years (Budget Provision)
	Effective Age	20 years
	Remaining Lifespan	10 years
Funding Analysis	Work	Remove and replace damaged door system components as required or desired.
	Budget	A budget equal to 50% of the estimated total cost is provided for significant expenditures every 30 years.

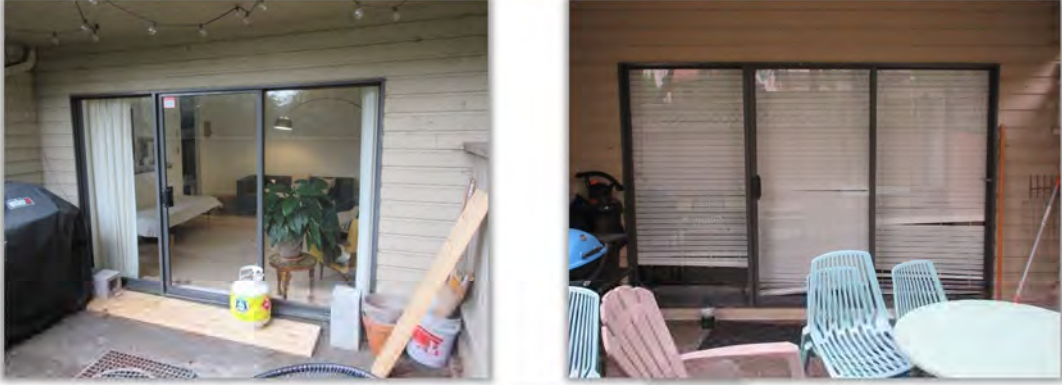
Description	This component accounts for the common-element sliding glass doors. This includes the doors, glass, frames, and all associated hardware. Each sliding door system is counted as one opening for the purposes of this report.		
	Quantity	21 Openings	
	Current Job Cost	\$43,864	
Condition Analysis	Based on a partial visual inspection, this component appears to be in average condition for its age. No major deficiencies were noted or reported at the time of inspection.		
Reserve History	Year of Acquisition	1977	
	Work Completed	None noted or reported	
	Dollars Spent	N/A	
Life Cycle Analysis	Expected Lifespan	30 years (Budget Provision)	
	Effective Age	22 years	
	Remaining Lifespan	8 years	
Funding Analysis	Work	Remove and replace damaged door system components as required or desired.	
	Budget	A budget equal to 75% of the estimated total cost is provided for significant expenditures every 30 years.

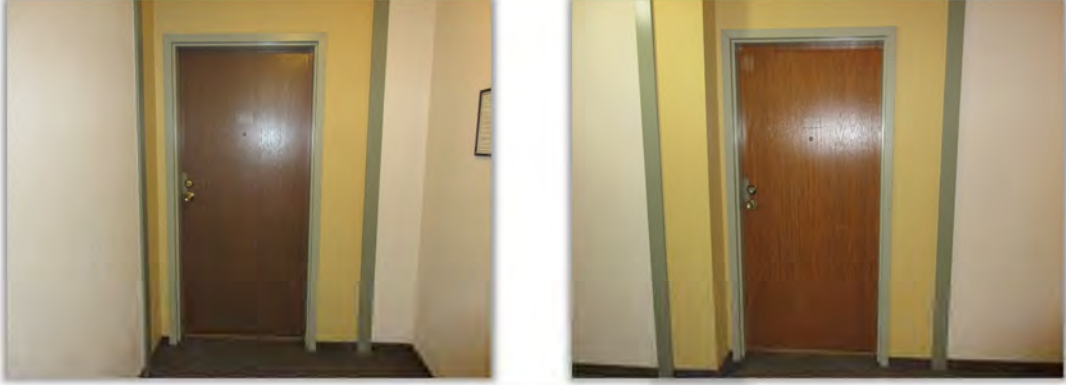
Description	This component accounts for the common-element interior wooden doors. This includes the doors, frames, and all associated hardware.		
	Quantity	36 Openings	
	Current Job Cost	\$7,574	
Condition Analysis	Based on a partial visual inspection, this component appears to be in average condition for its age. No major deficiencies were noted or reported at the time of inspection.		
Reserve History	Year of Acquisition	1977	
	Work Completed	None noted or reported	
	Dollars Spent	N/A	
Life Cycle Analysis	Expected Lifespan	35 years (Budget Provision)	
	Effective Age	18 years	
	Remaining Lifespan	17 years	
Funding Analysis	Work	Remove and replace damaged door system components as required or desired.	
	Budget	A budget equal to 25% of the estimated total cost is provided for significant expenditures every 35 years.	
Potential Deterioration	Includes impact damage, misalignment, failure to latch, and aesthetic degradation. Contributing factors include wear-and-tear, physical damage, excessive force, and subsurface shifting.

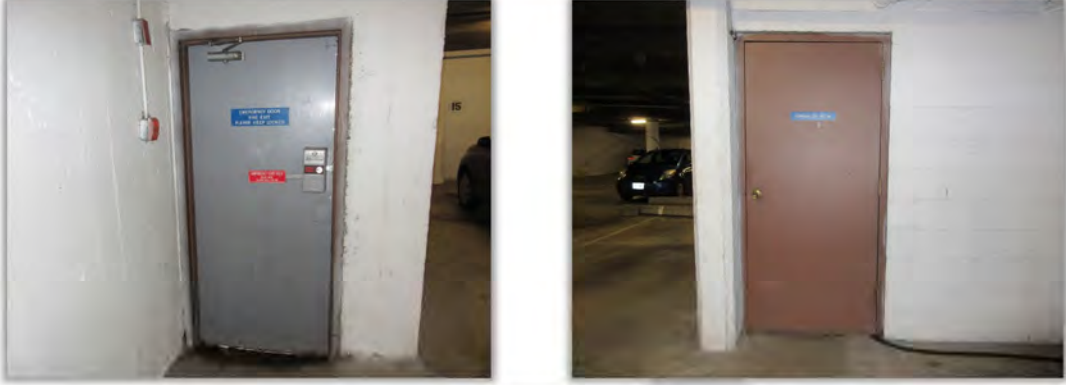
Description	This component accounts for the common-element interior metal doors. This includes the doors, frames, and all associated hardware.	
	Quantity	5 Openings
	Current Job Cost	\$752
Condition Analysis	Based on a partial visual inspection, this component appears to be in average condition for its age. No major deficiencies were noted or reported at the time of inspection.	
Reserve History	Year of Acquisition	1977
	Work Completed	None noted or reported
	Dollars Spent	N/A
Life Cycle Analysis	Expected Lifespan	40 years (Budget Provision)
	Effective Age	18 years
	Remaining Lifespan	22 years
Funding Analysis	Work	Remove and replace damaged door system components as required or desired.
	Budget	A budget equal to 25% of the estimated total cost is provided for significant expenditures every 40 years.
Potential Deterioration	Includes impact damage, misalignment, failure to latch, and aesthetic degradation. Contributing factors include wear-and-tear, physical damage, excessive force, and subsurface shifting.

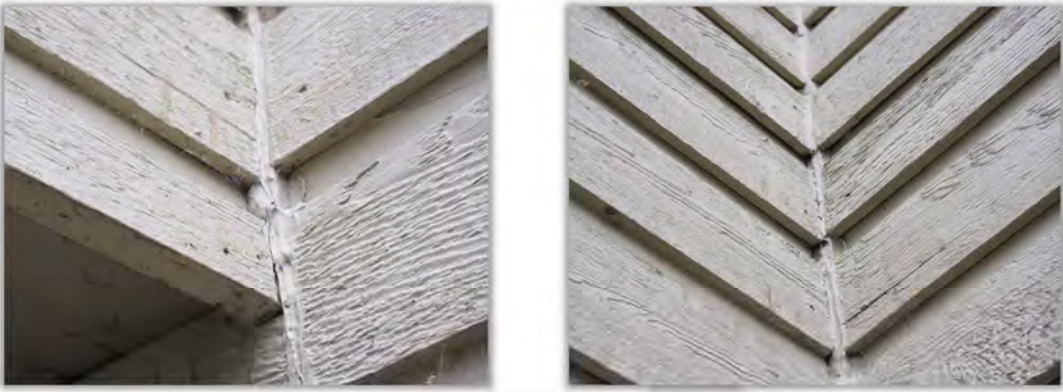
Description	This component accounts for the common-element caulking found around the windows, exterior doors, and some trim.	
	Quantity	2,000 LF
	Current Job Cost	\$4,922
Condition Analysis	Based on a partial visual inspection, this component appears to be in average condition for its age. No major deficiencies were noted or reported at the time of inspection.	
Reserve History	Year of Acquisition	1977
	Work Completed	None noted or reported
	Dollars Spent	N/A
Life Cycle Analysis	Expected Lifespan	12 years (Budget Provision)
	Effective Age	7 years
	Remaining Lifespan	5 years
Funding Analysis	Work	Remove and replace failed caulking as required. Appropriate safety preparation and precautions as required.
	Budget	A budget equal to 50% of the estimated total cost is provided for significant expenditures every 12 years.
Potential Deterioration	Includes hardening, cracking, shrinking, and powdering of the caulking surface. Contributing factors include environmental factors such as temperature changes, rain, snow, wind, and sun exposure.

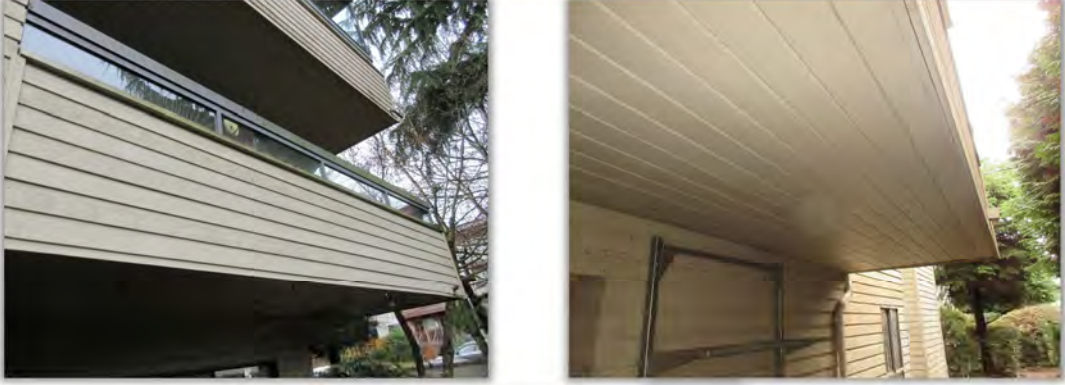
Description	This component accounts for typical repairs to the common-element balcony structure. This includes repairs to the beams and girders, framing joists, beam-to-girder saddles, subfloor, and associated hardware.	
	Quantity	1,400 SF
	Current Job Cost	\$36,677
Condition Analysis	Based on a partial visual inspection, this component appears to be in average condition for its age. There were deficiencies noted at the time of inspection.	
Reserve History	Year of Acquisition	1977
	Work Completed	Temporary balcony repairs to 203, 302 and 303. Permanent repairs to 105, 108 and 206 in 2020.
	Dollars Spent	N/A
Life Cycle Analysis	Expected Lifespan	25 years
	Effective Age	20 years
	Remaining Lifespan	5 years
Funding Analysis	Work	Remove and replace failed structural elements as required. Appropriate safety preparation and precautions as required.
	Budget	We have allowed for a full replacement of this component every 25 years.

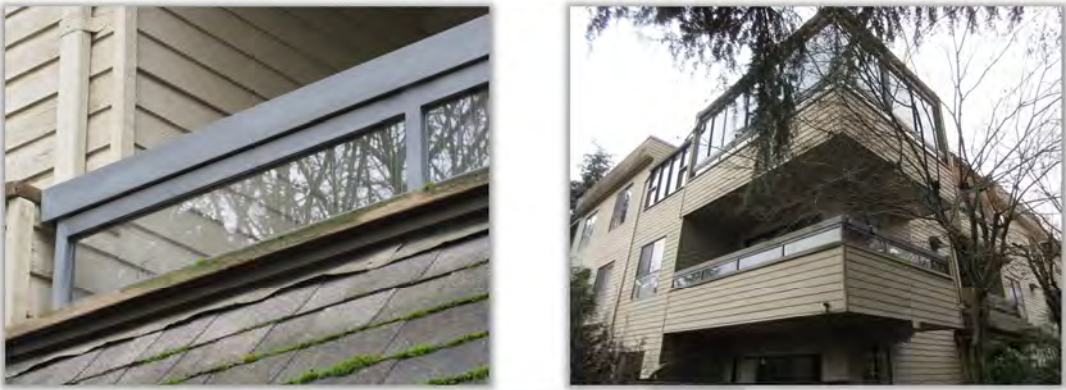
Description	<p>This component accounts for the common-element balcony railing systems, including all associated fasteners and hardware.</p> <table border="1" style="width: 100%; border-collapse: collapse;"> <tr> <td style="background-color: #e0e0e0; padding: 2px;">Quantity</td> <td style="padding: 2px;">330 LF</td> </tr> <tr> <td style="background-color: #e0e0e0; padding: 2px;">Current Job Cost</td> <td style="padding: 2px;">\$18,183</td> </tr> </table>		Quantity	330 LF	Current Job Cost	\$18,183		
Quantity	330 LF							
Current Job Cost	\$18,183							
Condition Analysis	<p>Based on a partial visual inspection, this component appears to be in average condition for its age. No major deficiencies were noted or reported at the time of inspection.</p>							
Reserve History	<table border="1" style="width: 100%; border-collapse: collapse;"> <tr> <td style="background-color: #e0e0e0; padding: 2px;">Year of Acquisition</td> <td style="padding: 2px;">1977</td> </tr> <tr> <td style="background-color: #e0e0e0; padding: 2px;">Work Completed</td> <td style="padding: 2px;">None noted or reported</td> </tr> <tr> <td style="background-color: #e0e0e0; padding: 2px;">Dollars Spent</td> <td style="padding: 2px;">N/A</td> </tr> </table>		Year of Acquisition	1977	Work Completed	None noted or reported	Dollars Spent	N/A

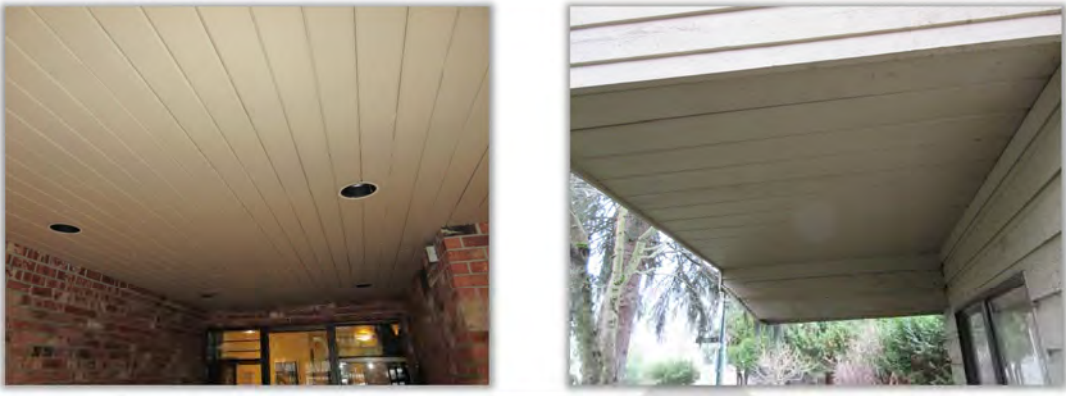
Description	This component accounts for the soffits, also known as the eaves.	
	Quantity	1,800 SF
	Current Job Cost	\$3,575
Condition Analysis	Based on a partial visual inspection, this component appears to be in average condition for its age. No major deficiencies were noted or reported at the time of inspection.	
Reserve History	Year of Acquisition	1977
	Work Completed	A portion of the soffits were changed in 2012.
	Dollars Spent	An unknown amount was spent from the CRF.
Life Cycle Analysis	Expected Lifespan	30 years (Budget Provision)
	Effective Age	16 years
	Remaining Lifespan	14 years
Funding Analysis	Work	Remove and replace damaged soffits. Appropriate safety preparation and precautions as required.
	Budget	A budget equal to 15% of the estimated total cost is provided for significant expenditures every 30 years.
Potential Deterioration	Includes impact damage, heat damage, water damage, fading, warping, and cracking. Contributing factors include physical damage and environmental factors such as extreme temperature changes, rain, snow, and wind exposure.

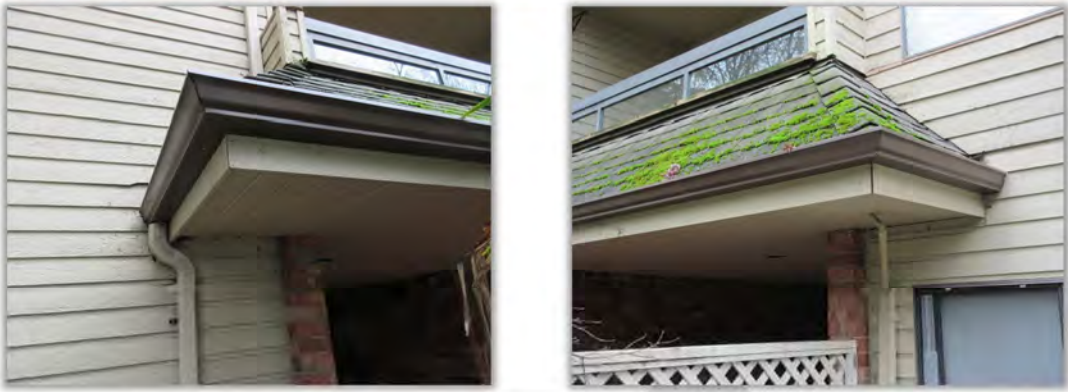
Description	This component accounts for the gutters (also referred to as "eavestroughs") and the downspouts.	
	Quantity	500 LF
	Current Job Cost	\$5,416
Condition Analysis	Based on a partial visual inspection, this component appears to be in average condition for its age. No major deficiencies were noted or reported at the time of inspection.	
Reserve History	Year of Acquisition	2012
	Work Completed	None noted or reported
	Dollars Spent	N/A
Life Cycle Analysis	Expected Lifespan	25 years
	Effective Age	20 years
	Remaining Lifespan	5 years
Funding Analysis	Work	Remove and replace damaged gutters and downspouts as required. Appropriate safety preparation and precautions as required.
	Budget	We have allowed for a full replacement of this component every 25 years.
Potential Deterioration	Includes impact damage, seal failure, warping, and deterioration. Contributing factors include physical damage and environmental factors such as extreme temperature changes, rain, snow, wind, and sun exposure.

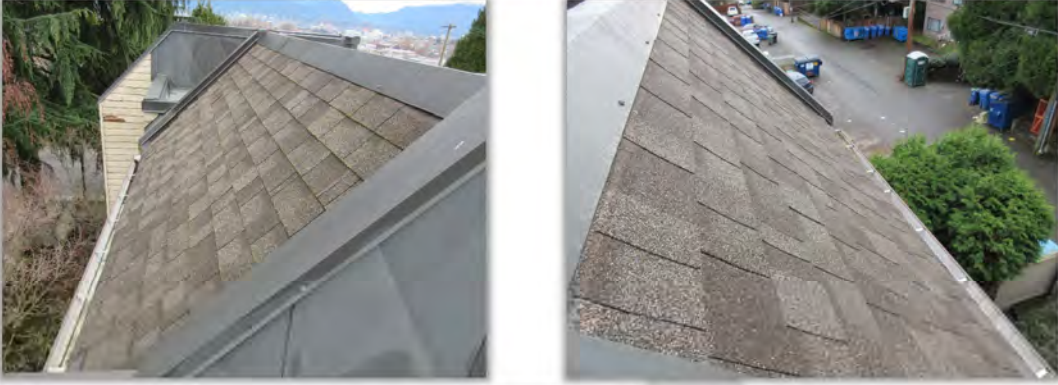
Description	<p>This component accounts for the asphalt/fiberglass shingle roofing system. This includes the shingles, underlayment, flashing, and an allowance for replacement of damaged sheathing and roof-openings such as vents.</p> <table border="1" style="width: 100%; border-collapse: collapse;"> <tr> <td style="background-color: #e0e0e0; padding: 2px;">Quantity</td> <td style="padding: 2px;">500 SF</td> </tr> <tr> <td style="background-color: #e0e0e0; padding: 2px;">Current Job Cost</td> <td style="padding: 2px;">\$4,841</td> </tr> </table>		Quantity	500 SF	Current Job Cost	\$4,841		
Quantity	500 SF							
Current Job Cost	\$4,841							
Condition Analysis	<p>Based on a partial visual inspection, this component appears to be in average condition for its age. No major deficiencies were noted or reported at the time of inspection.</p>

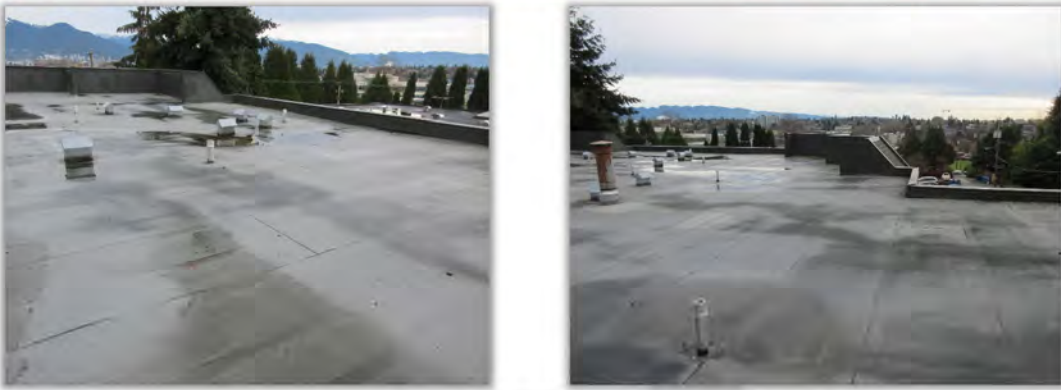
Description	This component accounts for the modified bituminous membrane roofing system. This includes the cap sheet, base sheet, insulation, flashing, and an allowance for replacement of roof-openings such as vents.	
	Quantity	4,800 SF
	Current Job Cost	\$79,955
Condition Analysis	Based on a partial visual inspection, this component appears to be in average condition for its age. No major deficiencies were noted or reported at the time of inspection.	
Reserve History	Year of Acquisition	2012
	Work Completed	The roof was replaced in 2012
	Dollars Spent	The cost was approximately
Life Cycle Analysis	Expected Lifespan	25 years
	Effective Age	8 years
	Remaining Lifespan	17 years
Funding Analysis	Work	Remove and replace existing roofing assembly. Appropriate safety preparation and precautions as required.
	Budget	We have allowed for a full replacement of this component every 25 years.

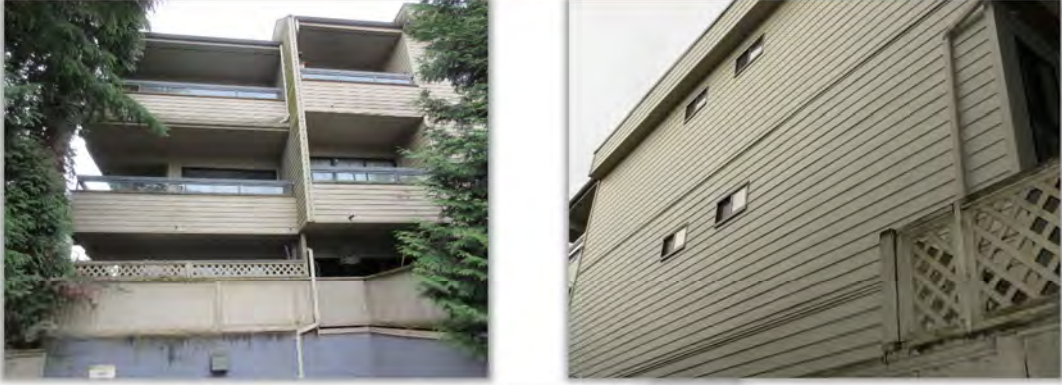
Description	This component accounts for the exterior paint finish. No caulking is accounted for in this component.	
	Quantity	8,800 SF
	Current Job Cost	\$26,661
Condition Analysis	Based on a visual inspection, this component appears to be in average condition for its age. No major deficiencies were noted or reported at the time of inspection.	
Reserve History	Year of Acquisition	1977
	Work Completed	None noted or reported
	Dollars Spent	N/A
Life Cycle Analysis	Expected Lifespan	18 years
	Effective Age	15 years
	Remaining Lifespan	3 years
Funding Analysis	Work	Surface preparation, painting, and clean-up.
	Budget	We have allowed for a full replacement of this component every 18 years.
Potential Deterioration	Includes impact damage, fading, peeling, chipping, and water damage. Contributing factors include physical damage, debris accumulation, and environmental factors such as extreme temperature changes, rain, snow, wind, and sun exposure. Painting may also be done for aesthetic reasons.

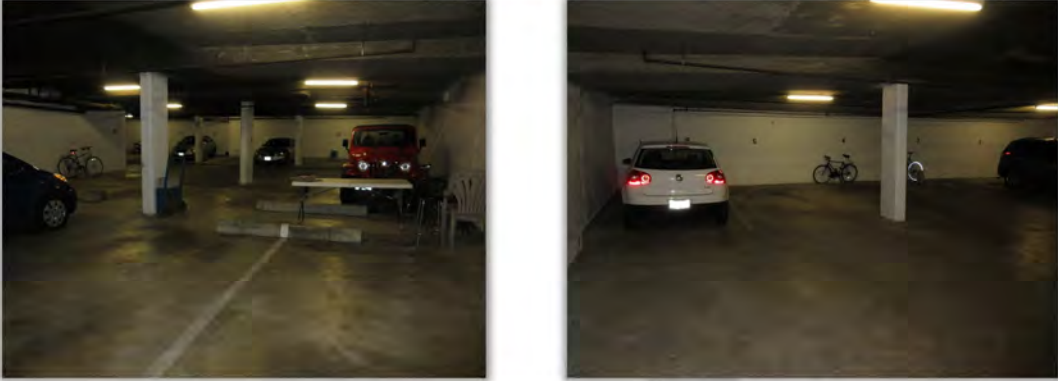
Description	This component accounts for the common-element pavement markings.		
	Quantity	23 Stalls	
	Current Job Cost	\$316	
Condition Analysis	Based on a visual inspection, this component appears to be in average condition for its age. No major deficiencies were noted or reported at the time of inspection.		
Reserve History	Year of Acquisition	2005	
	Work Completed	None noted or reported	
	Dollars Spent	N/A	
Life Cycle Analysis	Expected Lifespan	10 years	
	Effective Age	6 years	
	Remaining Lifespan	4 years	
Funding Analysis	Work	Repaint existing markings as required or desired.	
	Budget	We have allowed for a full replacement of this component every 10 years.	
Potential Deterioration	Includes chipping, fading, and obfuscation. Contributing factors include wear-and-tear, impact damage, debris accumulation, chemical damage (particularly from de-icing chemicals), and environmental factors such as temperature changes, rain, snow, wind, and sun exposure.

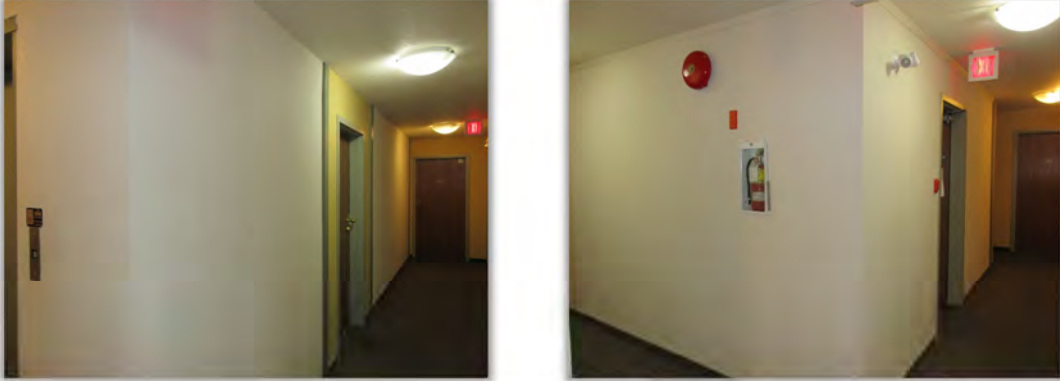
Description	This component accounts for the interior paint finish in common areas.	
	Quantity	4,600 SF
	Current Job Cost	\$18,090
Condition Analysis	Based on a visual inspection, this component appears to be in average condition for its age. No major deficiencies were noted or reported at the time of inspection.	
Reserve History	Year of Acquisition	1977
	Work Completed	None noted or reported
	Dollars Spent	N/A
Life Cycle Analysis	Expected Lifespan	16 years
	Effective Age	13 years
	Remaining Lifespan	3 years
Funding Analysis	Work	Surface preparation, painting, and clean-up.
	Budget	We have allowed for a full replacement of this component every 16 years.
Potential Deterioration	Includes impact damage, stains, markings, fading, and water damage. Contributing factors include physical damage, wear-and-tear, and environmental factors such as temperature changes, humidity, and sun exposure. Painting may also be done for aesthetic reasons.

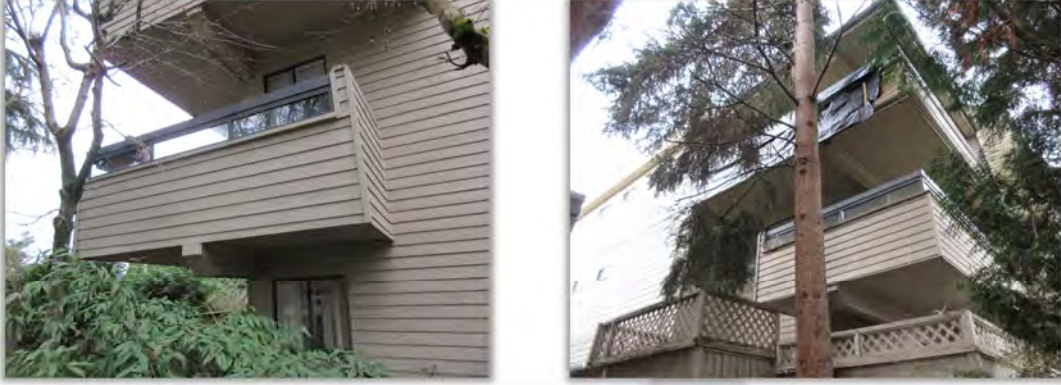
Description	This component accounts for the balcony waterproofing membrane.	
	Quantity	1,400 SF
	Current Job Cost	\$9,933
Condition Analysis	Based on a partial visual inspection, this component appears to be in average condition for its age. No major deficiencies were noted or reported at the time of inspection.	
Reserve History	Year of Acquisition	1977
	Work Completed	None noted or reported
	Dollars Spent	N/A
Life Cycle Analysis	Expected Lifespan	15 years
	Effective Age	12 years
	Remaining Lifespan	3 years
Funding Analysis	Work	Remove old membrane. Prepare balcony surface. Re-install metal flashing. Install vinyl membrane with liquid adhesive and hot-air welding.
	Budget	We have allowed for a full replacement of this component every 15 years.
Potential Deterioration	Includes impact damage, delamination, fading, cracking, bubbling, wear-and-tear, and water damage. Contributing factors include physical damage, debris accumulation, and environmental factors such as extreme temperature changes, rain, snow, wind, and sun exposure.

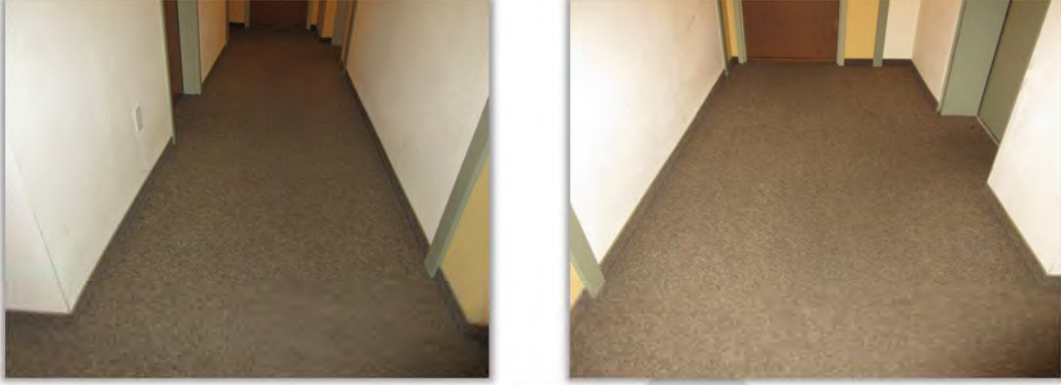
Description	This component accounts for the interior common-area carpet flooring.	
	Quantity	1,800 SF
	Current Job Cost	\$18,645
Condition Analysis	Based on a visual inspection, this component appears to be in average condition for its age. No major deficiencies were noted or reported at the time of inspection.	
Reserve History	Year of Acquisition	2005
	Work Completed	None noted or reported
	Dollars Spent	N/A
Life Cycle Analysis	Expected Lifespan	15 years
	Effective Age	12 years
	Remaining Lifespan	3 years
Funding Analysis	Work	Remove and replace the damaged carpet or the entire carpet, including the carpet pad, depending on the extent and cause of the damage.
	Budget	We have allowed for a full replacement of this component every 15 years.
Potential Deterioration	Includes fading, matting, colour-loss, wear-and-tear, wrinkles, ripples, stains, burns, strong odors, and lack of padding support. Contributing factors include physical damage, water damage, spills, debris accumulation, and damage from environmental factors such as temperature changes, humidity, and sun exposure. Carpet may also be replaced for aesthetic reasons.

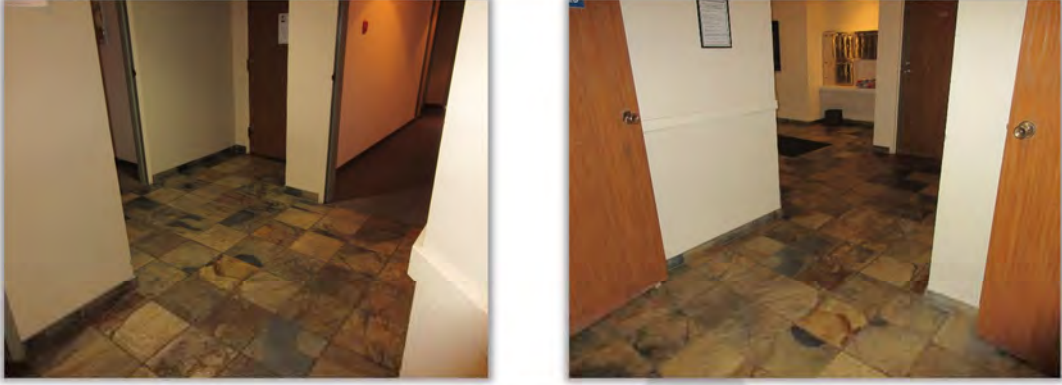
Description	This component accounts for the interior common-area tile flooring.	
	Quantity	180 SF
	Current Job Cost	\$3,646
Condition Analysis	Based on a visual inspection, this component appears to be in average condition for its age. No major deficiencies were noted or reported at the time of inspection.	
Reserve History	Year of Acquisition	2005
	Work Completed	None noted or reported
	Dollars Spent	N/A
Life Cycle Analysis	Expected Lifespan	25 years
	Effective Age	11 years
	Remaining Lifespan	14 years
Funding Analysis	Work	Remove and replace the damaged flooring or the entire flooring, depending on the extent and cause of the damage.
	Budget	We have allowed for a full replacement of this component every 25 years.
Potential Deterioration	Includes water damage, grout deterioration, cracking, and wear-and-tear. Contributing factors include physical damage, water pooling, debris accumulation, and damage from environmental factors such as temperature changes, humidity, and sun exposure. Tile flooring may also be replaced for aesthetic reasons.

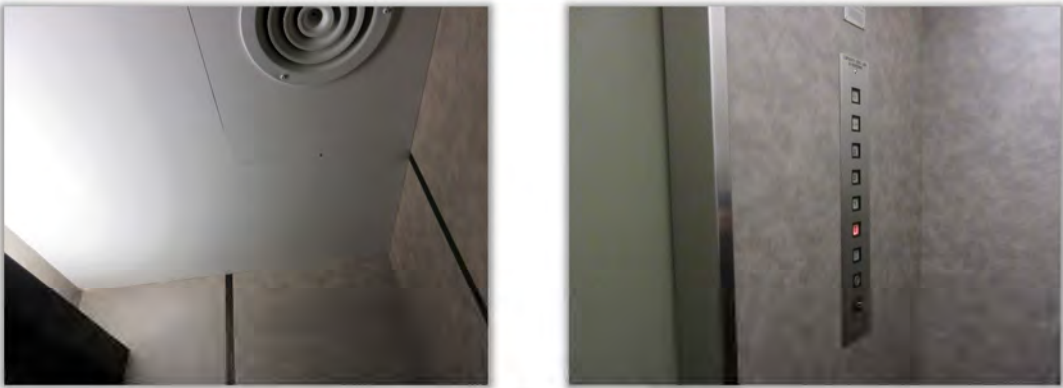
Description	This component accounts for periodic renovations to the interior of the elevator cabs. This includes the flooring, wall panels, ceiling, lighting, and railings. This component does not include safety features or mechanical/electrical components within the elevator enclosure.	
	Quantity	1 Cab
	Current Job Cost	\$6,386
Condition Analysis	Based on a visual inspection, this component appears to be in average condition for its age. No major deficiencies were noted or reported at the time of inspection.	
Reserve History	Year of Acquisition	2005
	Work Completed	None noted or reported
	Dollars Spent	N/A
Life Cycle Analysis	Expected Lifespan	22 years
	Effective Age	12 years
	Remaining Lifespan	10 years
Funding Analysis	Work	Renovate the elevator cab components as desired.
	Budget	We have allowed for a full replacement of this component every 22 years.
Potential Deterioration	Includes impact damage, water damage, wear-and-tear, and aesthetic degradation. Contributing factors include physical damage (usually from moving items in and out), debris accumulation, changing preferences, and damage from environmental factors such as temperature changes and humidity.

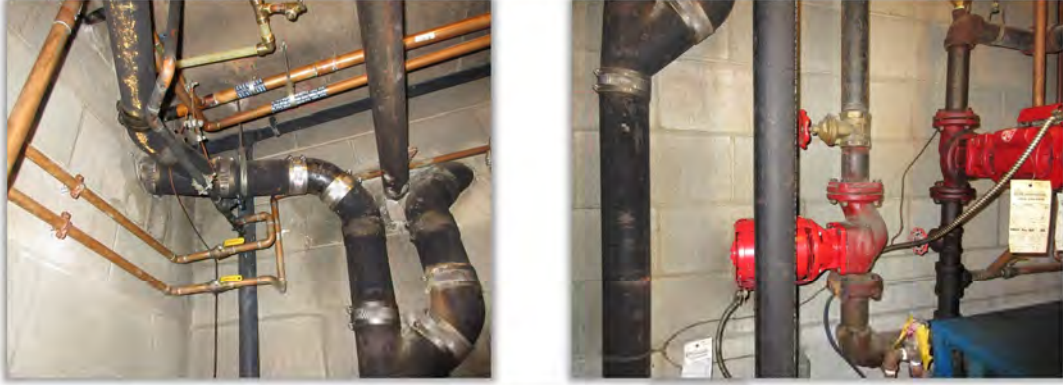
Description	This component accounts for the interior common-element domestic water distribution system. This includes risers, pumps, branch lines, valves, and backflow preventers for both the supply and removal of hot and cold water.	
	Quantity	1 System
	Current Job Cost	\$20,406
Condition Analysis	We were not able to visually inspect this component. No major deficiencies were reported at the time of inspection, so we assume it to be in average condition for its age.	
Reserve History	Year of Acquisition	1977
	Work Completed	A circulation pump was changed in 2004.
	Dollars Spent	An unknown amount was spent at that time.
Life Cycle Analysis	Expected Lifespan	25 years (Budget Provision)
	Effective Age	15 years
	Remaining Lifespan	10 years
Funding Analysis	Work	Notify residents of work scope, disruption, and timeline. Access relevant areas while causing minimal damage. Replace damaged water supply components (usually with PEX) or, if water damage is frequent and severe, repipe most or all of the property to prevent further damage from occurring. Test system. Repair any damage and clean work areas.

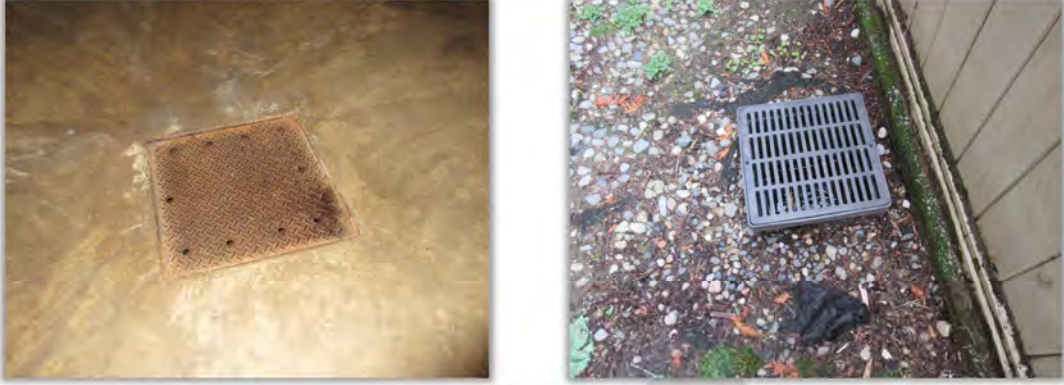
Description	This component accounts for the subsurface common-element domestic water distribution system, both for the supply and removal of domestic water.	
	Quantity	1 System
	Current Job Cost	\$3,976
Condition Analysis	We were not able to visually inspect this component. No major deficiencies were reported at the time of inspection, so we assume it to be in average condition for its age.	
Reserve History	Year of Acquisition	1977
	Work Completed	None noted or reported
	Dollars Spent	N/A
Life Cycle Analysis	Expected Lifespan	25 years (Budget Provision)
	Effective Age	10 years
	Remaining Lifespan	15 years
Funding Analysis	Work	Video inspection and internal cleaning, if possible. More significant damage will need the following: surface removal, excavation, damaged-pipe section removal, pipe bedding installation, pipe installation, backfill and compaction, and surface restoration.

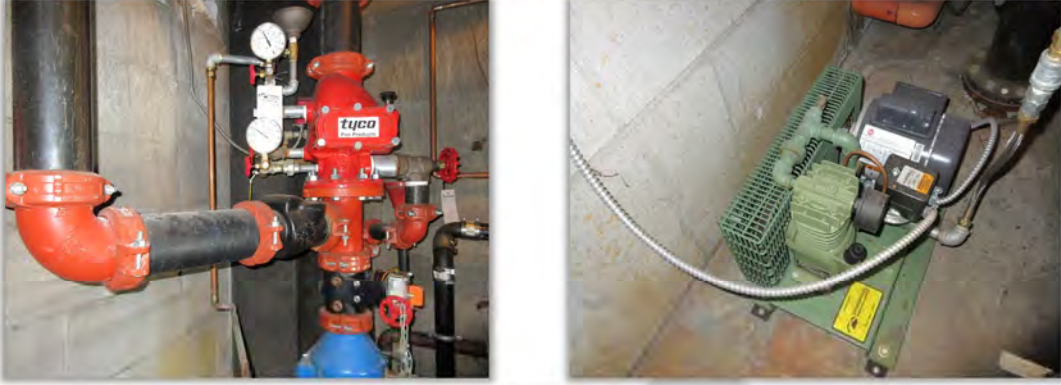
Description	This component accounts for the dry sprinkler system. This includes piping, pipe tees, valves, alarms, sprinkler heads, connections, air compression, and associated components.	
	Quantity	1 System
	Current Job Cost	\$34,760
Condition Analysis	Based on a partial visual inspection, this component appears to be in average condition for its age. No major deficiencies were noted or reported at the time of inspection.	
Reserve History	Year of Acquisition	1977
	Work Completed	None noted or reported
	Dollars Spent	N/A
Life Cycle Analysis	Expected Lifespan	25 years (Budget Provision)
	Effective Age	12 years
	Remaining Lifespan	13 years
Funding Analysis	Work	Inspect and test system regularly to comply with local regulations. Do all work as required or recommended by the inspector. Remove and replace failing components.
	Budget	A budget equal to 20% of the estimated total cost is provided for significant expenditures every 25 years.

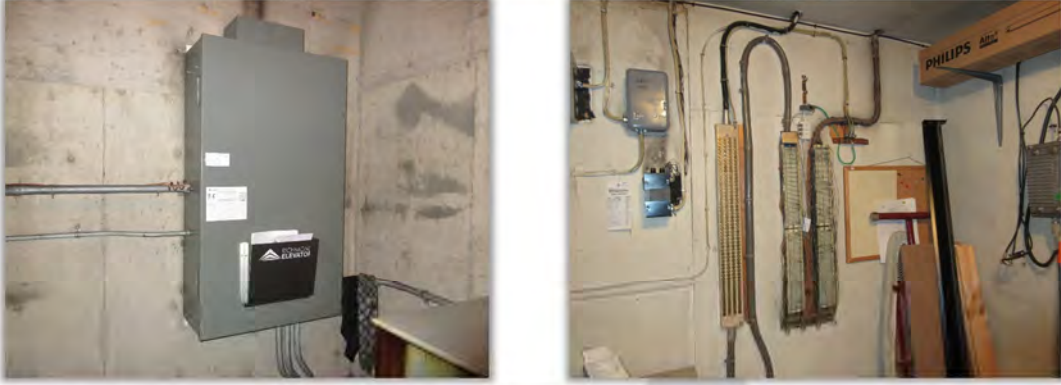
Description	This component accounts for major elevator modernization projects. The scope of work will depend in part on technological improvements over the life of the elevator.	
	Quantity	1 Elevator
	Current Job Cost	\$39,577
Condition Analysis	Based on a partial visual inspection, this component appears to be in average condition for its age. No major deficiencies were noted or reported at the time of inspection.	
Reserve History	Year of Acquisition	1977
	Work Completed	None noted or reported
	Dollars Spent	N/A
Life Cycle Analysis	Expected Lifespan	25 years (Budget Provision)
	Effective Age	16 years
	Remaining Lifespan	9 years
Funding Analysis	Work	Consult with certified elevator repair technicians. Repair and update the various elevator components according to the recommendations of the technicians.
	Budget	A budget equal to 33% of the estimated total cost is provided for significant expenditures every 25 years.

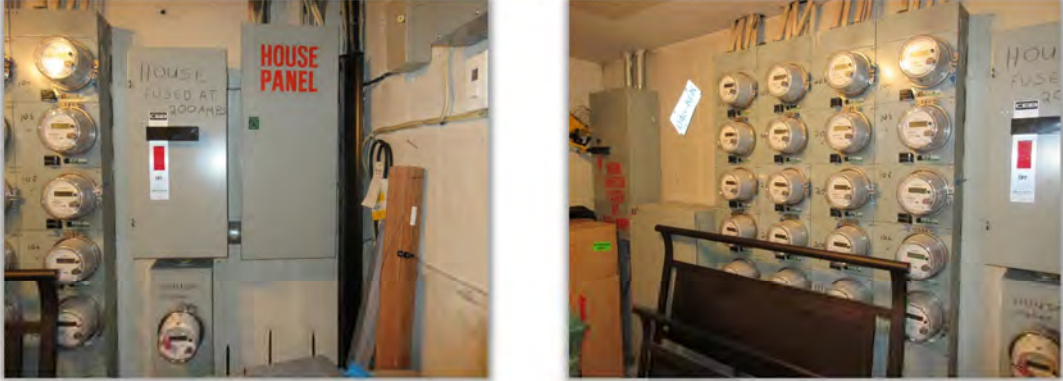
Description	This component accounts for the common-element electrical service and distribution system. This includes wiring, service panels, breakers, switches, receptacles, and various electrical accessories. Strata council indicated the building has aluminum wiring.	
	Quantity	1 System
	Current Job Cost	\$9,485
Condition Analysis	Based on a partial visual inspection, this component appears to be in average condition for its age. No major deficiencies were noted or reported at the time of inspection.	
Reserve History	Year of Acquisition	1977
	Work Completed	None noted or reported
	Dollars Spent	N/A
Life Cycle Analysis	Expected Lifespan	30 years (Budget Provision)
	Effective Age	18 years
	Remaining Lifespan	12 years
Funding Analysis	Work	Remove and replace the various electrical components as required or desired.
	Budget	A budget equal to 15% of the estimated total cost is provided for significant expenditures every 30 years.

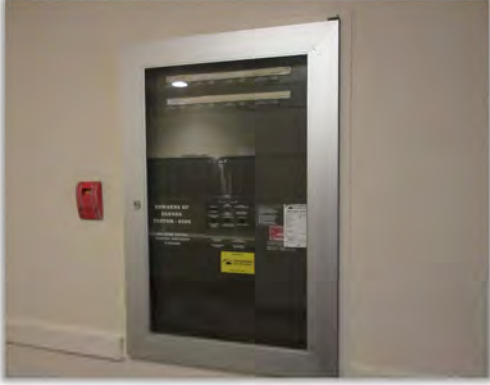
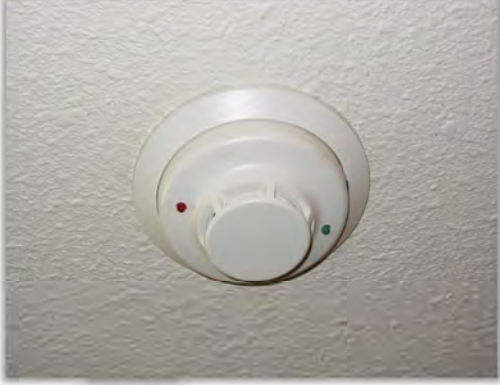
Description	This component accounts for the fire detection and notification system. This includes initiating devices, relays, conduits, wiring, panels, and fire equipment.	
	Quantity	1 System
	Current Job Cost	\$2,308
Condition Analysis	Based on a partial visual inspection, this component appears to be in average condition for its age. No major deficiencies were noted or reported at the time of inspection.	
Reserve History	Year of Acquisition	1977
	Work Completed	None noted or reported
	Dollars Spent	N/A
Life Cycle Analysis	Expected Lifespan	15 years (Budget Provision)
	Effective Age	10 years
	Remaining Lifespan	5 years
Funding Analysis	Work	Repair or replace the various components as required or recommended by qualified fire inspectors.
	Budget	A budget equal to 20% of the estimated total cost is provided for significant expenditures every 15 years.
Potential Deterioration	Includes component failure, wire degradation, electrical failure, impact damage, and functional obsolescence. Contributing factors include wear-and-tear, usage, debris accumulation, corrosion, physical damage, technological improvements, building code changes, and environmental factors such as extreme temperatures, humidity, and ventilation.
