DEPRECIATION REPORT

VAS 495—"Oasis"
2234 Prince Albert Street
Vancouver, BC
2021

February 2, 2021

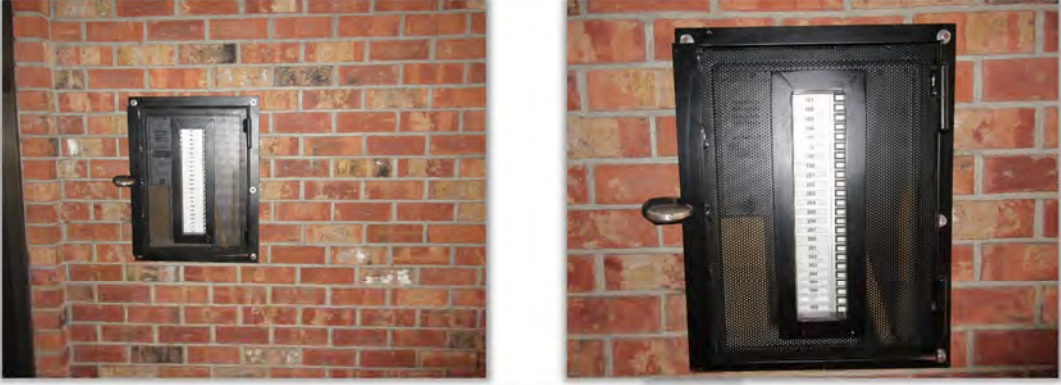
Description	This component accounts for the common-element access entry system. This includes the intercom terminal and door-release system.	
	Quantity	1 System
	Current Job Cost	\$8,710
Condition Analysis	Based on a partial visual inspection, this component appears to be in average condition for its age. No major deficiencies were noted or reported at the time of inspection.	
Reserve History	Year of Acquisition	1977
	Work Completed	None noted or reported
	Dollars Spent	N/A
Life Cycle Analysis	Expected Lifespan	15 years
	Effective Age	10 years
	Remaining Lifespan	5 years
Funding Analysis	Work	Remove and replace failing access control systems as required or replace as desired for upgraded security. Integrate the new system with the connected components where possible.
	Budget	We have allowed for a full replacement of this component every 15 years.
Potential Deterioration	Includes impact damage, electrical failure, component degradation, and functional obsolescence. Contributing factors include wear-and-tear, physical damage, technological improvements, and environmental factors such as extreme temperatures and humidity.

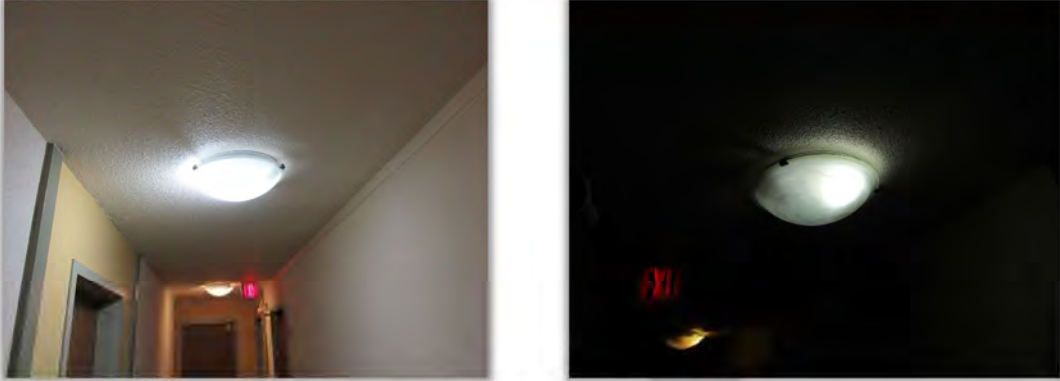
Description	This component accounts for the interior common-area lighting. This includes the fixtures and a small allowance for box and wiring costs.	
	Quantity	34 Lights
	Current Job Cost	\$5,652
Condition Analysis	Based on a visual inspection, this component appears to be in average condition for its age. No major deficiencies were noted or reported at the time of inspection.	
Reserve History	Year of Acquisition	2005
	Work Completed	None noted or reported
	Dollars Spent	N/A
Life Cycle Analysis	Expected Lifespan	25 years (Budget Provision)
	Effective Age	10 years
	Remaining Lifespan	15 years
Funding Analysis	Work	Remove and replace failed lighting components as required or desired.
	Budget	A budget equal to 60% of the estimated total cost is provided for significant expenditures every 25 years.
Potential Deterioration	Includes impact damage, electrical component failure, and water damage. Contributing factors include physical damage, power surges, usage, and damage from environmental factors such as temperature changes and humidity. Fixtures may also be replaced due to functional obsolescence or for aesthetic reasons.

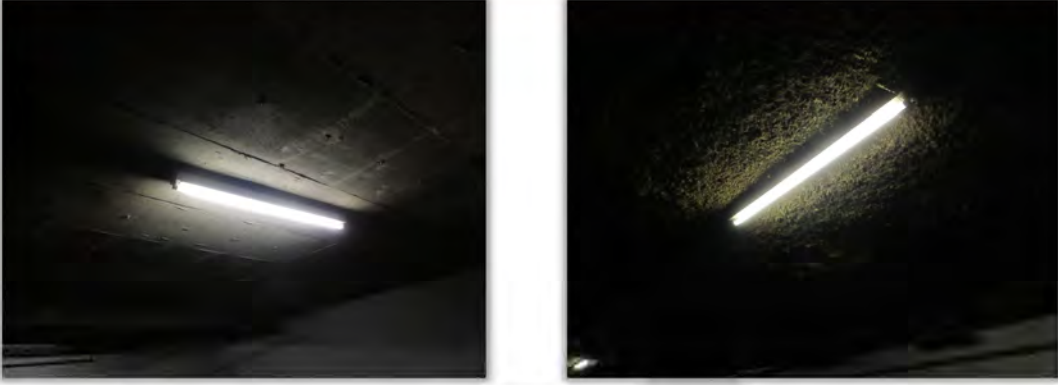
Description	This component accounts for the lighting in the underground parking area. This includes the fixtures and a small allowance for box and wiring costs.	
	Quantity	25 Lights
	Current Job Cost	\$2,359
Condition Analysis	Based on a visual inspection, this component appears to be in average condition for its age. No major deficiencies were noted or reported at the time of inspection.	
Reserve History	Year of Acquisition	2012
	Work Completed	The parkade lighting was upgraded with new flourscent fixtures in 2012.
	Dollars Spent	An unknown amount was spent from the reserve fund.
Life Cycle Analysis	Expected Lifespan	20 years (Budget Provision)
	Effective Age	7 years
	Remaining Lifespan	13 years
Funding Analysis	Work	Remove and replace failed lighting components as required or desired.
	Budget	A budget equal to 50% of the estimated total cost is provided for significant expenditures every 20 years.

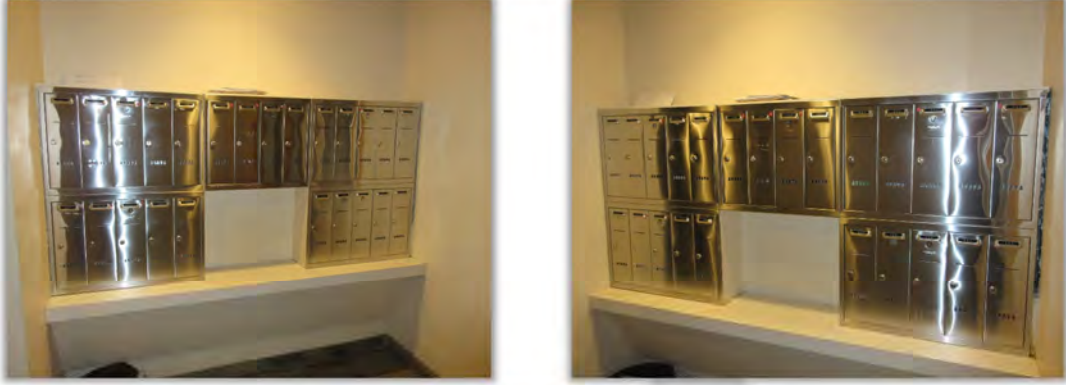
Description	This component accounts for the mailboxes.	
	Quantity	23 Mailboxes
	Current Job Cost	\$2,350
Condition Analysis	Based on a partial visual inspection, this component appears to be in average condition for its age. No major deficiencies were noted or reported at the time of inspection.	
Reserve History	Year of Acquisition	1977
	Work Completed	None noted or reported
	Dollars Spent	N/A
Life Cycle Analysis	Expected Lifespan	30 years
	Effective Age	15 years
	Remaining Lifespan	15 years
Funding Analysis	Work	Remove and replace the failed mailboxes.
	Budget	We have allowed for a full replacement of this component every 30 years.
Potential Deterioration	Includes impact damage and corrosion. Contributing factors include physical damage, wear-and-tear, and environmental factors such as temperature changes and humidity.	
Suggested Maintenance	Regular inspection of the mailboxes for deterioration and vandalism. Clean and repair as required.

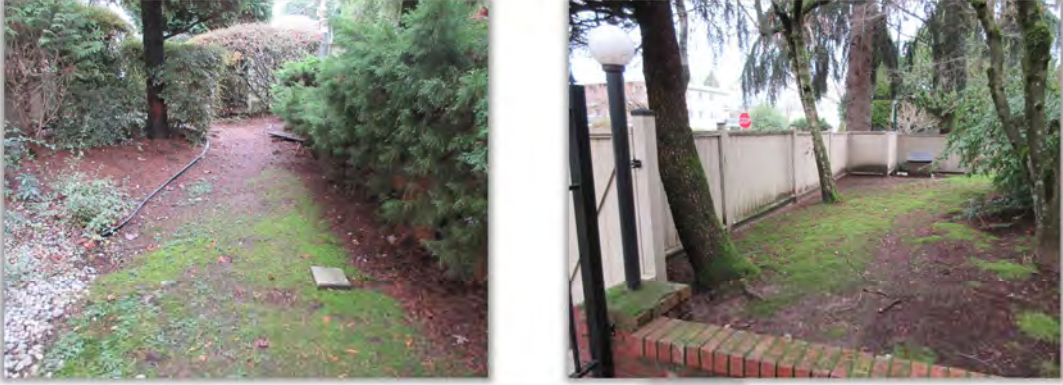
Description	This component accounts for the common-element landscaping. This excludes any routine maintenance that is covered by the operating fund.	
	Quantity	4,100 SF
	Current Job Cost	\$11,915
Condition Analysis	Based on a partial visual inspection, this component appears to be in good condition. No major deficiencies were noted or reported at the time of inspection.	
Reserve History	Year of Acquisition	1977
	Work Completed	None noted or reported
	Dollars Spent	N/A
Life Cycle Analysis	Expected Lifespan	5 years (Budget Provision)
	Effective Age	3 years
	Remaining Lifespan	2 years
Funding Analysis	Work	Regrade as necessary. Replace or repair dead and damaged vegetation. Top up beds. Change landscaping for aesthetic purposes.
	Budget	A budget equal to 15% of the estimated total cost is provided for significant expenditures every 5 years.
Potential Deterioration	Includes poor grading, impact damage, and wear-and-tear. Contributing factors include physical damage, subsurface shifting, debris accumulation, lack of maintenance, and environmental factors such as extreme temperature changes, rain, snow, wind, and sun exposure.

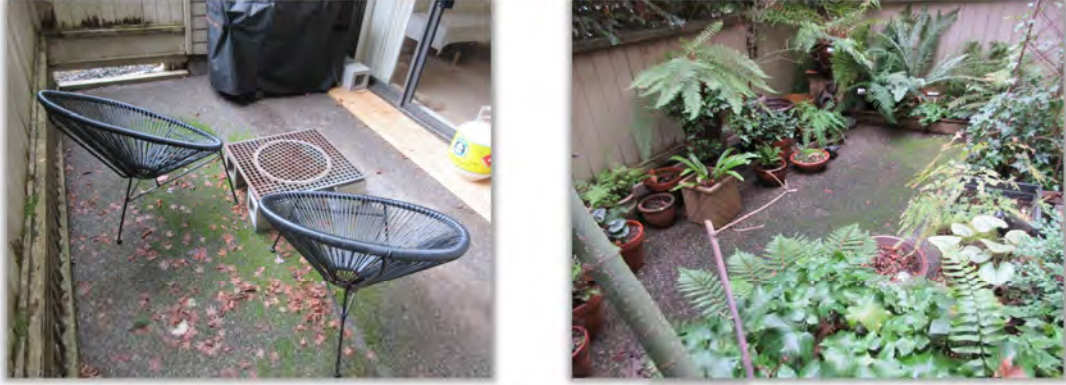
Description	This component accounts for the concrete patios.	
	Quantity	625 SF
	Current Job Cost	\$8,227
Condition Analysis	Based on a visual inspection, this component appears to be in average condition for its age. No major deficiencies were noted or reported at the time of inspection.	
Reserve History	Year of Acquisition	1977
	Work Completed	None noted or reported
	Dollars Spent	N/A
Life Cycle Analysis	Expected Lifespan	25 years
	Effective Age	14 years
	Remaining Lifespan	11 years
Funding Analysis	Work	Break and remove concrete slabs. Repair the subgrade and base course as required. Form and pour concrete with relief joints.
	Budget	We have allowed for a full replacement of this component every 25 years.
Potential Deterioration	Includes holes, cracking, spalling, delamination, poor grading, ponding water, and expansion joint failure. Contributing factors include impact damage, wear-and-tear, debris accumulation, subsurface shifting, and environmental factors such as temperature changes, rain, snow, wind, and sun exposure.

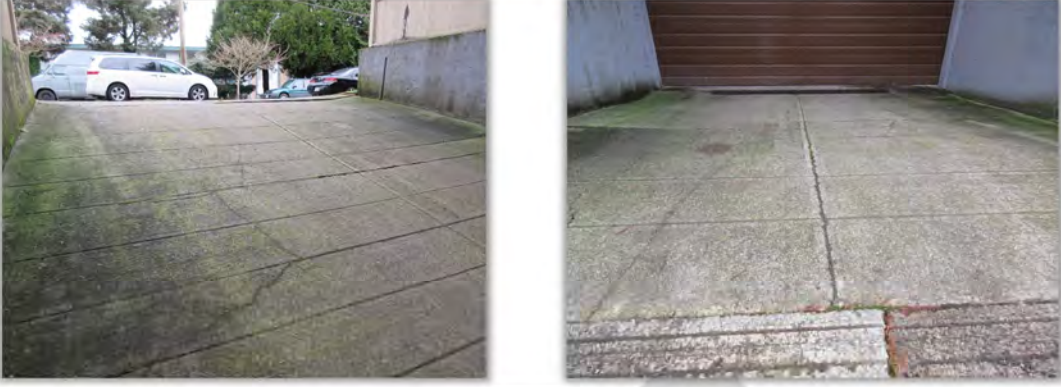
Description	This component accounts for the concrete driveways.	
	Quantity	1 EA
	Current Job Cost	\$2,944
Condition Analysis	Based on a visual inspection, this component appears to be in average condition for its age. No major deficiencies were noted or reported at the time of inspection.	
Reserve History	Year of Acquisition	1977
	Work Completed	None noted or reported
	Dollars Spent	N/A
Life Cycle Analysis	Expected Lifespan	35 years
	Effective Age	20 years
	Remaining Lifespan	15 years
Funding Analysis	Work	Break and remove concrete slab. Repair the subgrade and base course as required. Form and pour concrete. Spray membrane curing compound. Saw cut relief joints.
	Budget	We have allowed for a full replacement of this component every 35 years.
Potential Deterioration	Includes potholes, cracking, spalling, delamination, ponding water, and expansion joint failure. Contributing factors include impact damage, wear-and-tear, salt damage, debris accumulation, subsurface shifting, and environmental factors such as temperature changes, rain, snow, wind, and sun exposure.

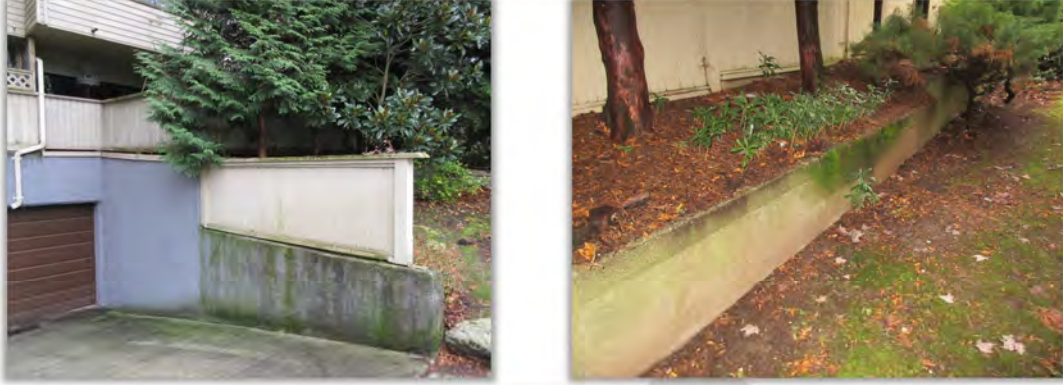
Description	<p>This component accounts for the common-element concrete retaining wall system.</p> <table border="1" style="width: 100%; border-collapse: collapse;"> <tr> <td style="background-color: #d3d3d3; padding: 2px;">Quantity</td> <td style="padding: 2px;">250 LF</td> </tr> <tr> <td style="background-color: #d3d3d3; padding: 2px;">Current Job Cost</td> <td style="padding: 2px;">\$4,933</td> </tr> </table>		Quantity	250 LF	Current Job Cost	\$4,933		
Quantity	250 LF							
Current Job Cost	\$4,933							
Condition Analysis	<p>Based on a visual inspection, this component appears to be in average condition for its age. No major deficiencies were noted or reported at the time of inspection.</p>							
Reserve History	<table border="1" style="width: 100%; border-collapse: collapse;"> <tr> <td style="background-color: #d3d3d3; padding: 2px;">Year of Acquisition</td> <td style="padding: 2px;">1977</td> </tr> <tr> <td style="background-color: #d3d3d3; padding: 2px;">Work Completed</td> <td style="padding: 2px;">None noted or reported</td> </tr> <tr> <td style="background-color: #d3d3d3; padding: 2px;">Dollars Spent</td> <td style="padding: 2px;">N/A</td> </tr> </table>		Year of Acquisition	1977	Work Completed	None noted or reported	Dollars Spent	N/A

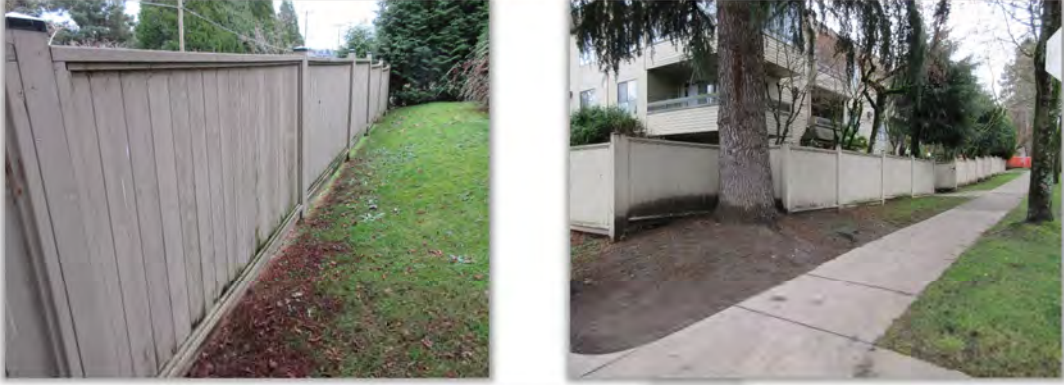
Description	This component accounts for the common-element wood fencing.	
	Quantity	700 LF
	Current Job Cost	\$35,205
Condition Analysis	Based on a partial visual inspection, this component appears to be in average condition for its age. No major deficiencies were noted or reported at the time of inspection.	
Reserve History	Year of Acquisition	2016
	Work Completed	None noted or reported
	Dollars Spent	N/A
Life Cycle Analysis	Expected Lifespan	25 years
	Effective Age	18 years
	Remaining Lifespan	7 years
Funding Analysis	Work	Remove and replace fencing as required or desired.
	Budget	We have allowed for a full replacement of this component every 25 years.
Potential Deterioration	Includes impact damage, cracking, splitting, warping, water damage, infestation, wear-and-tear, and leaning. Contributing factors include physical damage, subsurface shifting, debris accumulation, lack of maintenance, proximity to organic material, and environmental factors such as extreme temperature changes, rain, snow, wind, and sun exposure.

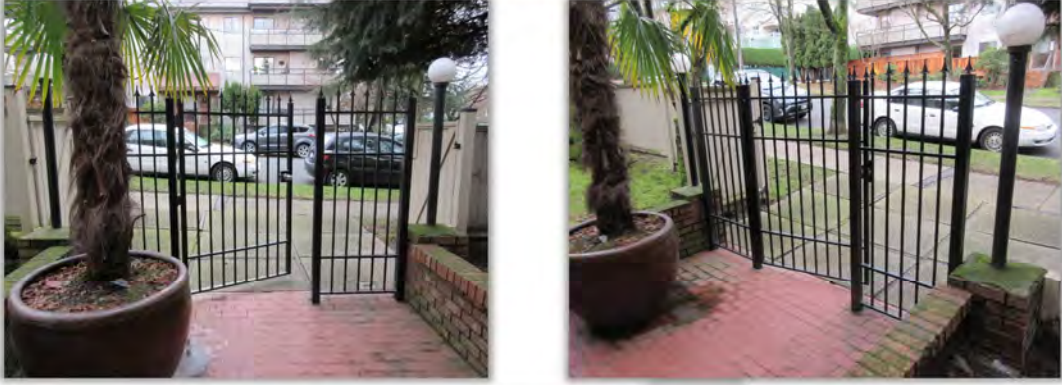
Description	This component accounts for the common-element exterior metal railings.	
	Quantity	10 LF
	Current Job Cost	\$208
Condition Analysis	Based on a visual inspection, this component appears to be in average condition for its age. No major deficiencies were noted or reported at the time of inspection.	
Reserve History	Year of Acquisition	1977
	Work Completed	None noted or reported
	Dollars Spent	N/A
Life Cycle Analysis	Expected Lifespan	30 years (Budget Provision)
	Effective Age	12 years
	Remaining Lifespan	18 years
Funding Analysis	Work	Remove and replace railing as required or desired.
	Budget	A budget equal to 25% of the estimated total cost is provided for significant expenditures every 30 years.
Potential Deterioration	Includes impact damage, breakage, corrosion, wear-and-tear, and leaning. Contributing factors include physical damage, subsurface shifting, debris accumulation, lack of maintenance, and environmental factors such as extreme temperature changes, rain, snow, wind, and sun exposure.
