2013 Depreciation Report Update

1500 Pendrell Street, Vancouver, BC

PROJECT # 2928.60

DATE September 13, 2013

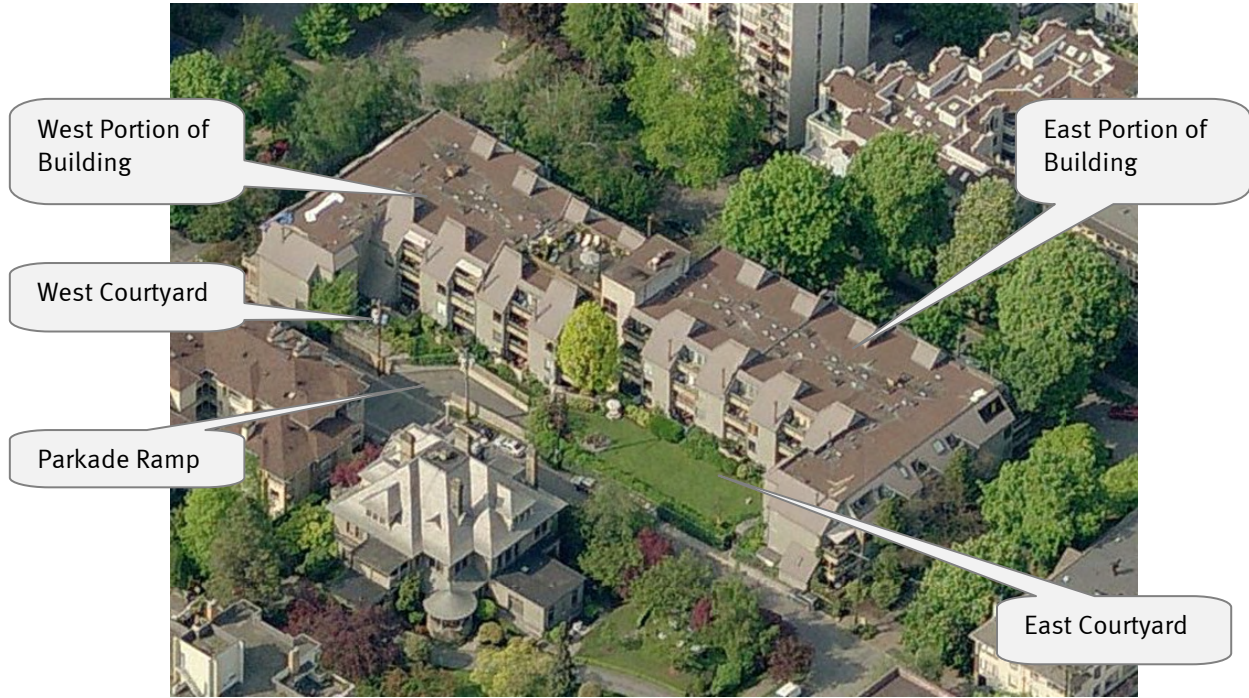
Fig. 2.2.1 Bird's eye view of 1500 Pendrell.

Below is a bird's eye view of 1500 Pendrell, showing an overview of some building reference location.

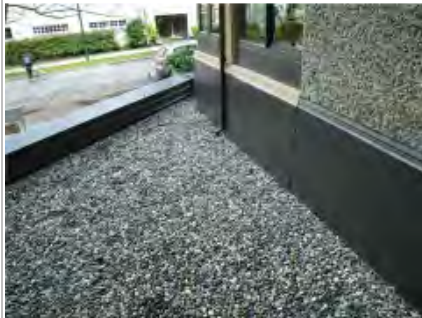
Encl 01 - Protected SBS Membrane Roof with Ballast

Above the main entry to the building on the north elevation.

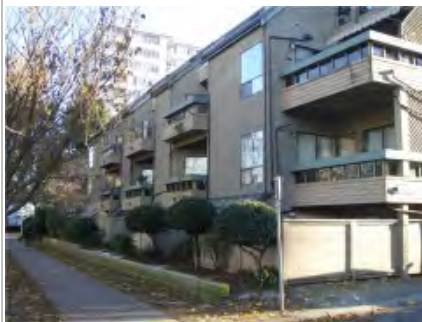
Encl 02 - Varied Deck Membranes

4th and 5th floor decks.

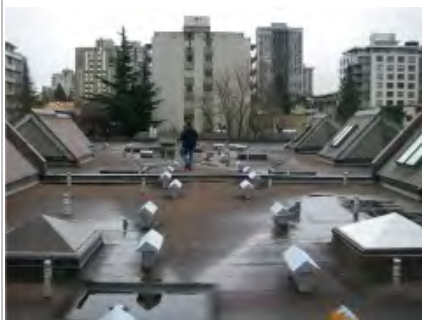
Encl 03 - 2 Ply SBS Roof

Main roof at the building.

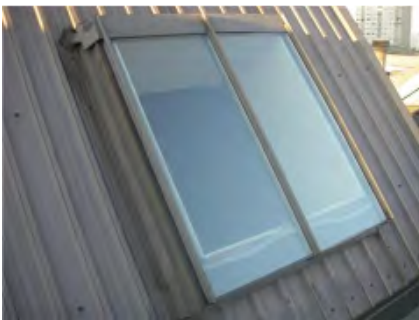
Encl 06 - Skylights

Sloped metal roofs at roof level, skylights on the east, west and north elevations on all floors.

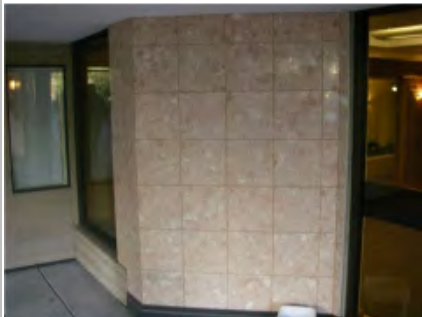
Encl 08 - Tiled Cladding

Portion of exterior walls at the lobby entrance.

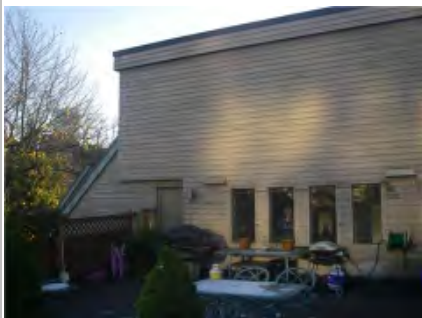
Encl 09 - Wood Siding & Wood Trim

Balcony upstand walls and portions of the exterior walls throughout the building. Soffits at balconies.

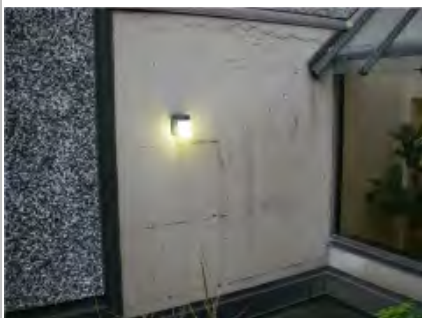
Encl 10 - Coated Concrete

Portions of the exterior walls throughout the building.

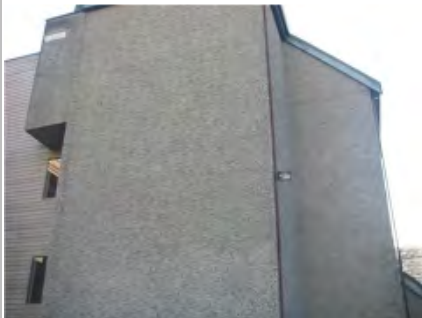
Encl 11 - Stucco Cladding - Face Seal

Exterior walls at all elevations.

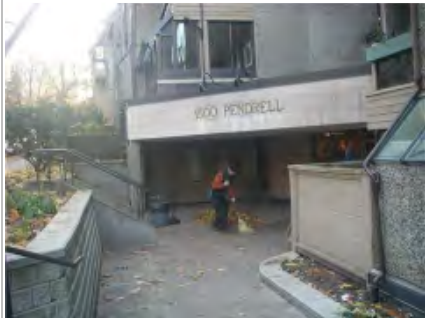
Encl 12 - Aluminum Windows - New (Placeholder)

Location	2nd floor on the north elevation above the main entry.	Description	Unknown window assembly.
Information			
Service Life:	30	Install Year:	2005
Chronological Age:	8	Next Event Year:	2035
Effective Age:	8

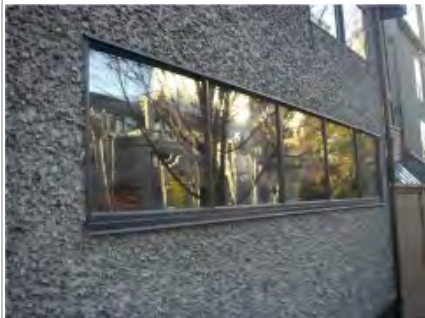
Encl 13 - Aluminum Windows

Location	All elevations throughout the building.	Description	Exterior glazed, non-thermally broken aluminum windows with both fixed and operable units. Windows at the roof terrace are single glazed, fixed units with wired glass.
Information			
Service Life:	30	Install Year:	1979
Chronological Age:	34	Next Event Year:	2024
Effective Age:	19

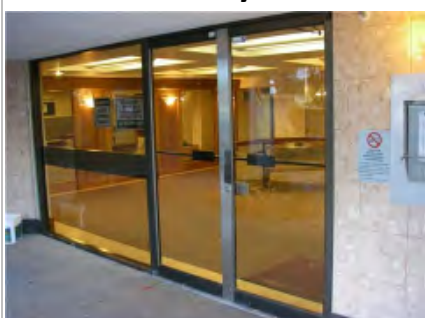
Encl 14 - Lobby Door Assembly

Location	Main entry to the building on the north elevation.	Description	Commercial glazing system including both fixed glazing units and operable door hardware with electric strike connected enterphone system.
Information			
Service Life:	25	Install Year:	2012
Chronological Age:	1	Next Event Year:	2037
Effective Age:	1

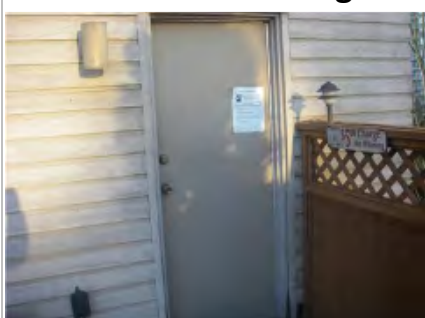
Encl 15 - Metal Swing Doors

Location	Access and egress doors from star wells and providing	Description	Metal doors in pressed steel frame set in cast in place concrete walls and wood frame door openings.
Information			
Service Life:	25	Install Year:	1979
Chronological Age:	34	Next Event Year:	2015
Effective Age:	23

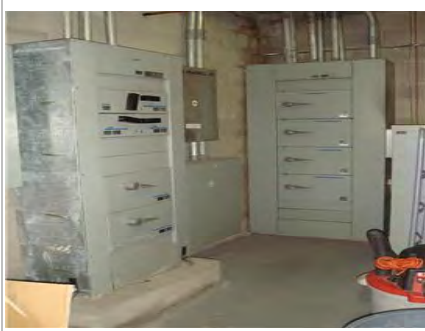
Elec 03 - Electrical Distribution

Location
Main electrical room

Description
A 600V hydro incoming power supply terminated to a 400A fused disconnected switch. The 600V power supply is converted to 120/208V via the 300KVA step down transformer. A 1200A 120/208V Sylvania fused distribution panel fed the meter stacks for the suites and another 400A 120/208V Sylvania fused distribution panel fed the house load such as lighting, elevator, mechanical equipments. There is an emergency panel located adjacent to the emergency generator. Meter stack with individual meters are installed in electrical closet at various typical floor to serve the load centre in each suite.

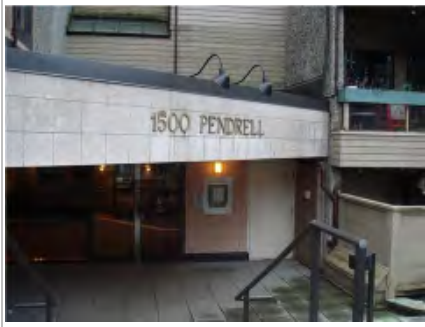
Elec 04 - Exterior Light Fixtures

Location
Exterior entrance, courtyard

Description
A mixture of wall-mounted, fully recessed, soffit recessed fixtures with compact fluorescent lights, incandescent, LV accents fixtures lights. Some bollards at the back courtyard are disconnected from the power supply. Low voltage landscape lighting were installed in August 2010.

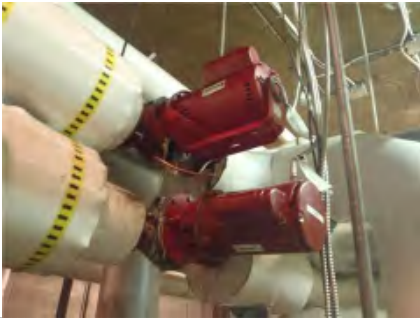
Mech 15 - Inline HVAC Pumps

Centrifugal, vertical in-line pumps for heating water.

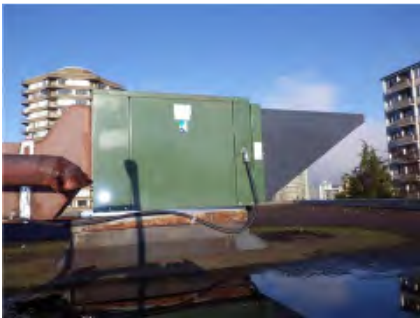
Mech 16 - Make Up Air Units

Belt-driven centrifugal fans to supply make-up air to the interior of the building.

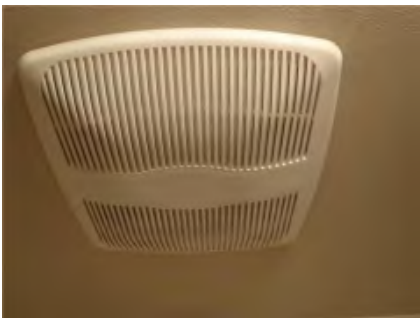
Mech 17 - General Exhaust Fans

Direct drive ceiling fans, ceiling and cabinet fans, centrifugal inline blower fans, propellor wall fans.

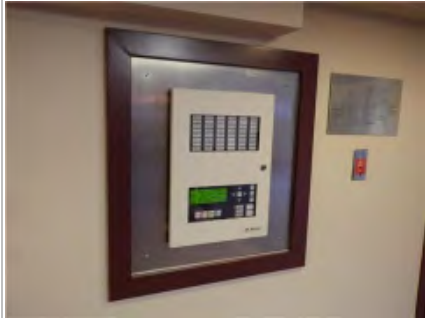
Fire 01 - Fire Control Panels

Location		Description	
Main electrical room and entrance lobby.		Mircom hardwired fire alarm panel located inside main electrical room, annunciator panel with zoned light is located at main entrance lobby, fire alarm audio devices throughout the building include suites.	
Information			
Service Life:	20	Install Year:	2011
Chronological Age:	2	Next Event Year:	2031
Effective Age:	2

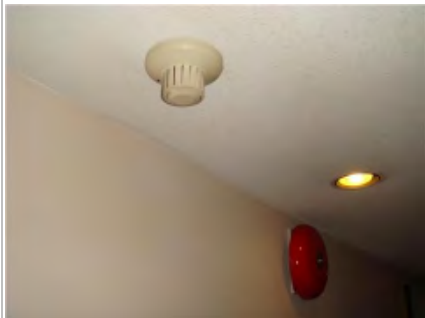
Fire 02 - Fire Detection & Alarm

Location		Description	
various services room, stairwell and hallway		Smoke detectors, heat detectors, flow switches, tamper switches, bells, pull stations and other fixed apparatus field devices to detect fire & smoke conditions and initiate timely response via audible devices. review next event date	
Information			
Service Life:	20	Install Year:	1995
Chronological Age:	18	Next Event Year:	2015
Effective Age:	18

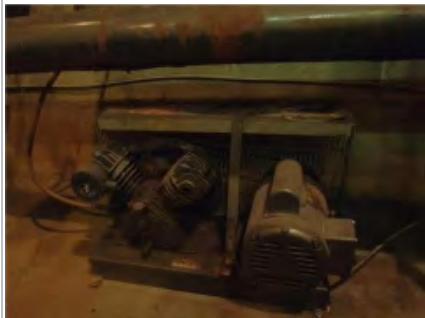
Fire 03 - Dry Sprinkler Compressor

Location		Description	
Parkade level boiler room.		Belt drive, single-stage, air cooled, fan type compressor assembly to increase the pressure of air in the fire sprinkler lines.	
Information			
Service Life:	15	Install Year:	1994
Chronological Age:	19	Next Event Year:	2015
Effective Age:	13

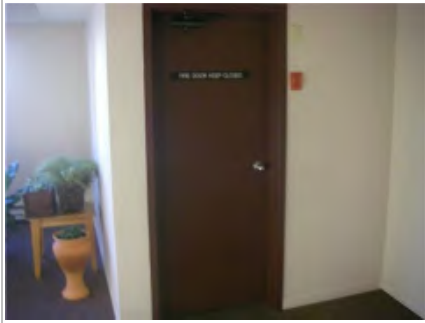
Finish 10 - Interior Swing Doors

Location	Providing access to various common areas.	Description	Variety of solid wood core and hollow metal swing doors hung in framed openings. Exterior doors are considered separately as part of the building enclosure system.
Information			
Service Life:	40	Install Year:	1979
Chronological Age:	34	Next Event Year:	2019
Effective Age:	34

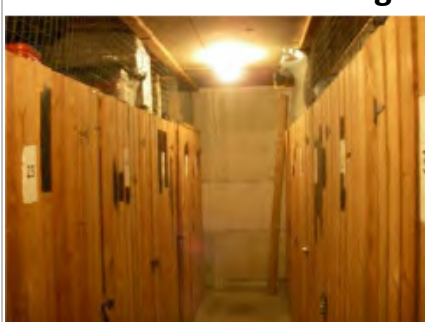
Amen 02 - Wood Storage Lockers

Location	Basement level.	Description	Wood framed general purpose storage lockers with swing door hardware.
Information			
Service Life:	30	Install Year:	1979
Chronological Age:	34	Next Event Year:	2018
Effective Age:	25
