To The Owners, Strata Plan BCS1871
c/o Mr. Von Bircic, Property Manager
Stratawest Management Ltd.
202 - 224 West Esplanade
North Vancouver BC V7M 1A4

Site Visit: August 1, 2019
Submitted March 30, 2020 by
RDH Building Science Inc.
#400 - 4333 Still Creek Drive
Burnaby BC V5C 6S6

RDH Building Science Inc. (RDH) was retained by The Owners, Strata Plan BCS1871 (the Owners) to prepare a Second Depreciation Report Update (the Report) for the residential and commercial complex known as The Olive, which is located at 3228 and 3238-3298 Tupper Street, Vancouver, BC. The Report considers the common property and limited common property components (the Assets) that the Strata Corporation is responsible to maintain, repair, and replace.

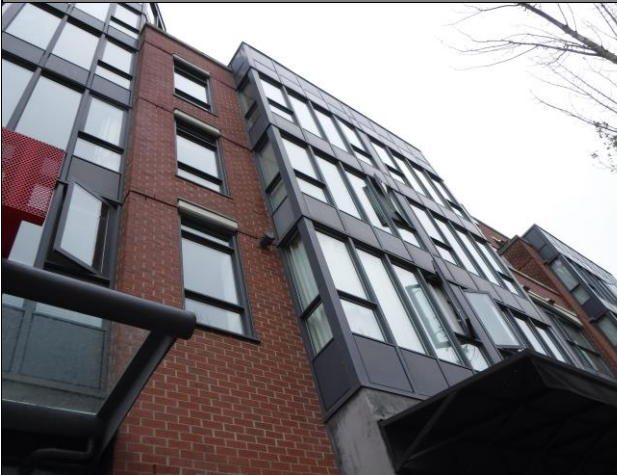
<p><i>Figure 2.1 Partial east elevation photograph of Olive.</i></p>	Approximate date of first occupancy	2006
	Approximate gross floor area (ft ²)	130,900
	Total area of Unit Entitlement	8,102
	Stories above grade	
	→ Midrise Building	6
	→ Townhouse Building	2
Total number of strata lots		
→ Midrise Suites	103	
→ Townhouse Units	6	
→ Total	109

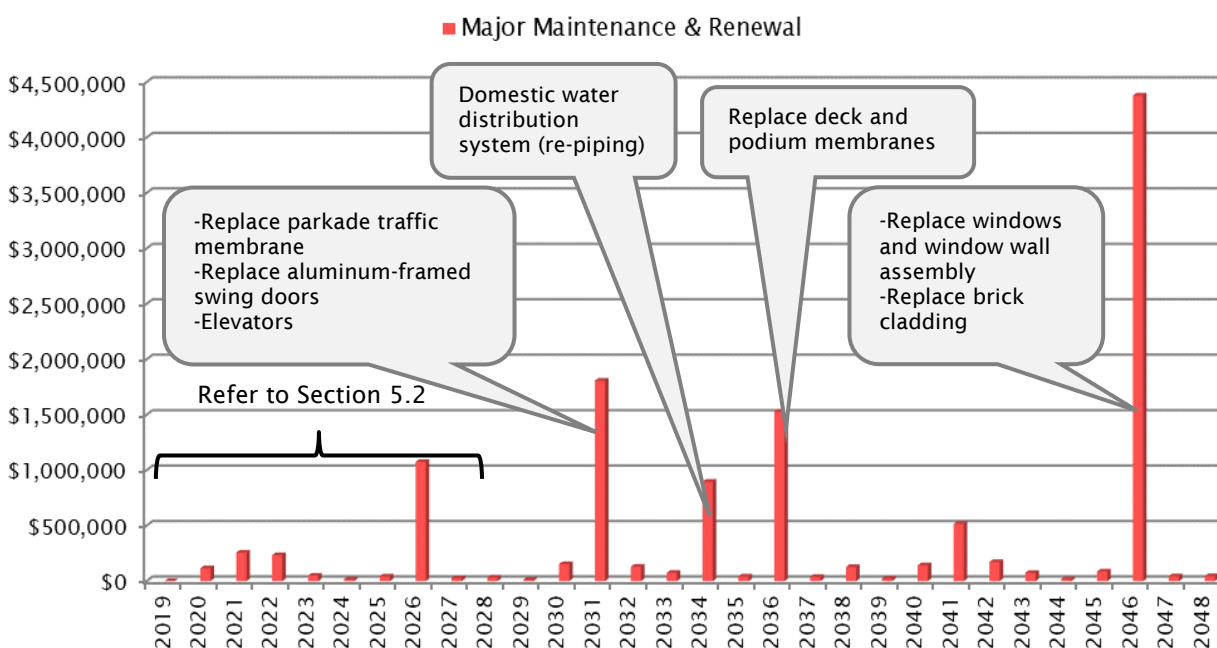
Figure 5.1 Strategic Forecast (30 Years), showing the approximate timing and value of some key capital expenditures.

Estimated major maintenance and renewal costs over the next 30 years are shown on the graph below (Figure 5.1). The red bars represent the estimated value of capital costs.

Each bar on the graph represents a collection of different major maintenance and renewal activities, each with different values. Detailed information about each year, including a description of the maintenance and renewal activities and estimated costs, is also available through the online version of the Report, available through BAMS (please contact the Strata Council for additional information).

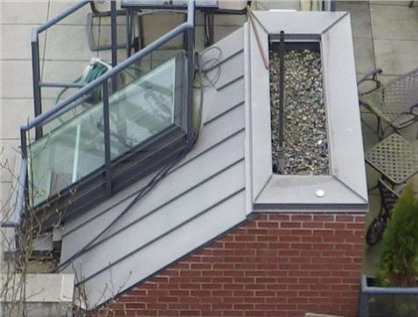
Encl 01 - Metal Roofs

Sloped townhouse roofs.

Service Life: 40
Installed Year: 2006
Chronological Age: 14
Effective Age: 14
Next Renewal Year: 2046

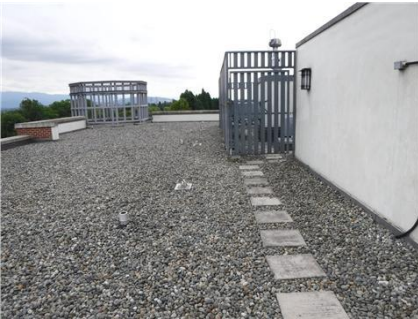
Encl 02 - Hot Rubber Roof Membrane

Main roof of the midrise building.

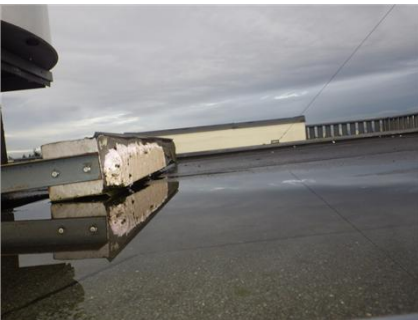
Encl 03 - 2-Ply SBS Conventional Roof

Roof of mechanical enclosure on north roof.

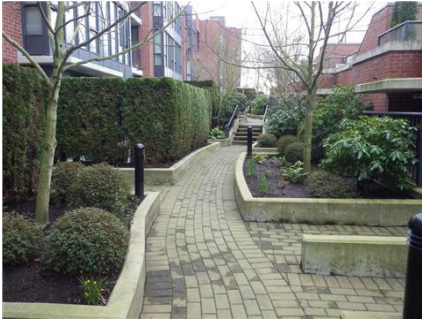
Encl 04 - Podium & Deck Waterproofing

Courtyard at level 2; all decks at east and west elevations of the midrise building; and at townhouse roof decks. Also at landscaped areas in front of the townhouse units.

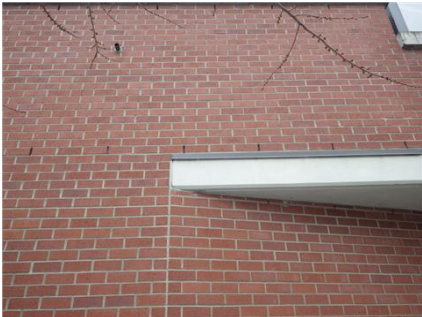
Encl 06 - Brick Masonry Walls

Each level on all elevations of the main building and the townhouse buildings.

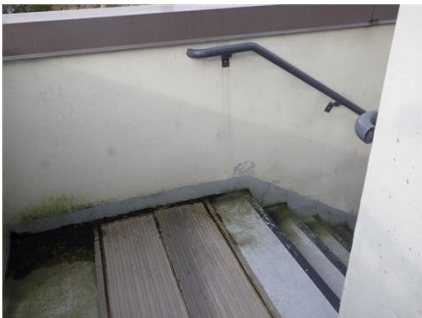
Encl 07 - Exterior Concrete Coatings

Exterior face of parapet walls, base of at-grade and level 2 foundations, interior and exterior of stairwell at southwest elevation, mechanical enclosure on north roof.

- Encl 02 Hot Rubber Roof Membrane – Localized repairs of roof membrane, as required.
- Encl 07 Exterior Concrete Coatings – Recoat exterior concrete surfaces.
- Encl 10 Window Wall – Clean and repaint spandrel panels, as required.

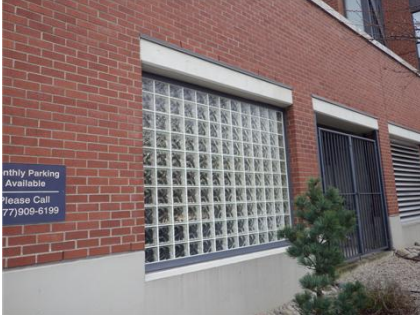
Encl 08 - Glass Block Windows

South elevation at ground level.

Service Life: 35
Installed Year: 2006
Chronological Age: 14
Effective Age: 14
Next Renewal Year: 2041

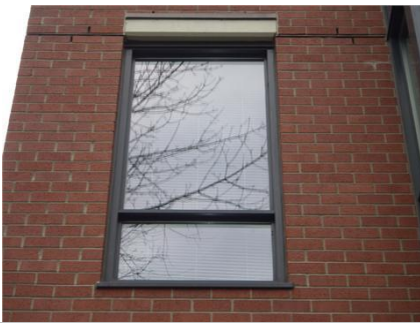
Encl 09 - Windows

Throughout the midrise building.

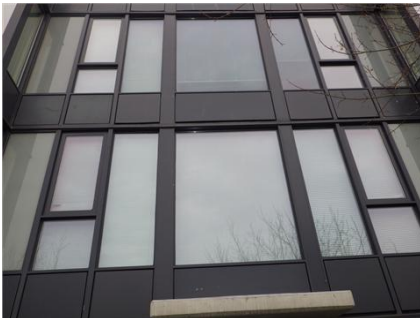
Encl 10 - Window Wall

All elevations of the midrise building and west elevation of the townhouses.

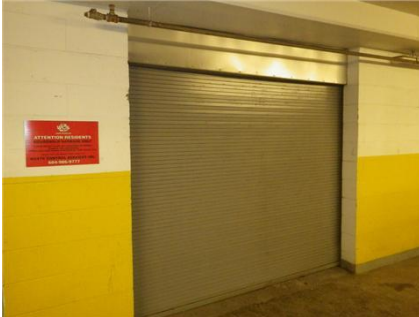
Encl 12 - Steel Rollup Door

Garbage room in parking garage on P2 level across from parking stall 24.

Service Life: 25
Installed Year: 2006
Chronological Age: 14
Effective Age: 14
Next Renewal Year: 2031

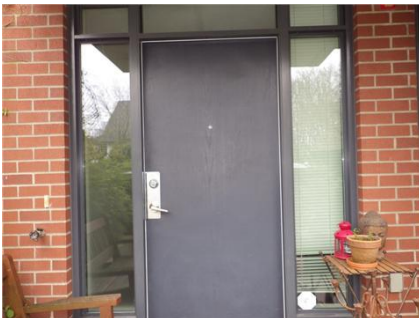
Encl 15 - Wood Swing Doors

Townhouse entrances.

Service Life: 25
Installed Year: 2006
Chronological Age: 14
Effective Age: 14
Next Renewal Year: 2031

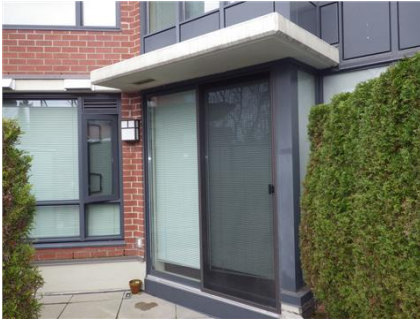
Encl 16 - Aluminum Sliding Doors

Balconies and decks on east, south and west elevations, levels 2 to 6 of the midrise building.

Service Life: 25
Installed Year: 2006
Chronological Age: 14
Effective Age: 14
Next Renewal Year: 2031

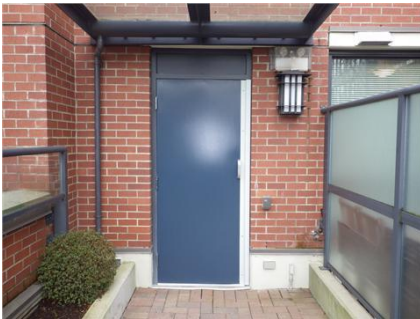
Encl 17 - Metal Clad Service & Entry Doors

Service access doors to commercial space, exterior exit stairs, exit doors to courtyard, and irrigation room.

Service Life: 25
Installed Year: 2006
Chronological Age: 14
Effective Age: 14
Next Renewal Year: 2031

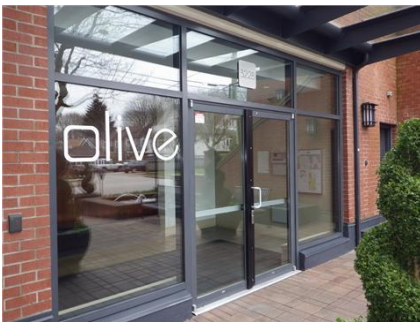
Encl 18 - Lobby Door Assembly

Entrance at west elevation, ground level.

Service Life: 25
Installed Year: 2006
Chronological Age: 14
Effective Age: 14
Next Renewal Year: 2031

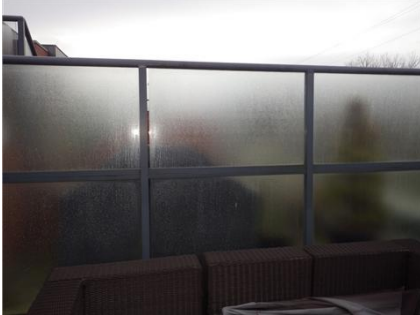
Encl 20 - Aluminum & Glass Privacy Screens

Between balconies and decks on all elevations of the midrise building and townhouses.

Service Life: 20
Installed Year: 2018
Chronological Age: 2
Effective Age: 2
Next Renewal Year: 2038

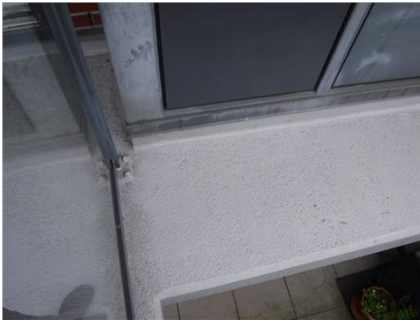
Encl 21 - Balcony and Eyebrow Urethane Membrane

Balconies and eyebrows on north, east and west elevations, levels 2 to 6 of the midrise building. Also at the townhouse balconies and eyebrows.

- Encl 02 Hot Rubber Roof Membrane – Replace roof membrane and associated components at the midrise building.
- Encl 21 Urethane Coatings – Renew remaining urethane membranes from original construction.

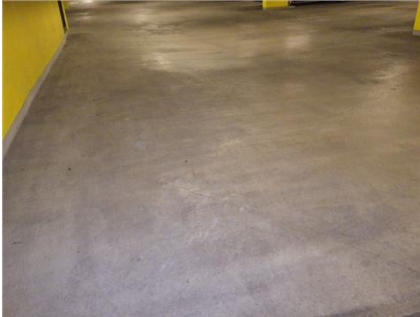
Encl 26 - Parkade Traffic Membrane

Parkade levels P1 and P2, ending at parking stall R-66.

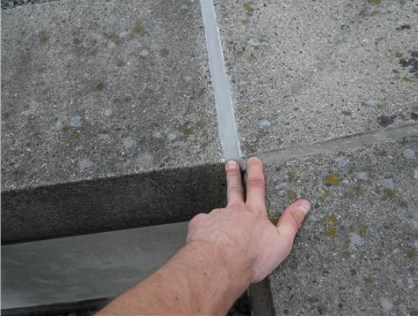
Encl 29 - Exterior Sealant

Interfaces and service penetrations at the exterior walls, roofs, windows, doors and other building enclosure locations.

Service Life: 10
Installed Year: 2006
Chronological Age: 14
Effective Age: 10
Next Renewal Year: 2020

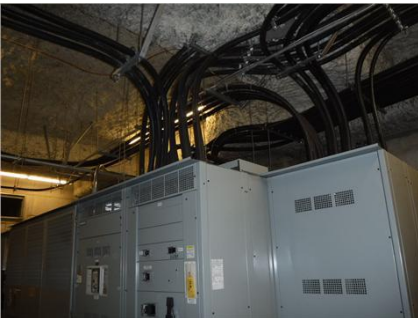
Elec 01 - Unit Substation

P1 main electrical room.

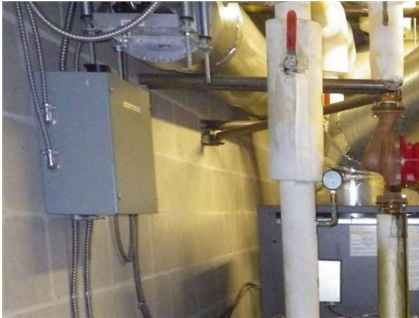
Mech 01 - Controls - Direct Digital

Mechanical room adjacent to parking stall R-79 on P2 level.

Service Life: 15
Installed Year: 2006
Chronological Age: 14
Effective Age: 14
Next Renewal Year: 2021

- Mech 01 Controls – Direct Digital – Replace DDC central components.
- Mech 09 & 10 DHW Boilers and Storage Tanks – Replace Domestic Hot Water (DHW) boiler controls and storage tanks.
- Mech 13 & 14 Storm and Sanitary Drainage – Insert video cameras into the main lines to conduct pipe inspection and jetflush drainage Assets, as needed (camera inspection completed on a five-year cycle; cleaning on 10-year cycle).
- Mech 15 & 16 Storm and Sanitary Sump Pumps – Cyclical replacement of sump pump lift and control panels, as required.
- Mech 17 & 18 Air Conditioning and Fan Coil Units – Cyclical replacement of components of the split AC system.

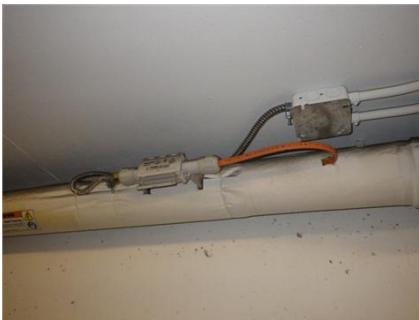
Mech 02 - Heat Tracing

Above main entrance ramp to parking garage.

Service Life: 15
Installed Year: 2006
Chronological Age: 14
Effective Age: 14
Next Renewal Year: 2021

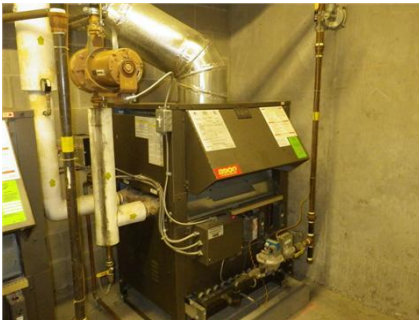
Mech 09 - DHW Boilers

Mechanical room adjacent to parking stall R-79 on P2 level.

- Mech 12 Domestic Water Distribution – Comprehensive third-party testing and inspection of the copper domestic water distribution system.
- Mech 09 DHW Boilers – Replace DHW boilers.
- Mech 21 Make-up Air Units – Rebuild or replace make-up air units.
- Mech 22 Parkade Ventilation Fans – Rebuild or replace parkade exhaust fans.
- Mech 24 Trash Compactor – Replace trash compactor.

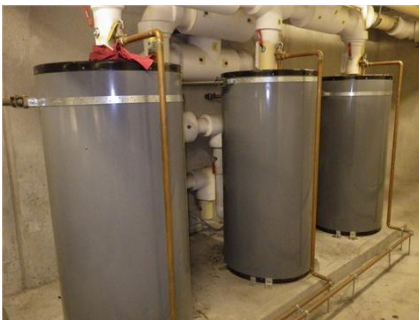
Mech 10 - DHW Storage Tanks

Mechanical room adjacent to parking stall R-79 on P2 level.

Service Life: 10
Installed Year: 2006
Chronological Age: 14
Effective Age: 9
Next Renewal Year: 2021

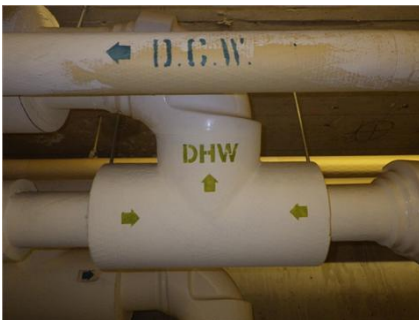
Mech 12 - Domestic Water Distribution

Throughout building.

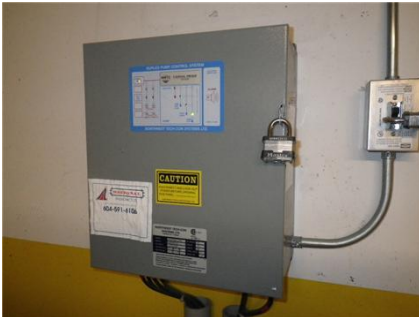
Mech 15 - Sump Pumps - Storm

Across from parking stall R-130 on P3 level.

Service Life: 15
Installed Year: 2006
Chronological Age: 14
Effective Age: 14
Next Renewal Year: 2021

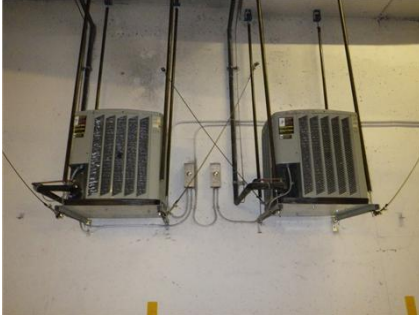
Mech 17 - Air Conditioning

Above parking stall R-86 on P2 level and adjacent to parking stall C-1 on P1 level.

Trane condensing units, TWE060A3, and associated horizontal fan coil units for air conditioning in P1 electrical room. Trane air-to-air heat pumps, TWA036A3, and associated horizontal fan coil units.

Service Life: 15
Installed Year: 2006
Chronological Age: 14
Effective Age: 14
Next Renewal Year: 2021

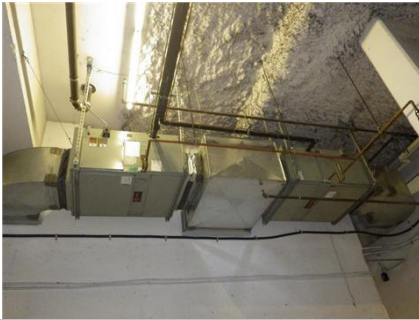
Mech 18 - Fan Coil Units

Wall adjacent parking stall C-87 on P1 level.

Condensing units and ceiling suspended fan coil units on a ducted system for air conditioning.

Service Life: 15
Installed Year: 2006
Chronological Age: 14
Effective Age: 14
Next Renewal Year: 2021

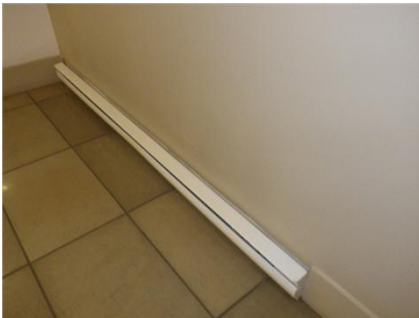
Mech 19 - Electric Baseboards

Lobby, storage rooms, equipment service rooms.

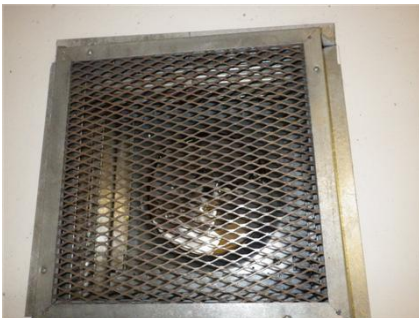
Mech 20 - General Exhaust Fans

Olive room washroom, equipment service rooms, storage rooms, garbage room.

Broan, Delhi, Penn, Reversomatic, Tjernlund and Circul-aire, propeller, direct drive ceiling fan, belt drive centrifugal inline blower and stairwell pressurization fans. Information from Mechanical drawings.

Service Life: 12
Installed Year: 2006
Chronological Age: 14
Effective Age: 11
Next Renewal Year: 2021

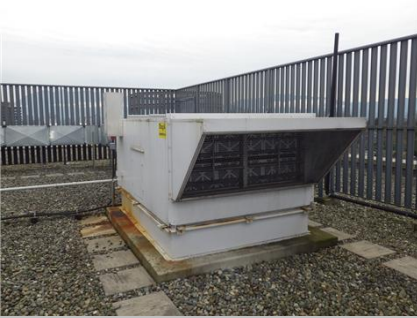
Mech 21 - Make up Air Units

North and south main roofs.

Engineered Air, 600,000 and 400,000 BTU input, supply capacities 8380 and 5400 CFM, belt-driven, centrifugal fans to supply tempered fresh air and make-up air to the interior of the building.

Service Life: 20
Installed Year: 2006
Chronological Age: 14
Effective Age: 14
Next Renewal Year: 2026

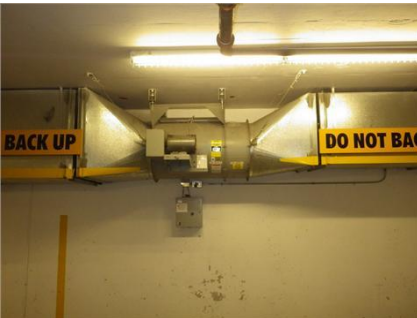
Mech 22 - Parkade Ventilation Fans

Throughout parking garage.

Service Life: 20
Installed Year: 2006
Chronological Age: 14
Effective Age: 14
Next Renewal Year: 2026

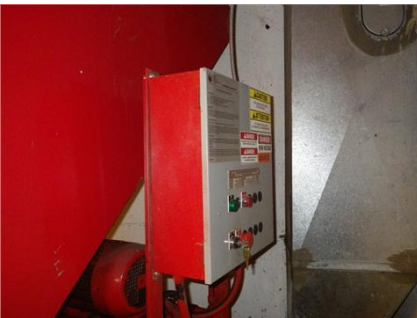
Mech 24 - Trash Compactor

Garbage room adjacent to parking stall 24 on P2 level.

Service Life: 20
Installed Year: 2006
Chronological Age: 14
Effective Age: 14
Next Renewal Year: 2026

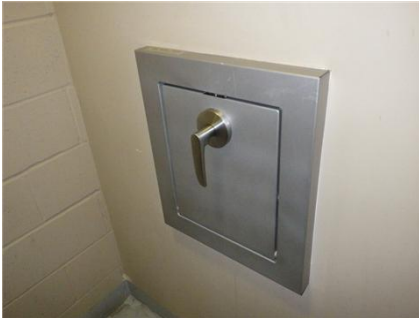
Mech 25 - Trash Chute

Garbage room at each floor.

Service Life: 30
Installed Year: 2006
Chronological Age: 14
Effective Age: 14
Next Renewal Year: 2036

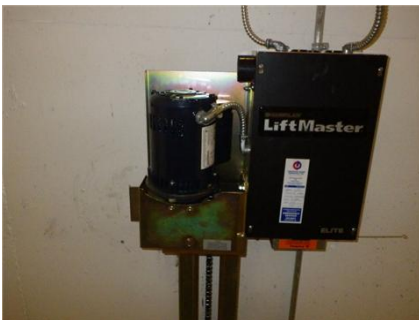
Mech 26 - Overhead Gate Motors

Residential parking garage entrance.

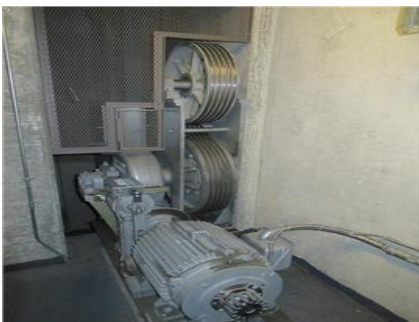
Elev 01 - North and South Tower Basement Traction Elevators

Elevator machine rooms at basement level.

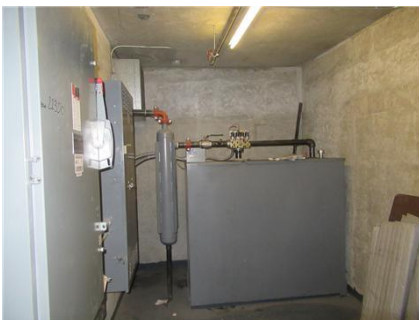
Elev 02 - Podium Hydraulic Elevator [PLACEHOLDER]

Elevator machine room at basement.

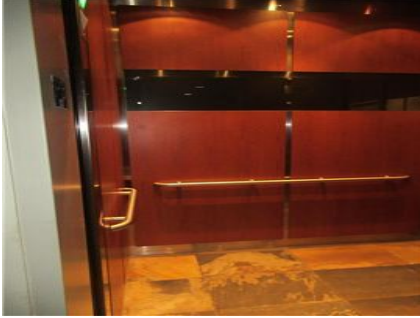
Elev 03 - North and South Tower Elevator Cabs and Hoistways

Elevator cab interiors, fixtures, and hoistways.

Single speed side opening door; one (1) car operating panel with stainless steel pushbuttons; infrared light curtain door protection; E.C.I door operators; stainless steel door panels, frame, header, reveals and ceiling; plastic laminate wall panels; tile flooring, stainless steel tubular handrails on all non-access walls, hands-free voice communication device, seismic provisions.

Service Life: 25
Installed Year: 2006
Chronological Age: 14
Effective Age: 14
Next Renewal Year: 2031

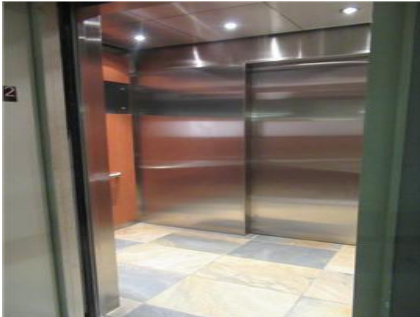
Elev 04 - Podium Elevator Cab and Hoistway [PLACEHOLDER]

Elevator cab interior, fixture, and hoistway.

Single speed side opening door; one (1) car operating panel with stainless steel pushbuttons; infrared light curtain door protection; Rear opening; E.C.I door operators; stainless steel door panels, frame, header, reveals and ceiling; plastic laminate wall panels; tile flooring, stainless steel tubular handrails on all non-access walls, hands-free voice communication device.

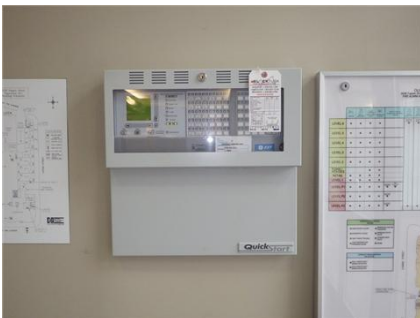
Fire 01 - Fire Control Panels

Adjacent to lobby entrance at west elevation.

Edwards quick start conventional, multi-zone, solid state microprocessor and supervised unit with graphic annunciator and LCD display. A fire panel was replaced in 2012.

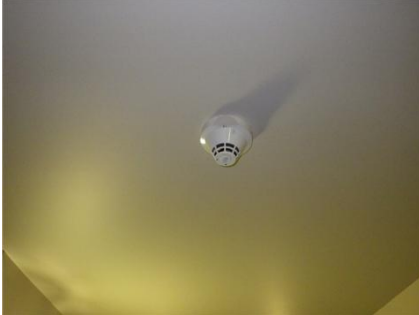
Fire 02 - Fire Detection & Alarm

Strategically mounted to walls and ceiling throughout building.

Smoke detectors, heat detectors, flow switches, tamper switches, horns, pull stations and other fixed apparatus field devices to detect fire and smoke conditions and initiate timely response.

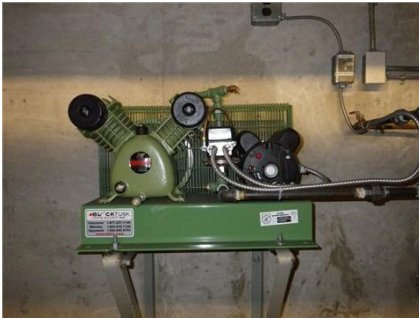
Fire 03 - Dry Sprinkler Compressor

Mechanical room adjacent to parking stall R-12 on P2 level.

Swan compressor to maintain the pressure of air in the dry fire sprinkler lines. Repaired in 2017.

Service Life: 14
Installed Year: 2006
Chronological Age: 14
Effective Age: 14
Next Renewal Year: 2020

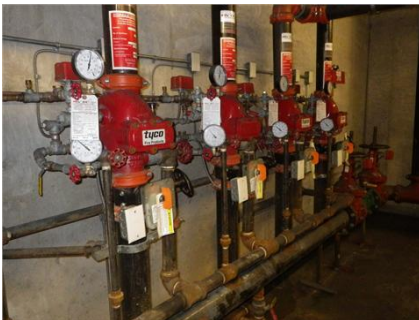
Fire 04 - Sprinkler Valve Assembly - Dry

Mechanical room adjacent to parking stall 12 on P2 level.

Service Life: 40
Installed Year: 2006
Chronological Age: 14
Effective Age: 14
Next Renewal Year: 2046

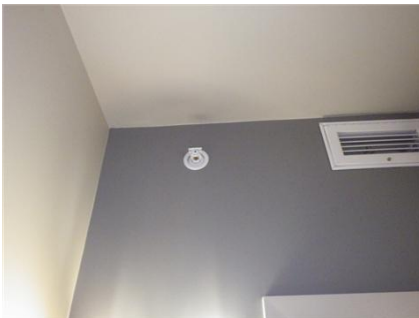
Fire 05 - Sprinklers & Standpipe - Wet

Throughout building.

Service Life: 100
Installed Year: 2006
Chronological Age: 14
Effective Age: 14
Next Renewal Year: 2106

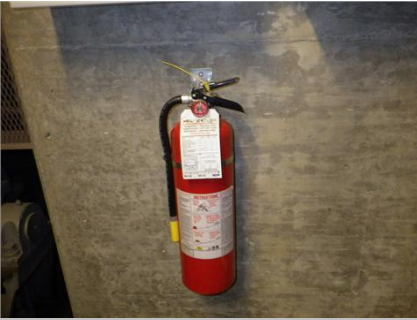
Fire 06 - Portable Fire Extinguishers

Strategically mounted to walls throughout building.

Service Life: 24
Installed Year: 2006
Chronological Age: 14
Effective Age: 14
Next Renewal Year: 2030

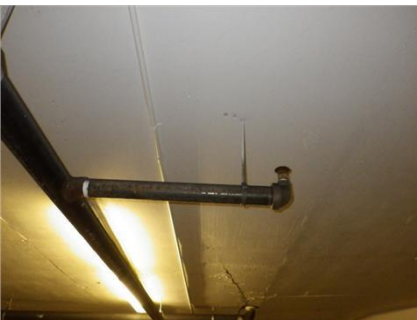
Fire 07 - Sprinkler System - Dry

Throughout the parkade.

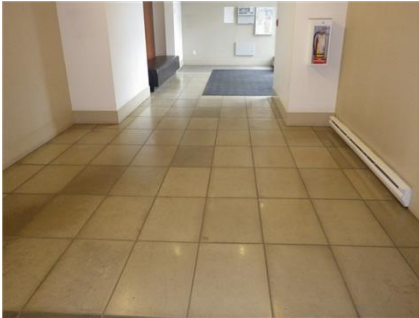
Finish 01 - Tile Flooring

Main lobby, elevator vestibules, and Olive room.

Service Life: 40
Installed Year: 2006
Chronological Age: 14
Effective Age: 14
Next Renewal Year: 2046

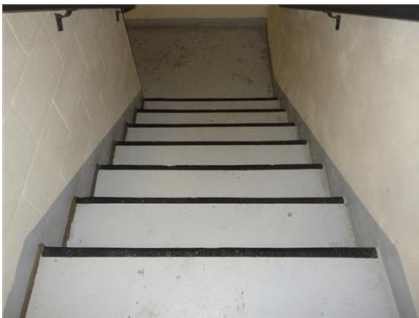
Finish 02 - Painted Concrete Flooring

Stairwells, storage rooms, garbage chute rooms and equipment service rooms.

Exposed concrete floors, painted in some locations to provide a cleaner finish. This flooring asset does not include the foundation, which is included with the structural system.

Service Life: 15
Installed Year: 2006
Chronological Age: 14
Effective Age: 14
Next Renewal Year: 2021

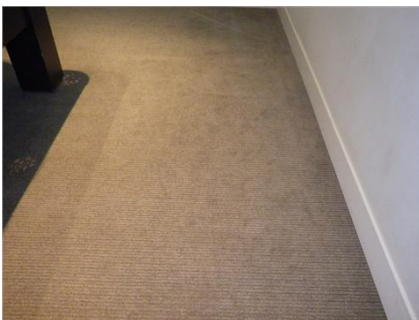
Finish 03 - Carpet Flooring

Hallways and the common room.

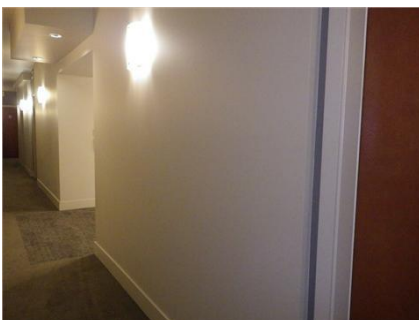
Finish 04 - Interior Painting

Main lobby, hallways and stairwells.

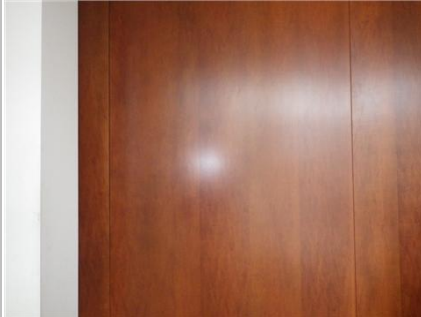
Finish 05 - Wood Paneling

Lobby, opposite main entrance and above mailboxes.

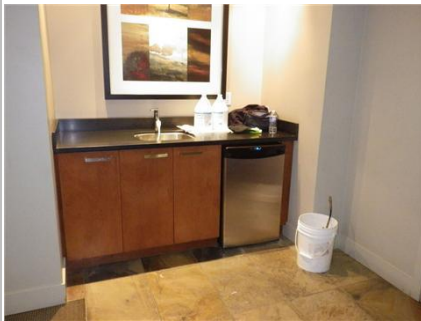
Finish 06 - Carpentry & Millwork

Common room kitchenette and lobby of the midrise building.

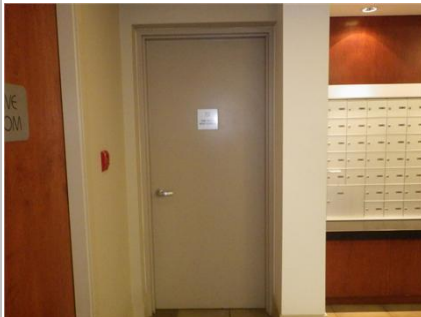
Finish 07 - Interior Swing Doors

All common area and interior service doors throughout the building.

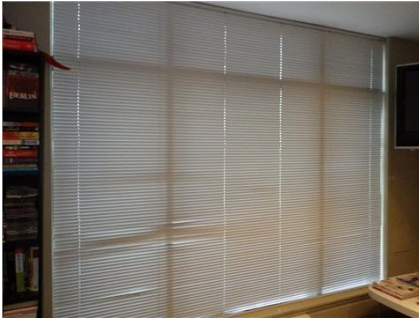
Amen 01 - Window Shades & Draperies

Common room of midrise building.

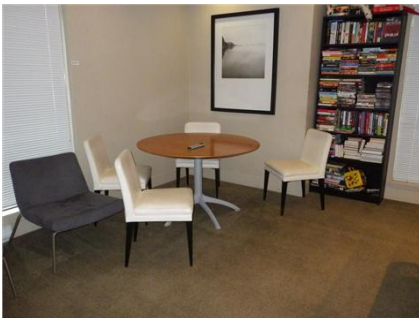
Amen 02 - Furniture & Accessories

Lobby and common room of midrise building.

Service Life: 15
Installed Year: 2006
Chronological Age: 14
Effective Age: 14
Next Renewal Year: 2021

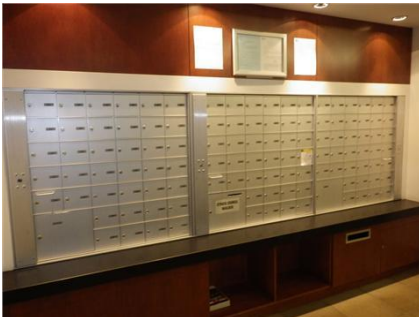
Amen 03 - Central Mailboxes

Lobby of the midrise building.

Service Life: 30
Installed Year: 2006
Chronological Age: 14
Effective Age: 14
Next Renewal Year: 2036

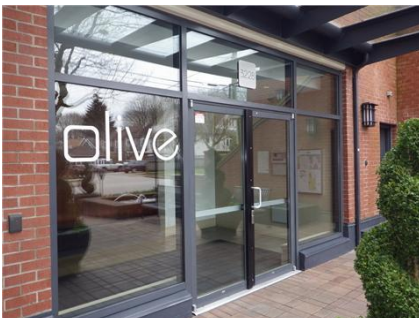
Amen 04 - Public Signage

Various locations throughout the complex.

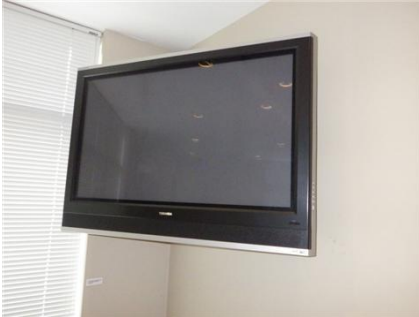
Amen 05 - Audio Visual Equipment

Common room.

Service Life: 15
Installed Year: 2006
Chronological Age: 14
Effective Age: 14
Next Renewal Year: 2021

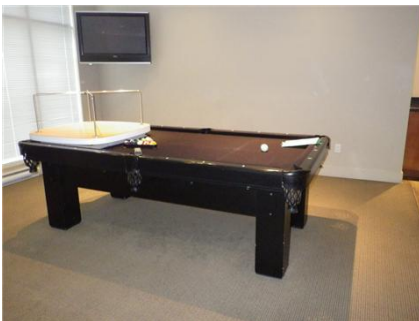
Amen 06 - Pool Table

Common room.

Service Life: 20
Installed Year: 2006
Chronological Age: 14
Effective Age: 14
Next Renewal Year: 2026

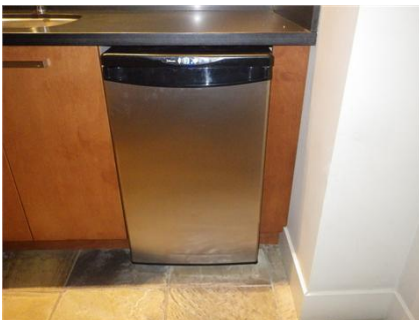
Amen 07 - Domestic Appliances

Common room.

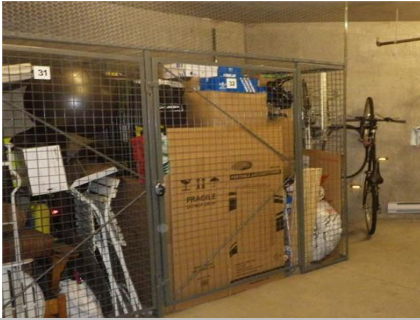
Amen 09 - Metal Storage Lockers

In various locations throughout parkade.

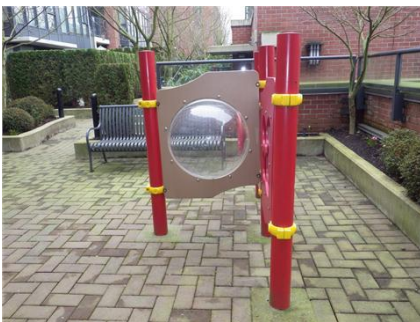
Site 02 - Playground Equipment

Courtyard on level 2.

Service Life:	30
Installed Year:	2006
Chronological Age:	14
Effective Age:	14
Next Renewal Year:	2036

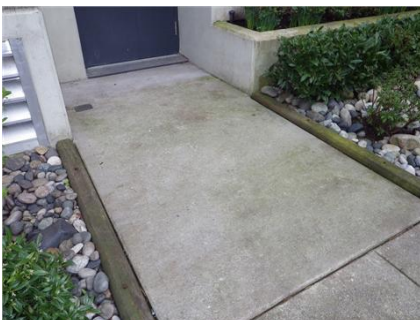
Site 03 - Concrete Paving

Parkade entrance at ground level, south elevation.

Service Life:	40
Installed Year:	2006
Chronological Age:	14
Effective Age:	14
Next Renewal Year:	2046

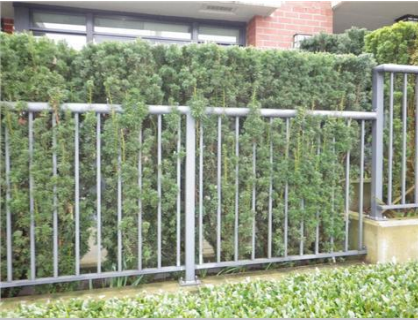
Site 04 - Metal Fencing & Guardrails

All elevations at level 2 courtyard and in the parkade.

Service Life: 40
Installed Year: 2006
Chronological Age: 14
Effective Age: 14
Next Renewal Year: 2046

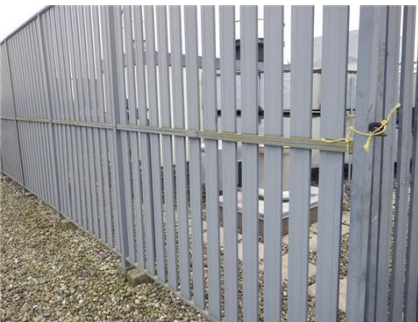
Site 05 - Metal Screen Fencing

Surrounding mechanical equipment at the southwest and northeast corners of the roof of the midrise building.

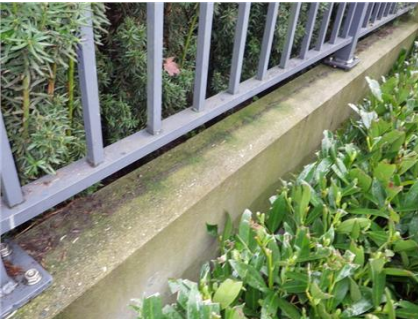
Site 06 - Planter Retaining Walls

Ground level in front of townhouse units and at the level two courtyard.

Service Life: 45
Installed Year: 2006
Chronological Age: 14
Effective Age: 14
Next Renewal Year: 2051

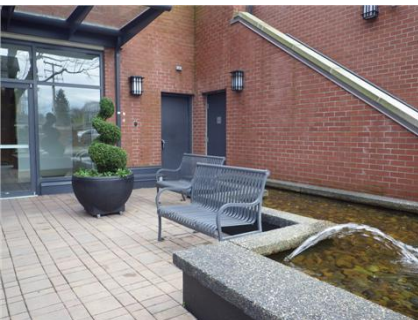
Site 07 - Site Furniture

Adjacent to the west lobby entrance and level 2 courtyard.

Service Life: 15
Installed Year: 2006
Chronological Age: 14
Effective Age: 14
Next Renewal Year: 2021

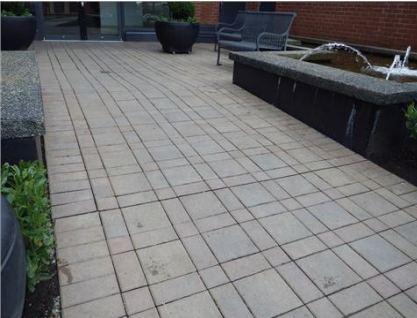
Site 08 - Unit Paving

At-grade on west elevation at lobby entrance and level 2 courtyard.

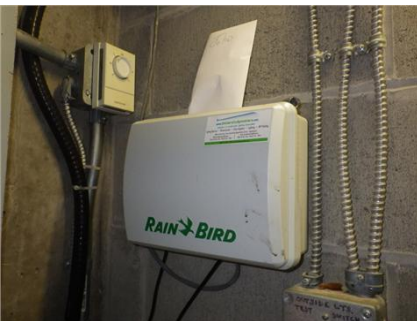
Site 09 - Irrigation Sprinklers

Mechanical room adjacent to lobby.

Service Life: 15
Installed Year: 2006
Chronological Age: 14
Effective Age: 14
Next Renewal Year: 2021

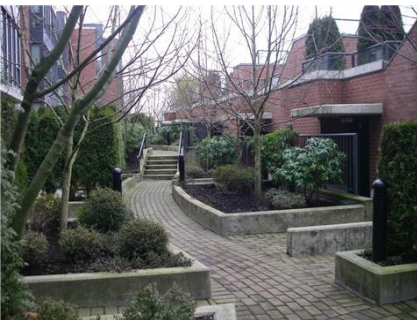
Site 10 - Soft Landscaping

Along west elevation.
