DEPRECIATION REPORT

AZURA ONE

1438 RICHARDS STREET
VANCOUVER, BC

DATE: **APRIL 9, 2021**

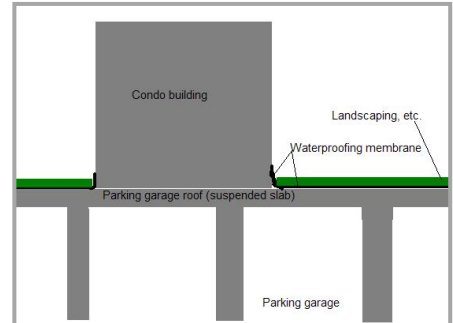
Condition: This component could not be visually reviewed. However, there did not appear to be any active leaks into the parkade at the time of our inspection. Representatives of the Strata Corporation did not report any active leaks in the parkade structure that may indicate the podium level waterproofing has been compromised.

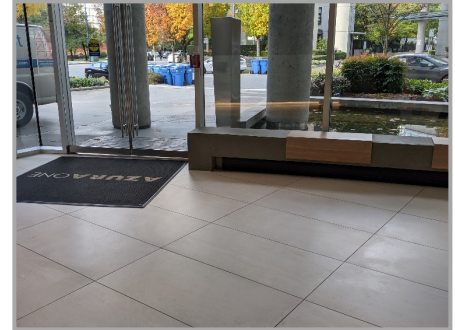
Lobby

Condition: The lobby is in serviceable condition with no major deficiencies observed.

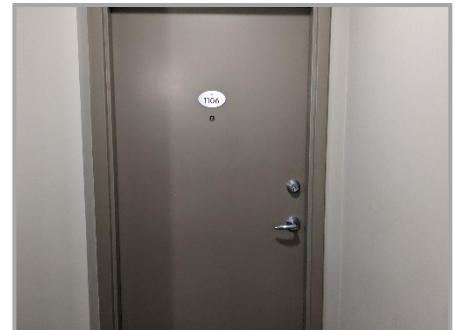
Interior Doors

Condition: The interior doors are functioning as intended.

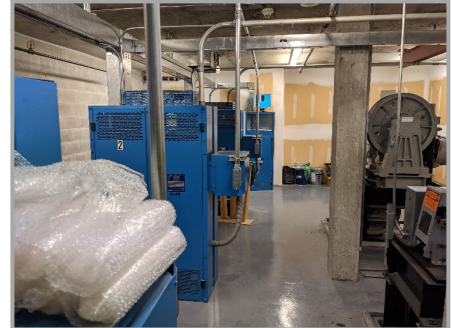
Elevator Modernization - Traction

Condition: The elevators appear to be regularly serviced and are functioning as intended.

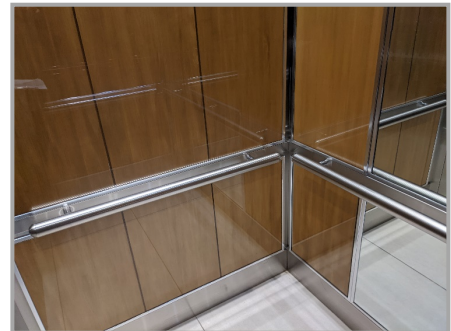
Elevator Cab Finishes

Condition: The elevator cab finishes are in satisfactory condition with no major deficiencies observed.

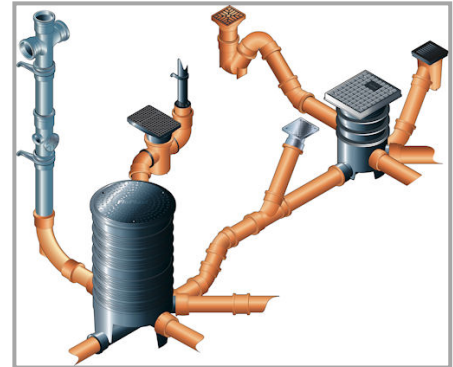
Domestic Water Pipes

Condition: This asset's condition is not verifiable with a non-exploratory visual review; however, no leaks have been reported.

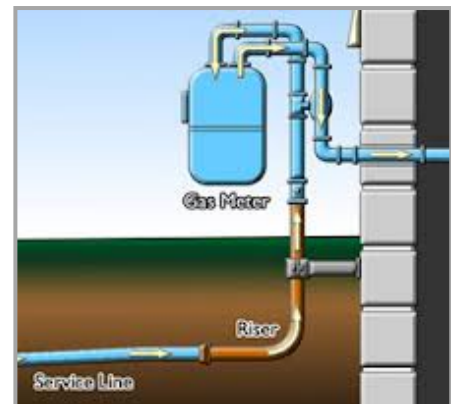
Gas Pipes

Condition: The gas piping could not be visually reviewed; however, no issues were reported by the building representative.

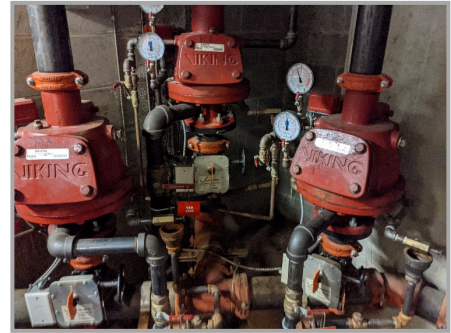
Condition: The sprinkler pipes and fire pump components appear to be functioning as intended.

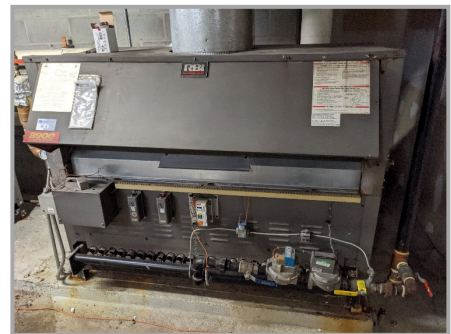
Condition: The boilers appear to be functioning as intended with no reported deficiencies.

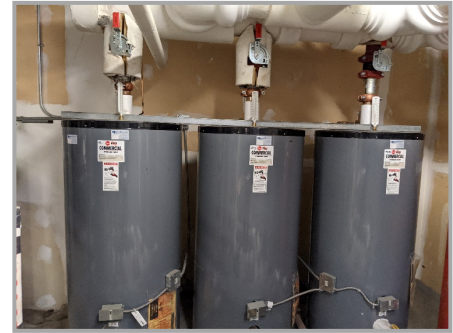
Hot Water Storage Tanks

Condition: The hot water storage tanks appear to be function as intended.

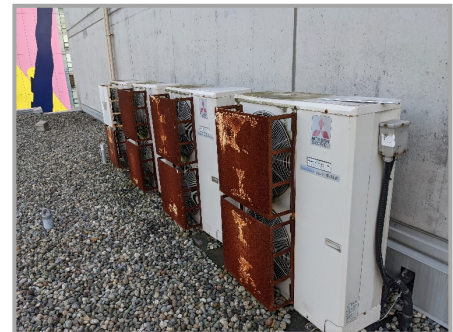
Heat Exchangers

Condition: The heat exchangers are in serviceable condition and appear to be functioning as intended.

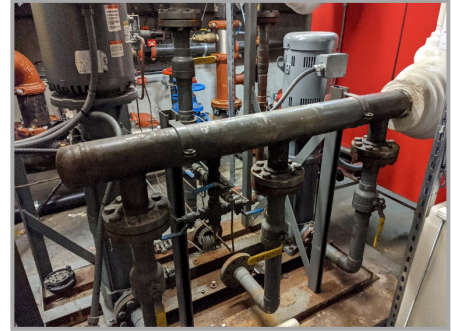
Miscellaneous Mechanical Room Components

Condition: The miscellaneous mechanical room components appear to be functioning as intended.

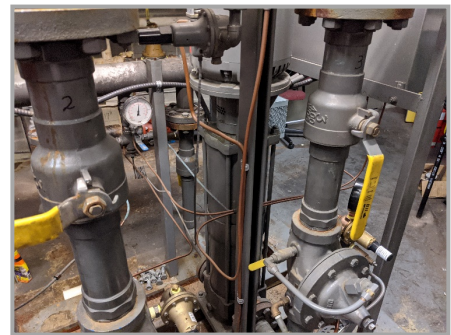
Water Pumps

Condition: The water pumps appear to be functioning as intended.

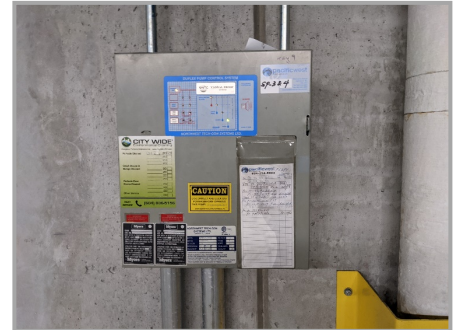
Condition: The sump pump appears to be functioning as intended with no major deficiencies reported.

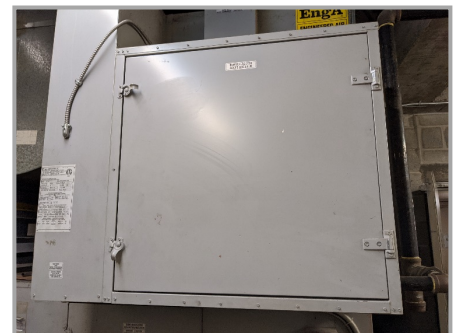
Condition: The building HVAC components appear to be functioning as intended.

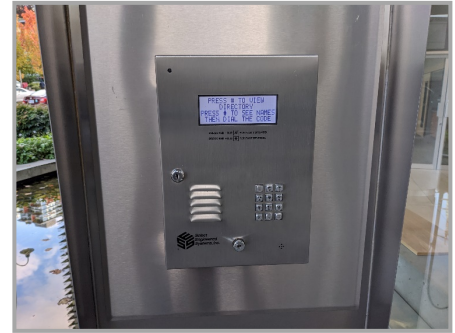
Condition: The enterphone system appears to be functioning as intended with no major deficiencies reported.

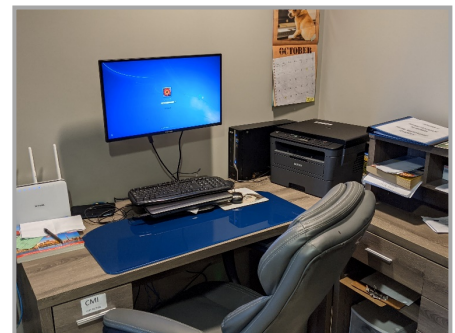
Condition: The security access system and cameras appear to be functioning as intended.

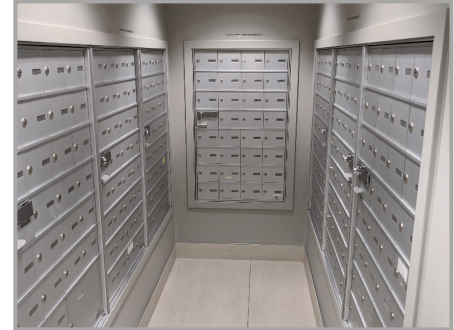
44**Mailboxes**

Condition: The mailboxes are in serviceable condition.

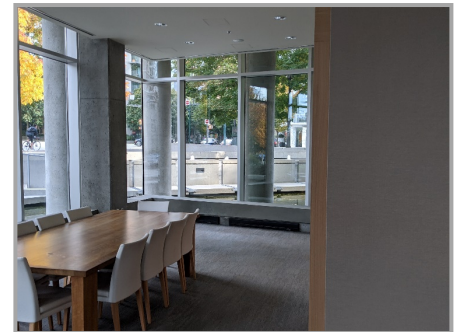
45**Meeting Room**

Condition: The meeting room finishes, furniture, and appliances are in serviceable condition.

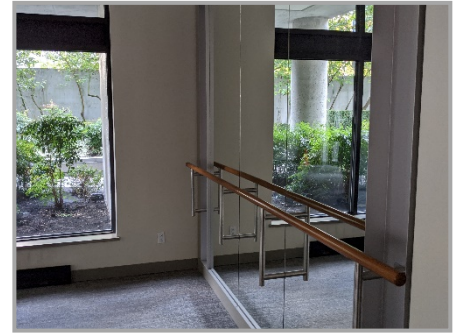
Condition: The finishes and equipment appear to be in serviceable condition.

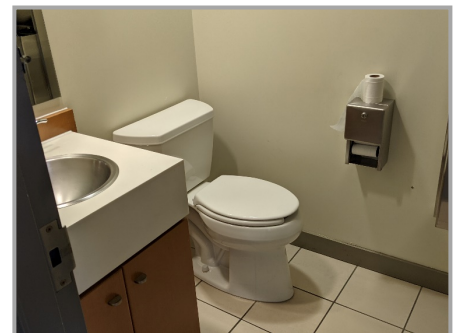
Description: This component includes the finishes and fixtures in the washroom.

Condition: The washroom finishes and fixtures appear to be functioning as intended.

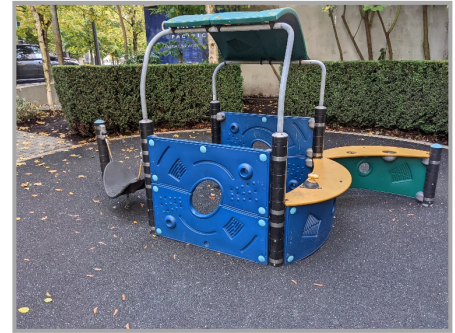
Description: This component includes the play structure at the northeast end of the property.

Condition: The play structure appears to be functioning as intended.

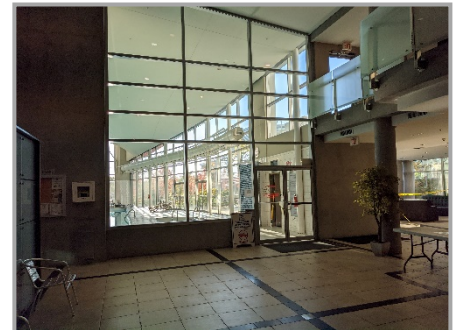
Description: These assets include the building envelope components, amenities, mechanical and electrical systems for Club Viva.

Condition: Refer to 2020 Club Viva Depreciation Report completed by Morrison Hershfield for further detail.

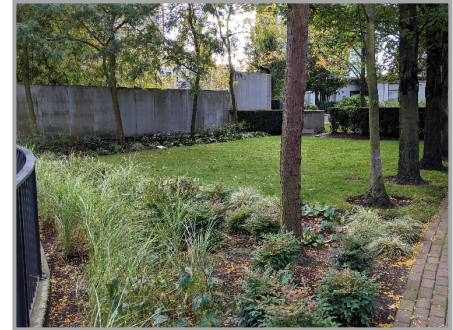
Description: This component includes the landscaped area between the highrise and townhouse building, as well as the surrounding plants in the planters.

Condition: The softscaping is in satisfactory condition with no major deficiencies observed.

Comments: The cost of this reserve item is based on the overall complexity of vegetation, frequency of large trees and total area and provides funds for a percentage of complete replacement. It is recommended for trees that are becoming too large, be pruned to prevent damage to the surrounding hardscaping. Reserve costs include allowances for softscaping work in conjunction with below-grade waterproofing membrane renewal projects.

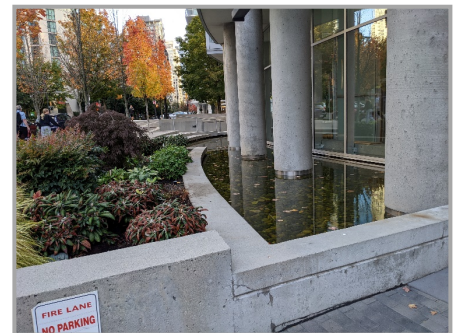
Description: This component includes the waterproofing membrane, sand filters, and water pumps for the water feature.

Condition: The water feature appears to be functioning as intended with no major deficiencies reported.

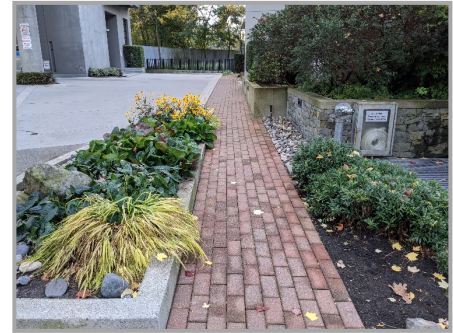
Description: This component includes the concrete walkway pavers, townhouse patio pavers, driveways, ramp, stairs, planters.

Condition: The hardscaping is in serviceable condition.

Comments: The hardscaping should be monitored for developing issues and potential tripping hazards. The cost of this component is based on overall complexity and size and provides funds for a percentage of complete replacement. Hardscaping is generally considered to last the life of the property and may only see partial renewals. The major renewal year is timed to coincide with renewal of the below-grade membrane, as any membrane work will require removal of large portions of the hardscaping areas.

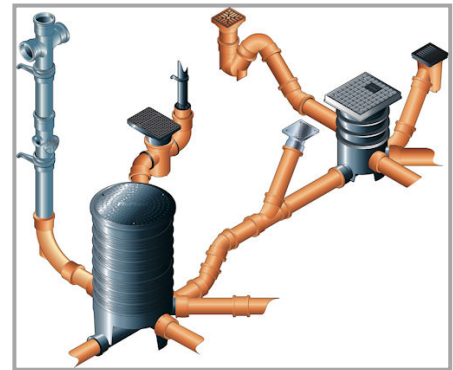
Description: This component consists of the incoming water supply from the water mains, sewer, and storm water drainage.

Condition: These components could not be visually reviewed; however, they are generally in satisfactory condition with no reported issues.

Comments: Reserve costs consist of an allowance to replace a percentage of the underground piping systems. Additional allowance has been included to flush the drainage system every 3 years.

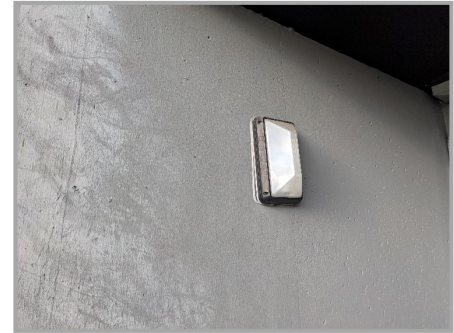
Description: This component includes the exterior lighting on the balconies, townhouse unit entrances, and walkways.

Condition: The exterior light fixtures are in satisfactory condition with no major deficiencies observed or reported.

Comments: Reserve costs include an allowance for targeted replacements.

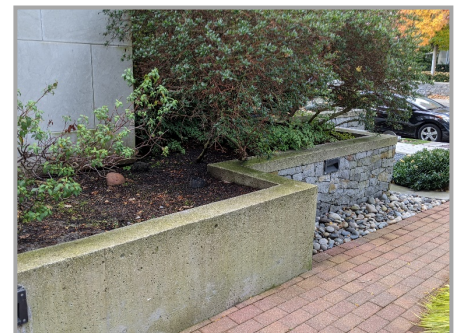
Description: This component includes the cast-in-place concrete retaining wall above the parkade entrance and the concrete planters around the complex. The concrete interlocking unit planters around the townhouse building are also included.

Condition: The concrete retaining walls are in serviceable condition.

Comments: Reserve costs include an allowance for targeted concrete repairs.

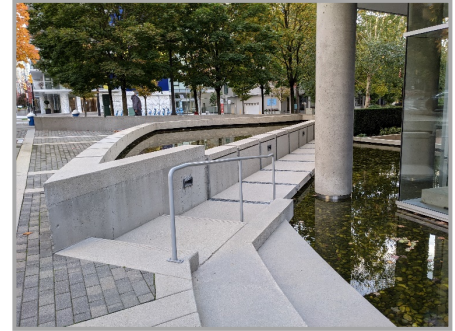
Description: This component includes the metal guard rails adjacent the water feature.

Condition: The site guard rails are in satisfactory condition with no major deficiencies observed.

Comments: Reserve costs include the replacement of the site guard rails.

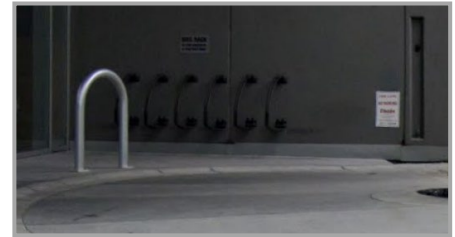
Description: This component includes the metal bike rack adjacent to the highrise main entrance.

Condition: The bike rack is in serviceable condition.

Comments: Reserve costs include an allowance for targeted repairs.
