BUILDING ENVELOPE CONDITION REVIEW

CONFERENCE PLAZA
438 SEYMOUR STREET, VANCOUVER, B.C.

Our File No.: R13-221

December 5, 2013

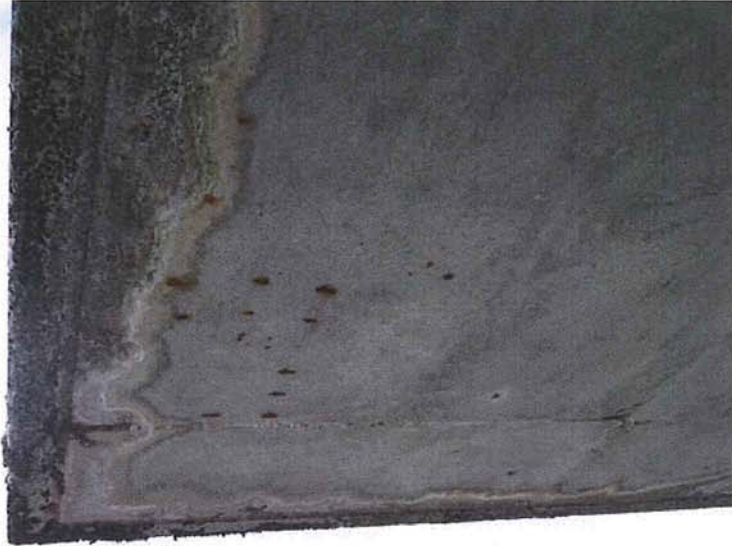
Photos No. 7 and 8

Description		Photos
3.2.1	Suspended concrete balcony slabs at Level 31 were noted to have exposed rebar at several locations as well as visible corrosion. Efflorescence staining was also visible.	5-8
3.2.2	Exposed rebar was observed at the underside of the Level 4 suspended concrete balcony slab on the north elevation	9
3.2.3	Spalling concrete was observed on the Level 4 deck which wraps around the residential tower on the west and south elevations	10-14
3.2.4	Efflorescence staining was typically noted at the embedded swing stage cable bypass sleeves.	15-18

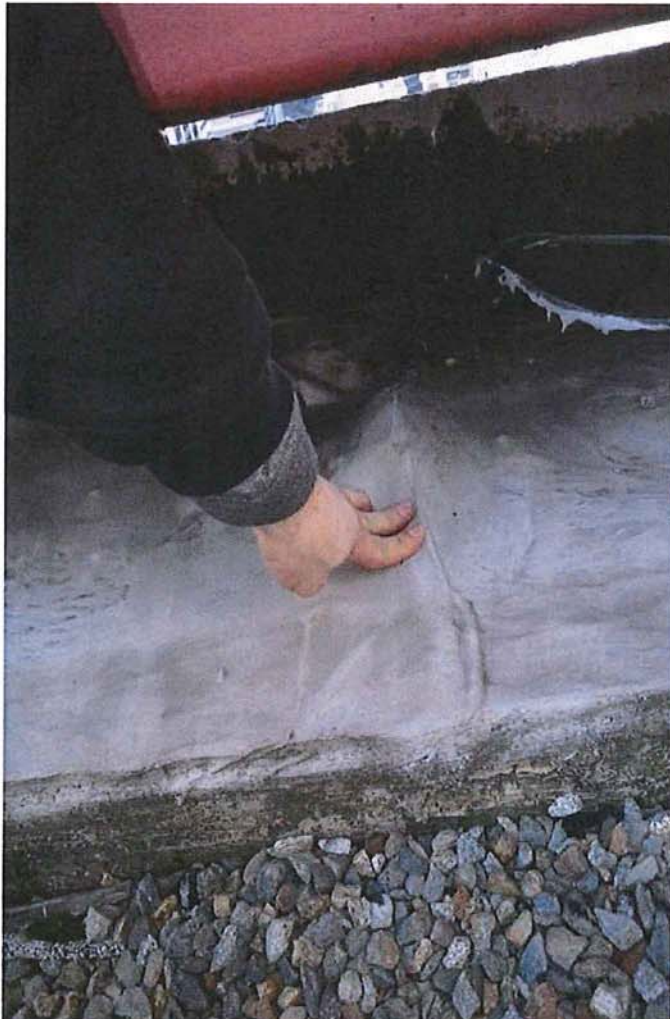
Photos No. 19 and 20

Description	Photos
3.3.1	A liquid-applied PMMA (polymethyl methacrylate) has been applied to the rooftop's steel structure column footings and the concrete curb on which the columns stand. In a few locations, large air pockets and minor delaminations were noted.	19-22

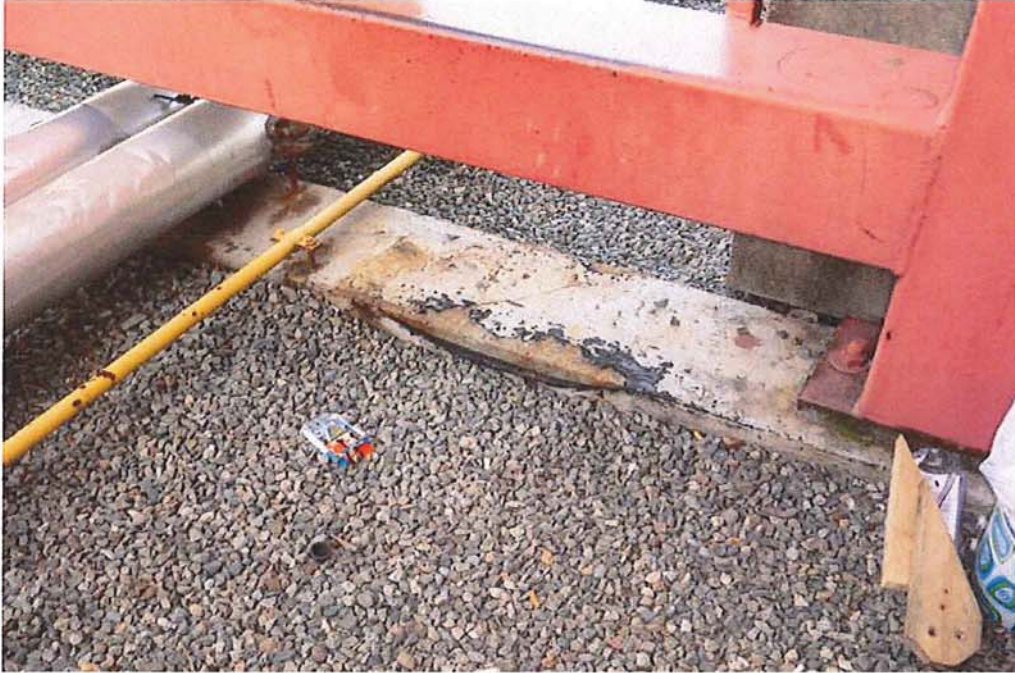
Photos No. 23 and 24

3.3.2	The original membrane applied to rooftop concrete curbs and mechanical equipment pedestals was noted to be delaminating and wearing through in multiple locations.	23-24

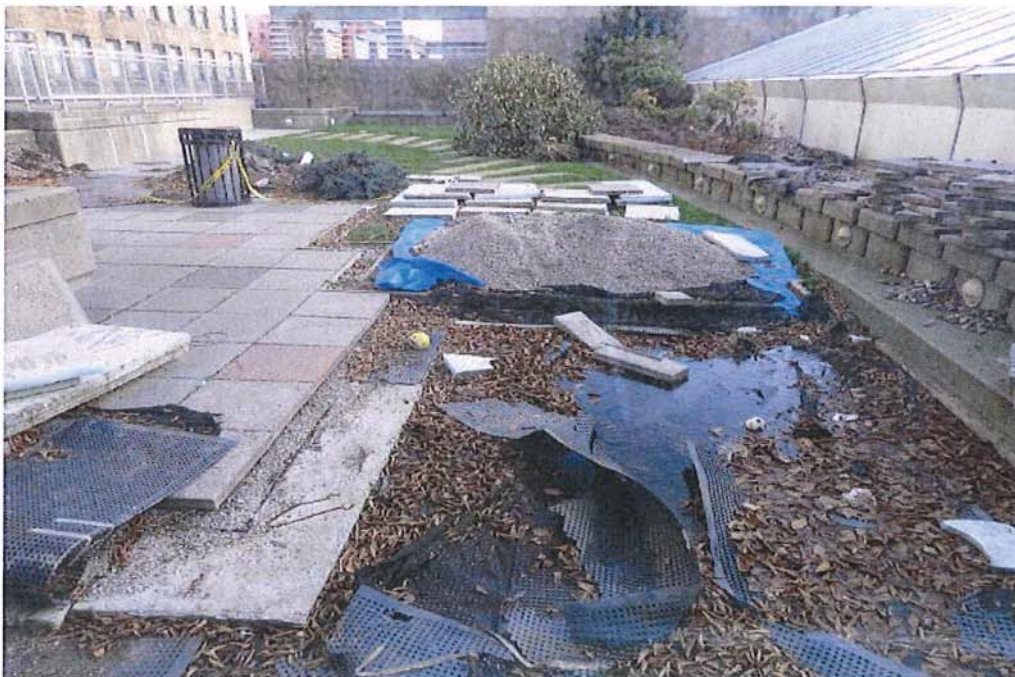
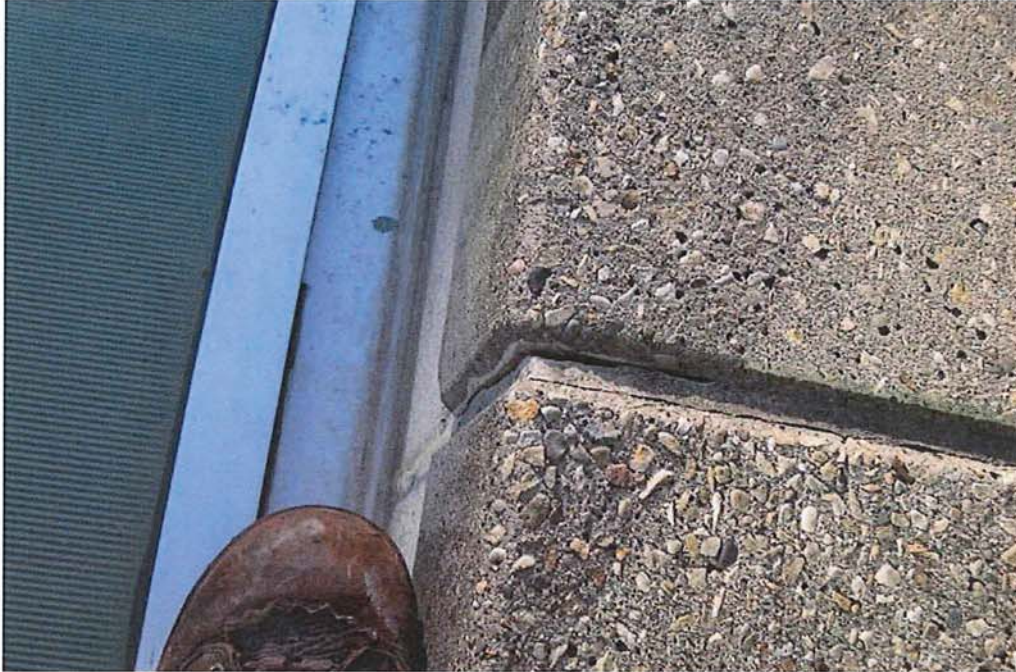
Photos No. 27 and 28

3.3.4	At the Level 4 roof patio, repair work is underway to the existing membrane in the area of the east facing door.	26
3.3.5	The polyurethane sealant applied to joints in precast concrete parapet cap sections was observed to be failing in several locations at the Level 5 roof, which abuts the pool's skylight canopy.	27-29

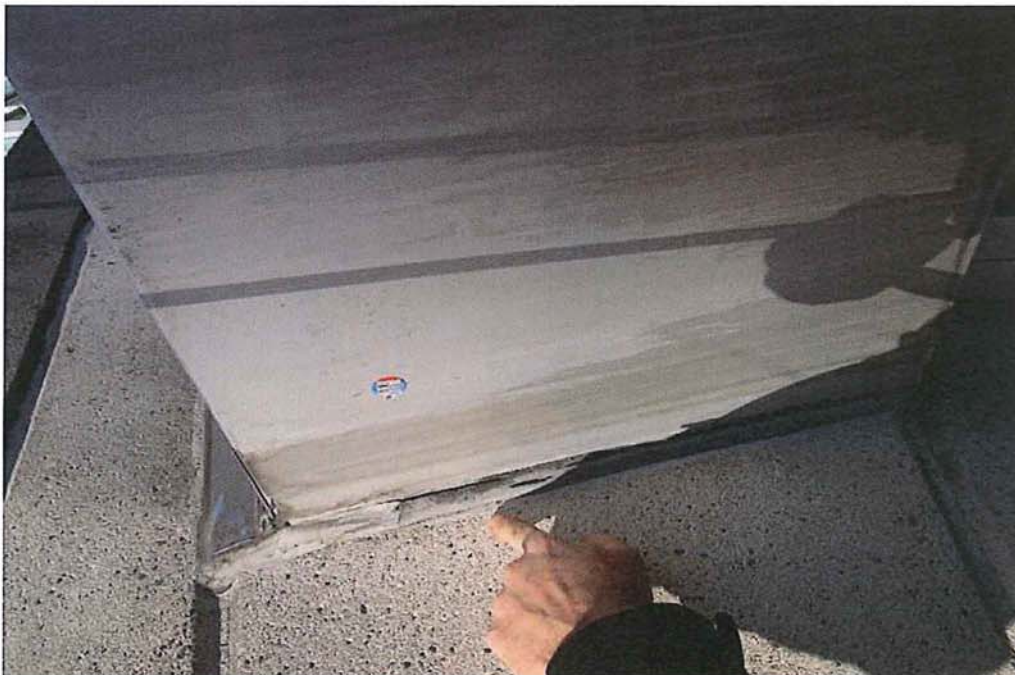
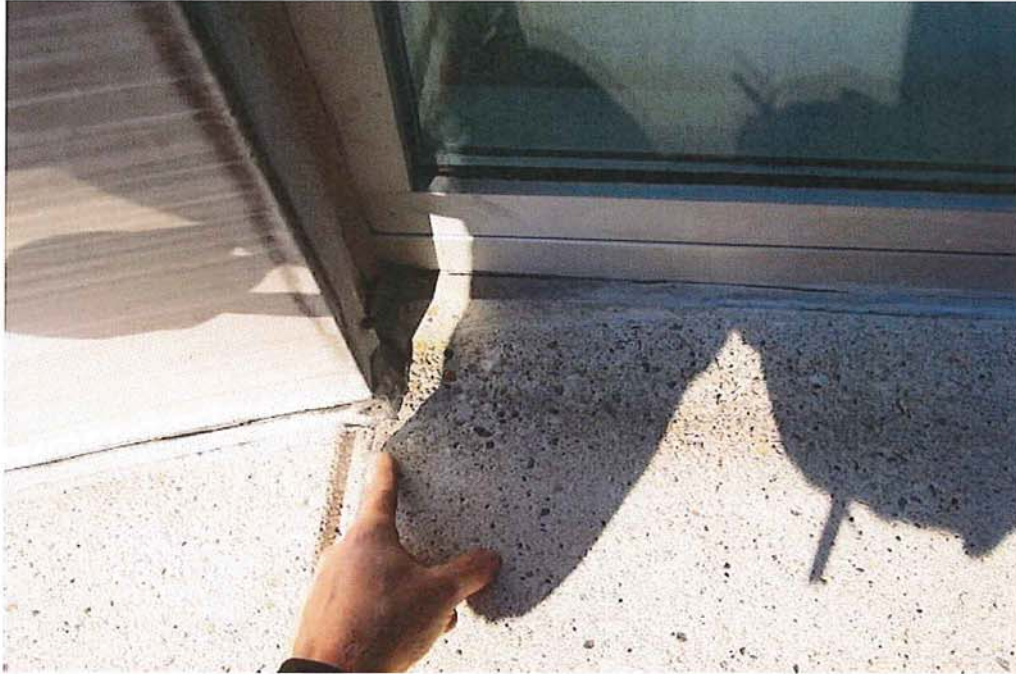
Photos No. 29 and 30

3.3.6	At the commercial low rise roof, membrane up-legs are protected by gum-lip flashings. Sealant appears to be in good condition.	30-31
3.3.7	At the commercial low rise roof, the concrete curb supporting the rooftop steel columns is protected by a flashing, which incorporates standing seam joints. The flashing appears to be in good condition.	32-33

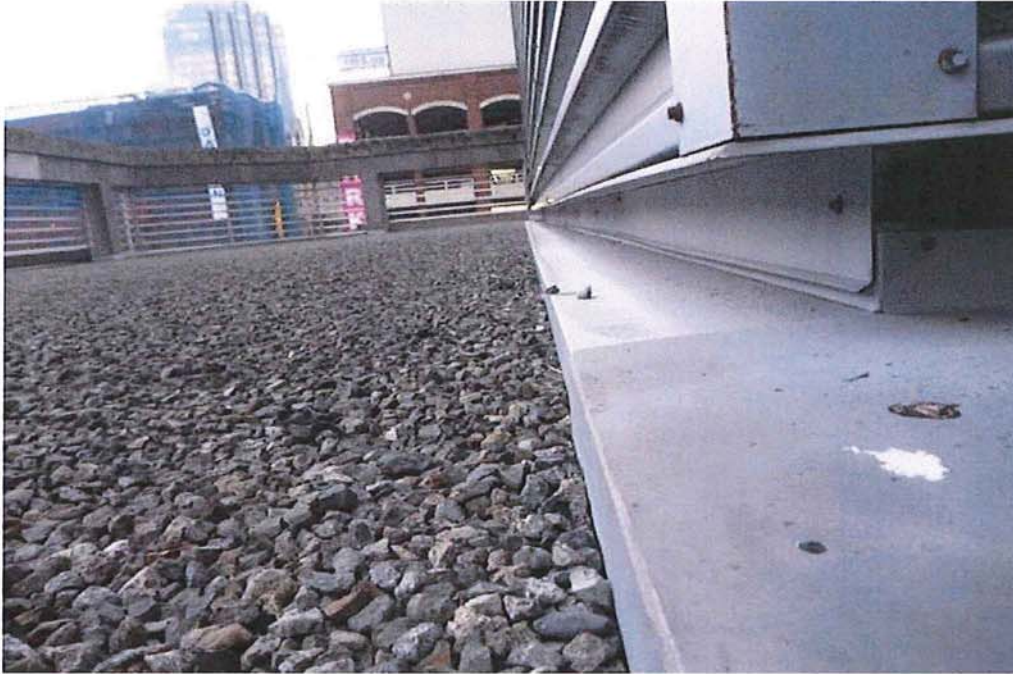
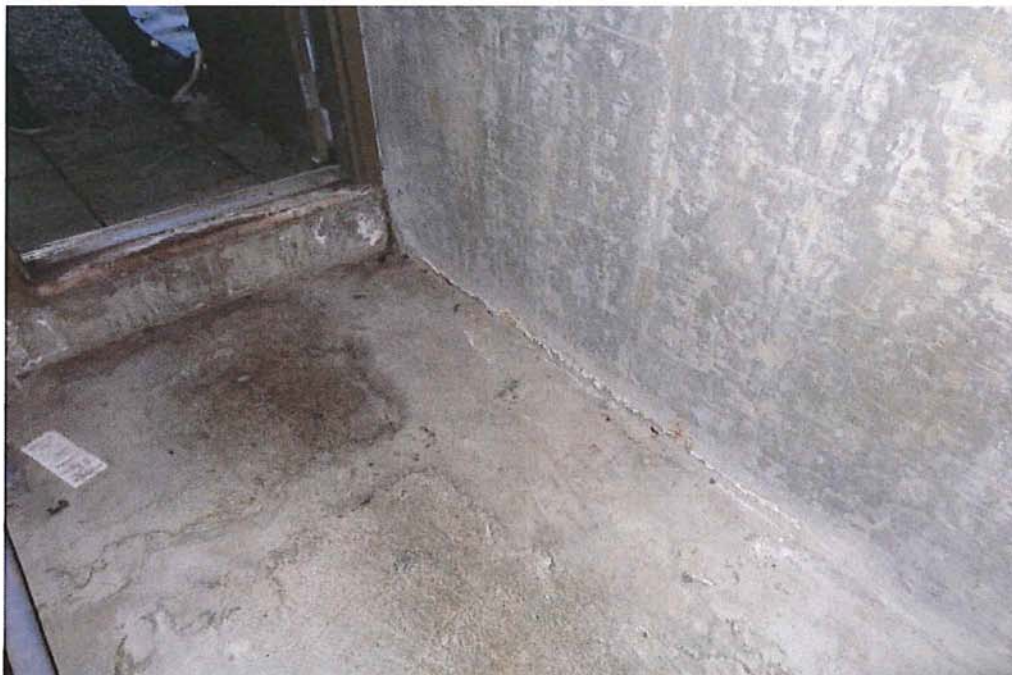
Photos No. 33 and 34

3.3.8	At the commercial low rise roof, efflorescence staining was observed at the interior of the roof level stair case, at the construction joint between the cast-in-place concrete curb and concrete block wall. It appears that a new flashing has been installed at the exterior of this area.	34-35

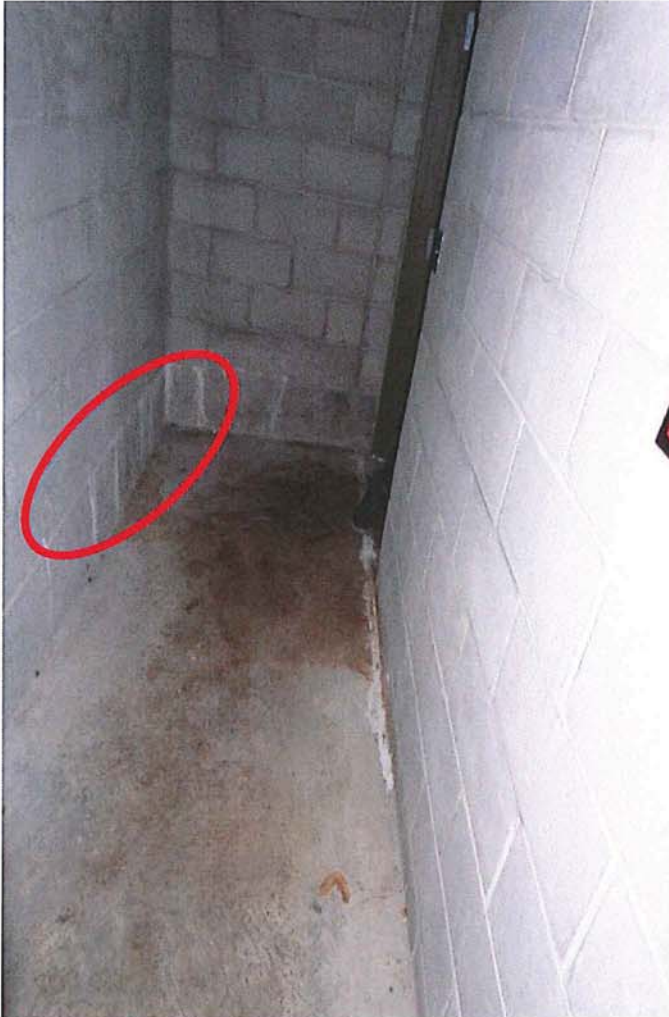
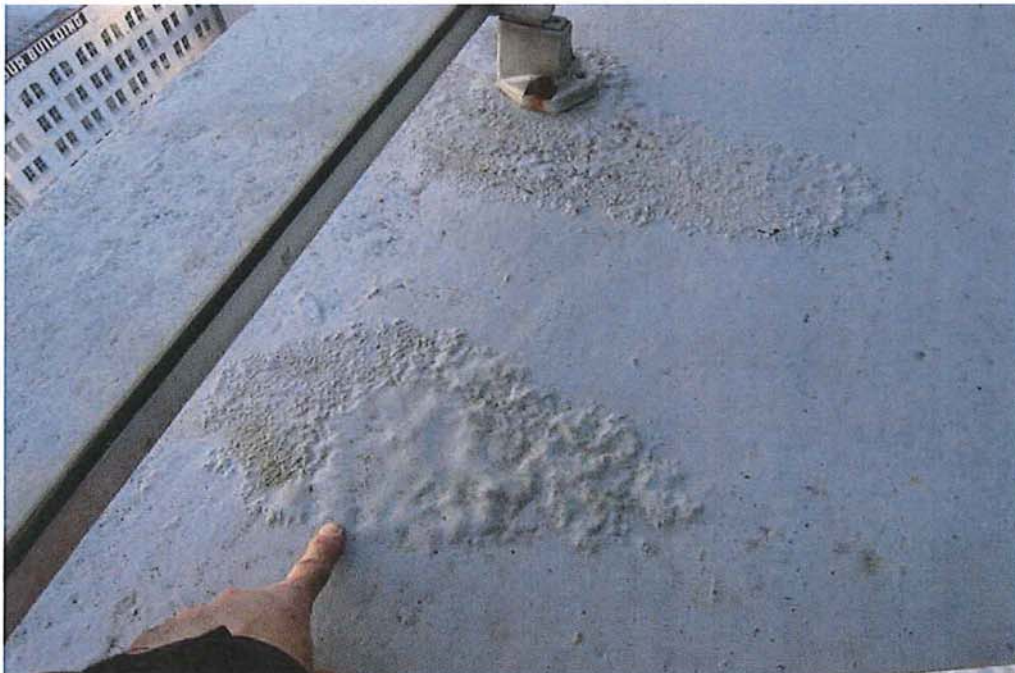
Photos No. 35 and 36

Description		Photos
3.4.1	The polyurethane traffic coating applied to the balconies and eyebrows was noted to be delaminating in several locations. Membrane up-legs and downlegs were observed to be inadequate in several locations. Concrete cracking was also observed in multiple locations.	36-37

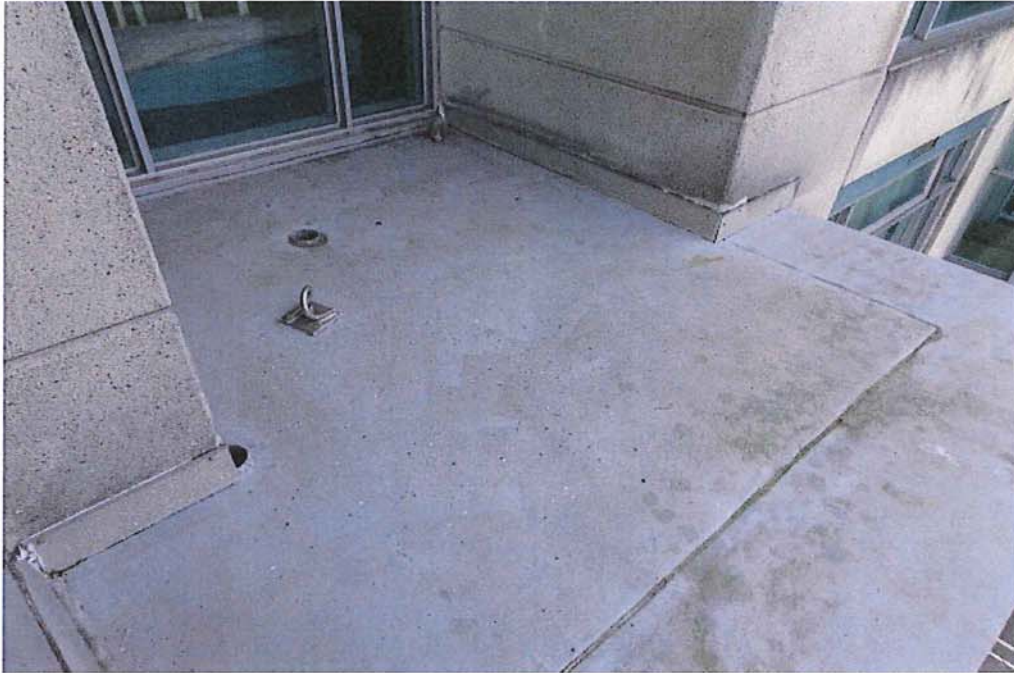
Photos No. 39 and 40

3.4.2	Water ingress is apparent around the embedded swing stage cable bypass sleeves at both eyebrows. Some of the tethered caps were noted to be missing.	38-40

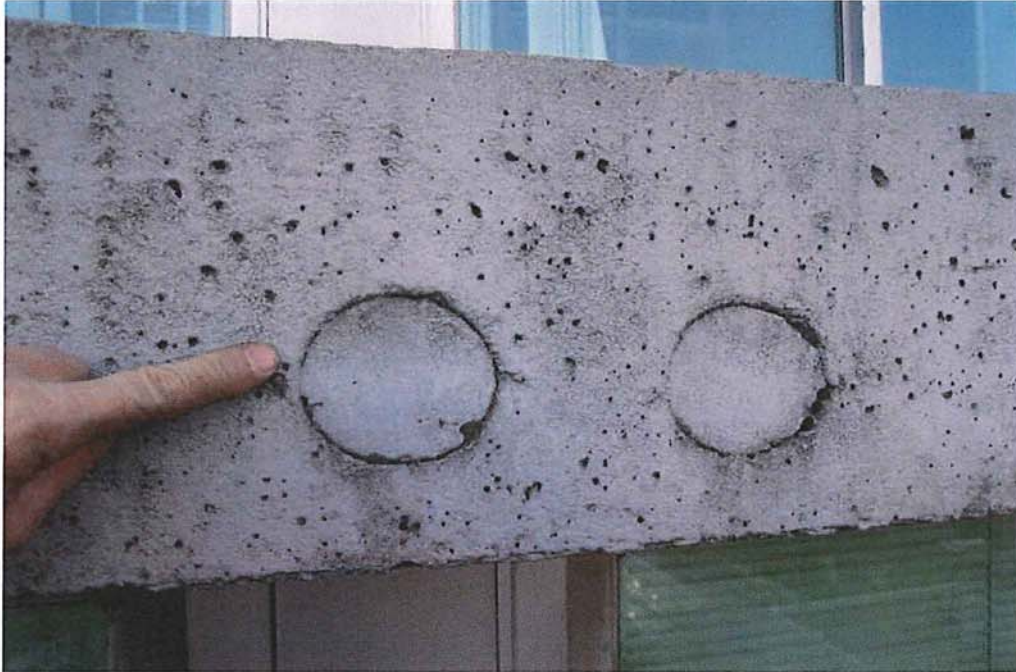
Photos No. 41 and 42

3.4.3	Concrete post tension cable grout plug sealant was observed to have failed on the south elevation at the Level 23 eyebrow.	41-42
3.4.4	Bolts and nuts for the guard rail mounting posts were observed to have surface corrosion throughout the building. It appears that the original hardware was galvanized steel.	43-45

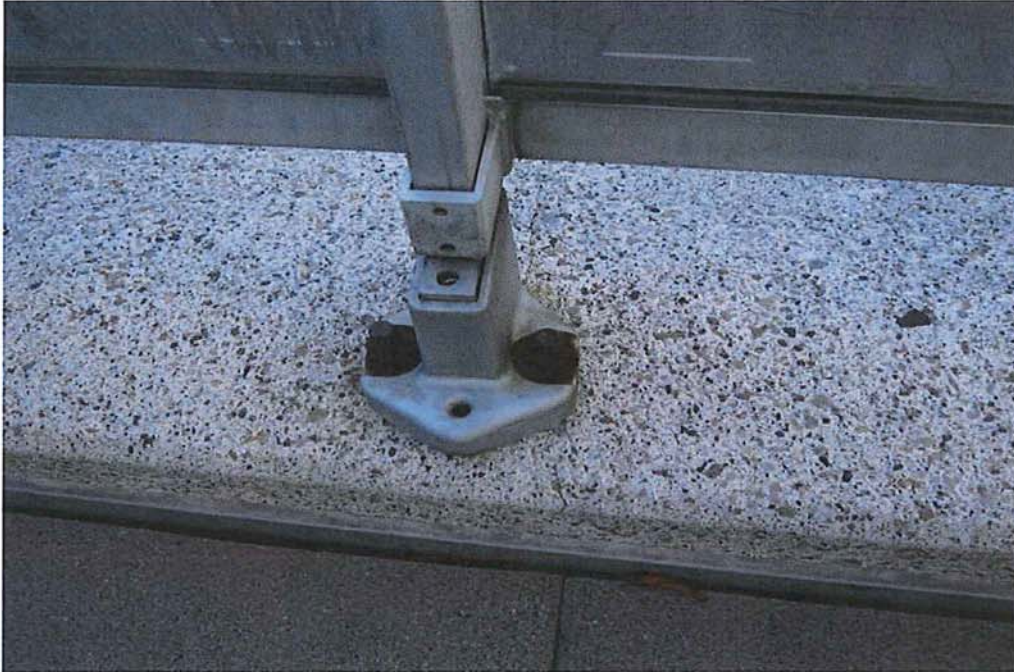
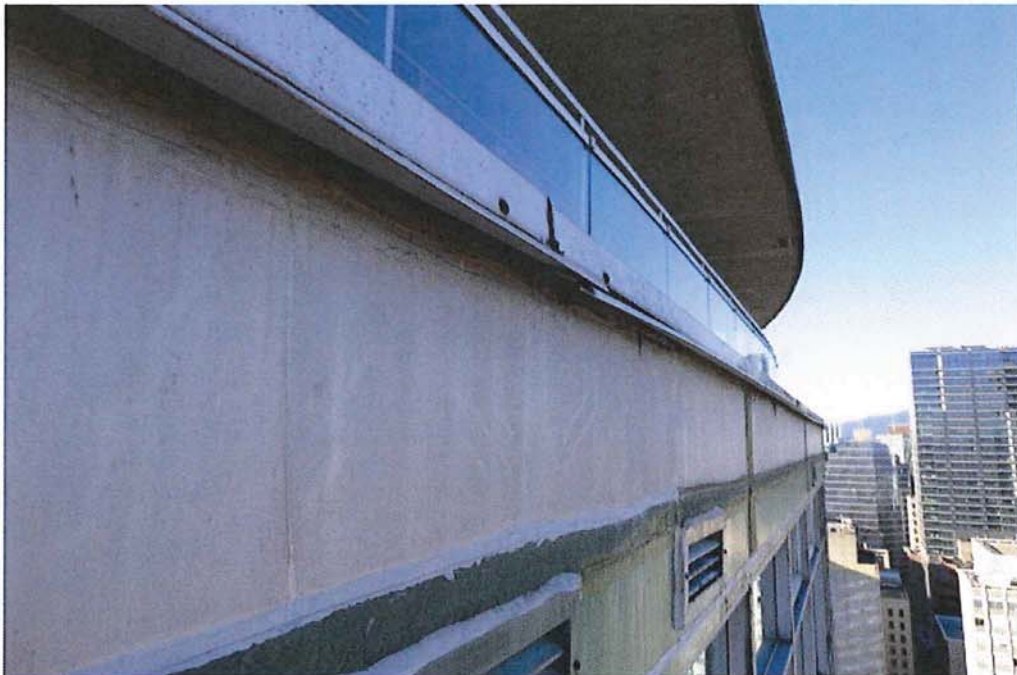
Photos No. 45 and 46

3.4.5	Parapet flashings at Level 30 decks were noted to incorporate a lap seam at joints finished with an application of sealant. A drip edge extension has been fastened to original flashings effectively extending flashing's overhang.	46-47
