DEPRECIATION REPORT

BCS 2637 - "CORUS"
5989 WALTER GAGE ROAD
VANCOUVER, BC
YEAR 2013

January 30, 2013

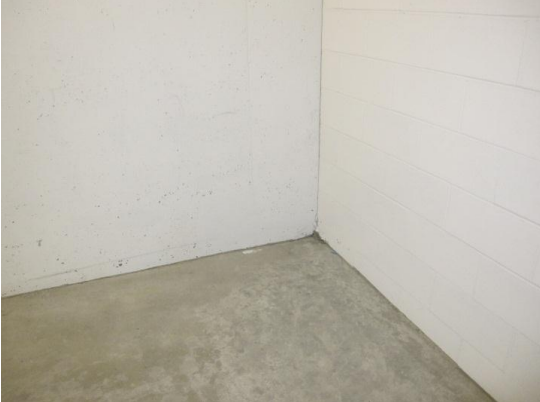
Component 1		Building - Structural and Architectural	Substructure and Underground Garage

Component Description	This component includes all below-grade portions of the building including footings, basement floors, walls, ceilings, columns, membrane, and expansion joints. These are typically poured concrete or masonry block.		
Reserve History	Year of Acquisition	2007	
	Description	Original to the building.	
Potential Deterioration	Potential deterioration includes water and road salt penetration of the surface of the concrete in the underground garage. Salt corrosion and water penetration of reinforcing rebar and freeze-thaw cycles could spall concrete in ceilings and walls in underground. Hydraulic pressure caused by poor drainage and settling could also cause concrete cracking. The membrane can be damaged by cracked concrete, wear and tear, and material breakdown due to age.		
Condition Analysis	Based upon a partial visual-inspection, this component appears to be in good condition for its age.

Life Cycle Analysis	Expected Lifespan	20 years	
	Effective Age	5 years	
	Remaining Lifespan	15 years	
Funding Analysis	Description	No money has been spent on this component to date.	
	Work	Remove finish material, clean and patch, perform slab edge repair if required including injection of sealant and resurface materials. A budget equal to 10% of the estimated cost of the component is provided for periodic major repairs every 20 years.	
	Quantity	1,000 LF	
	Job Cost	\$104,864.88	
Deficiency Analysis	No major deficiencies were noted at the time of visual inspection. The life of this component may be prolonged by effective maintenance which include regular visual inspection of the walls, columns, and slab edges for signs of cracking.

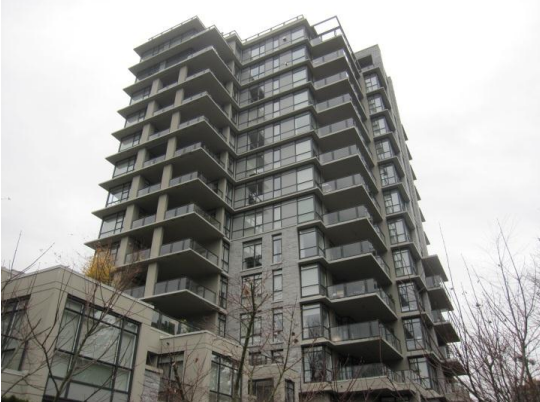
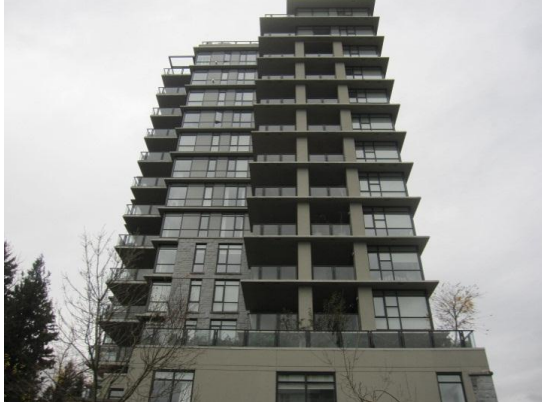
Component 7		Building - Structural and Architectural		Wall Assemblies - Concrete Siding

Component Description	Poured in place concrete wall assemblies are commonly constructed of materials built up in layers. In addition the application of a sealant to the exterior surface is required to maintain concrete integrity. Concrete wall assemblies can also be "Pre-cast" when used as support for Curtain wall construction.				
Reserve History	Year of Acquisition	2007			
	Description	Original to the building.			
Potential Deterioration	One of the most common problems with concrete walls is cracking. Cracks can be benign or serious, depending on the location of the crack, the size, and the direction of the crack. Earthquakes, impact and settling of the underlying ground can result in cracking of the concrete. Water ingress may cause further cracking and corrosion.				
Condition Analysis	Based upon a partial visual-inspection, this component appears to be in good condition for its age.

Life Cycle Analysis	Expected Lifespan	20 years			
	Effective Age	5 years			
	Remaining Lifespan	15 years			
Funding Analysis	Description	No money has been spent on this component to date.			
	Work	Provided damage is structural, the wall can be injected with a flexible sealant. Other repair options may include spot replacement of damaged concrete and patchwork. A budget equal to 10% of the estimated cost of the component is provided for periodic major repairs every 20 years.			
	Quantity	3,000 SF			
	Job Cost	\$103,013.50			
Deficiency Analysis	There are some areas of efflorescence on the concrete. This could be due to water ingress in some components. Some fasteners of canopies show corrosion at the concrete. There are some minor cracks in various areas. The life of this component may be prolonged by effective maintenance which include regular visual inspection of the walls for signs of cracking.

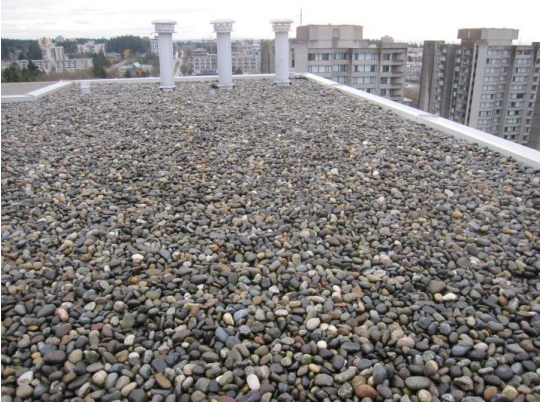
Component 19		Building - Structural and Architectural		Roof Assembly - Single Ply Membrane

Component Description	<p>A roof system in which the principal roof covering is a single layer of flexible membrane often thermoset or thermoplastic. Thermoset membranes are compounded from synthetic rubber polymers, and the most commonly used polymers are EPDM, CSPE and Neoprene. Two of the most commonly-used thermoplastic single-ply membranes are PVC and TPO, both of them plastic-based materials.</p>				
Reserve History	Year of Acquisition	2007			
	Description	Original to the building.			
Potential Deterioration	<p>Roofing systems are susceptible to weather. Due to the thinner surface, these roof systems can be easily punctured. They have a relatively shorter life span than other roofing material and can be susceptible to water retention and seam failure.</p>				
Condition Analysis	<p>Based upon a partial visual-inspection, this component appears to be in good condition for its age.</p>

Life Cycle Analysis	Expected Lifespan	20 years			
	Effective Age	5 years			
	Remaining Lifespan	15 years			
Funding Analysis	Description	No money has been spent on this component to date.			
	Work	Cut away and remove damaged or failed roofing material. Replace underlay or insulation material as required. Clean sub surface and apply new membrane. Care to maintain solid seam finish and appropriate flashing at connector points.			
	Quantity	5,700 SF			
	Job Cost	\$36,394.84			
Deficiency Analysis	<p>Membrane appears to be in good condition. There is some debris which could damage the membrane. Ballast should be distributed evenly. The life of this component may be prolonged by effective maintenance which could include patching and repairs as required.</p>

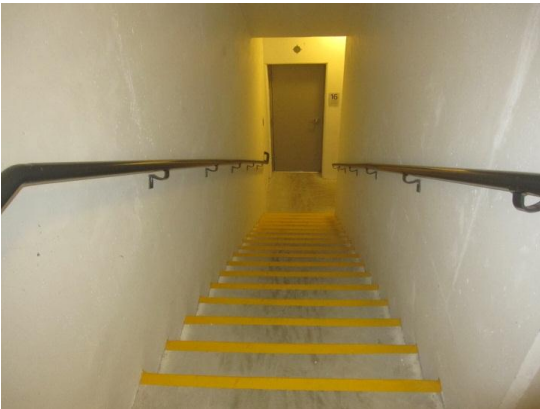
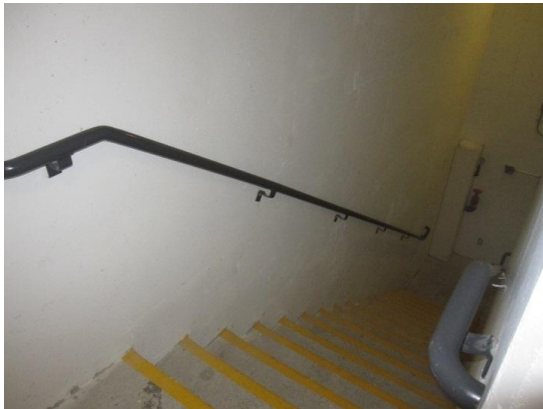
Component 21		Building - Finishes and Decoration		Interior Stairwell Painting

Job Cost	\$137,354.33			
Deficiency Analysis	No major deficiencies were noted at the time of visual inspection. The life of this component may be prolonged by effective maintenance which could include regular inspection for paint fading due to wear and tear and repaint as required.

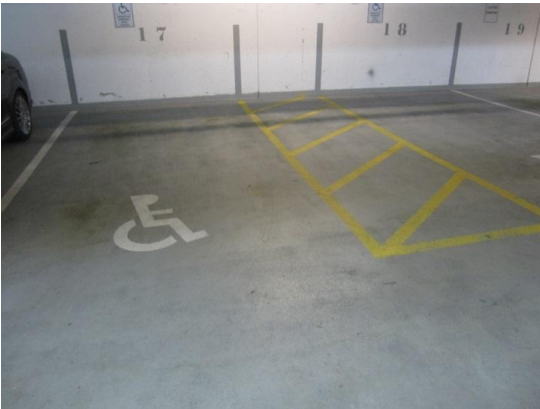
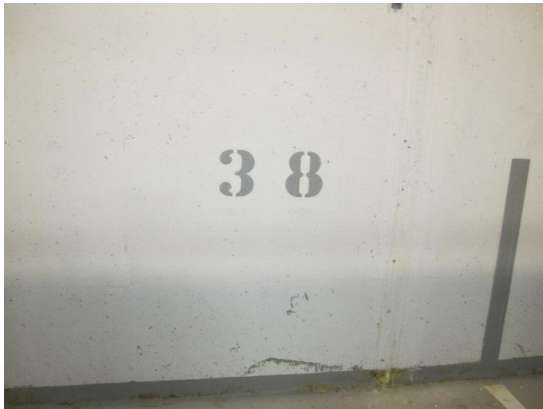
Component 22		Building - Finishes and Decoration	Underground Garage Markings

Job Cost	\$15,424.68	
Deficiency Analysis	No major deficiencies were noted at the time of visual inspection. The life of this component may be prolonged by effective maintenance which could include power washing, regular staining and regular inspection for damage.

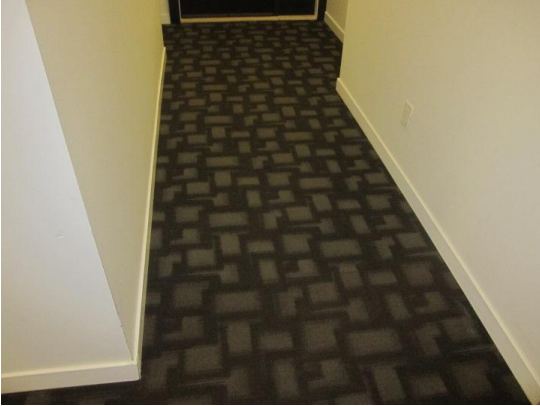
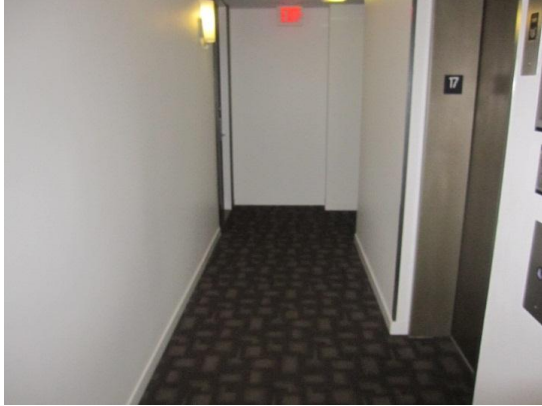
Component 24		Building - Finishes and Decoration		Interior Common Corridor Flooring

Work	Replacing the damaged area or replacement of the entire area depending on the scope of the deterioration.			
	Quantity	4,800 SF			
	Job Cost	\$103,294.02			
Deficiency Analysis	No major deficiencies were noted at the time of visual inspection. The life of this component may be prolonged by effective maintenance including carpet cleaning and repairs as required.

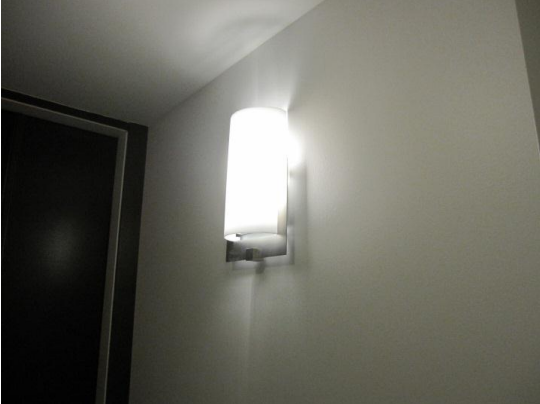
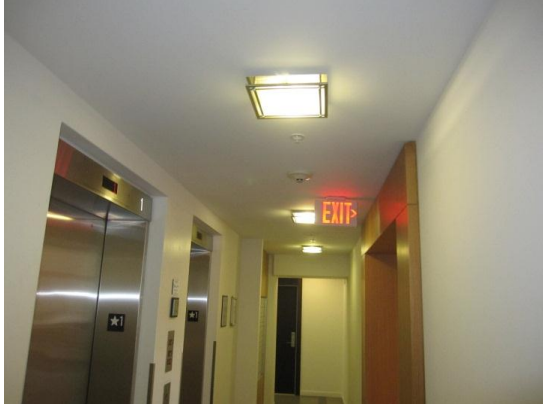
Component 25		Building - Finishes and Decoration		Interior Common Area Lighting

Condition Analysis	Based upon a partial visual-inspection, this component appears to be in good condition for its age.				
Life Cycle Analysis	Expected Lifespan	20 years			
	Effective Age	5 years			
	Remaining Lifespan	15 years			
Funding Analysis	Description	No money has been spent on this component to date.			
	Work	Removal and disposal of existing assembly, repairs or replacement as required to the drywall and installation of the new assembly. Upon replacement, it may be advisable to switch to LED lighting depending on cost, repayment time, and availability.			
	Quantity	90 Lights			
	Job Cost	\$66,993.65			
Deficiency Analysis	No major deficiencies were noted at the time of visual inspection. The life of this component may be prolonged by effective maintenance which could include regular inspections and repairs as required.

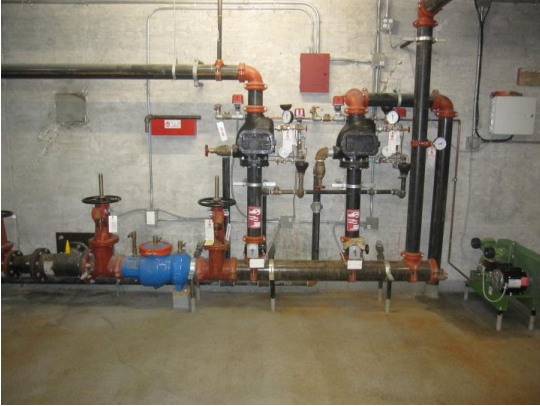
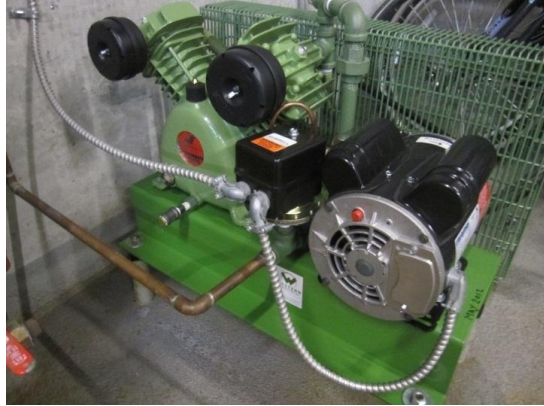
Component 29		Building - Mechanical Systems		Sprinkler System

Remaining Lifespan	20 years			
Funding Analysis	Description	No money has been spent on this component to date.			
	Work	A fire sprinkler system needs to be maintained regularly to comply with numerous regulations. The System is inspected and tested for operational readiness, and parts failure. A budget equal to 10% of the estimated cost of the component is provided for periodic major repairs every 25 years.			
	Quantity	1 System			
	Job Cost	\$72,057.16			
Deficiency Analysis	<p>No major deficiencies were noted at the time of visual inspection. The life of this component may be prolonged by effective maintenance.</p>

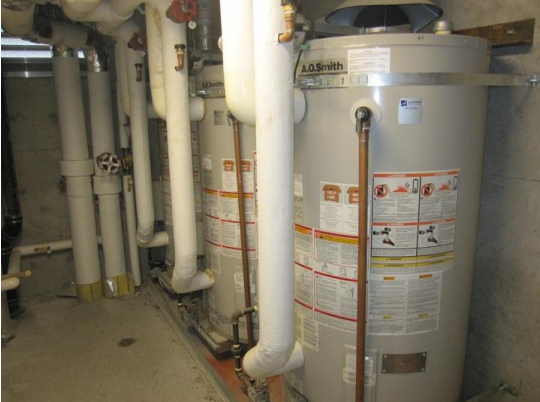
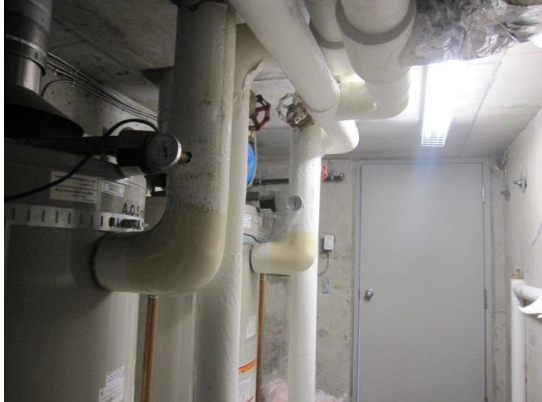
Component 30		Building - Mechanical Systems		Hot Water Storage Tanks

Quantity	3 Tanks			
	Job Cost	\$9,191.98			
Deficiency Analysis	No major deficiencies were noted at the time of visual inspection. Replacement is recommended at the end of the manufacturer's recommended life.

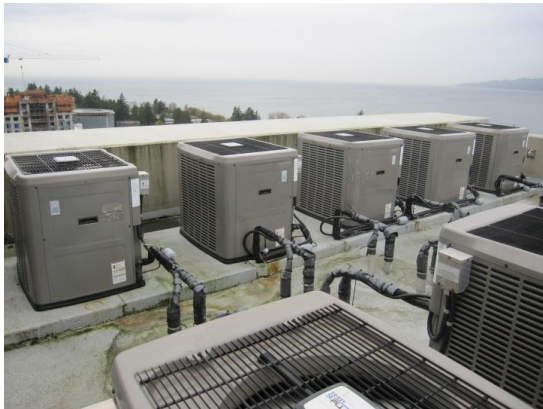
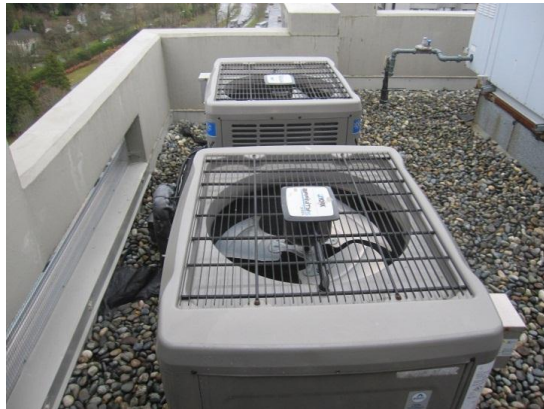
Component 31		Building - Mechanical Systems		Terminal & Packaged Units - Air Handling

Condition Analysis	Based upon a partial visual-inspection, this component appears to be in good condition for its age.				
Life Cycle Analysis	Expected Lifespan	20 years			
	Effective Age	5 years			
	Remaining Lifespan	15 years			
Funding Analysis	Description	No money has been spent on this component to date.			
	Work	Remove existing equipment and controls so connections can be reused, replace with similar equipment, and balance and re-commission the system.			
	Quantity	12 Units			
	Job Cost	\$53,355.92			
Deficiency Analysis	No major deficiencies were noted at the time of visual inspection. The life of this component may be prolonged by effective maintenance which could include periodic inspection and repair or replacement of damaged motors and air handling systems.

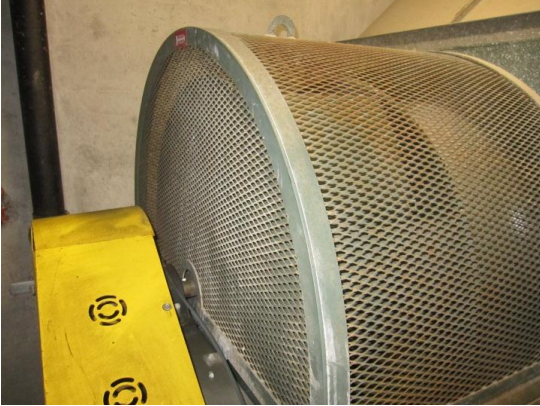
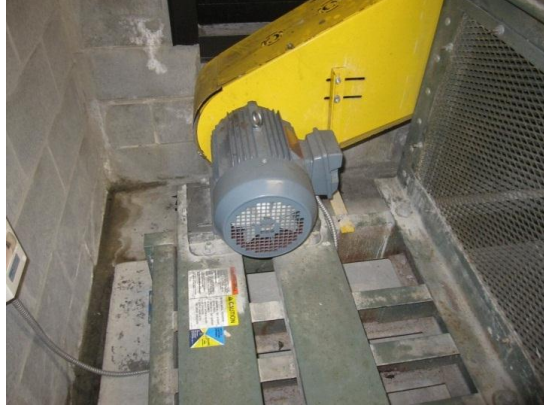
Component 32		Building - Mechanical Systems		Special and Exhaust Equipment

Component Description	Exhaust equipment provides ventilation for underground parkades.				
Reserve History	Year of Acquisition	2007			
	Description	Original to the building.			
Potential Deterioration	Environmental elements, physical damage, wear and tear, metal fatigue or failure of equipment and parts.				
Condition Analysis	Based upon a partial visual-inspection, this component appears to be in good condition for its age.				
Life Cycle Analysis	Expected Lifespan	20 years			
	Effective Age	5 years			
	Remaining Lifespan	15 years			
Funding Analysis	Description	No money has been spent on this component to date.			
	Work	Removal and disposal of failed equipment or parts and replacement of such parts as required.			
	Quantity	1 System			
	Job Cost	\$6,928.46			
Deficiency Analysis	No major deficiencies were noted at the time of visual inspection. The life of this component may be prolonged by effective maintenance.

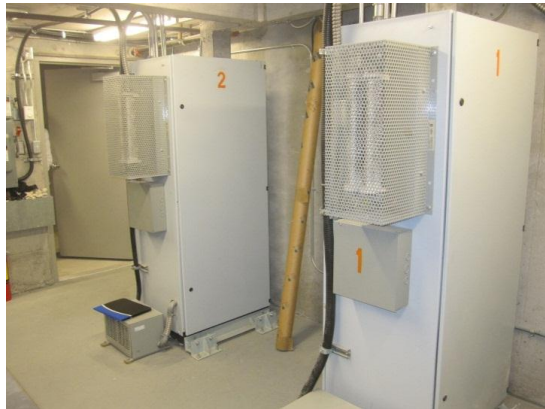
Component 33		Building - Mechanical Systems		Elevator Replacement - Traction

Condition Analysis	<p>Based upon a partial visual-inspection, this component appears to be in good condition for its age.</p>				
Life Cycle Analysis	Expected Lifespan	30 years			
	Effective Age	5 years			
	Remaining Lifespan	25 years			
Funding Analysis	Description	No money has been spent on this component to date.			
	Work	Removal and replacement of cab, traction system, and ancillary elevator equipment, including a 50% door budget. This component has been phased over 2 years in order to allow an elevator to remain in operation. This is also budgeted at 50% replacement at 30 years.			
	Quantity	1 Elevator			
	Job Cost	\$342,874.56			
Deficiency Analysis	<p>No major deficiencies were noted at the time of visual inspection. Maintenance routines and preventive maintenance are required.</p>

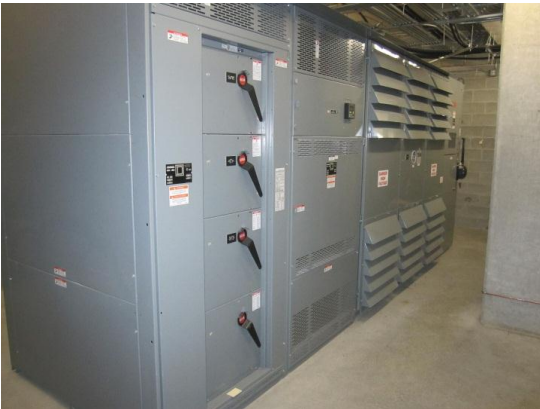
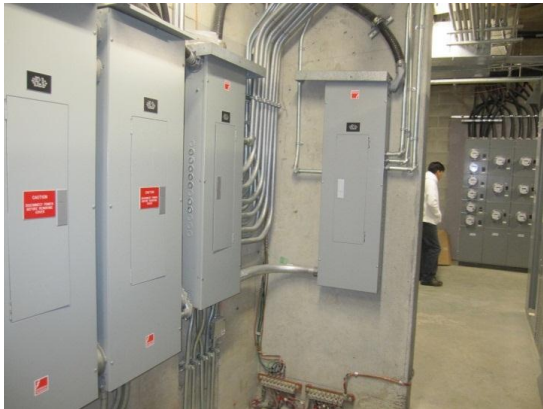
Component 35		Building - Electrical Systems		Electrical Distribution System and Fixtures

Funding Analysis	Description	No money has been spent on this component to date.			
	Work	Removal and replacement of components as required. A budget equal to 20% of the estimated cost of the component is provided for periodic major repairs every 20 years.			
	Quantity	1 System			
	Job Cost	\$61,847.33			
Deficiency Analysis	<p>No major deficiencies were noted at the time of visual inspection. The life of this component may be prolonged by effective maintenance which could include regular inspection and subsequent repairs as required.</p>

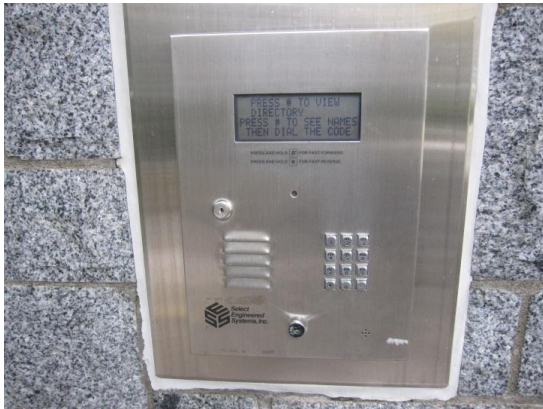
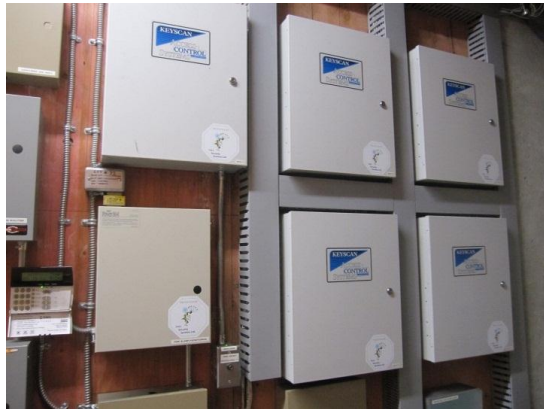
Component 36		Building - Electrical Systems		Entry System - Intercom

Condition Analysis	Based upon a partial visual-inspection, this component appears to be in good condition for its age.				
Life Cycle Analysis	Expected Lifespan	20 years			
	Effective Age	5 years			
	Remaining Lifespan	15 years			
Funding Analysis	Description	No money has been spent on this component to date.			
	Work	Removal of old system installation and setup of replacement system. Integration with connected components where required.			
	Quantity	1 System			
	Job Cost	\$20,180.96			
Deficiency Analysis	No major deficiencies were noted at the time of visual inspection. The life of this component may be prolonged by effective maintenance and adequate protection from the elements.

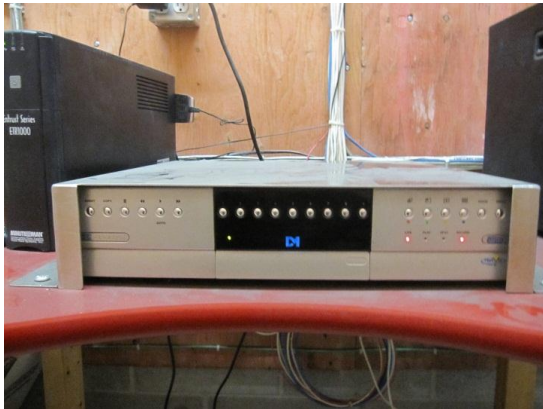
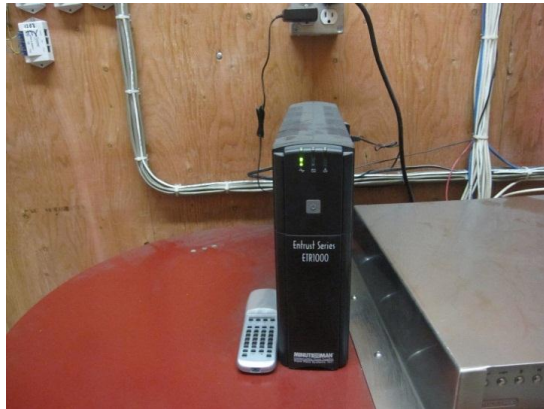
Component 37		Building - Electrical Systems		Security / Surveillance System

Condition Analysis	Based upon a partial visual-inspection, this component appears to be in good condition for its age.				
Life Cycle Analysis	Expected Lifespan	10 years			
	Effective Age	5 years			
	Remaining Lifespan	5 years			
Funding Analysis	Description	No money has been spent on this component to date.			
	Work	Replacement of the inoperative component. A budget equal to 50% of the estimated cost of the component is provided for periodic major repairs every 10 years.			
	Quantity	1 System			
	Job Cost	\$6,183.10			
Deficiency Analysis	No major deficiencies were noted at the time of visual inspection. The life of this component may be prolonged by effective maintenance which includes regular inspection of the components for failure.

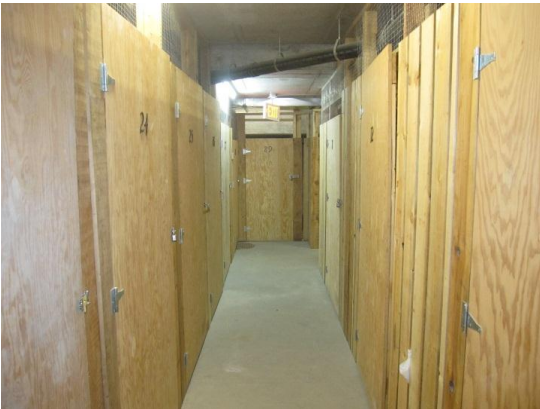
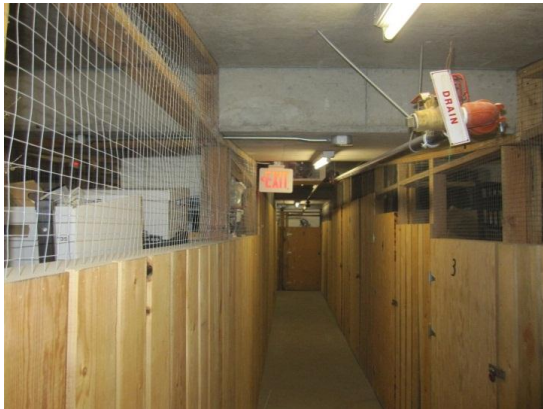
Component 40		Building - Amenities		Storage Lockers

Quantity	1 Locker			
	Job Cost	\$8,094.53			
Deficiency Analysis	No major deficiencies were noted at the time of visual inspection. The life of this component may be prolonged by effective maintenance which could include regular inspection for damaged lockers / latches / hinges / floor fasteners and repair / replace as required.

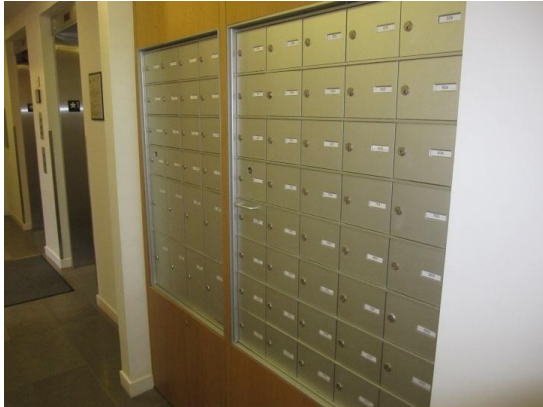
Component 41		Building - Amenities	Mailboxes

Component Description	Mailboxes are typically comprised of metal boxes with locks / hardware and their associated structure.		
Reserve History	Year of Acquisition	2007	
	Description	Original to the building.	
Potential Deterioration	Exterior mailboxes suffer from exposure to environmental elements which may cause rusting and can affect the general quality of appearance over time. Physical damage may occur from debris, wear and tear, and impact damage. Interior mailboxes may suffer from wear and tear or vandalism.		
Condition Analysis	Based upon a partial visual-inspection, this component appears to be in good condition for its age.		
Life Cycle Analysis	Expected Lifespan	25 years	
	Effective Age	5 years	
	Remaining Lifespan	20 years	
Funding Analysis	Description	No money has been spent on this component to date.	
	Work	Removal and disposal of existing mailboxes and associated structure and repair / replace as required.

Quantity	1 Mailbox	
	Job Cost	\$830.74	
Deficiency Analysis	No major deficiencies were noted at the time of visual inspection. The life of this component may be prolonged by effective maintenance which could include regular maintenance of associated structure to protect the mailboxes from the elements, and repair / replace as required.

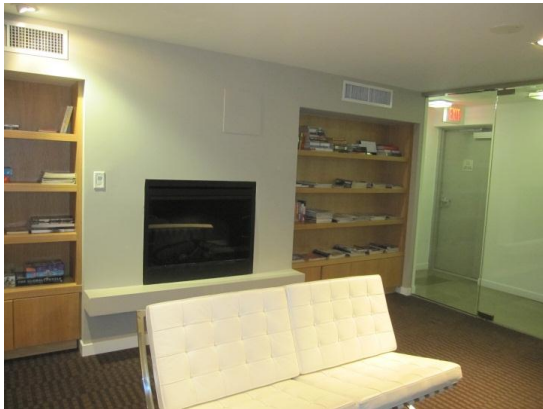
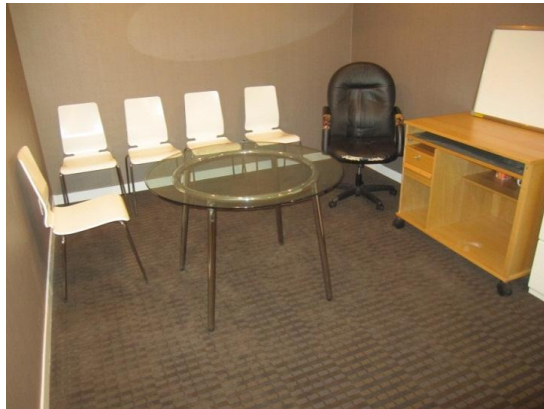
Component 42		Building - Amenities		Amenity Room

Component Description	This component comprises all of the reserve items and materials of the common amenity room, including flooring, wall finish, ceiling finish, fixtures, furnishings, and decorations.				
Reserve History	Year of Acquisition	2007			
	Description	Original to the building.			
Potential Deterioration	This component will typically experience wear and tear from owner and visitor use, which could include marking / damage to the wall surfaces including impact damage, damage to the flooring due to use, obsolescence of fixtures and furnishings due to diminished utility or dated design / aesthetics.				
Condition Analysis	Based upon a partial visual-inspection, this component appears to be in good condition for its age.				
Life Cycle Analysis	Expected Lifespan	20 years			
	Effective Age	5 years			
	Remaining Lifespan	15 years

Funding Analysis	Description	No money has been spent on this component to date.			
	Work	Removal and disposal of old furnishings and fixtures, potentially re-painting / wallpapering, re-flooring, and replacement of fixtures and furnishings. Special conditions may include staged project completion due to access limitations.			
	Quantity	625 SF			
	Job Cost	\$28,372.69			
Deficiency Analysis	No major deficiencies were noted at the time of visual inspection. The life of this component may be prolonged by effective maintenance which could include regular inspection for damage and subsequent repairs as required.

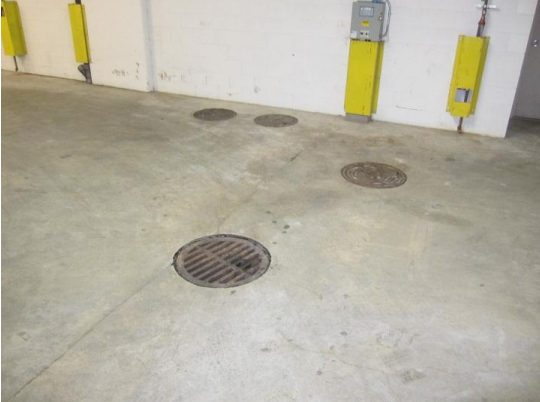
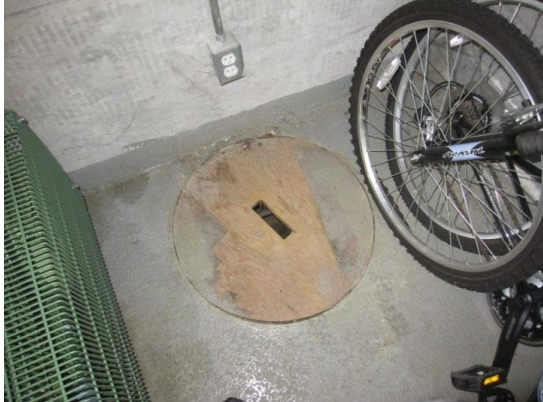
Component 43		Common Site Improvements	Site Services - Sewer and Water

Component Description	This component refers to sub-surface piping such as sewer system and drainage, and water supply system from roadway to building main. Storm sewer system includes storm sewer lines, catch basins, man holes, and connections to the individual units. Sanitary sewer system includes lines and service connections. Also includes any ancillary equipment such as sump pumps and sewage pumps and tanks.		
Reserve History	Year of Acquisition	2007	
	Description	Original to the building.	
Potential Deterioration	This component can be affected by erosion, freeze / thaw cycles, corrosion, and in some cases physical damage from excavation.		
Condition Analysis	Based upon a partial visual-inspection, this component appears to be in good condition for its age.		
Life Cycle Analysis	Expected Lifespan	30 years	
	Effective Age	5 years

Remaining Lifespan	25 years	
Funding Analysis	Description	No money has been spent on this component to date.	
	Work	Excavation and replacement of damaged component on an item by item basis. Will require shut down of building service for the duration. A budget equal to 15% of the estimated cost of the component is provided for periodic major repairs every 30 years.	
	Quantity	1 Allowance	
	Job Cost	\$13,357.73	
Deficiency Analysis	No major deficiencies were noted at the time of visual inspection. The life of this component may be prolonged by effective maintenance which could include repairs as required.

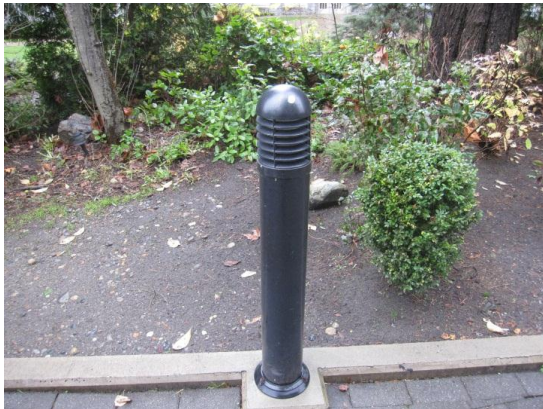
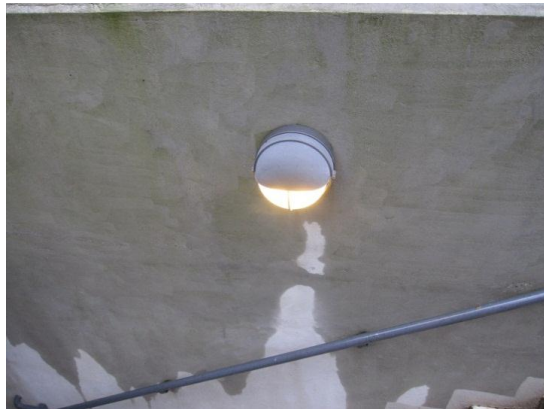
Component 46		Common Site Improvements		Exterior Lighting

Component Description	This component considers all exterior lighting in the complex, including front entry, landscaping, and lamp posts.				
Reserve History	Year of Acquisition	2007			
	Description	Original to the building.			
Potential Deterioration	Deterioration primarily results from exposure to elements, corrosion and physical damage.				
Condition Analysis	Based upon a partial visual-inspection, this component appears to be in good condition for its age.				
Life Cycle Analysis	Expected Lifespan	20 years			
	Effective Age	5 years			
	Remaining Lifespan	15 years			
Funding Analysis	Description	No money has been spent on this component to date.			
	Work	Remove and replace as required. An allowance is allocated for minor electrical work.			
	Quantity	90 Lights			
	Job Cost	\$81,394.45			
Deficiency Analysis	No major deficiencies were noted at the time of visual inspection. The life of this component may be prolonged by effective continuous maintenance.

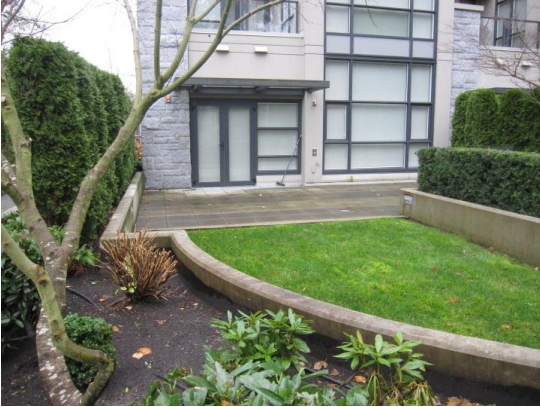
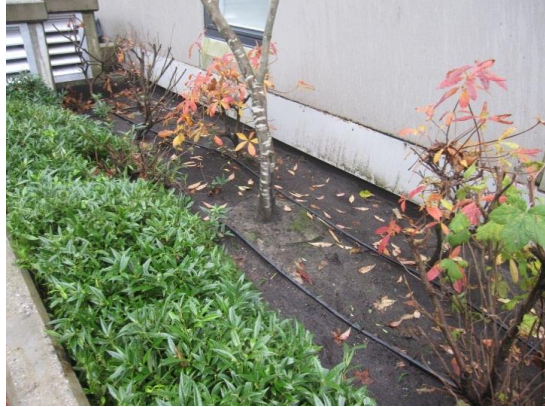
Component 47		Common Site Improvements	Exterior Landscaping

Component Description	Exterior landscaping may be comprised of grass, trees, shrubbery, associated gardens, walkways, irrigation system, and various plants.		
Reserve History	Year of Acquisition	2007	
	Description	Original to the building.	
Potential Deterioration	Includes exposure to the elements, such as wind, rain, snow, freeze-thaw cycles, and extreme temperature / humidity changes. Some plants are subject to fungus and disease. Additional deterioration can be caused by lack of water and nutrients. Physical damage can occur to the plants.		
Condition Analysis	Based upon a partial visual-inspection, this component appears to be in good condition for its age.		
Life Cycle Analysis	Expected Lifespan	20 years	
	Effective Age	5 years	
	Remaining Lifespan	15 years	
Funding Analysis	Description	No money has been spent on this component to date.

Work	Replace / repair walkways, irrigation system, diseased or damaged trees, or change landscaping for aesthetic purposes. A budget equal to 10% of the estimated cost of the component is provided for periodic major repairs every 20 years.	
	Quantity	1 Allowance	
	Job Cost	\$9,854.61	
Deficiency Analysis	No major deficiencies were noted at the time of visual inspection. The life of this component may be prolonged by effective maintenance, including regular landscaping.
