DEPRECIATION REPORT

GEORGIA COURT
1823 EAST GEORGIA
VANCOUVER, B.C.

DATE: **NOVEMBER 4, 2015**

JRS PROJECT: VR14332

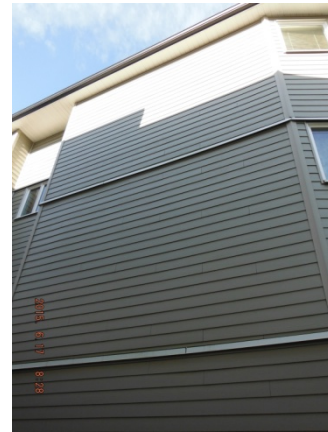
Exterior Paint

Location:	Exterior Walls
Year Installed:	2009
Typical Service Life (yrs):	10
Effective Age (yrs):	6
Remaining Service Life (yrs):	4
Planned Renewal Date:	2019

Description: The paint coating is necessary for the side cladding.

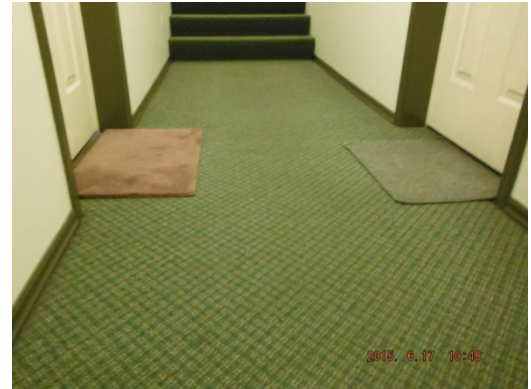
Carpet

Location:	Interior Hallways & Staircases
Year Installed:	1993
Typical Service Life (yrs):	25
Effective Age (yrs):	22
Remaining Service Life (yrs):	3
Planned Renewal Date:	2018

Description: This asset includes the carpet in the hallways and staircases.

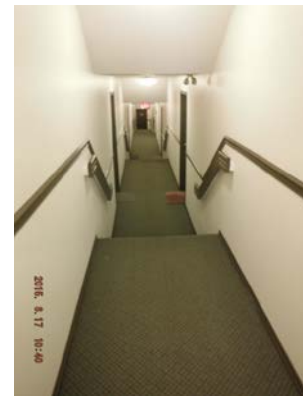
Interior Paint

Location:	Interior Hallways & Staircases
Year Installed:	2014
Typical Service Life (yrs):	10
Effective Age (yrs):	1
Remaining Service Life (yrs):	9
Planned Renewal Date:	2024

Description: This component includes the walls and ceilings of the hallways and staircases.

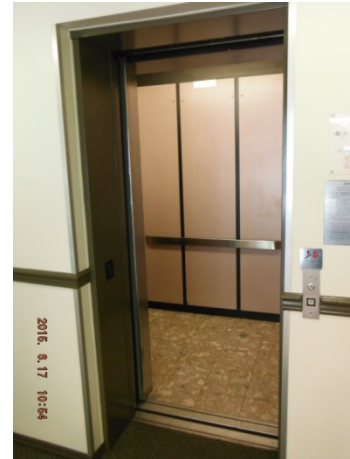
Elevator

Location:	Main Entrance, All Floors, & Parkade
Year Installed:	1993
Typical Service Life (yrs):	30
Effective Age (yrs):	22
Remaining Service Life (yrs):	8
Planned Renewal Date:	2023

Description: There is one hydraulic elevator that services the building. The elevator has a capacity of 900 kg and is maintained by Richmond Elevators.

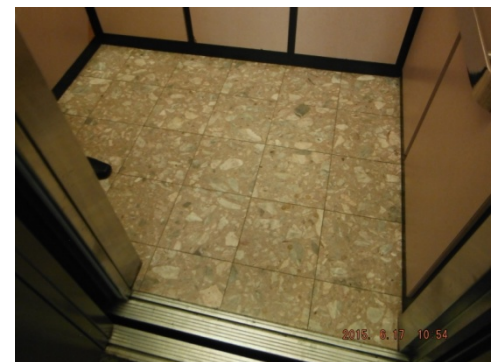
Elevator Cab Finishes

Location:	Elevator Interior
Year Installed:	1993
Typical Service Life (yrs):	15
Effective Age (yrs):	7
Remaining Service Life (yrs):	8
Planned Renewal Date:	2023

Description: This component includes interior cab finishes such as the walls, flooring, push buttons, and railings.

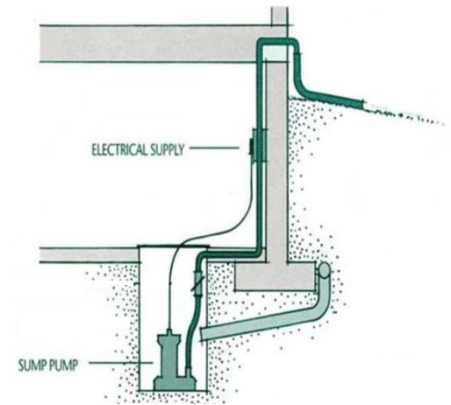
Sump Pumps

Location:	Parkade
Year Installed:	1993
Typical Service Life (yrs):	10
Effective Age (yrs):	5
Remaining Service Life (yrs):	5
Planned Renewal Date:	2020

Description: This reserve item includes two sump pumps.

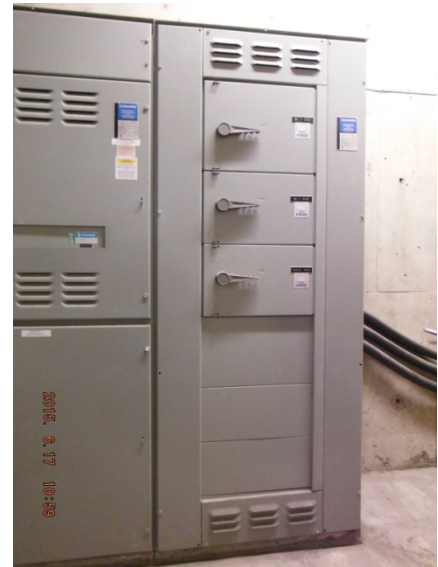
Service Distribution

Location:	Electrical Room
Year Installed:	1993
Typical Service Life (yrs):	50
Effective Age (yrs):	22
Remaining Service Life (yrs):	28
Planned Renewal Date:	2043

Description: Service distribution includes electrical distribution equipment (i.e. transformers, disconnects, switches, panels, etc.) and the incoming underground electrical service cabling.

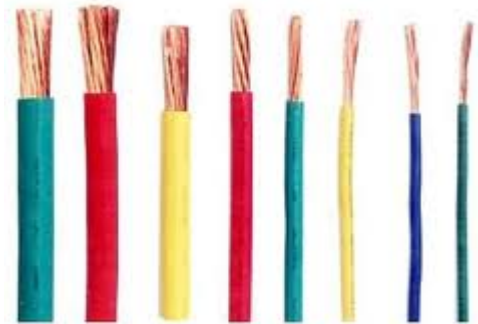
Power Distribution

Location:	Shared & Common Walls
Year Installed:	1993
Typical Service Life (yrs):	40
Effective Age (yrs):	22
Remaining Service Life (yrs):	18
Planned Renewal Date:	2033

Description: Power distribution includes interior wiring, lighting, baseboard heaters, and emergency exit signs.

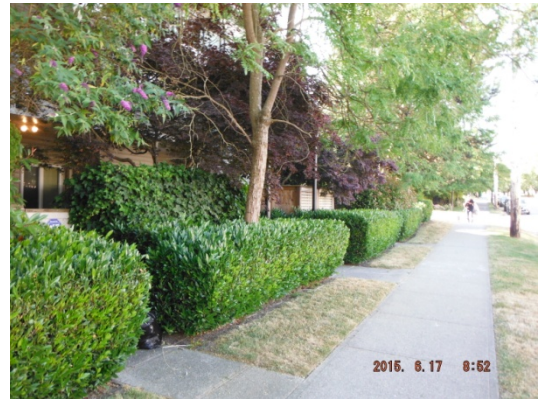
Location:	Surrounding Building
Year Installed:	1993
Typical Service Life (yrs):	50
Effective Age (yrs):	22
Remaining Service Life (yrs):	28
Planned Renewal Date:	2043

Description: Softscaping includes all grass and planter areas located throughout the property.

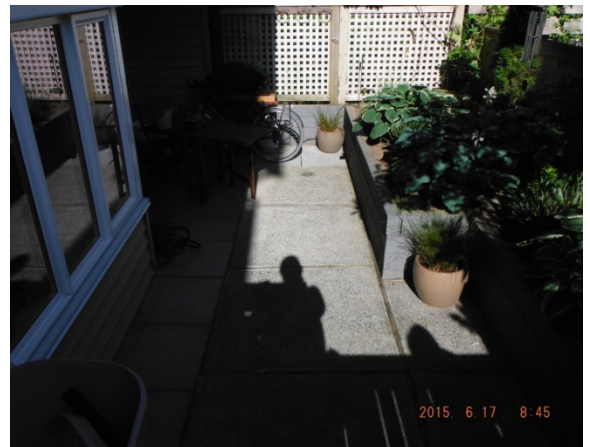
Location:	Surrounding Building
Year Installed:	1993
Typical Service Life (yrs):	50
Effective Age (yrs):	22
Remaining Service Life (yrs):	28
Planned Renewal Date:	2043

Description: Hardscaping includes all walkways and paved areas throughout the property.
