2018 DEPRECIATION REPORT
UPDATE (REVISED)
FOR
PACIFIC LANDMARK II,
930 CAMBIE STREET, VANCOUVER

June 19, 2019
Sense's Project No. 17A004A

EXECUTIVE SUMMARY

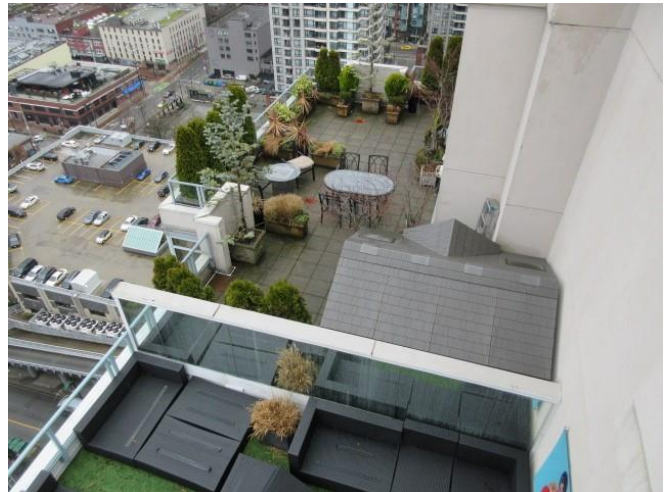
Photo 9: 30th floor roof decks.

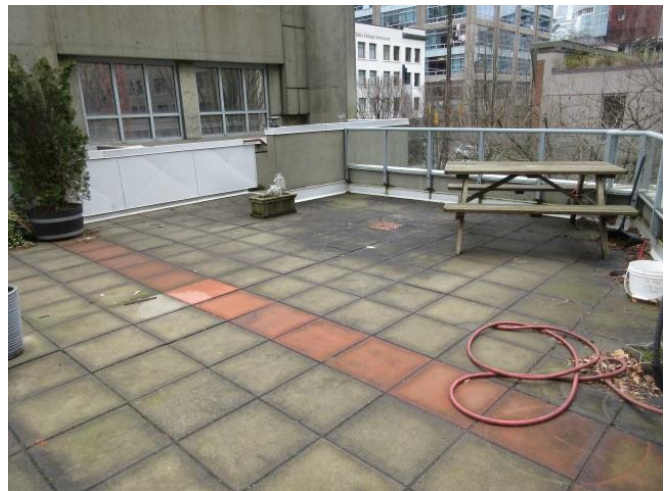
Photo 10: 2nd floor roof deck.

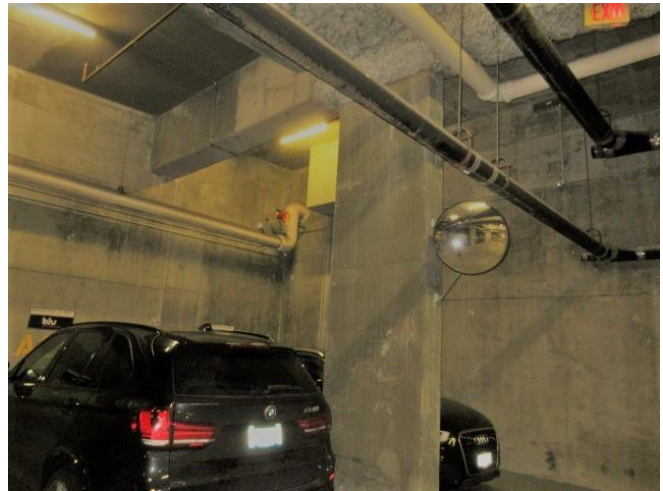
Most of the structural components are concealed from view. We noted no evidence of unusual settlement, displacement, or structural cracking in the areas reviewed.

Photo 1: Typical structural frame in the parking garage.

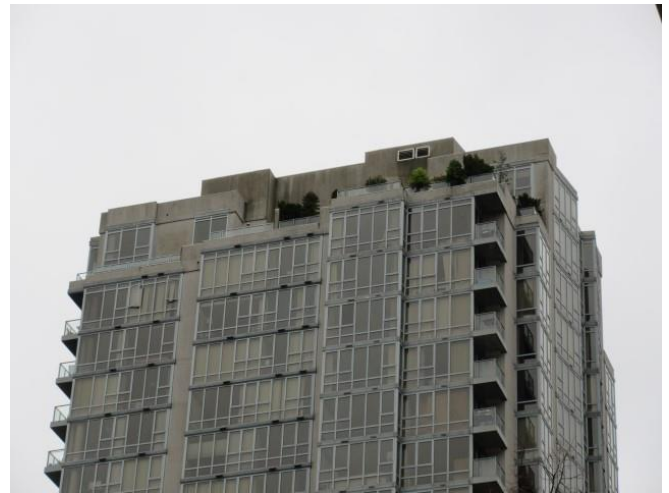
We did not access a suite with a balcony; however, based on past reports and our understanding, the balconies, pedestrian traffic coating, and guards are all in relatively good condition. The 2013 Depreciation Report indicated that guard fasteners are rusting and the finish to the guards is faded.

Pedestrian traffic coatings such as installed are required to protect the concrete from deterioration and prevent water from leaking through cracks in the concrete. Coatings of this type typically have a service life of 20 to 25 years.

Photo 2: Typical balconies at corners of the building.

The projected expenditures allow for an evaluation of the condition of the balconies, to better develop a scope and timing of required maintenance and repairs in relation to the concrete, pedestrian coating, guard finishes and fasteners, etc. Pending this evaluation, the projected expenditures allow for periodic programs of re-coating of the balconies, including local repairs to the concrete and guard fasteners.

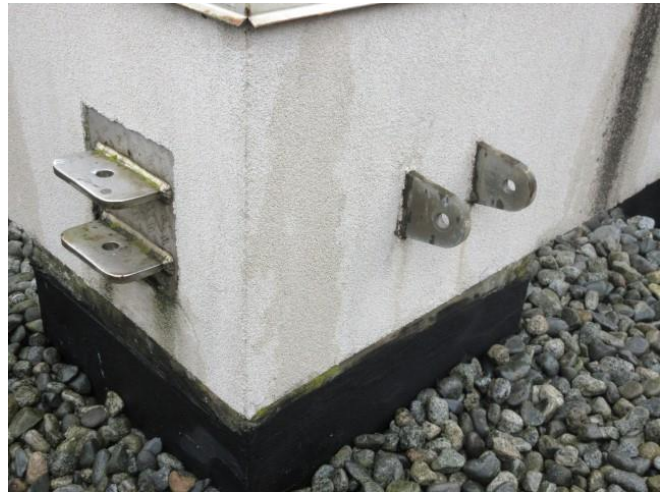
Photo 3: Typical roof anchors.

The system relies on cast-in-place and welded anchors, which are required to be annually inspected, but not load-tested. The welds on the welded anchors also require periodic testing. We assume that inspections, testing, and minor repairs arising from inspection and testing, will be completed as a maintenance expense.

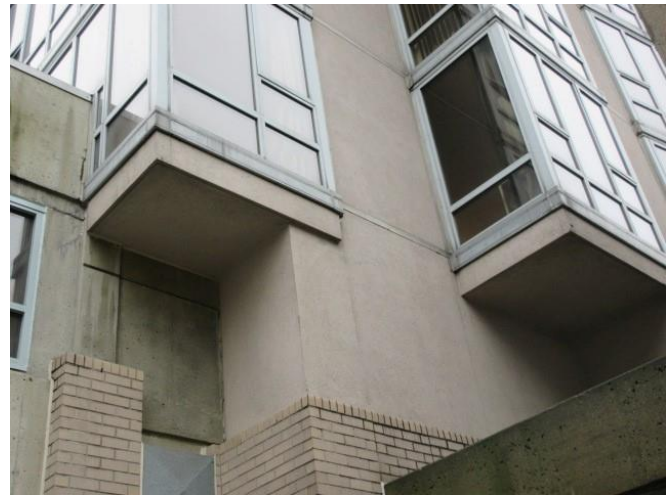
Photo 5: Typical exterior walls.

The exterior walls have been problematic over the years, resulting in leaks into the suites at many locations. Leaks have been most commonly associated with the window walls (see the Windows, Balcony and Roof Deck Doors section of this report for further discussion). Following re-cladding there will be a need for future maintenance of the exterior cladding; however, until the type of new cladding is determined, it is difficult to predict the type, extent and frequency of maintenance type repairs. The projected expenditures provide an allowance for future repairs, which should be reconsidered as part of updates to the Depreciation Report, once the new cladding system is determined.

The EIFS is heavily stained at top of the building due to exposure. Consideration could be given to cleaning and re-coating the EIFS; however, given the limited extent of EIFS and that EIFS surrounds the window walls which need to be replaced within the coming years, the projected expenditures allow for replacement of the EIFS as part of the window wall replacement project to help ensure proper detailing and long term durability. Caulking will also be replaced/installed throughout the exterior of the building, as part of this project.

The masonry is stained, covered with moss, and mortar joints are deteriorating, typically at the top of the masonry panels at locations where water run-off from above is concentrated and not shed away from the masonry. There are rowlock courses of masonry (bricks turned on their side) at the top of the masonry panels, which is not ideal with respect to masonry absorbing moisture. The concrete walls at the top of the commercial unit walls are also similarly stained with some moisture apparently gaining access to the walls from the top and opposite/roof side of the walls. The projected expenditures allow for local repairs to address present deterioration and improve water shedding of these walls areas, followed by local repairs in the future.

Repair Masonry and Improve Water Shedding at Masonry and Concrete Clad Walls	\$30,000	2019	
Locally Repair Masonry and Concrete Clad Walls	\$10,000	2029 2039	10
Complete Maintenance Type Repairs to New Cladding System	\$300,000	2034	15

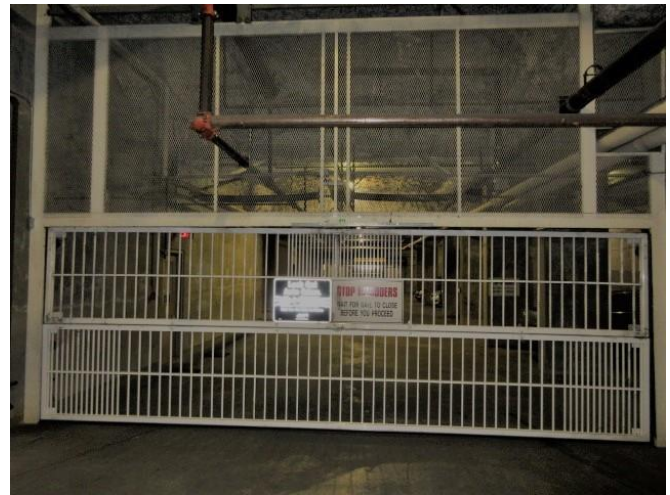
Photo 7: Door separating commercial and residential areas.

Replace Garage Entrance Overhead Door	\$7,500	2029	35
Replace Door and Screened Enclosure Separating the Commercial and Residential Parking Areas	\$9,500	2031	35
Replace Coiling Overhead Fire Doors in the Parking Garage - per phase (cost shown is 40% of the total, representing the Strata's share)	\$5,000	2039 2041	40

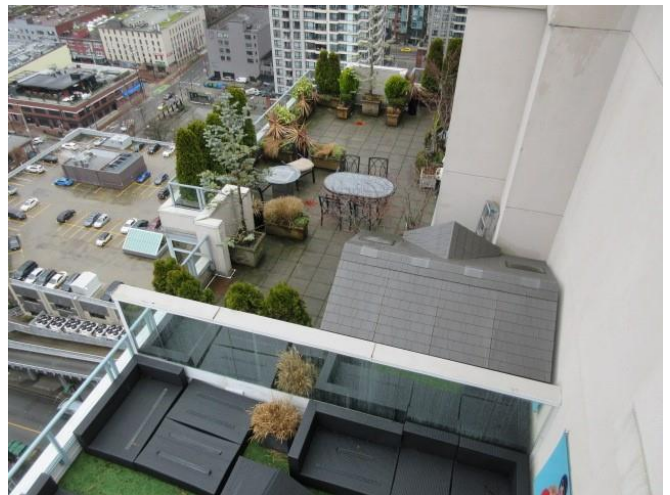
Photo 9: 30th floor roof decks.

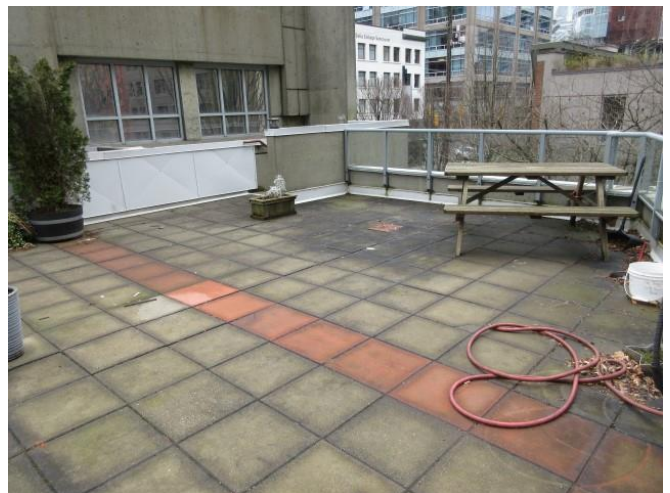
Photo 10: 2nd floor roof deck.

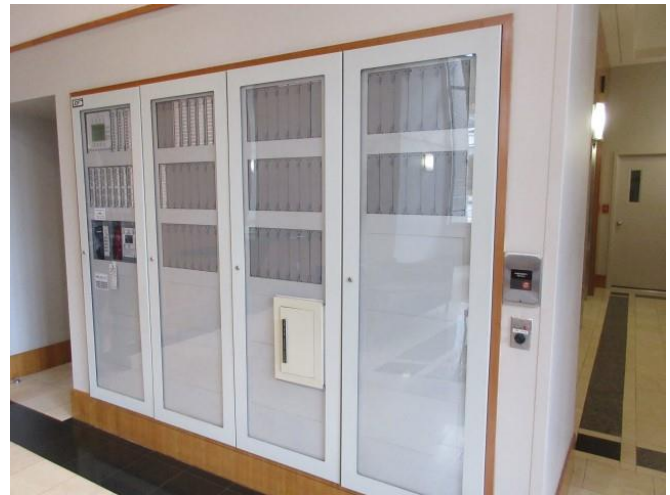
Photo 11: Fire alarm control panel.

While the system is presently performing well, the projected expenditures allow for eventual replacement of the control panel. The projected expenditure assumes that the panel will be replaced with a similar compatible system, re-using the majority of the existing field devices and wiring; however, allows for upgrades to accommodate modernization of the elevators (see the Elevators section of this report for further discussion). Replacement timing will be dependent on performance of the system and the service contractor’s ability to continue to find replacement parts. Replacement timing should be re-considered as part of future updates to the Depreciation Report.

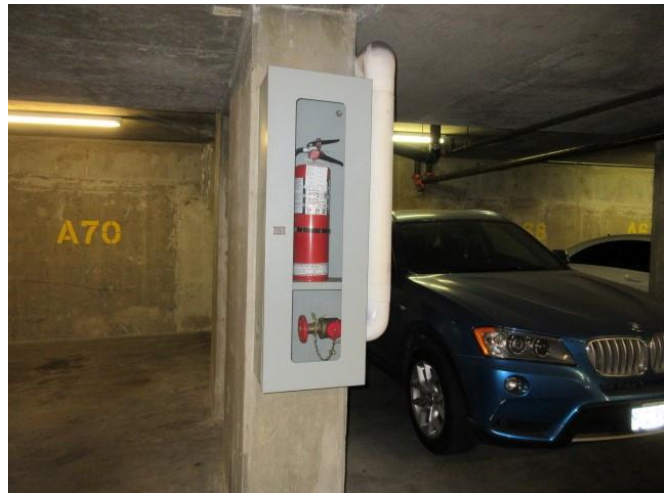
Photo 12: Typical fire extinguisher and hose connection.

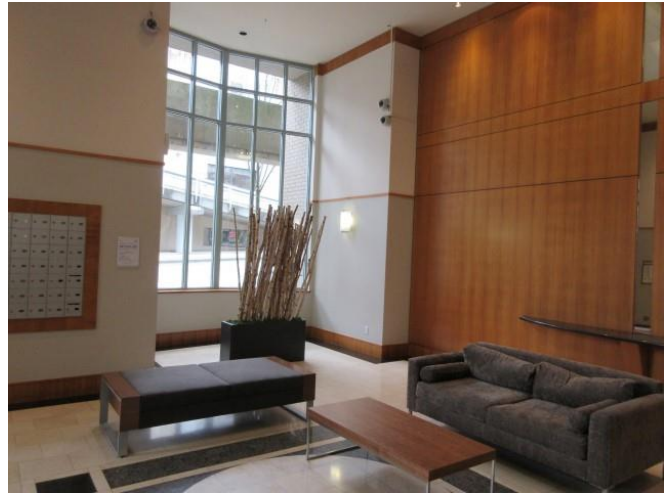
Photo 14: Main entrance lobby.

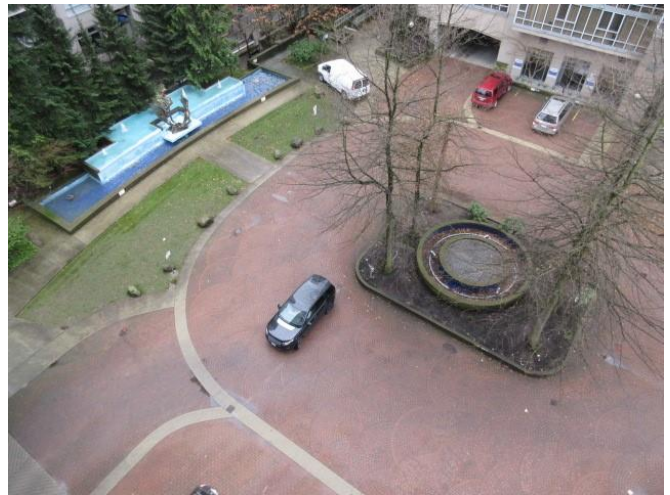
Photo 15: Entrance drive and water features.

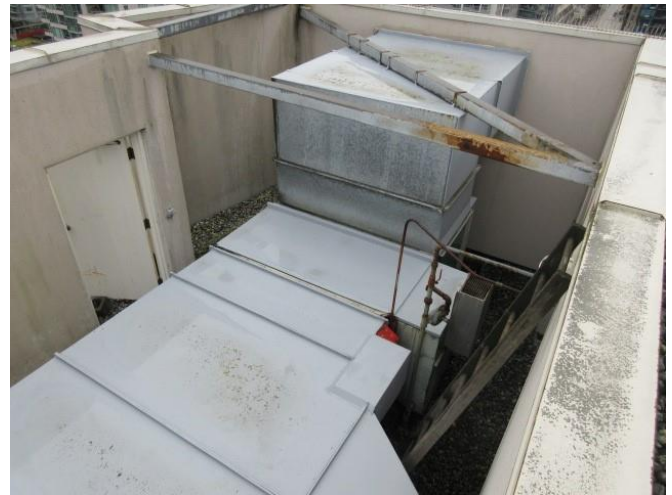
Photo 16: Roof-top make up air unit.

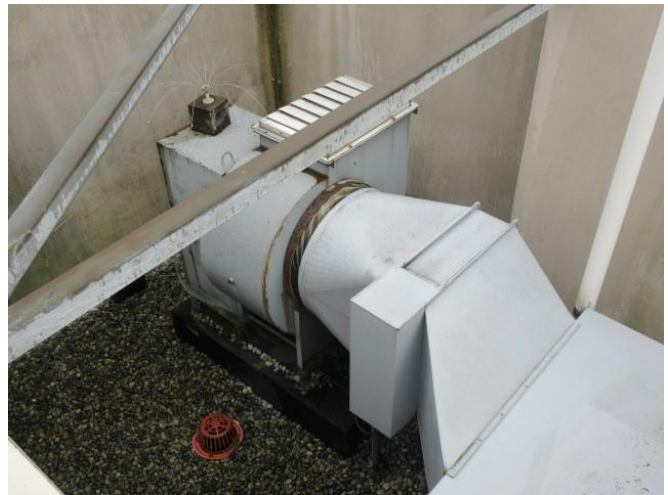
Photo 17: Smoke exhaust fan.

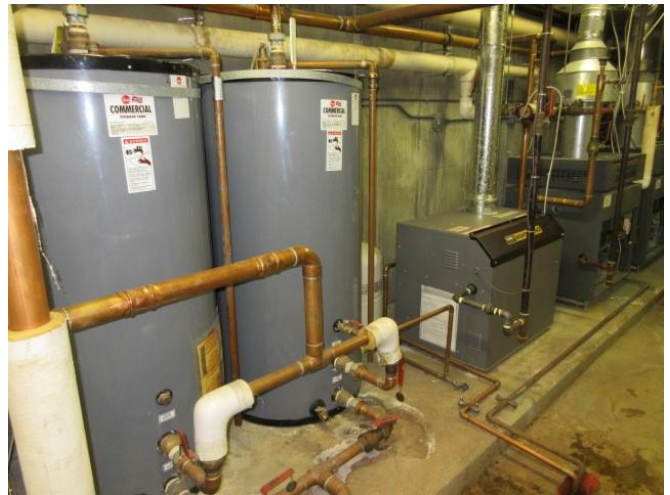
Photo 18: Typical domestic hot water boilers and storage tanks.

The projected expenditures allow for periodic, phased, replacement of the boilers and storage tanks. We assume the boilers will continue to be maintained and overhauled, on an as-needed basis, as part of maintenance.

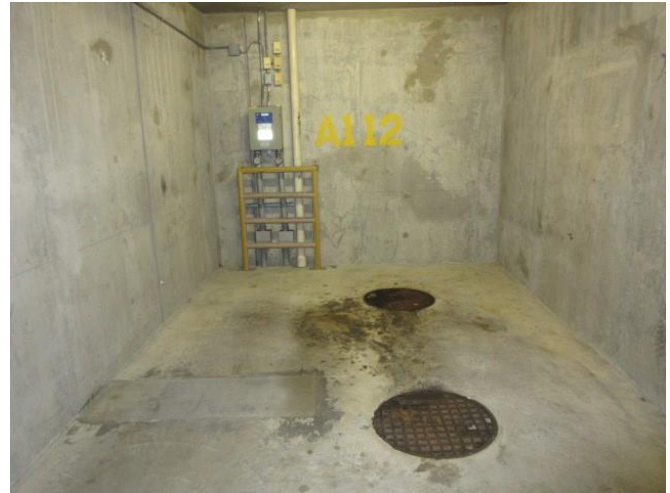
Photo 20: Typical storm sump controls.

The projected expenditures allow for inevitable periodic repairs as required. Actual repairs and related costs should be closely tracked, and budgets modified to suit, in future updates to the Depreciation Report.

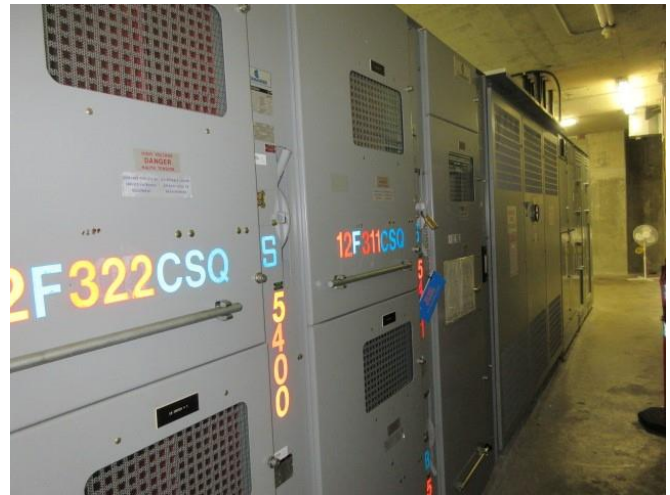
Photo 21: Main electrical equipment.

We recommend that all panels and equipment be thermally scanned every few years to identify hot spots that require repair. The scans, and related repairs found to be needed (assuming minor tightening, etc.) are assumed to be an operating expense.

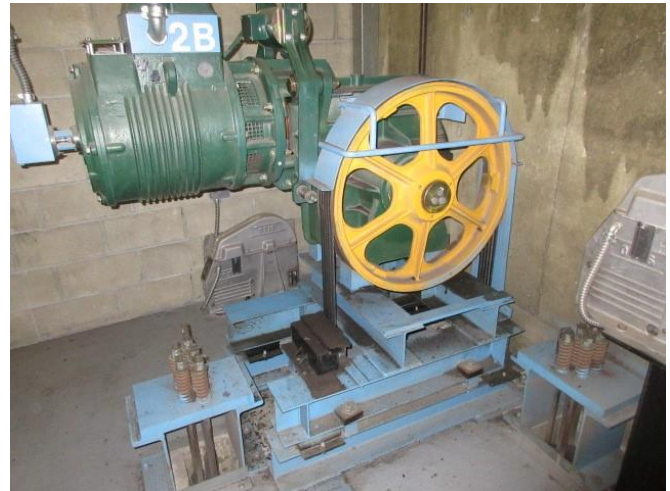
The door operators are original and nearing the end of their expected, standard, service life. The projected expenditures allow for replacement with newer closed loop, heavy duty, door operators, which should improve performance, reliability, and lessen door related callbacks in the future.

Photo 23: Typical elevator machine.

The projected expenditures also allow for modernization of the elevators. Since upgrades to the fire alarm system will be required as part of modernizing the elevators, both the elevator modernization and replacement of the fire alarm control panel are timed to be undertaken in the same year. Should performance dictate one project being required before the other, consideration should still be given to completing both projects at the same time to prevent redundancy in completed work, which should be further considered as part of future updates to the Depreciation Report.

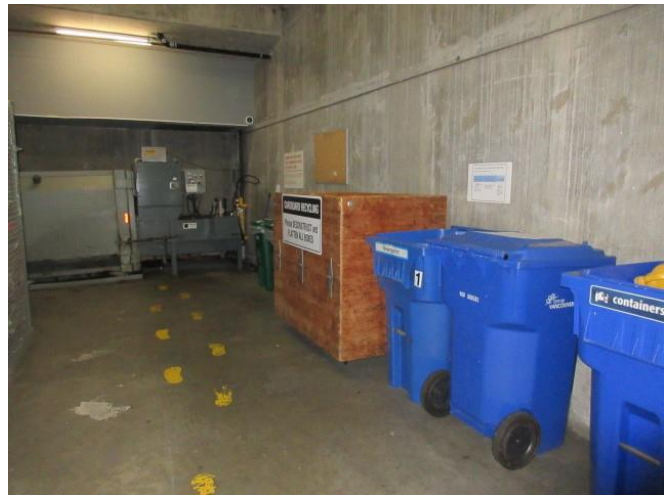
Photo 24: Garbage room with compactor and recycle bins.

Description	Present Cost	Timing (Year)	Cycle (Years)
Replace Garbage Compactor	\$15,000	2025	30
