To The Owners, Strata Plan LMS712  
c/o Mr. Cam Carruthers, Senior Strata Manager  
FirstService Residential  
700 - 200 Granville Street  
Vancouver BC V6C 1S4

Site Visit: October 9, 2018  
Submitted: September 10, 2019  
by  
RDH Building Science Inc.  
#400-4333 Still Creek Drive,  
Burnaby BC V5C 6S6

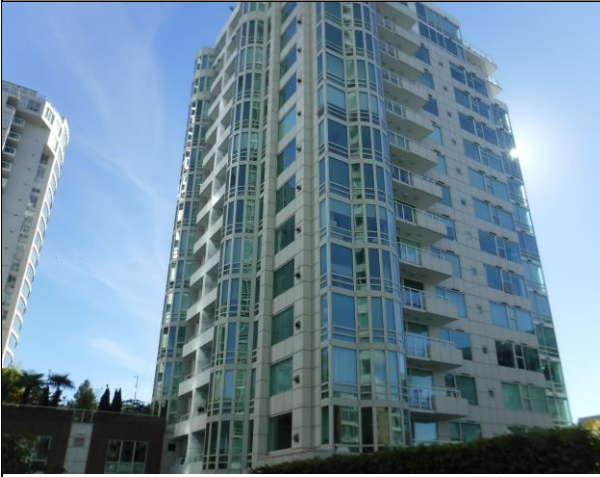
| TABLE 2.1 KEY PHYSICAL PARAMETERS | | |
|---|---|---|
| <p><i>Figure 2.1 North and west elevations of Ocean Tower.</i></p> | Date of first occupancy (approximate) | 1992 |

Key physical parameters of 888 Beach are summarized in Table 2.1 and Figures 2.1 to 2.4 below.

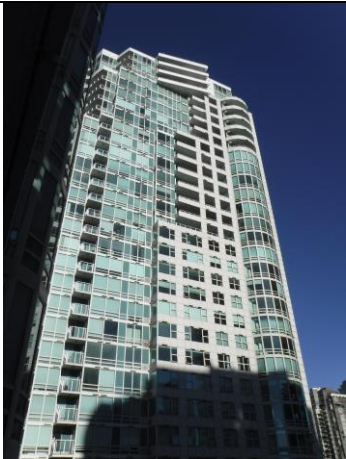
| TABLE 2.1 KEY PHYSICAL PARAMETERS | | |
|---|---|---|
| <p><i>Figure 2.2 East elevation of Beach Tower.</i></p> | Total number of strata lots | |

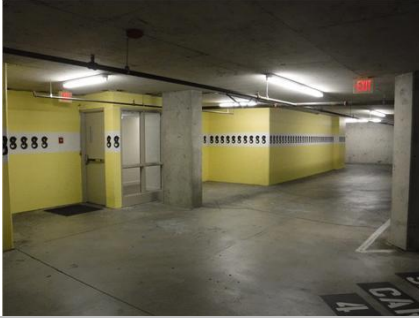
###### Struct 01 - Concrete Foundation

Below-grade concrete parkade.

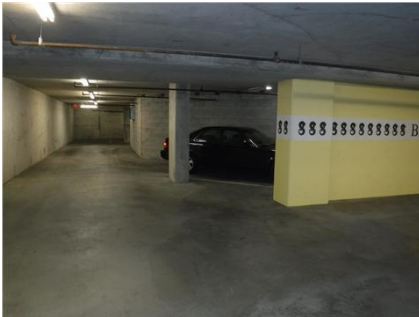
###### Struct 02 - Concrete Walls and Columns

Throughout the complex.

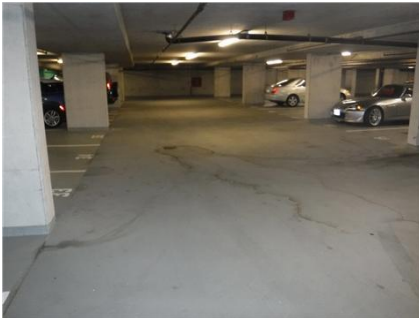
###### Struct 03 - CIP Concrete Suspended Slabs

Throughout the building.

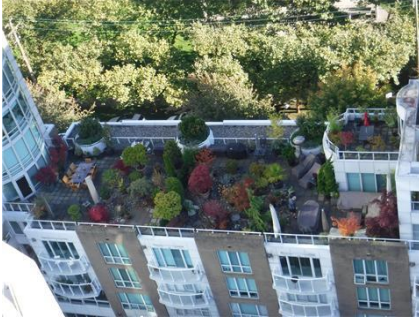
##### Encl 01 - Protected SBS Membrane Decks and Roofs (IRMA Assembly) with Traffic-Bearing Surface or Ballast

Renewed townhouse/tower roofs and decks.

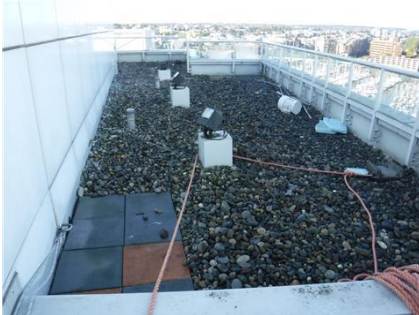
##### Encl 02 - Protected Sheet Applied Rubber Waterproofing Membrane

Portions of Garden, Ocean, and Beach Tower roofs and decks.

- Encl 02 – Protected Sheet Applied Rubber Roof Waterproofing Membrane – Replace remaining original roof areas.
- Encl 03 – Protected Sheet Applied Rubber Podium Waterproofing Membrane – Replace interior courtyard and exterior perimeter podium waterproofing membrane.

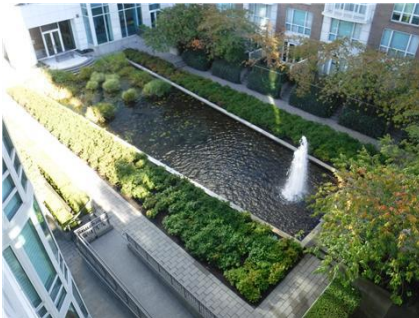
##### Encl 03 - Protected Sheet Applied Rubber Podium Waterproofing Membrane

Interior courtyard common areas, original townhouse decks, and pond areas.

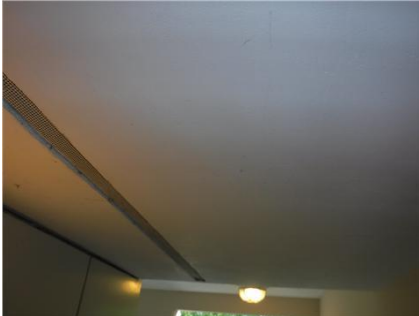
### Encl 04 - Stucco Clad Soffit

Underside of balconies, walkway soffits, and select overhangs.

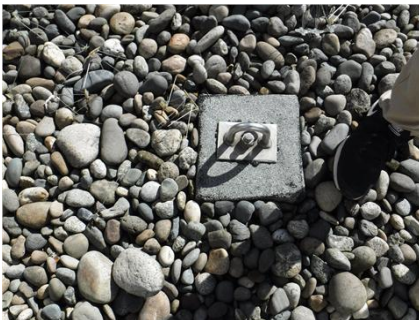
### Encl 05 - Anchor Fall Protection Equipment

Tower roofs and decks.

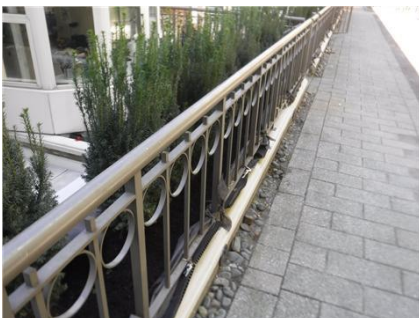
### Encl 07 - Guardrail Aluminum

Courtyard.

- Encl 07 – Guardrail Aluminum – Replace guardrails at the podium level in conjunction with the podium membrane renewal.
- Encl 21 – Metal Clad Swing Doors – Replace original metal clad swing doors at the townhouses in conjunction with the podium membrane renewal.

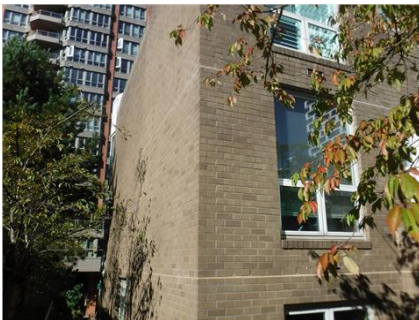
### Encl 09 - Clay Masonry Veneer Wall

All elevations of townhouses and lower levels of towers.

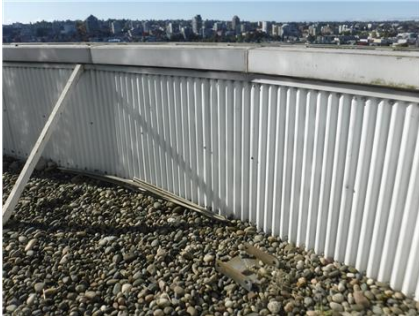
### Encl 12 - Profiled Sheet Metal Cladding Wall

Rooftop parapet walls and Mechanical room enclosures at Ocean, Beach, and Garden Towers.

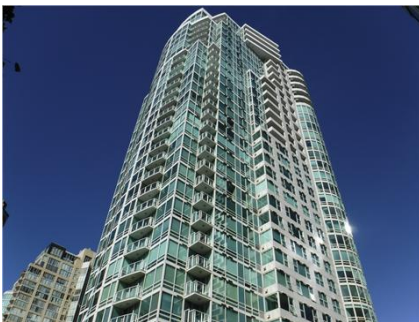
### Encl 13 - Aluminum Framed Window

All elevations towers and townhouses.

- Encl 13 – Aluminum Framed Windows – Cyclical replacement of insulating glazing units (IGUs), as required. An allowance has been included on a two-year cycle.

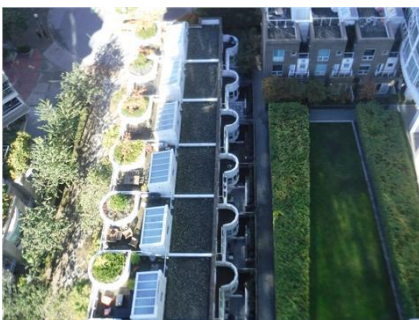
### Encl 14 - Pressure Cap Skylight

South elevation townhouse roofs.

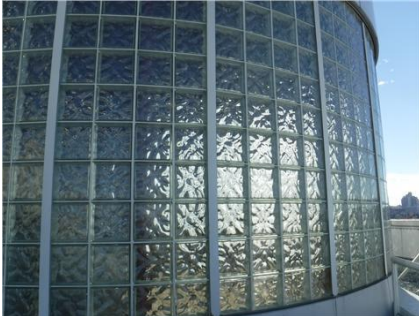
### Encl 15 - Glass Block Window

Select locations on the lower levels of the north and south elevations, including the California walkways, and the rooftop of Garden Tower.

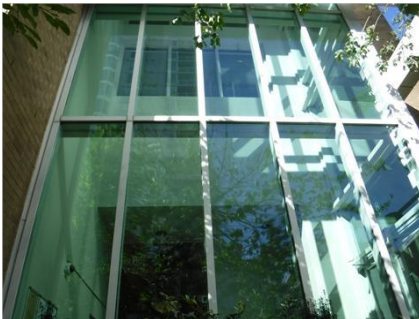
### Encl 16 - Curtain Wall - Stick Capped

Ground floor common areas.

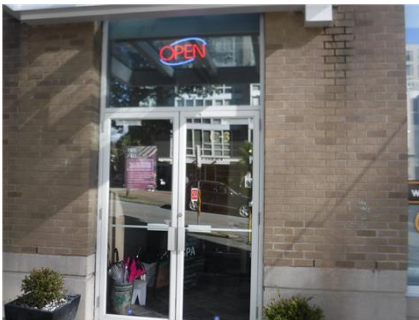
### Encl 17 - Aluminum Storefront

Ground floor commercial areas and townhouse roof top windows adjacent to skylights.

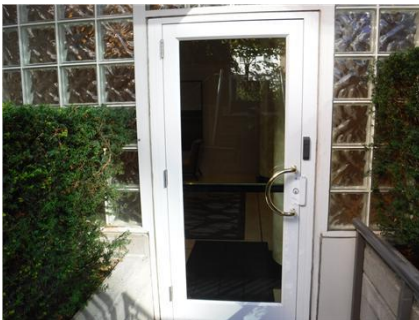
### Encl 18 - Aluminum Framed Glazed Swing Door

Lobby and commercial space access doors.

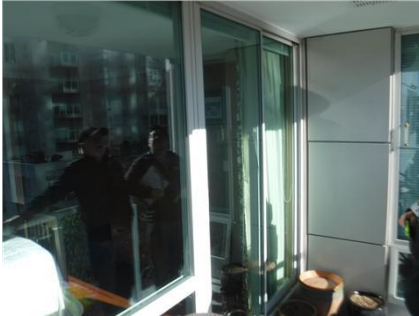
#### Encl 19 - Aluminum Framed Sliding Glass Door

Suite balcony and deck access doors.

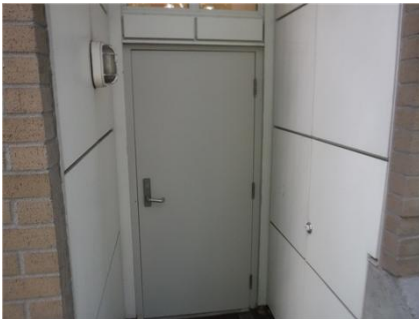
#### Encl 20 - Steel Swing Door

Parkade and stairwell exit doors.

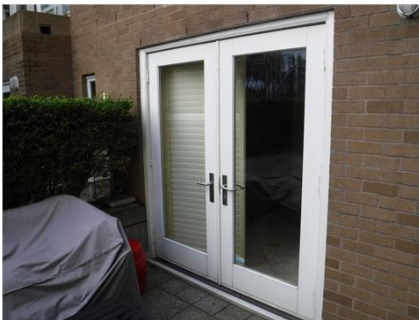
#### Encl 21 - Metal Clad Swing Door

Townhouse courtyard single and double swing doors.

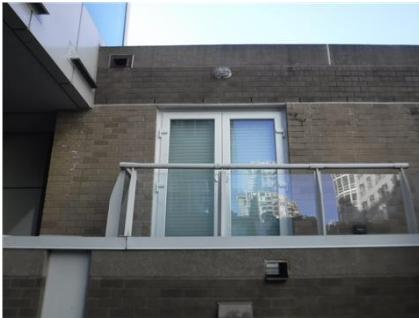
#### Encl 23 - Fiberglass Frame Glazed Swing Door

Select single and double townhouse doors (T5-T11 and T23-26).

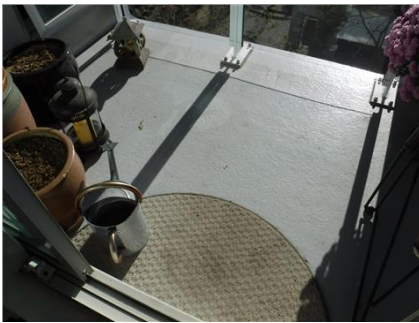
#### Encl 24 - Exposed Urethane Balcony Membrane - Concrete Substrate

Balconies.

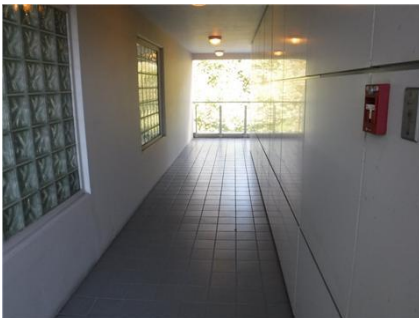
#### Encl 25 - Tiled California Walkways and Remaining Original Balconies

California walkways between Beach Tower and Garden Tower along the north elevation townhouses and the remaining original townhouse balconies.

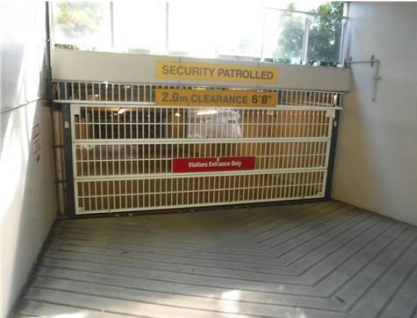
##### Encl 27 - Open-grid Overhead Parkade Gate

Parkade entrances.

Pre-finished metal grid overhead gate with motor drive and hardware for underground parkade. One gate was replaced in 2013.

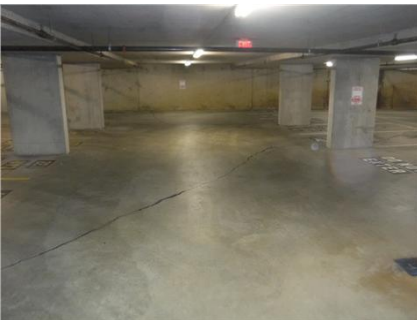
##### Encl 28 - Slab-on-Grade

Parkade Level P1.

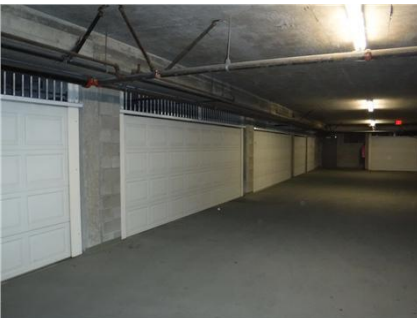
##### Encl 29 - Sectional Overhead Door - Metal

Townhouse garages.

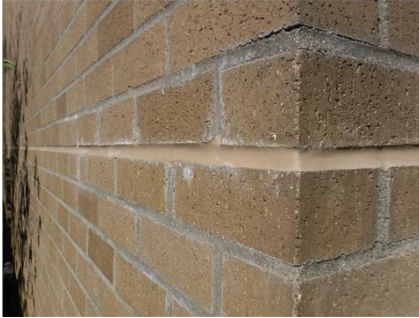
##### Encl 31 - Sealant

Interfaces and service penetrations at the exterior walls, roofs, and other locations.

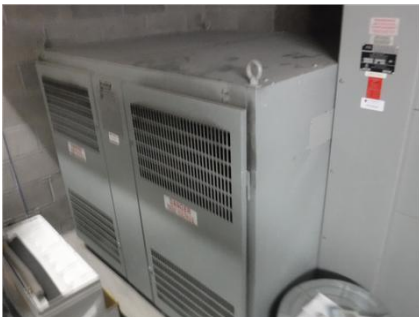
##### Elec 01 - Distribution Transformer

All electrical rooms in parkade.

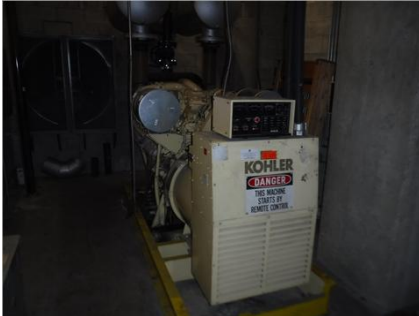
#### Elec 02 - Emergency Generator

Emergency generator room.

Service Life: 35  
 Installed Year: 1992  
 Chronological Age: 27  
 Effective Age: 27  
 Next Renewal Year: 2027

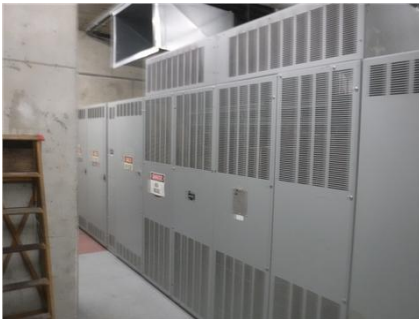
#### Elec 03 - Unit Substation

Main electrical room.

Service Life: 35  
 Installed Year: 1992  
 Chronological Age: 27  
 Effective Age: 27  
 Next Renewal Year: 2027

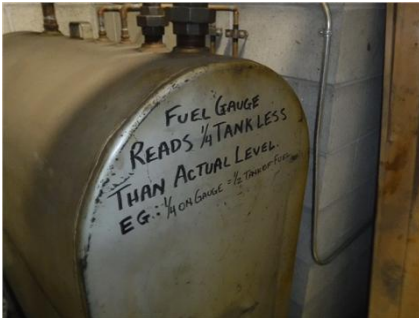
#### Elec 04 - Tank - Fuel Oil Storage

Emergency generator room.

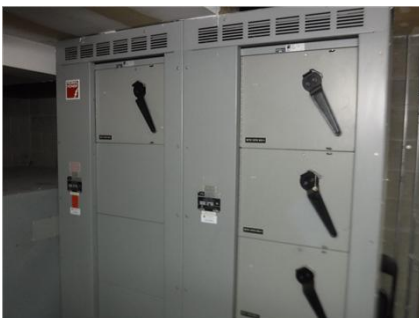
#### Elec 05 - Electrical Distribution

All electrical rooms in parkade.

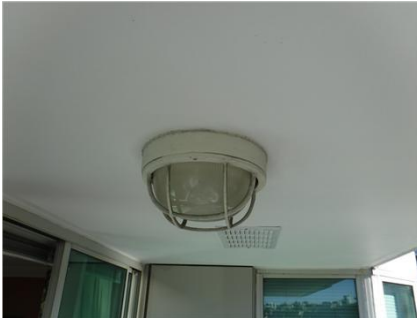
##### Elec 06 - Exterior Light Fixtures

Mounted to walls, and soffits, and throughout the complex.

A variety of fixture types, including wall, pole and post mounted, street, pathway, and recessed soffit pot lighting. A variety of lamp types, including fluorescent, compact fluorescent, halogen, incandescent, LED, etc. for exterior direct, indirect and accent lighting applications. A variety of light fixture controls, including switches, motion sensors, timers, and photocells. Lighting at the tops of each tower was replaced in 2019.

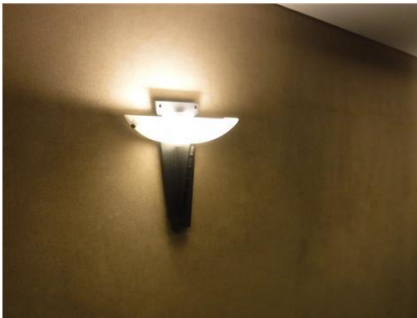
##### Elec 07 - Interior Light Fixtures

All common areas throughout the building.

A variety of fixture types, including fixed surface (pendant, track, and sconce) and recessed (pot, troffer, and cove). A variety of lamp types, including fluorescent, compact fluorescent, halogen, incandescent, LED, etc. for interior direct, indirect and accent lighting applications. A variety of light fixture controls, including switches, motion sensors, timers, dimmers, and photocells. Replacement of bulbs and ballasts is currently occurring on an as needed basis.

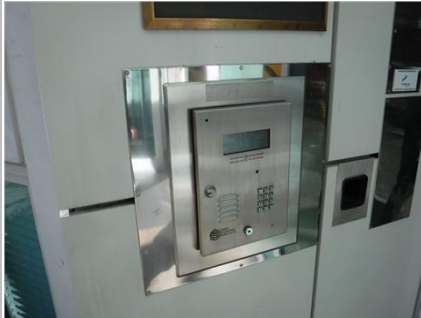
#### Elec 09 - Enterphone System

Lobby entrances and front of parkade gate.

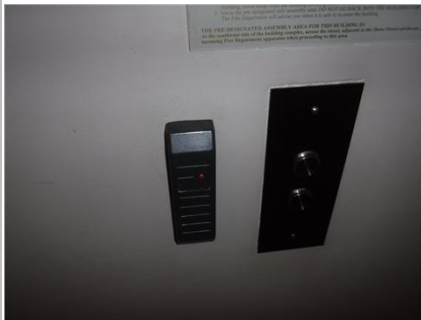
#### Elec 10 - Proximity Access Control

Lobbies, parking garage, elevators, and common area entrances.

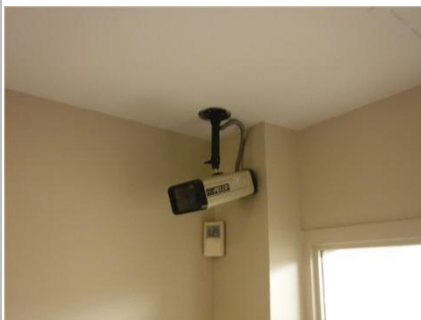
#### Elec 11 - Security Surveillance

Strategically located throughout the complex.

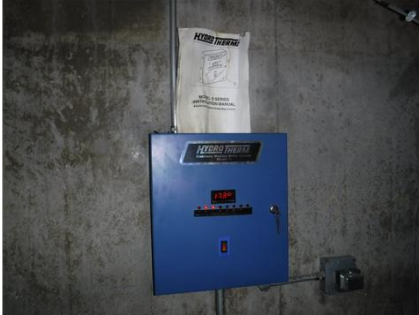
##### Mech 01 - Controls - Boiler Electronic

Rooftop and parkade mechanical rooms with boilers.

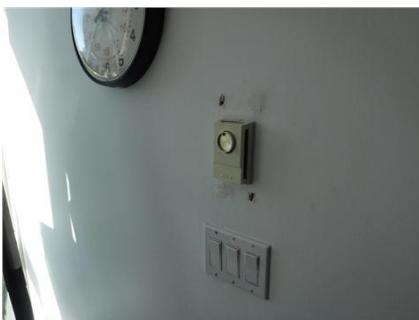
##### Mech 03 - Controls - HVAC Instrumentation

Common areas and service rooms throughout the building.

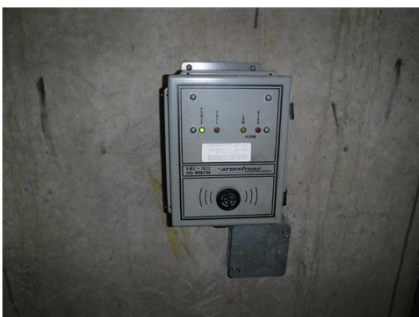
##### Mech 04 - Gas Detection - Parkade

Mounted to columns throughout the parkade.

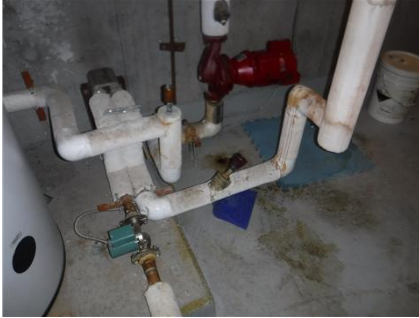
##### Mech 05 - Piping - Domestic Water Distribution

Connected to fixtures throughout the building.

K and L copper piping for vertical/horizontal mains system and distribution piping within the suites. Soldered connections. The hot water supply riser and recirculation riser in Garden Tower were replaced in 2013 and 2008 respectively. Hot water recirculation lines were replaced in Beach Tower in 2015 on one elevation. Hot water recirculation lines were replaced in Ocean Tower in 2018 between floors 3 and 8 on one elevation.

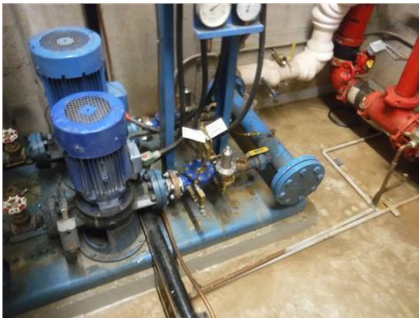
##### Mech 06 - Pump - Domestic Water Booster

Sprinkler rooms under Ocean and Beach Towers.

Franklin Electric duplex system with 2 HP lead pump, 1/2 HP lag pump (Ocean Tower). Original electrical duplex system with 2-5 HP lead pump, and 1 HP lag pump (Beach Tower). One booster pump was replaced in March 2019 with a new VFD pump.

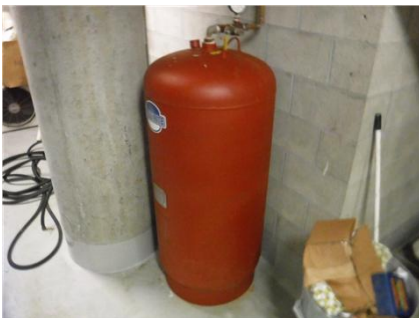
##### Mech 07 - Tank - Expansion -DHW - Diaphragm

Parkade Mechanical room under Beach Tower.

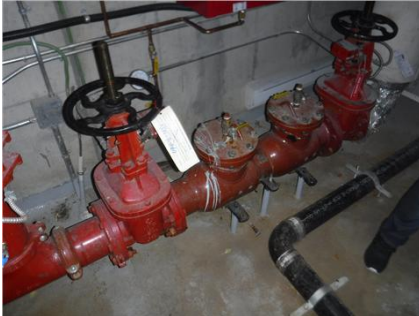
#### Mech 08 - Valves - Cross Connection & Backflow Prevention

Sprinkler rooms under Beach and Ocean Towers.

Various types and sizes of backflow prevention valves, including vacuum breakers, double check, reduced pressure valves on systems. Various valves are replaced as required.

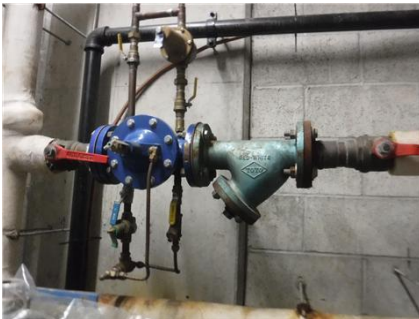
#### Mech 09 - Valves - Plumbing Flow Control and Directional

Mechanical rooms on rooftops and in the parkade.

Various types and sizes of valves, including pressure reducing valves, isolation valves, two-way and three-way valves, circuit flow control valves and check valves to regulate the flow of water through domestic plumbing systems. Select valves were replaced in 2015.

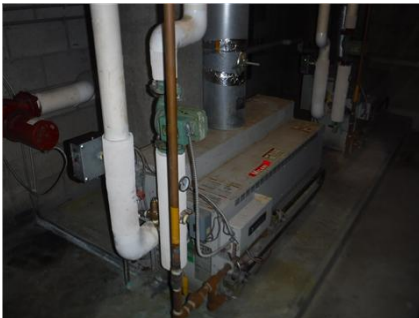
#### Mech 10 - Boiler - DHW - Heating - Gas Fired

Mechanical room on parkade Level P2 under Beach Tower.

Service Life: 14  
Installed Year: 2003  
Chronological Age: 16  
Effective Age: 11  
Next Renewal Year: 2022

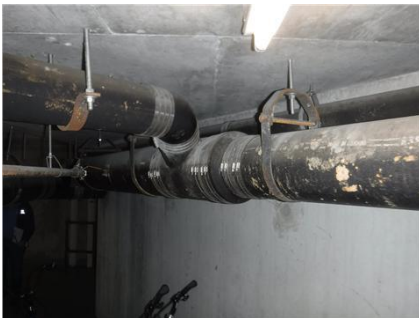
#### Mech 11 - Drainage - Sanitary

Connected to waste fixtures throughout the building.

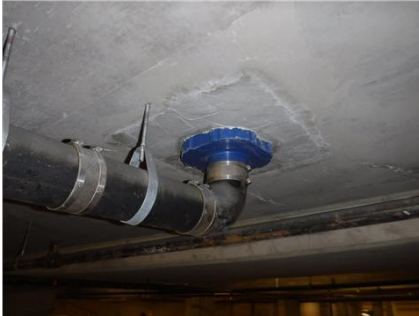
#### Mech 12 - Drainage - Storm - Internal

Throughout the building.

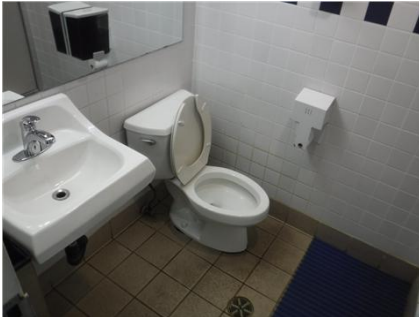
#### Mech 13 - Fixtures - Toilets/Sinks/showers

Pool common area washrooms.

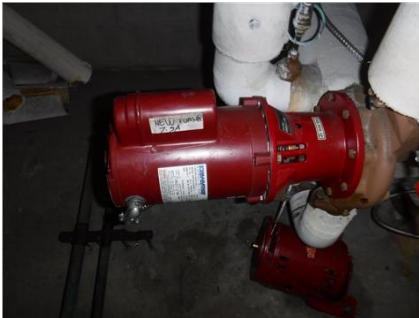
#### Mech 14 - Pump - DHW - Circulation and Recirculation

Mechanical rooms and spaces throughout the complex.

Various manufacturer 1/2 HP, pipe-mounted bronze body domestic hot water circulation pumps. Circulating hot water from boilers to tanks and recirculating hot water from system. Pumps are periodically replaced or repaired on an as needed basis. Age of asset is blended based on dates of pumps installed during the site review.

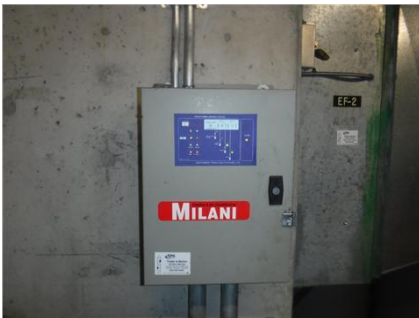
#### Mech 15 - Pumps - Sanitary Lift and Control Panel

Parkade Level P4.

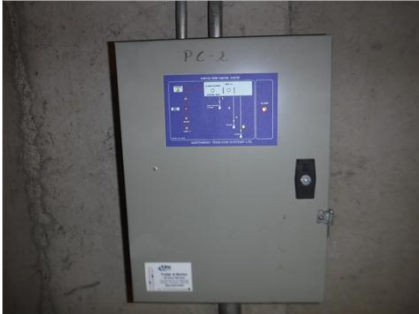
#### Mech 16 - Pumps - Storm Lift and Control Panel

Parkade Level P4.

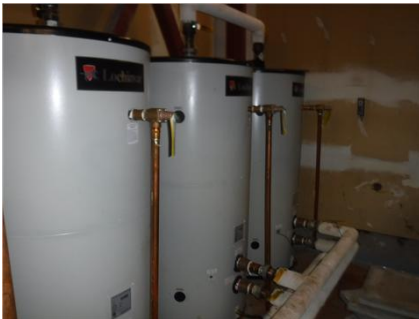
#### Mech 17 - Tank - DHW - Storage (and DHW Heating)

Parkade and rooftop mechanical rooms for each tower.

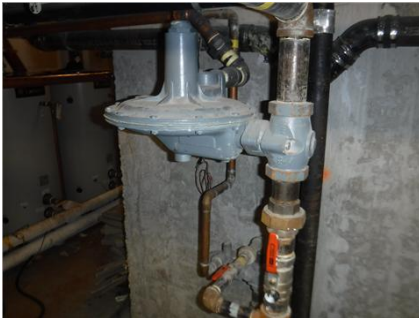
#### Mech 18 - Piping - Gas Distribution

Connected to gas fixtures throughout the complex.

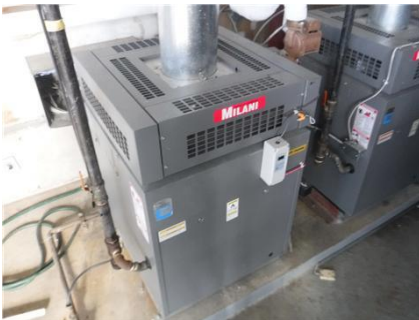
#### Mech 19 - Boiler - Hydronic - Gas Fired

Rooftop mechanical rooms in Beach and Ocean Towers.

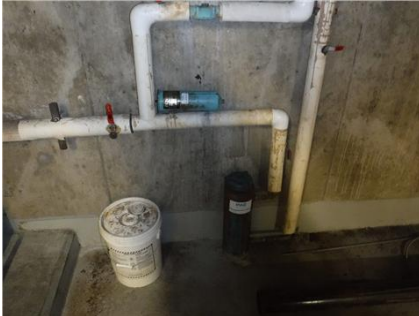
#### Mech 20 - Chemical Treatment Equipment

Mechanical room on parkade Level P2 in Beach Tower.

Pot feeder with chemicals, metering pumps and other associated equipment to provide corrosion protection to boilers, loops, and piping.

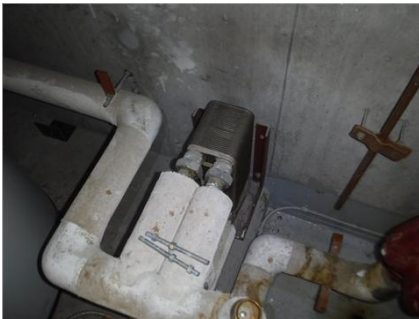
#### Mech 21 - Heat Exchanger - Brazen Plate

Mechanical room on parkade Level P2 in Beach Tower.

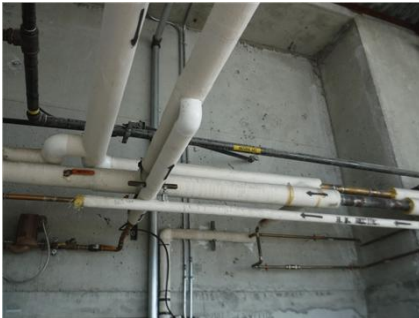
#### Mech 22 - Piping - Hydronic Loop

Rooftop and parkade mechanical rooms in all Towers.

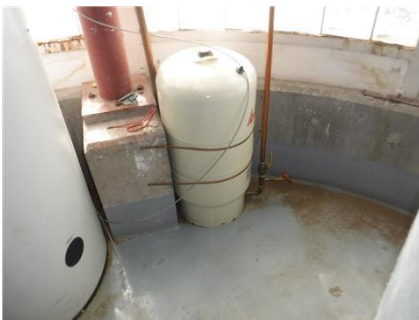
#### Mech 23 - Tank - Expansion - Hydronic - Diaphragm

Rooftop mechanical room in Garden Tower.

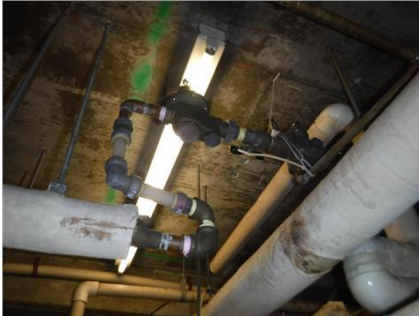
#### Mech 24 - Valves - HVAC Flow Control and Directional

Rooftop and parkade mechanical rooms.

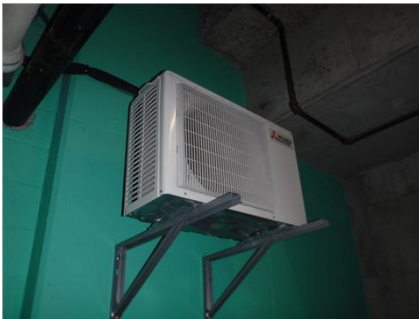
#### Mech 25 - A/C Split System

Parkade Levels P1 and P2.

Mitsubishi Electrical R410a condensing split system for air conditioning to electrical rooms. wall mounted indoor units, with wall mounted controllers.

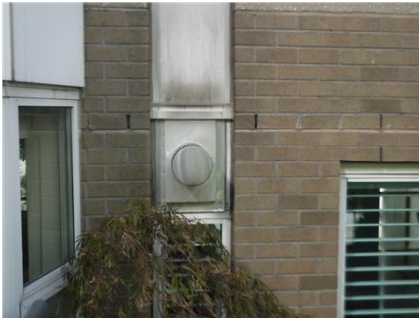
#### Mech 26 - Gas Chimney Vent - Wall type

Exterior of suites where fireplaces have been installed.

Gas appliance vent with approved collars, fittings, vent terminal, and guard. Select vents were replaced in 2014 as part of targeted repairs.

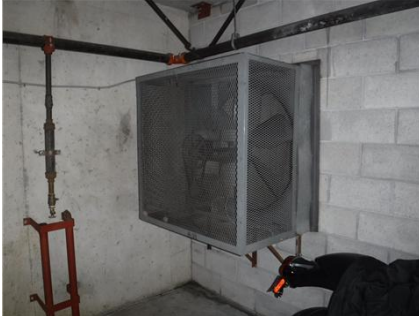
#### Mech 28 - Exhaust Fan - Parkade - Propellor

Corners of the parkade on all levels.

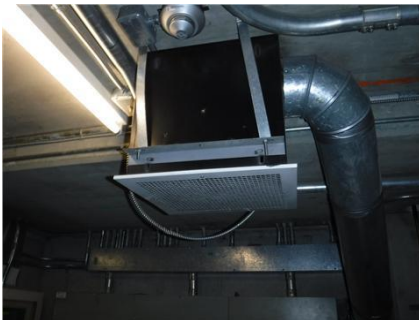
#### Mech 29 - Exhaust Fan - Small Service - Cabinet

Mechanical, electrical, and storage rooms throughout the parkade and common areas.

Various direct drive fans, ceiling and cabinet fans, and centrifugal inline blower fans.

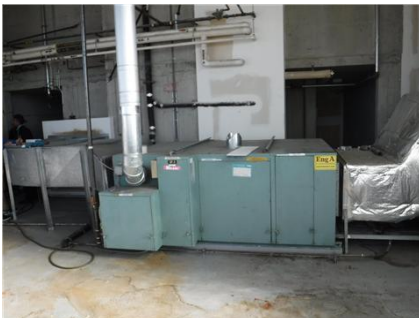
#### Mech 30 - Indoor Air Handler - Gas Fired

Rooftop mechanical rooms in Beach and Ocean Towers.

Engineered Air 10,100 (9,500 in Beach Tower) CFM indoor unit, belt-driven, centrifugal fan with natural gas fired (600,000 BTU max) heating to supply tempered make-up air to the interior spaces.

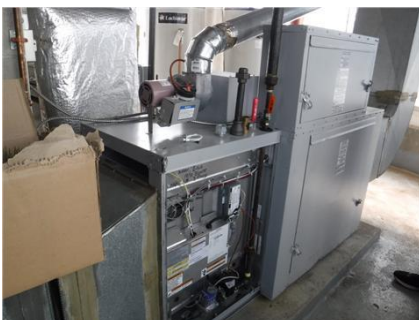
#### Mech 31 - Make Up Air Unit - Indoor - Gas Fired

Rooftop mechanical room in Garden Tower.

Engineered Air 1,400 CFM indoor unit, belt-driven, centrifugal fan with natural gas fired (125,000 BTU max) heating to supply tempered make-up air to the interior spaces.

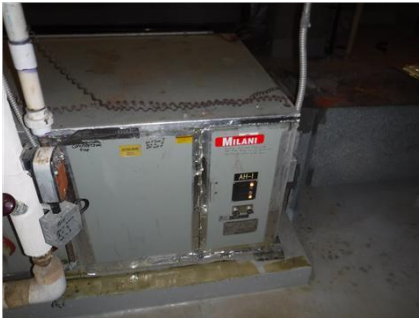
#### Mech 32 - Dehumidifying Pool Heater

Mechanical room on parkade Level P2 under Beach Tower.

Zephyr dehumidifying pool heater and air handling package, nominal 2,800 cfm capacity, belt-driven, centrifugal fans, for circulating and drying air to the interior pool spaces and heating the pool water.

| ASSET ID | ASSET NAME | CHRONOLOGICAL AGE | ESTIMATED REMAINING SERVICE LIFE |
|---|---|---|---|
| Mech 32 | Dehumidifying Pool Heater | 27 | 3 |

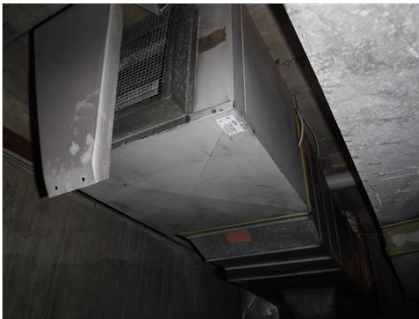
#### Mech 33 - Air Handler - Make Up Air Unit

Mechanical room on parkade Level P2 below Beach Tower.

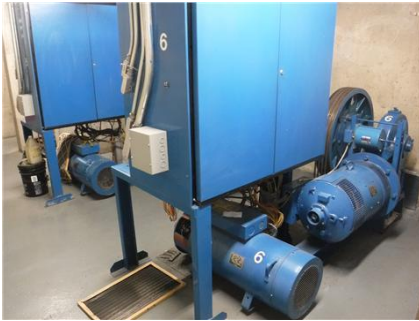
###### Elev 01 - Geared Traction, Overhead

Elevator rooms on the top floor of each tower.

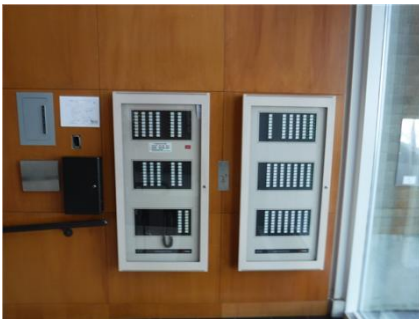
##### Fire 02 - Fire Alarm Panel - Addressable

Main lobbies of the 3 towers, parkade gate entry, and Parkade Level P1.

Simplex 4100 supervised units with annunciator and LED light display. Exterior panel near Beach Tower was replaced in 2016. All fire panel interior components were upgraded in 2010 based on the 2013 depreciation report by Halsall.

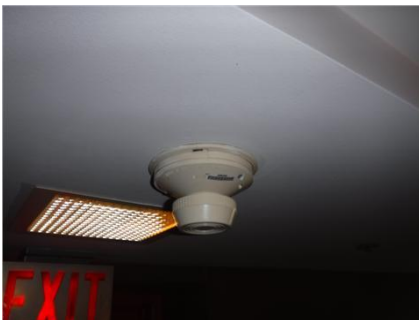
##### Fire 03 - Fire Detection & Alarm

Mounted to walls and ceilings in various strategic locations throughout the complex.

Smoke detectors, heat detectors, flow switches, tamper switches, horns, pull stations and other fixed apparatus field devices to detect fire and smoke conditions and initiate timely response. Smoke detectors are replaced on an as needed basis. A number of detectors were replaced in 2017.

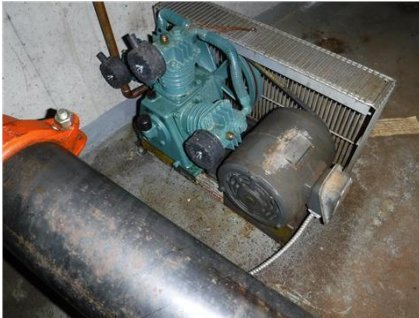
##### Fire 04 - Dry Sprinkler Compressor

Sprinkler room under Ocean Tower.

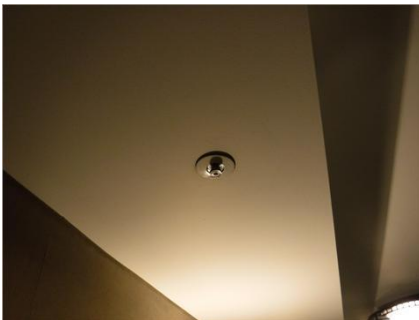
##### Fire 05 - Sprinkler & Standpipe - Wet

Mounted to ceilings and walls throughout the common areas, hallways, and suites.

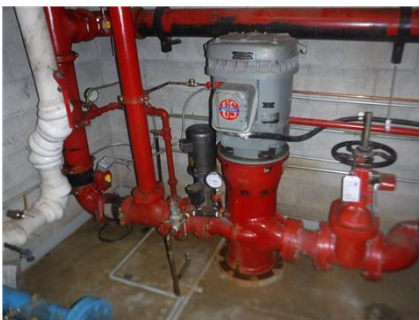
##### Fire 06 - Fire & Jockey Pump

Sprinkler room under Ocean Tower.

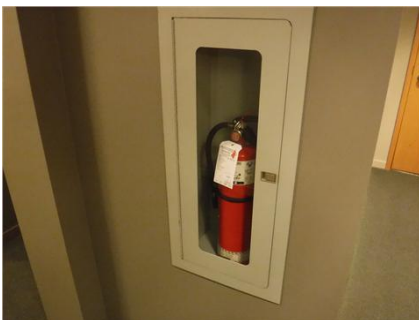
##### Fire 07 - Portable Fire Extinguisher

Mounted to walls in various strategic locations throughout the buildings.

Wall mounted, manually operated, 5lbs and 10lbs ABC type, pressurized vessels for controlled discharge of chemicals to extinguish small fires. Extinguishers are replaced on an as needed basis.

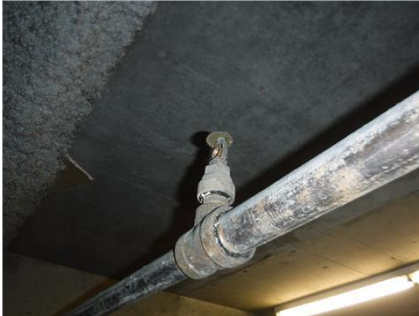
#### Fire 08 - Sprinkler System - Dry

Throughout the parkade and unconditioned mechanical space.

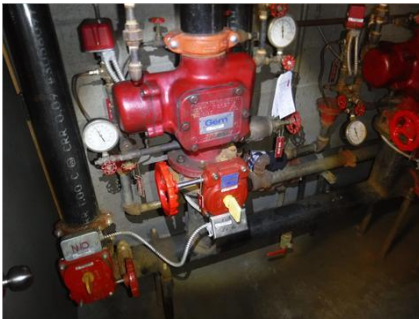
#### Fire 09 - Sprinkler Valve Assembly - Dry

Sprinkler room under Ocean Tower.

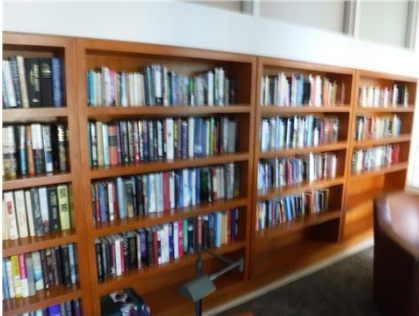
#### Finish 15 - Carpentry and Millwork

Beach and Ocean Tower libraries and meeting areas.

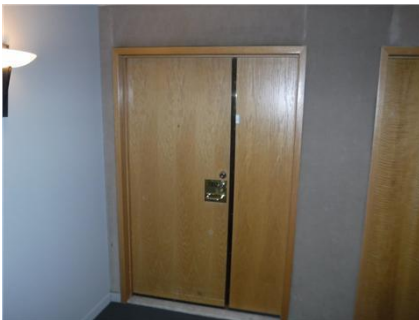
#### Finish 16 - Interior Swing Door - General

All common area and interior service doors throughout the towers and townhouse buildings.

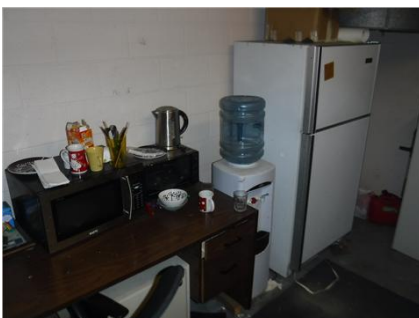
#### Amen 02 - Domestic Appliances

Mechanical space with maintenance staff area on Parkade Level P1.

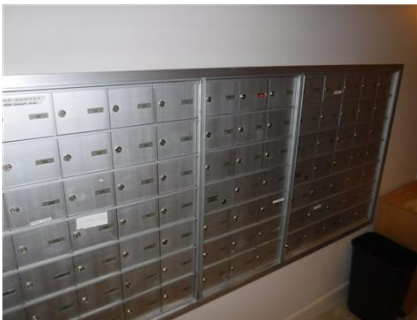
#### Amen 04 - Central Mailboxes

Tower lobbies.

Service Life: 40  
Installed Year: 1992  
Chronological Age: 27  
Effective Age: 27  
Next Renewal Year: 2032

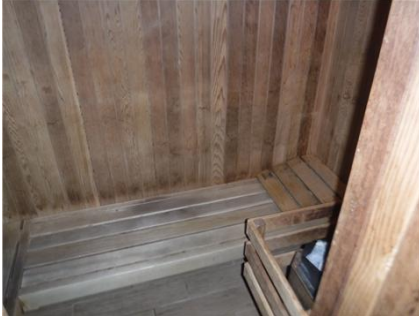
##### Amen 07 - Dry Sauna

Beach Tower pool area.

Service Life: 20  
Installed Year: 2013  
Chronological Age: 6  
Effective Age: 7  
Next Renewal Year: 2032

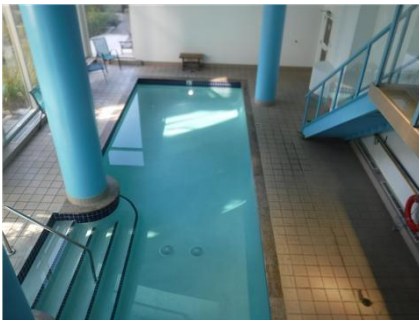
##### Amen 08 - Pool/Spa Tank

Pool room in Beach Tower.

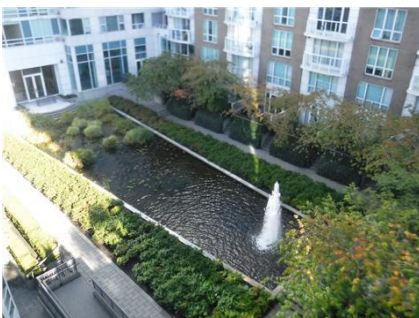
##### Site 02 - Water Feature

Interior Courtyard

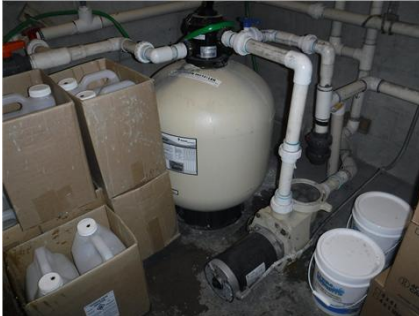
### Site 03 - Water Feature Circulation & Filtration

Pool water filtration system on Parkade Level P1.

Service Life: 10  
Installed Year: 1992  
Chronological Age: 27  
Effective Age: 8  
Next Renewal Year: 2021

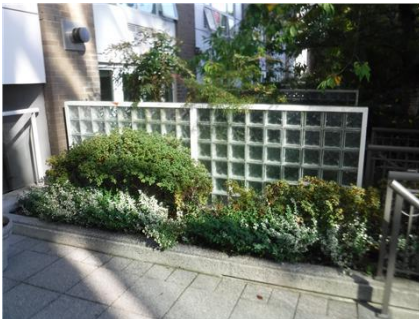
### Site 04 - Glass Block Privacy Screens

Between townhouse patios in courtyard.

Service Life: 30  
Installed Year: 1992  
Chronological Age: 27  
Effective Age: 28  
Next Renewal Year: 2021

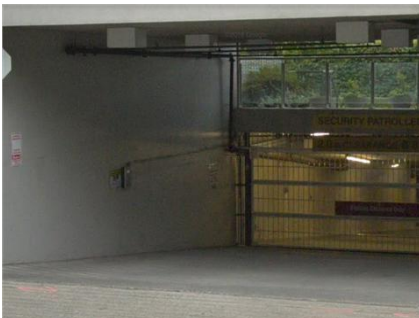
### Site 06 - Paving Driveway

Parkade entrance.

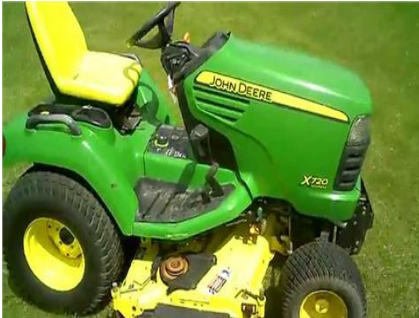
#### Site 07 - Grounds-keeping Equipment

Parkade Level P1.

John Deere x720 tractor for moving garbage bins. Major repairs completed in 2018. Tractor assumed to have been purchased in 2010.

Service Life: 20  
 Installed Year: 2010  
 Chronological Age: 9  
 Effective Age: 9  
 Next Renewal Year: 2030

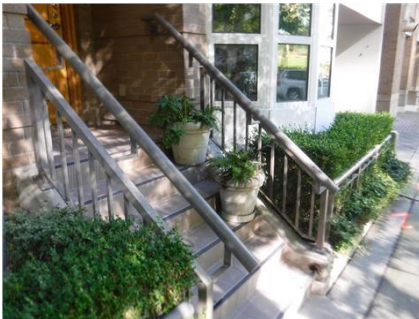
#### Site 08 - Ceramic Tile

Townhouse exterior entry stairs.

Tile on mortar bed and substrate with grout and sealant at interfaces. Front step tiles have already been replaced on TH5-13.

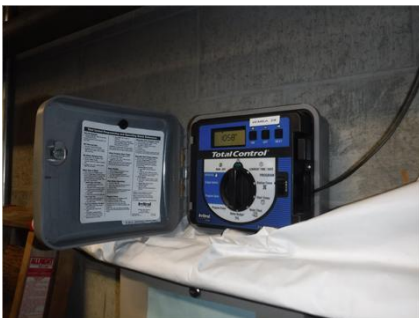
#### Site 09 - Irrigation System

Sprinklers throughout interior courtyard area with a controller on Parkade Level P1.

Service Life: 20  
 Installed Year: 1992  
 Chronological Age: 27  
 Effective Age: 18  
 Next Renewal Year: 2021

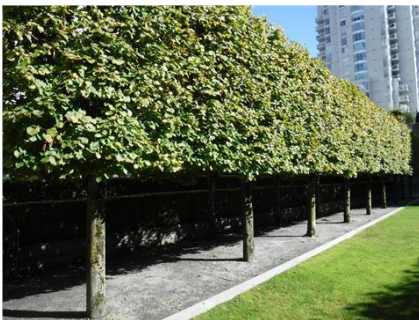
#### Site 10 - Soft Landscaping

Interior Courtyard.
