**JRS ENGINEERING**  
BUILDING ENVELOPE CONSULTANTS

## DEPRECIATION REPORT

### **COSMO**

161 WEST GEORGIA STREET  
VANCOUVER, BC

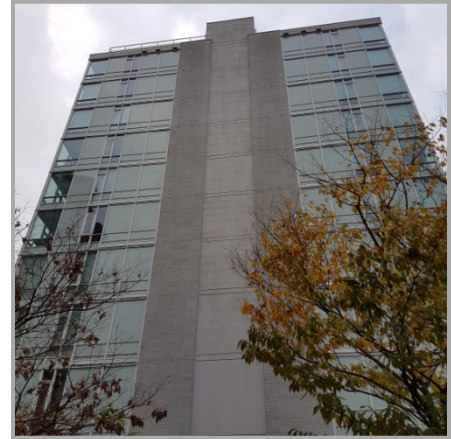
### Concrete Structure

<b>Location:</b>	Building exteriors
<b>Year Installed:</b>	2012
<b>Typical Service Life (yrs):</b>	50
<b>Effective Age (yrs):</b>	4
<b>Remaining Service Life (yrs):</b>	46
<b>Planned Renewal Date:</b>	2062

**Description:** This item includes exterior concrete that comprises the residential units, cantilevered balconies, as well as parkade slabs and walls.

**Condition:** This item appears to be in reasonable condition.

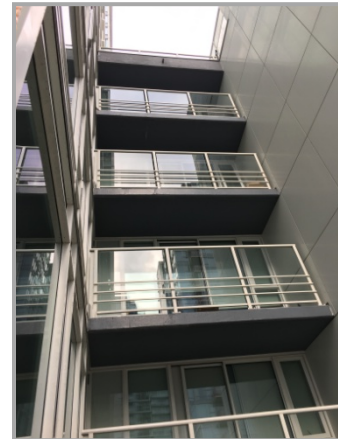
### Guardrails

<b>Location:</b>	Unit Balconies, roof decks, and stairwells
<b>Year Installed:</b>	2012
<b>Typical Service Life (yrs):</b>	30
<b>Effective Age (yrs):</b>	4
<b>Remaining Service Life (yrs):</b>	26
<b>Planned Renewal Date:</b>	2042

**Description:** This item includes guardrails at unit balconies, roof decks, stairwells and site grounds.

**Condition:** This asset appears to be in reasonable condition.

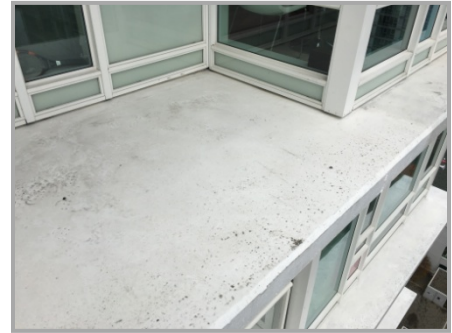
<b>Location:</b>	Balcony and eyebrow surfaces
<b>Year Installed:</b>	2012
<b>Typical Service Life (yrs):</b>	15
<b>Effective Age (yrs):</b>	4
<b>Remaining Service Life (yrs):</b>	11
<b>Planned Renewal Date:</b>	2027

**Description:** This item includes liquid applied membrane at unit balconies and architectural concrete eyebrow features.

**Condition:** This asset appears to be in reasonable condition.

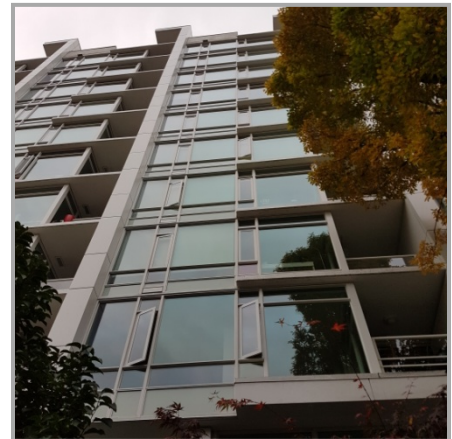
<b>Location:</b>	Building exteriors
<b>Year Installed:</b>	2012
<b>Typical Service Life (yrs):</b>	30
<b>Effective Age (yrs):</b>	4
<b>Remaining Service Life (yrs):</b>	26
<b>Planned Renewal Date:</b>	2042

**Description:** This item includes the window wall assemblies at building exteriors.

**Condition:** This asset appears to be in reasonable condition.

The aluminum framed window walls are manufactured by Allan Window Technologies. These windows are set between the floor slabs and bypass the edge of the slab with a metal or glass panel furred out to create a rainscreen assembly. The windows consist of a thermally improved aluminum frame and double-glazed insulated IGUs, set within the frames with glazing tape.

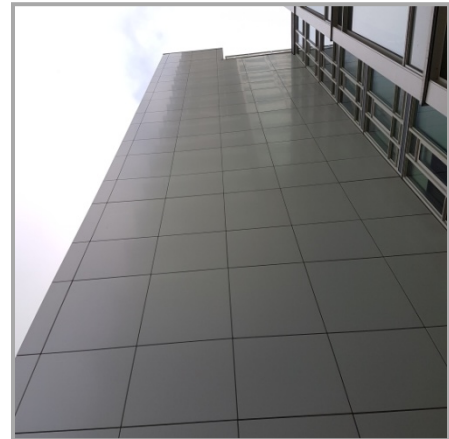
<b>Location:</b>	Building exteriors
<b>Year Installed:</b>	2012
<b>Typical Service Life (yrs):</b>	50
<b>Effective Age (yrs):</b>	4
<b>Remaining Service Life (yrs):</b>	46
<b>Planned Renewal Date:</b>	2062

**Description:** This item includes the exterior metal cladding elements.

**Condition:** This asset appears to be in reasonable condition.

The metal panel cladding system contains metal panels, exterior insulation, and a moisture barrier. It is installed on a furring system that creates a drainage plane behind the cladding. The furring system is attached through the insulation to the steel stud infill wall or concrete wall. Metal panel cladding exists primarily at balcony return walls.

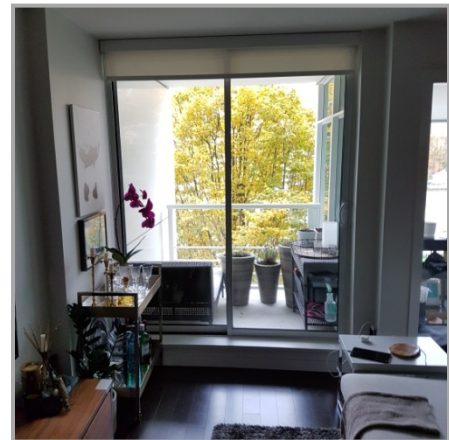
<b>Location:</b>	Unit balconies
<b>Year Installed:</b>	2012
<b>Typical Service Life (yrs):</b>	30
<b>Effective Age (yrs):</b>	4
<b>Remaining Service Life (yrs):</b>	26
<b>Planned Renewal Date:</b>	2042

**Description:** This item includes sliding doors at unit balconies.

**Condition:** This asset appears to be in reasonable condition.

The main entrance assembly is manufactured by Columbia Glazing Systems Inc and the sliding and swing balcony/deck doors are manufactured by Allan Window technologies. These assemblies include aluminum frames and sills, and double-glazed insulating glazing units (IGUs). The doors are set in a bed of sealant, applied to the self-adhesive sill membrane. An allowance for a portion of the swing doors at balconies and roof decks has been included, as comprehensive renewal is unlikely in the 30 year projection.

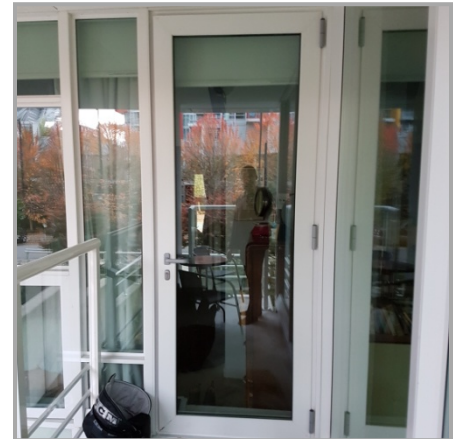
<b>Location:</b>	Unit balconies
<b>Year Installed:</b>	2012
<b>Typical Service Life (yrs):</b>	30
<b>Effective Age (yrs):</b>	4
<b>Remaining Service Life (yrs):</b>	26
<b>Planned Renewal Date:</b>	2042

**Description:** This item includes exterior swing doors at unit balconies, and unit entrances.

**Condition:** This asset appears to be in reasonable condition.

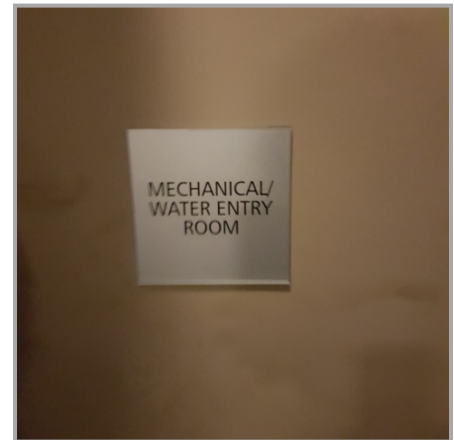
<b>Location:</b>	Throughout building
<b>Year Installed:</b>	2012
<b>Typical Service Life (yrs):</b>	50
<b>Effective Age (yrs):</b>	4
<b>Remaining Service Life (yrs):</b>	46
<b>Planned Renewal Date:</b>	2062

**Description:** This item includes services doors in the parkade, common areas, utility rooms, and stairwells.

**Condition:** This asset appears to be in reasonable condition.

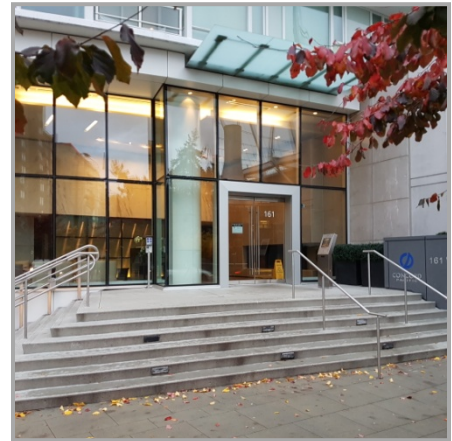
<b>Location:</b>	Exterior of front entrances
<b>Year Installed:</b>	2012
<b>Typical Service Life (yrs):</b>	40
<b>Effective Age (yrs):</b>	4
<b>Remaining Service Life (yrs):</b>	36
<b>Planned Renewal Date:</b>	2052

**Description:** This item includes the door assembly at the main entrance.

**Condition:** This asset appears to be in reasonable condition.

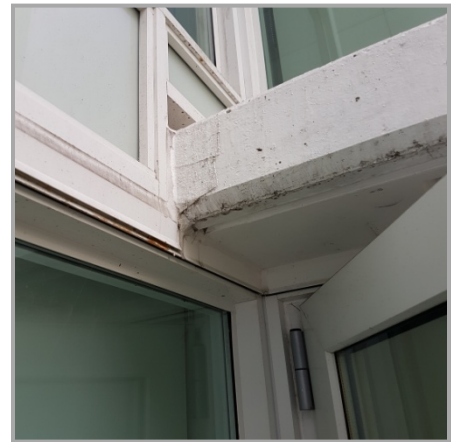
<b>Location:</b>	At building envelope component transitions
<b>Year Installed:</b>	2012
<b>Typical Service Life (yrs):</b>	10
<b>Effective Age (yrs):</b>	4
<b>Remaining Service Life (yrs):</b>	6
<b>Planned Renewal Date:</b>	2022

**Description:** This item includes sealant at transitions between dissimilar building envelope components at building exteriors.

**Condition:** This asset appears to be in reasonable condition.

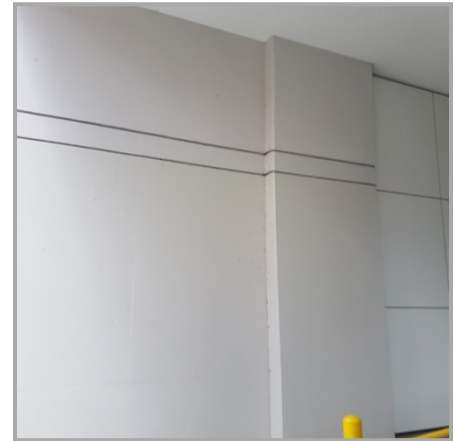
<b>Location:</b>	Exterior concrete elements
<b>Year Installed:</b>	2012
<b>Typical Service Life (yrs):</b>	10
<b>Effective Age (yrs):</b>	4
<b>Remaining Service Life (yrs):</b>	6
<b>Planned Renewal Date:</b>	2022

**Description:** This item includes a paint coating / sealer at exterior concrete surfaces.

**Condition:** This asset appears to be in reasonable condition.

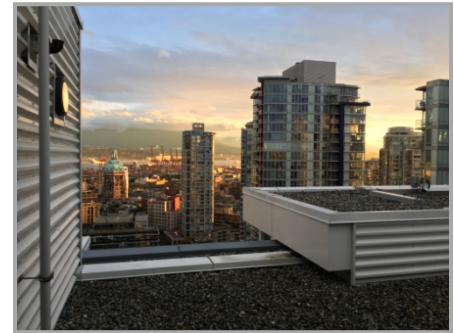
<b>Location:</b>	Main roof and level 15 roof
<b>Year Installed:</b>	2012
<b>Typical Service Life (yrs):</b>	40
<b>Effective Age (yrs):</b>	4
<b>Remaining Service Life (yrs):</b>	36
<b>Planned Renewal Date:</b>	2052

**Description:** This item includes the inverted roof assembly with gravel ballast at the main roof and architectural cantilevered roof features at the level 15 roof deck.

**Condition:** This asset appears to be in reasonable condition.

The main roof consists of an inverted roof system consisting of gravel ballast, filter fabric, rigid insulation, drainmat, waterproofing membrane, and the underlying concrete slab. This type of roof assembly is generally durable as there is little pedestrian traffic and the design limits the membrane from exposure to UV radiation and climatic conditions.

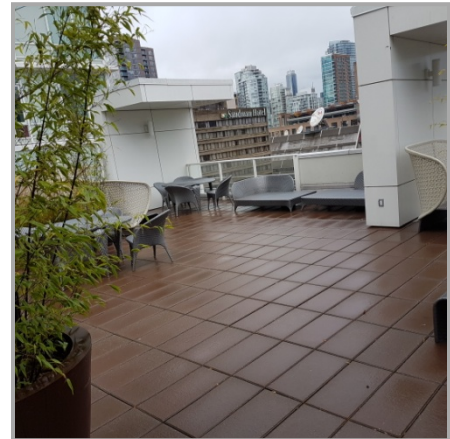
<b>Location:</b>	Level 15 Roof
<b>Year Installed:</b>	2012
<b>Typical Service Life (yrs):</b>	30
<b>Effective Age (yrs):</b>	4
<b>Remaining Service Life (yrs):</b>	26
<b>Planned Renewal Date:</b>	2042

**Description:** This item includes the inverted roof assembly at the level 15 roof deck.

**Condition:** This asset appears to be in reasonable condition.

Unit roof decks and the majority of the level 15 roof is composed of precast concrete pavers, filter fabric, rigid insulation, drainmat, waterproofing membrane, and underlying concrete substrate. This roof is generally durable; however, accelerated wear may occur from increased pedestrian usage. The hot tub area contains the same assembly and utilizes a sloped topping for a continuous finish. An allowance for a roof review has been included three years prior to the anticipated renewal date.

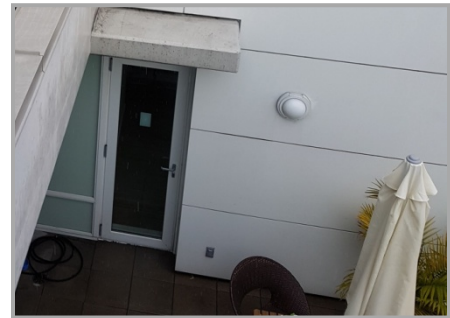
<b>Location:</b>	Building exteriors
<b>Year Installed:</b>	2012
<b>Typical Service Life (yrs):</b>	30
<b>Effective Age (yrs):</b>	4
<b>Remaining Service Life (yrs):</b>	26
<b>Planned Renewal Date:</b>	2042

**Description:** This item includes the inverted roof assemblies at unit roof decks.

**Condition:** This asset appears to be in reasonable condition.

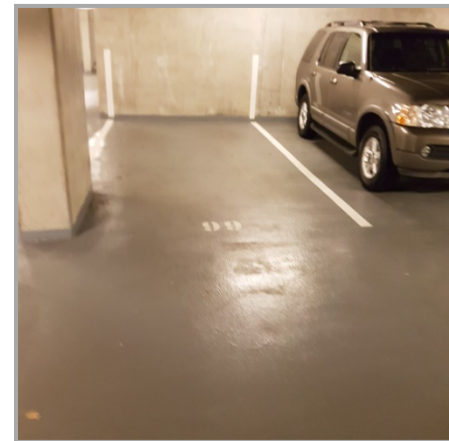
<b>Location:</b>	Parkade
<b>Year Installed:</b>	2012
<b>Typical Service Life (yrs):</b>	20
<b>Effective Age (yrs):</b>	4
<b>Remaining Service Life (yrs):</b>	16
<b>Planned Renewal Date:</b>	2032

**Description:** This item includes the liquid applied traffic membrane at parkade drive aisles and parking stalls.

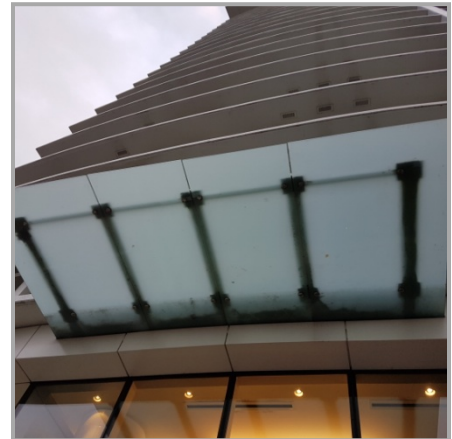
<b>Location:</b>	Above front entrance
<b>Year Installed:</b>	2012
<b>Typical Service Life (yrs):</b>	30
<b>Effective Age (yrs):</b>	4
<b>Remaining Service Life (yrs):</b>	26
<b>Planned Renewal Date:</b>	2042

**Description:** This item includes the metal and glass canopy above the main entrance.

**Comments:** An allowance has been included for the replacement of the canopy lites as the canopy's structure should last the life of the building.

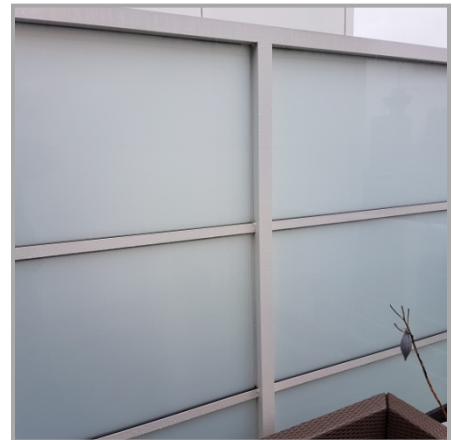
<b>Location:</b>	Building exterior
<b>Year Installed:</b>	2012
<b>Typical Service Life (yrs):</b>	30
<b>Effective Age (yrs):</b>	4
<b>Remaining Service Life (yrs):</b>	26
<b>Planned Renewal Date:</b>	2042

**Description:** This item includes the partition walls between units at unit roof decks.

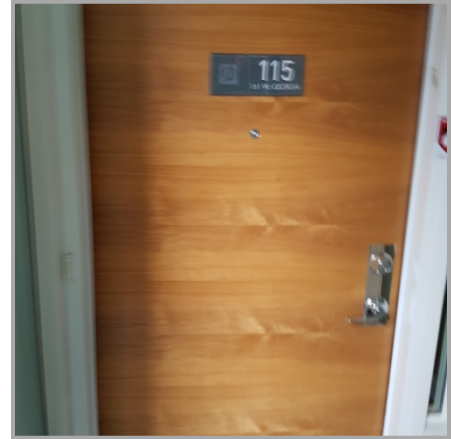
#### Entry Doors

<b>Location:</b>	At unit entrances
<b>Year Installed:</b>	2012
<b>Typical Service Life (yrs):</b>	50
<b>Effective Age (yrs):</b>	4
<b>Remaining Service Life (yrs):</b>	46
<b>Planned Renewal Date:</b>	2062

**Description:** This item includes the interior unit entry doors.

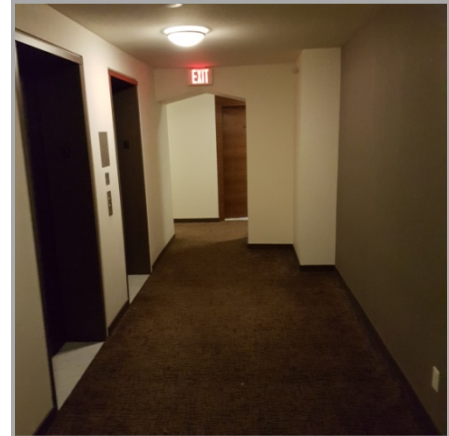
**22****Elevator**

<b>Location:</b>	Tower core
<b>Year Installed:</b>	2012
<b>Typical Service Life (yrs):</b>	30
<b>Effective Age (yrs):</b>	4
<b>Remaining Service Life (yrs):</b>	26
<b>Planned Renewal Date:</b>	2042

**Description:** This item includes the three gear traction elevators.

**Comments:** This item includes three gear traction elevators that service the tower and parkade. We understand that Richmond Elevator is performing regular inspections and maintenance. An allowance has been included for an engineering review and targeted repairs 3 years before the planned renewal date.

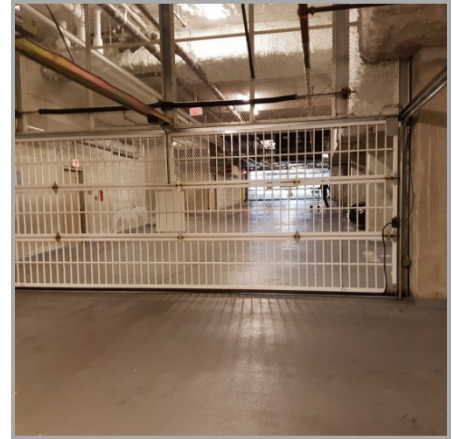
### Parkade Gates

<b>Location:</b>	Parkade entrance
<b>Year Installed:</b>	2012
<b>Typical Service Life (yrs):</b>	30
<b>Effective Age (yrs):</b>	4
<b>Remaining Service Life (yrs):</b>	26
<b>Planned Renewal Date:</b>	2042

**Description:** This item includes the parkade gates and associated hardware.

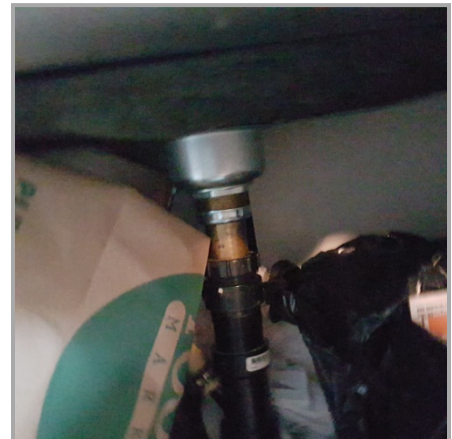
### Domestic Water Pipes

<b>Location:</b>	Building interior
<b>Year Installed:</b>	2012
<b>Typical Service Life (yrs):</b>	30
<b>Effective Age (yrs):</b>	4
<b>Remaining Service Life (yrs):</b>	26
<b>Planned Renewal Date:</b>	2042

**Description:** This item includes the copper domestic water pipes that service the building.

**Condition:** This asset appears to be in reasonable condition; however, a leak was observed in the ceiling of unit 1216.

**Comments:** Pitting corrosion is expected near the end of a copper pipe's service life. An allowance has been included three years prior to the expected replacement in order to allow for an assessment and repairs that typically need to be performed before a full scale re-piping. Based on a leak investigation performed by JRS, a repair allowance has been included for the leak observed at the water supply line of the water fountain on the level 15 roof deck.

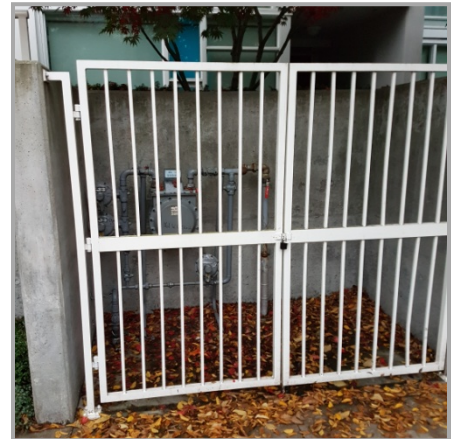
<b>Location:</b>	Below-grade
<b>Year Installed:</b>	2012
<b>Typical Service Life (yrs):</b>	50
<b>Effective Age (yrs):</b>	4
<b>Remaining Service Life (yrs):</b>	46
<b>Planned Renewal Date:</b>	2062

**Description:** This item includes the below-grade gas lines.

**Condition:** This asset appears to be in reasonable condition; however, could not be visually reviewed.

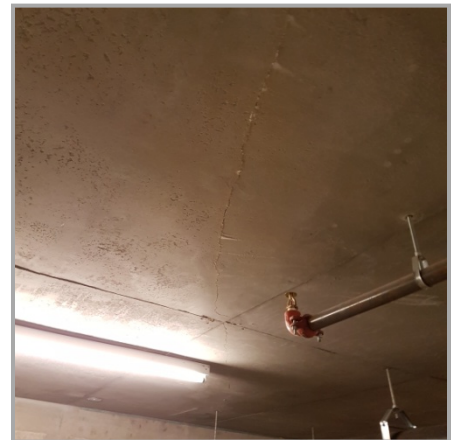
<b>Location:</b>	Parkade
<b>Year Installed:</b>	2012
<b>Typical Service Life (yrs):</b>	50
<b>Effective Age (yrs):</b>	4
<b>Remaining Service Life (yrs):</b>	46
<b>Planned Renewal Date:</b>	2062

**Description:** This item includes the sprinkler pipes for the parkade and fire pump components.

**Comments:** A detailed review by a fire protection specialist should be performed three years before the expected replacement date.

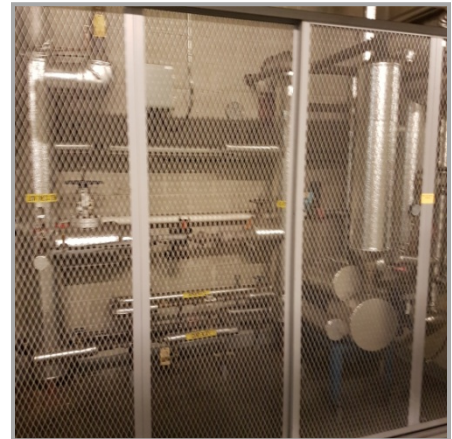
<b>Location:</b>	Roof top mechanical room/ throughout the building
<b>Year Installed:</b>	2012
<b>Typical Service Life (yrs):</b>	N/A
<b>Effective Age (yrs):</b>	N/A
<b>Remaining Service Life (yrs):</b>	N/A
<b>Planned Renewal Date:</b>	N/A

**Description:** This item includes the piping and associated components for the steam plant system.

**Comments:** Steam heating services are provided by Central Heat Distribution. Cost to renew a portion of the piping is captured in the domestic water pipes item.

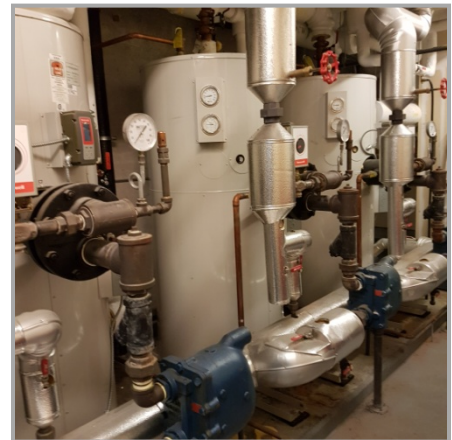
<b>Location:</b>	Roof top mechanical room
<b>Year Installed:</b>	2012
<b>Typical Service Life (yrs):</b>	10
<b>Effective Age (yrs):</b>	4
<b>Remaining Service Life (yrs):</b>	6
<b>Planned Renewal Date:</b>	2022

**Description:** This item includes the three hot water storage tanks.

**Comments:** An allowance has been included for the complete replacement of this item.

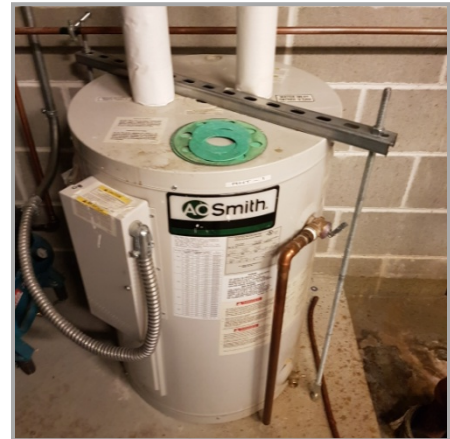
<b>Location:</b>	Mechanical/water entry room
<b>Year Installed:</b>	2012
<b>Typical Service Life (yrs):</b>	10
<b>Effective Age (yrs):</b>	4
<b>Remaining Service Life (yrs):</b>	6
<b>Planned Renewal Date:</b>	2022

**Description:** This item includes the electric hot water heater.

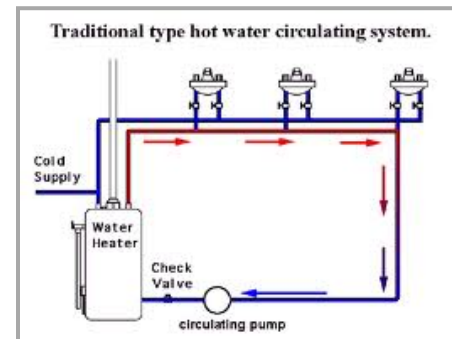
<b>Location:</b>	Mechanical rooms/ building interiors
<b>Year Installed:</b>	2012
<b>Typical Service Life (yrs):</b>	20
<b>Effective Age (yrs):</b>	4
<b>Remaining Service Life (yrs):</b>	16
<b>Planned Renewal Date:</b>	2032

**Description:** This item includes circulation and recirculation pumps distributed throughout the building.

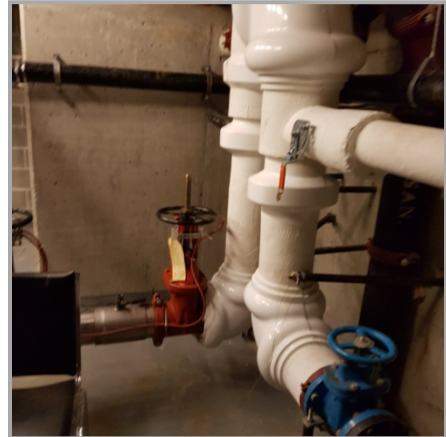
<b>Location:</b>	Mechanical rooms/ building interiors
<b>Year Installed:</b>	2012
<b>Typical Service Life (yrs):</b>	20
<b>Effective Age (yrs):</b>	4
<b>Remaining Service Life (yrs):</b>	16
<b>Planned Renewal Date:</b>	2032

**Description:** This item includes backflow preventers, pressure reducing valves, and other miscellaneous components that contribute to the building's mechanical system.

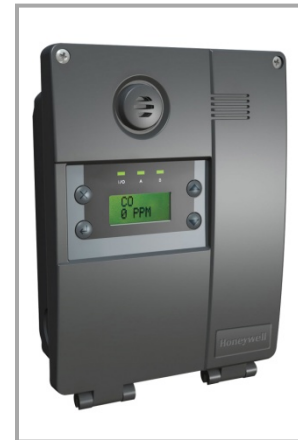
<b>Location:</b>	Parkade
<b>Year Installed:</b>	2012
<b>Typical Service Life (yrs):</b>	20
<b>Effective Age (yrs):</b>	4
<b>Remaining Service Life (yrs):</b>	16
<b>Planned Renewal Date:</b>	2032

**Description:** This item includes the CO detectors located in the parkade.

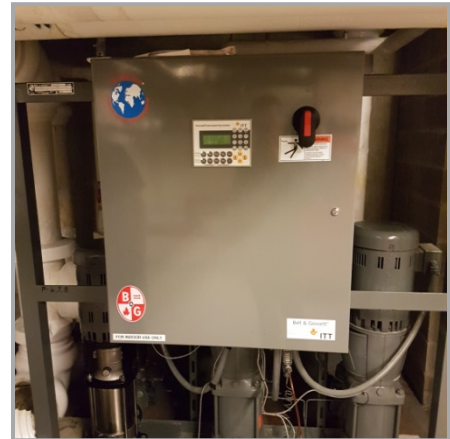
<b>Location:</b>	Mechanical/water room
<b>Year Installed:</b>	2012
<b>Typical Service Life (yrs):</b>	15
<b>Effective Age (yrs):</b>	4
<b>Remaining Service Life (yrs):</b>	11
<b>Planned Renewal Date:</b>	2027

**Description:** This item includes 3 booster pumps and the booster pump panel.

**Comments:** An allowance has been included for targeted repairs and replacement of system components.

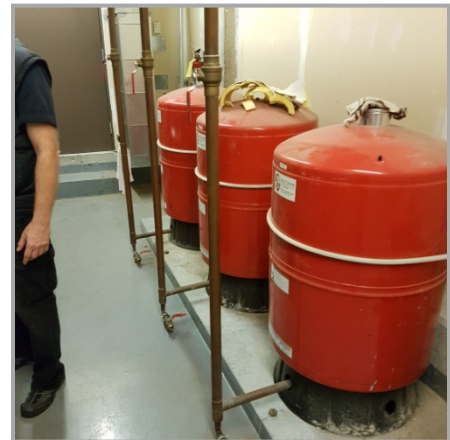
<b>Location:</b>	Rooftop mechanical room
<b>Year Installed:</b>	2012
<b>Typical Service Life (yrs):</b>	15
<b>Effective Age (yrs):</b>	4
<b>Remaining Service Life (yrs):</b>	11
<b>Planned Renewal Date:</b>	2027

**Description:** This item includes the 3 draw down tanks located in the roof top mechanical room.

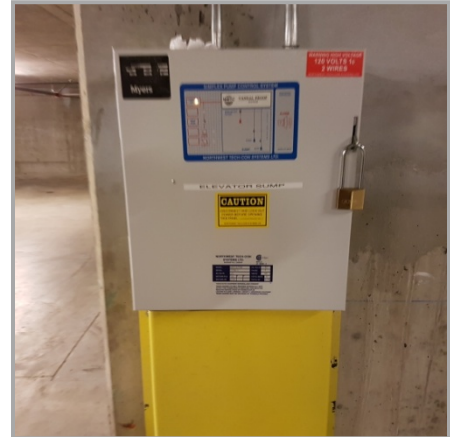
<b>Location:</b>	Parkade
<b>Year Installed:</b>	2012
<b>Typical Service Life (yrs):</b>	10
<b>Effective Age (yrs):</b>	4
<b>Remaining Service Life (yrs):</b>	6
<b>Planned Renewal Date:</b>	2022

**Description:** This item includes the storm, sanitary sewer and elevator pit sump pumps.

**Comments:** An allowance has been included for the replacement of the sump pumps.

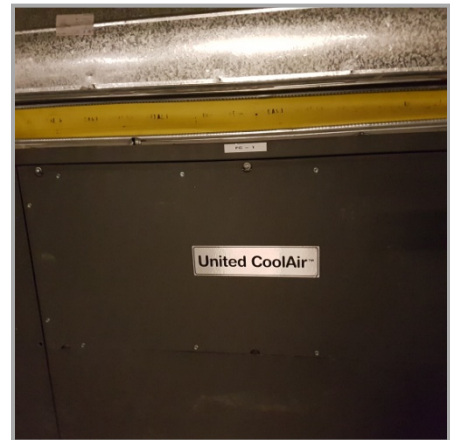
<b>Location:</b>	Parkade
<b>Year Installed:</b>	2012
<b>Typical Service Life (yrs):</b>	20
<b>Effective Age (yrs):</b>	4
<b>Remaining Service Life (yrs):</b>	16
<b>Planned Renewal Date:</b>	2032

**Description:** This item includes the United CoolAir unit and associated components.

**Comments:** An allowance has been included for the replacement of this item. Proper maintenance can help to extend the serviceable life of this item.

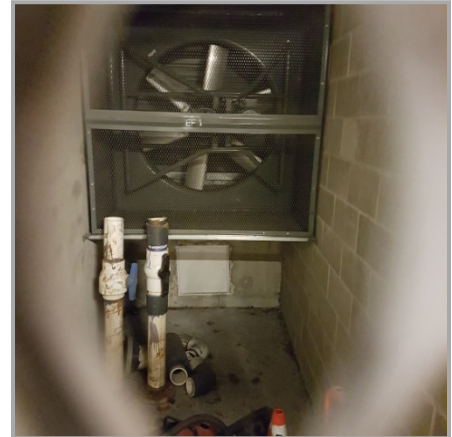
<b>Location:</b>	Throughout parkade
<b>Year Installed:</b>	2012
<b>Typical Service Life (yrs):</b>	15
<b>Effective Age (yrs):</b>	4
<b>Remaining Service Life (yrs):</b>	11
<b>Planned Renewal Date:</b>	2027

**Description:** This item includes the parkade exhaust fans located throughout the parkade.

**Comments:** An allowance has been included for the replacement of this item. Proper maintenance can help to extend the serviceable life of this item.

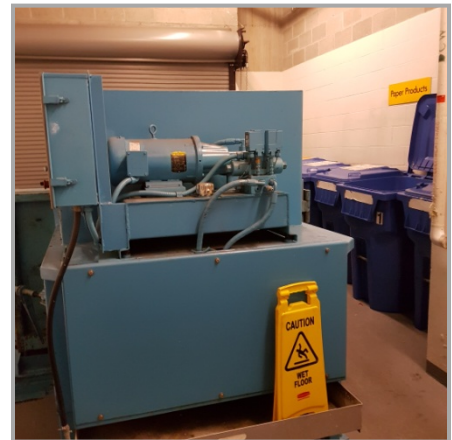
<b>Location:</b>	Garbage and recycling room
<b>Year Installed:</b>	2012
<b>Typical Service Life (yrs):</b>	15
<b>Effective Age (yrs):</b>	4
<b>Remaining Service Life (yrs):</b>	11
<b>Planned Renewal Date:</b>	2027

**Description:** This item includes the trash compactor in the garbage and recycling room.

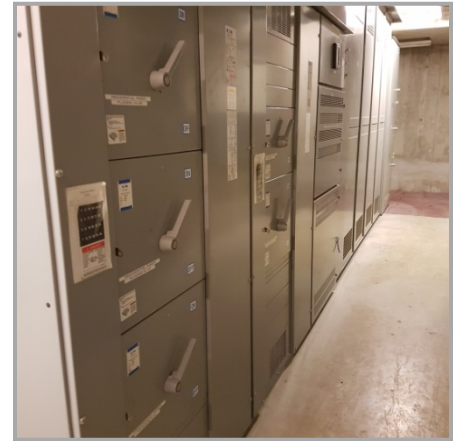
### Service Distribution

<b>Location:</b>	Building interior/ main electrical room
<b>Year Installed:</b>	2012
<b>Typical Service Life (yrs):</b>	50
<b>Effective Age (yrs):</b>	4
<b>Remaining Service Life (yrs):</b>	46
<b>Planned Renewal Date:</b>	2062

**Description:** This item includes various transformers, distribution disconnects, and transfer switches.

**Comments:** Dirt and dust can hasten deterioration and should be kept away from these components. An allowance has been included for scanning and cleaning of service distribution components every three years.

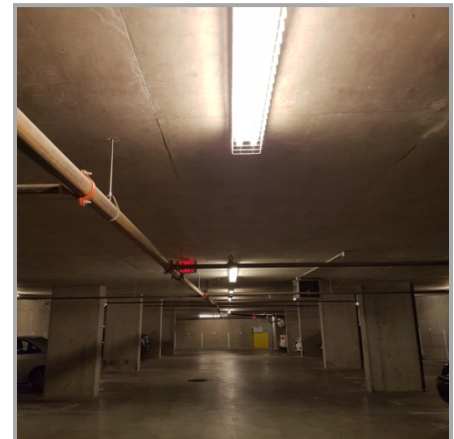
### Power Distribution

<b>Location:</b>	Building Interiors
<b>Year Installed:</b>	2012
<b>Typical Service Life (yrs):</b>	40
<b>Effective Age (yrs):</b>	4
<b>Remaining Service Life (yrs):</b>	36
<b>Planned Renewal Date:</b>	2052

**Description:** This item includes interior wiring, parkade fixtures, and hallway and common area lighting.

**Condition:** The wiring was not reviewed; however, JRS assumes it is in reasonable condition due to its age, and there were no reported issues with it.

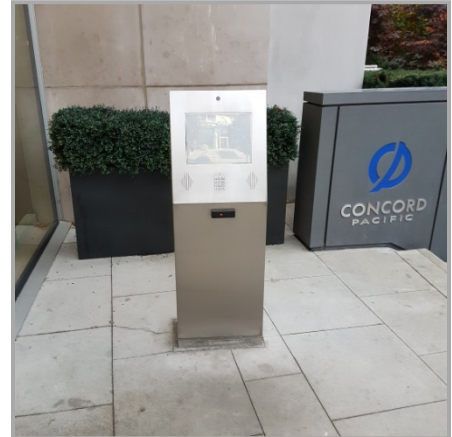
## Enterphone System

<b>Location:</b>	Front entrance and parkade
<b>Year Installed:</b>	2012
<b>Typical Service Life (yrs):</b>	30
<b>Effective Age (yrs):</b>	4
<b>Remaining Service Life (yrs):</b>	26
<b>Planned Renewal Date:</b>	2042

**Description:** This item includes the three enterphone systems.

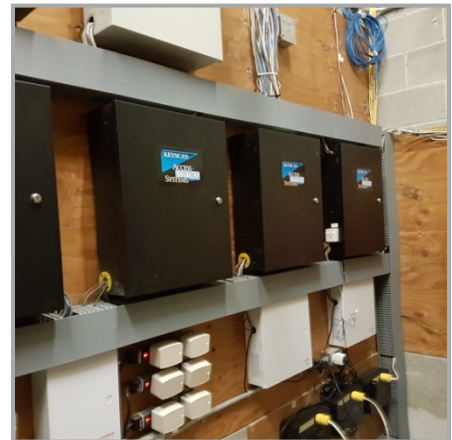
## Security Access System and Cameras

<b>Location:</b>	Building interiors
<b>Year Installed:</b>	2012
<b>Typical Service Life (yrs):</b>	30
<b>Effective Age (yrs):</b>	4
<b>Remaining Service Life (yrs):</b>	26
<b>Planned Renewal Date:</b>	2042

**Description:** This item includes the security system and FOB access.

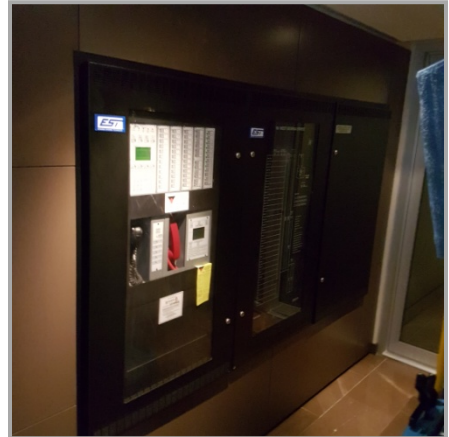
<b>Location:</b>	Lobby/building interiors
<b>Year Installed:</b>	2012
<b>Typical Service Life (yrs):</b>	20
<b>Effective Age (yrs):</b>	4
<b>Remaining Service Life (yrs):</b>	16
<b>Planned Renewal Date:</b>	2032

**Description:** This item includes the fire alarm panel and emergency lighting.

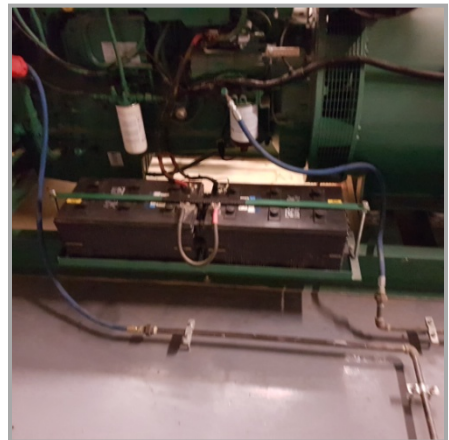
<b>Location:</b>	Emergency generator room (P1)
<b>Year Installed:</b>	2012
<b>Typical Service Life (yrs):</b>	50
<b>Effective Age (yrs):</b>	4
<b>Remaining Service Life (yrs):</b>	46
<b>Planned Renewal Date:</b>	2062

**Description:** This item includes the emergency generator located in the parkade

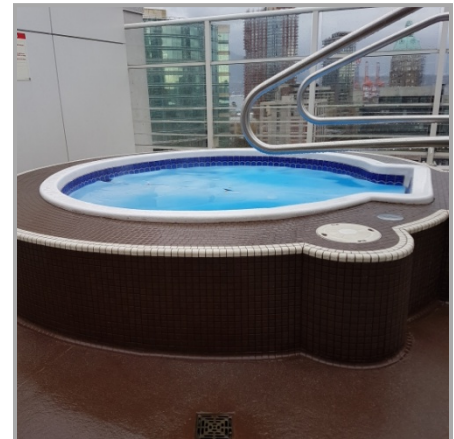
**47****Hot Tub Area**

<b>Location:</b>	Level 15 Roof
<b>Year Installed:</b>	2012
<b>Typical Service Life (yrs):</b>	15
<b>Effective Age (yrs):</b>	4
<b>Remaining Service Life (yrs):</b>	11
<b>Planned Renewal Date:</b>	2027

**Description:** This item includes the hot tub and associated components at the level 15 roof.

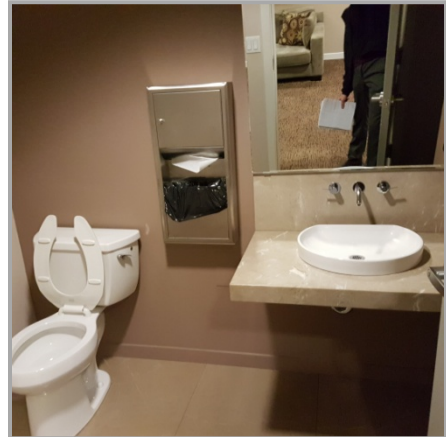
<b>Location:</b>	Building interiors
<b>Year Installed:</b>	2012
<b>Typical Service Life (yrs):</b>	25
<b>Effective Age (yrs):</b>	4
<b>Remaining Service Life (yrs):</b>	21
<b>Planned Renewal Date:</b>	2037

**Description:** This item includes four washrooms, complete with toilet and sink.

**Condition:** This asset appears to be in reasonable condition.

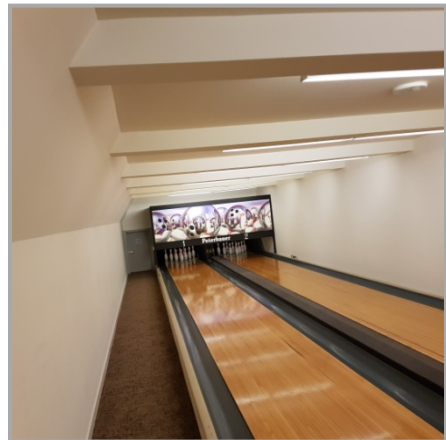
<b>Location:</b>	Level P1
<b>Year Installed:</b>	2012
<b>Typical Service Life (yrs):</b>	20
<b>Effective Age (yrs):</b>	4
<b>Remaining Service Life (yrs):</b>	16
<b>Planned Renewal Date:</b>	2032

**Description:** This item includes the bowling alley lanes, pinsetter, balls, shoes, and wall, ceiling and flooring finishes.

**Condition:** This asset appears to be in reasonable condition.

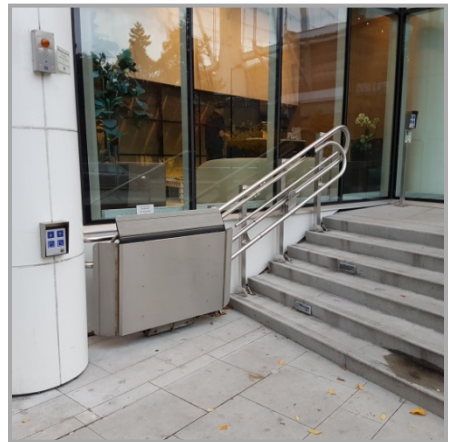
## Accessibility Lifts

<b>Location:</b>	Front entrance and level 15 roof
<b>Year Installed:</b>	2012
<b>Typical Service Life (yrs):</b>	20
<b>Effective Age (yrs):</b>	4
<b>Remaining Service Life (yrs):</b>	16
<b>Planned Renewal Date:</b>	2032

**Description:** This item includes two accessibility lifts at the main entrances and hot tub area.

**Condition:** This asset appears to be in reasonable condition.

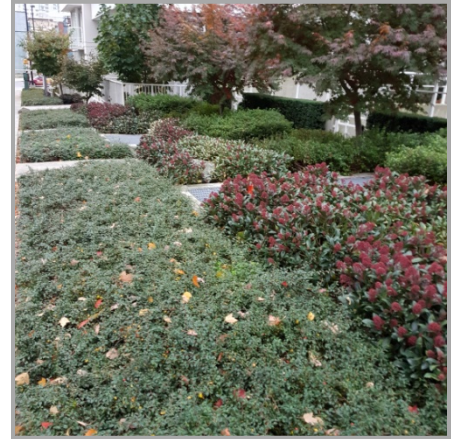
### Softscaping

<b>Location:</b>	Site grounds and planters
<b>Year Installed:</b>	2012
<b>Typical Service Life (yrs):</b>	50
<b>Effective Age (yrs):</b>	4
<b>Remaining Service Life (yrs):</b>	46
<b>Planned Renewal Date:</b>	2062

**Description:** This item includes the vegetation at ground floor and planters on the level 15 roof deck.

**Condition:** This asset appears to be in reasonable condition.

**Comments:** This reserve cost is based on the overall complexity of vegetation, frequency of trees and total area. Allowances have been made for targeted repairs and periodic removal of trees.

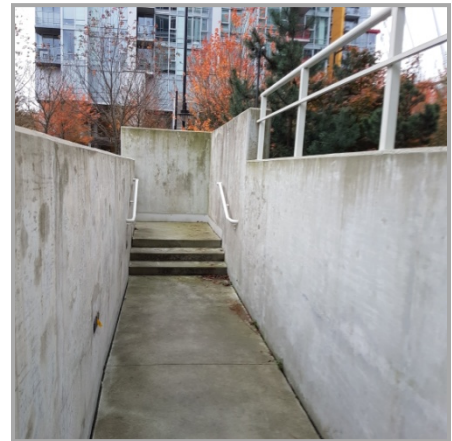
### Hardscaping

<b>Location:</b>	Site grounds
<b>Year Installed:</b>	2012
<b>Typical Service Life (yrs):</b>	50
<b>Effective Age (yrs):</b>	4
<b>Remaining Service Life (yrs):</b>	46
<b>Planned Renewal Date:</b>	2062

**Description:** This item includes the concrete curbs, walls and walkways at the exterior of the building.

**Condition:** This asset appears to be in reasonable condition.

**Comments:** The cost of this component is based on overall complexity and size. Hardscaping is generally considered to last the life of the property and may only see partial renewals. An allowance has been included for targeted repairs.

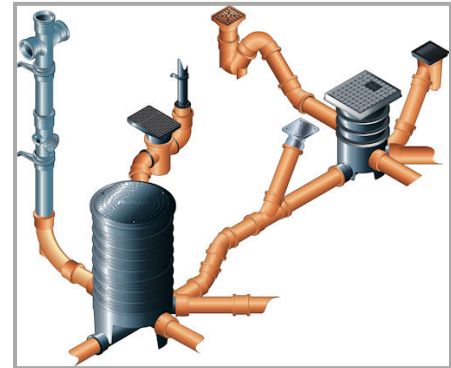
<b>Location:</b>	Below-grade
<b>Year Installed:</b>	2012
<b>Typical Service Life (yrs):</b>	50
<b>Effective Age (yrs):</b>	4
<b>Remaining Service Life (yrs):</b>	46
<b>Planned Renewal Date:</b>	2062

**Description:** This item includes the below grade water supply, sanitary sewer, and perimeter drains.

**Condition:** This asset appears to be in reasonable condition.

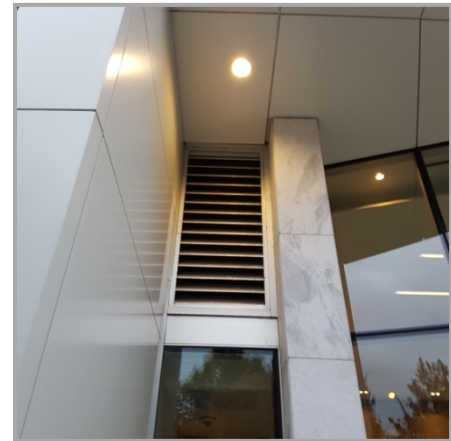
<b>Location:</b>	Side grounds and balconies
<b>Year Installed:</b>	2012
<b>Typical Service Life (yrs):</b>	40
<b>Effective Age (yrs):</b>	4
<b>Remaining Service Life (yrs):</b>	36
<b>Planned Renewal Date:</b>	2052

**Description:** This item includes the exterior lighting fixtures and outlets at the building exterior and site grounds.

**Condition:** This asset appears to be in reasonable condition.

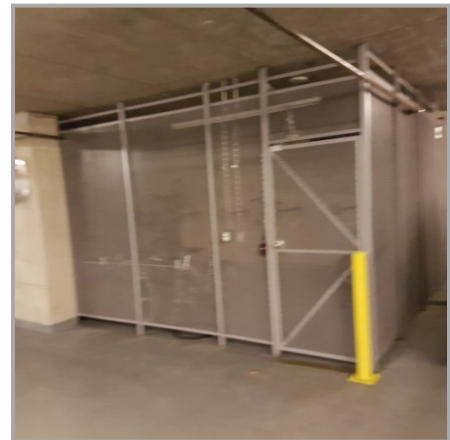
<b>Location:</b>	Building/parkade interiors
<b>Year Installed:</b>	2012
<b>Typical Service Life (yrs):</b>	30
<b>Effective Age (yrs):</b>	4
<b>Remaining Service Life (yrs):</b>	26
<b>Planned Renewal Date:</b>	2042

**Description:** This item includes the metal mesh fencing at parkade fans, bicycle storage areas, and common storage areas.

**Condition:** This asset appears to be in reasonable condition.

**Comments:** This item is typically robust. An allowance has been included for targeted repairs.

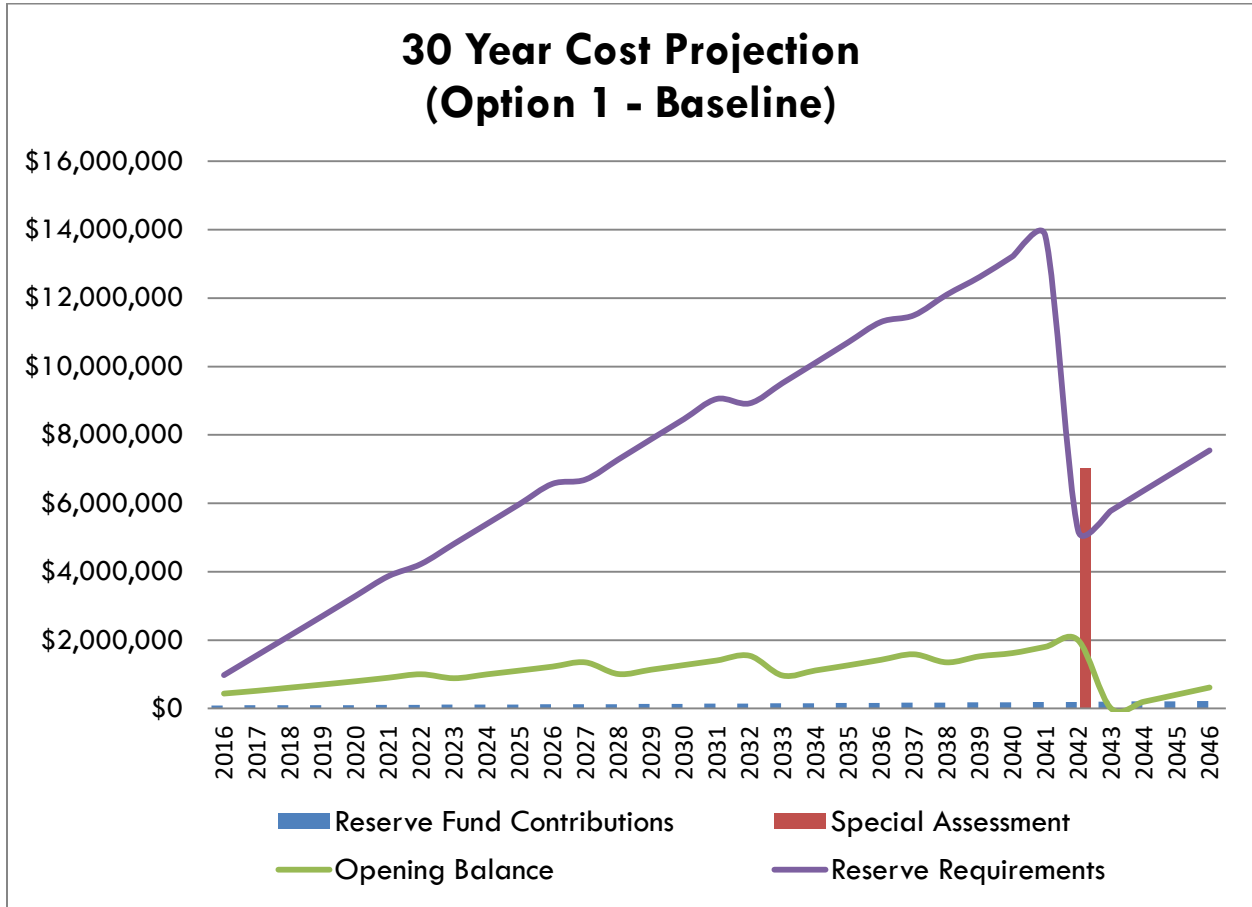
### OPTION 1 (BASELINE)

This model shows annual contributions (increasing with inflation) consistent with status quo (current contributions) or the statutory requirement of 10% of operating budget, whichever is higher. In this case the former. As seen below, multiple special levies will be required. From 2016 to 2046 (the end of the 30-year outlook), special levies will theoretically be required in 1 out of 30 years.

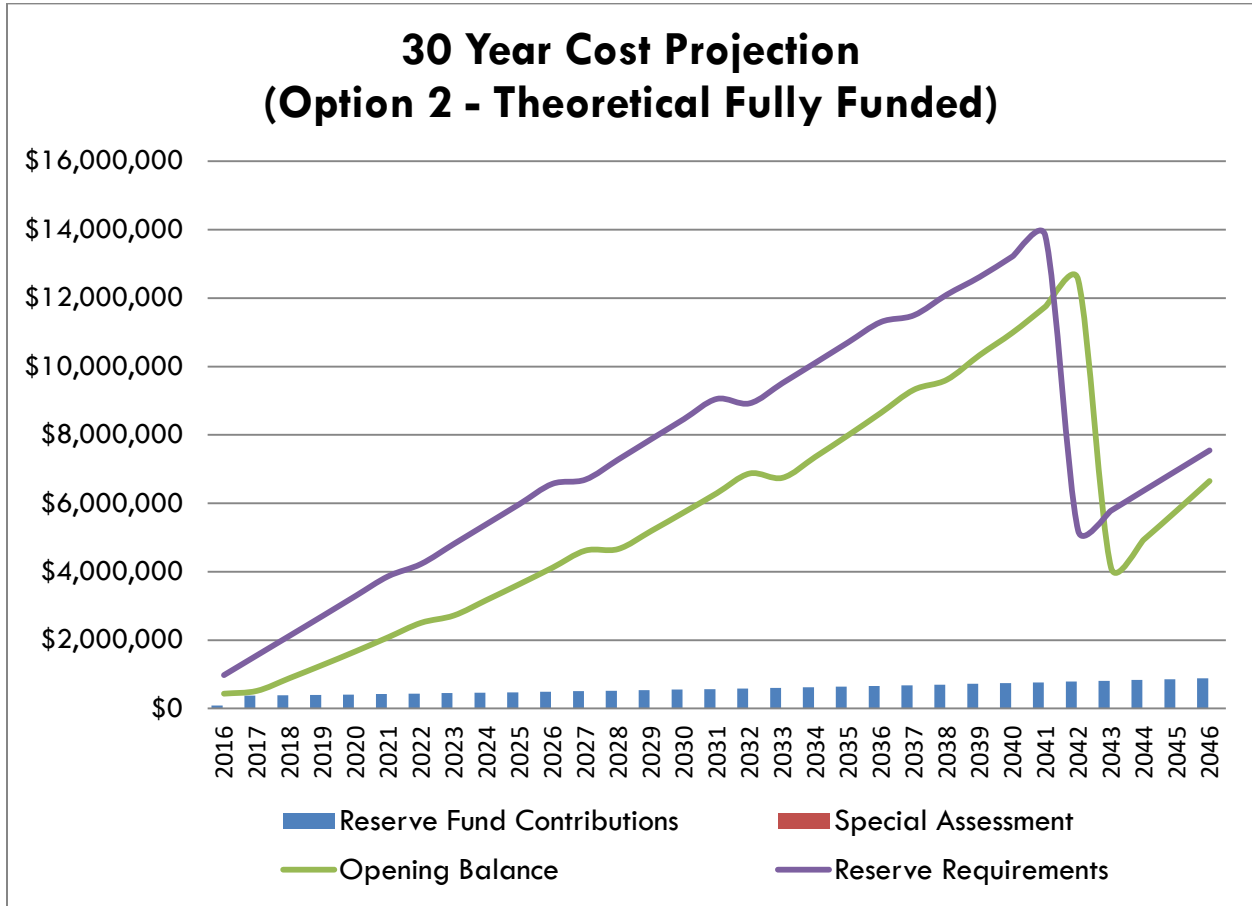
## OPTION 2 (THEORETICAL FULLY FUNDED)

This model shows annual contributions (increasing with inflation) that would allow for a sufficient and fully funded CRF that should theoretically not require special levies during the 30-year outlook. This contribution level is immediate and based on the objective of achieving a positive value in the accumulated CRF balance after 30 years.

Fully funded contributions are usually much higher than the amount the Owners are actually contributing to the CRF. Therefore, it is usually impractical and difficult to achieve this immediately.

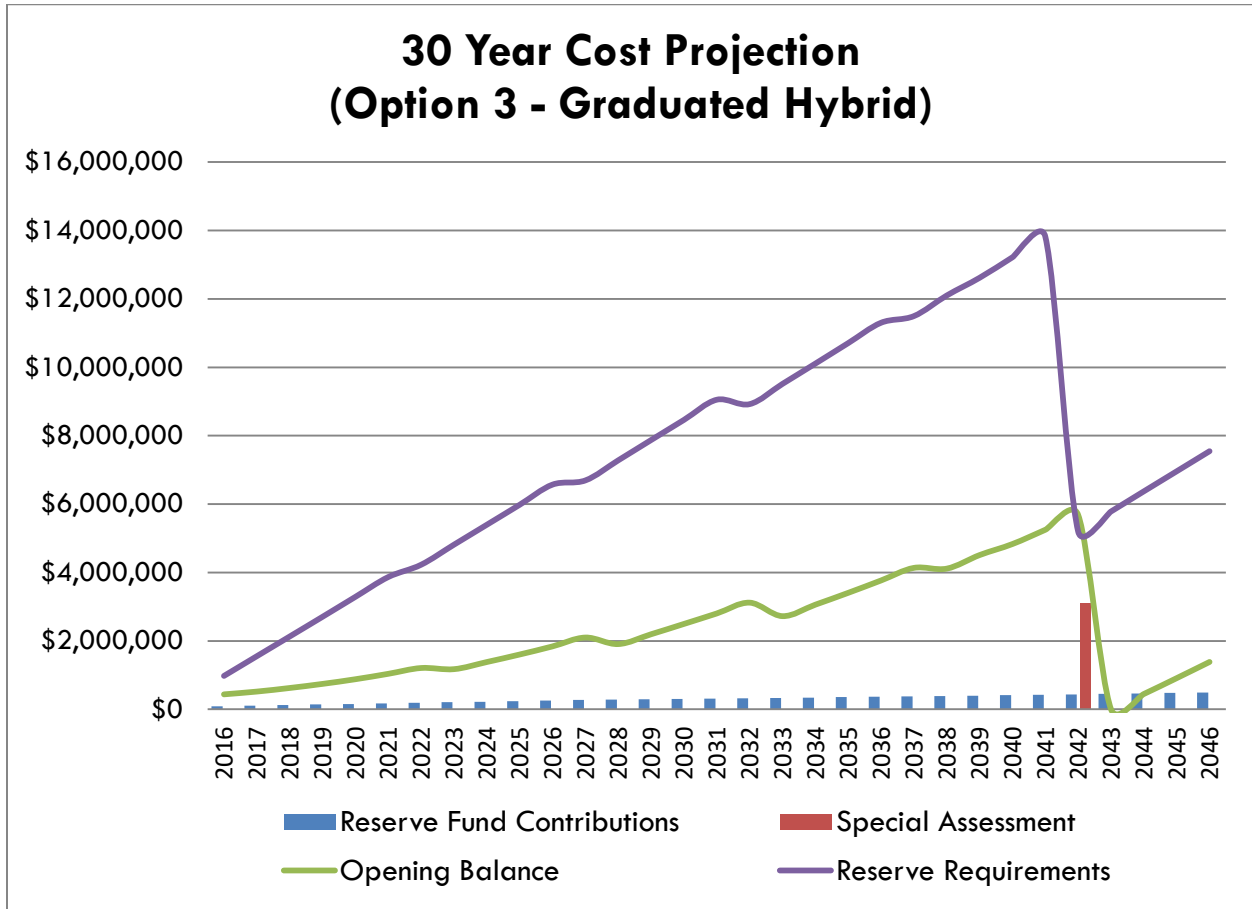
### OPTION 3 (GRADUATED HYBRID)

This model shows annual contributions that increase for twelve years until 2028. These increases can be revised during the 3 year updates based on a number of factors: actual CRF contributions, recent upgrades, anticipated short term expenditures, as well as current interest and inflation factors. This model generally indicates that eventually (12 years) the CRF contribution level achieves 50% of the fully funded contribution level (\$288,424) and is likely the most prudent option that the general Ownership would be willing to accept. The owners can ultimately revise the percent of annual increases and time it takes to get to this value.
