**Re:** Tribeca Lofts – 988 Richards St., Vancouver  
2013 Final Depreciation Report

## 2013 DEPRECIATION REPORT FOR

**Tribeca Lofts**  
988 Richards Street  
Vancouver, BC

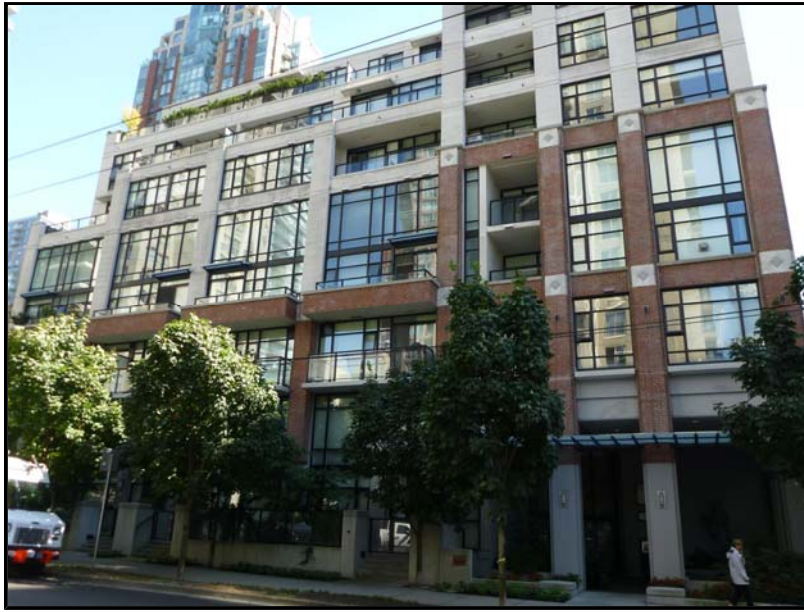
Photo No. 1: West elevation

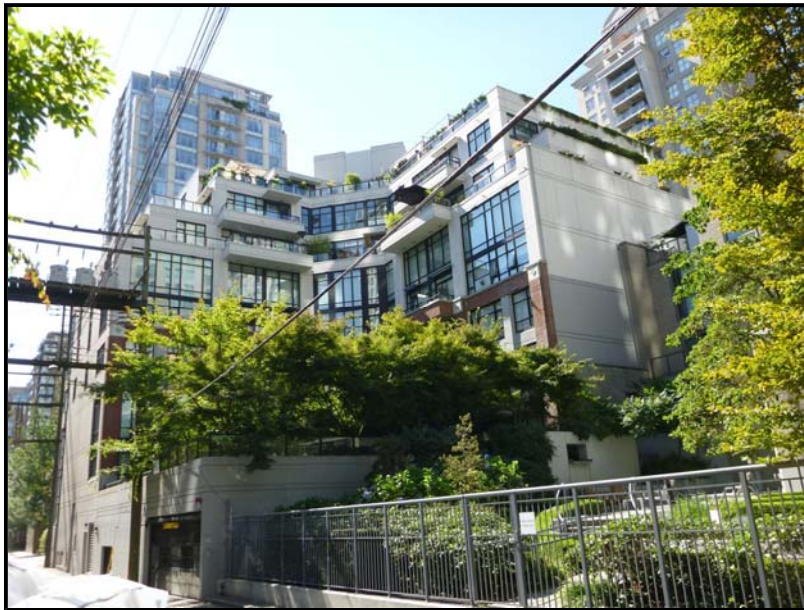
Photo No. 2: North and east elevations and courtyard

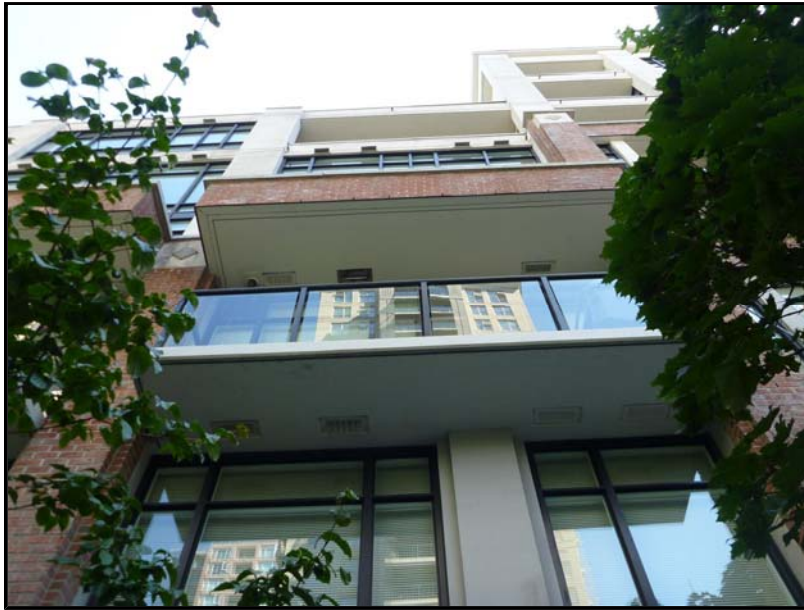
Photo No. 3: Balconies

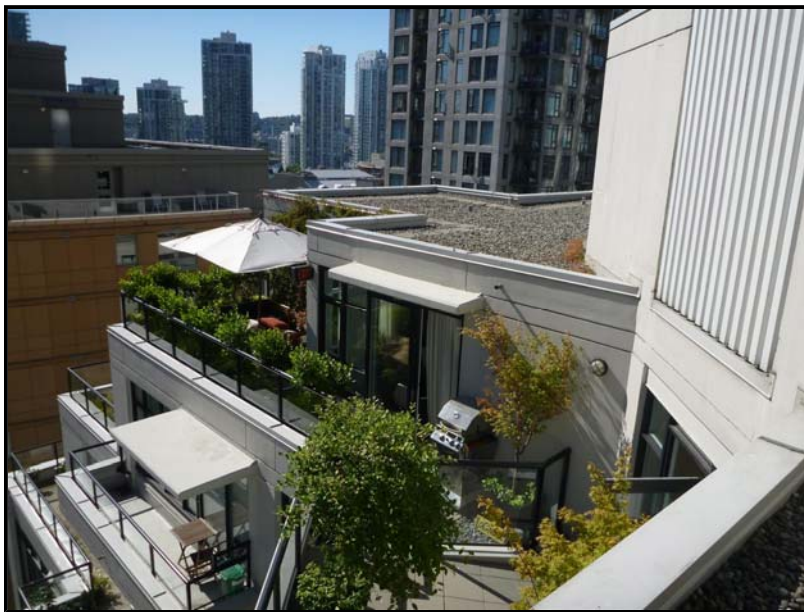
Photo No. 4: Typical terraces and main roof

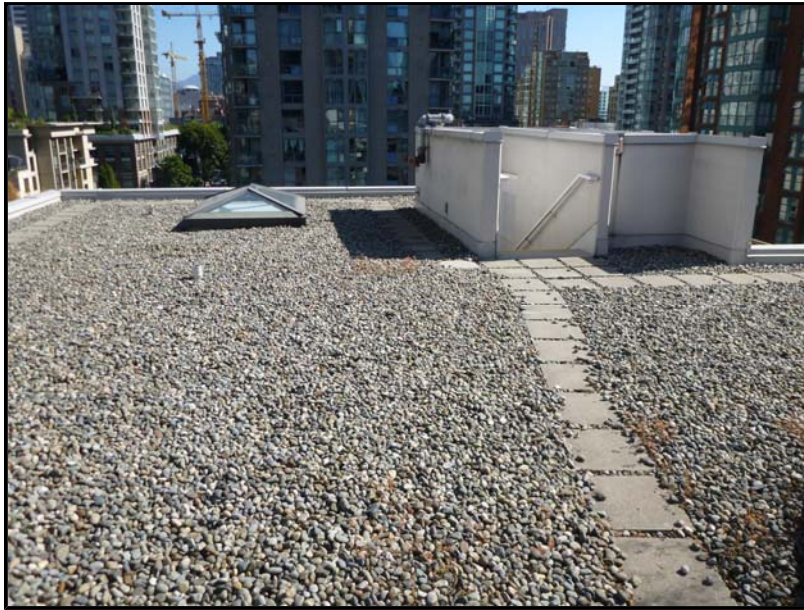
Photo No. 5: Main roof and skylight

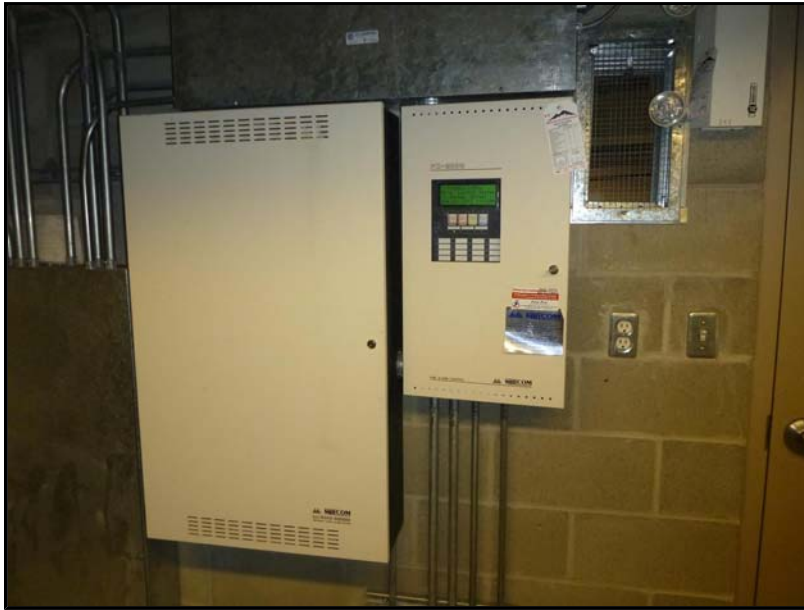
Photo No. 9: Fire alarm panel

3.1.1	Replace Fire Alarm Panel	3	Forecasted	\$44,100	2026	20															\$57,048	
3.1.2	Replace Fire Alarm System Wiring and Devices	3	Forecasted	\$146,081	2046	40

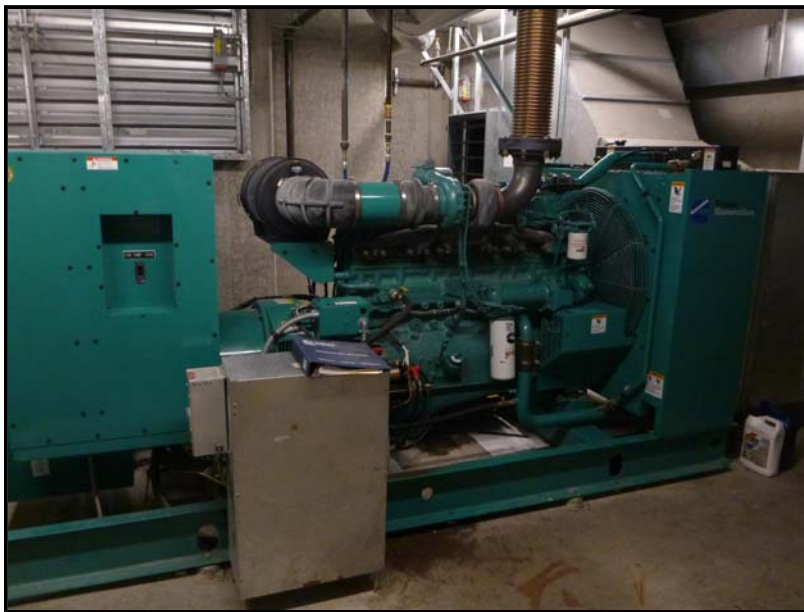
Photo No. 10: Generator

3.3.1	Generator - Major Repairs	3	Forecasted	\$12,600	2031	35																
3.3.2	Replace Generator Fuel Storage Tank	3	Forecasted	\$15,750	2037	25

3.3.3	Replace Generator and Transfer Switch	3	Forecasted	\$225,225	2042	35																
<b>4 FINISHES, FURNITURE AND EQUIPMENT</b>

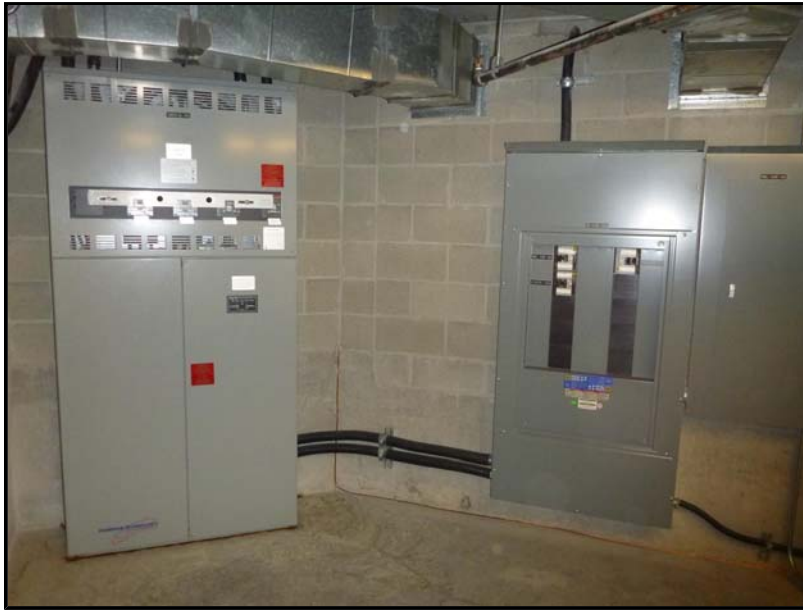
Photo No. 11: Automatic transfer switch and emergency distribution panels

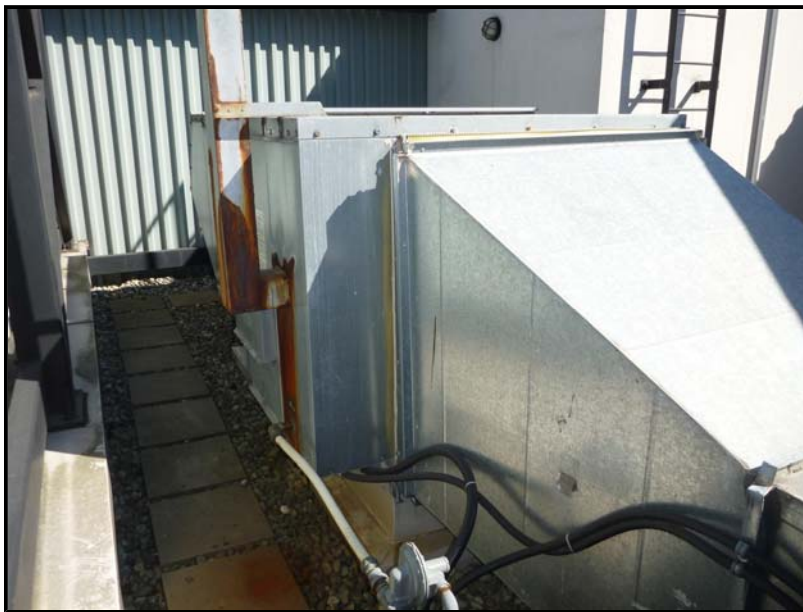
Photo No. 14: Make-up air unit

6.1.1	Replace Garage CO Detection System	3	Forecasted	\$17,640	2026	20																\$22,819	
6.1.2	Replace Make-up Air Unit	3	Forecasted	\$69,300	2031	25

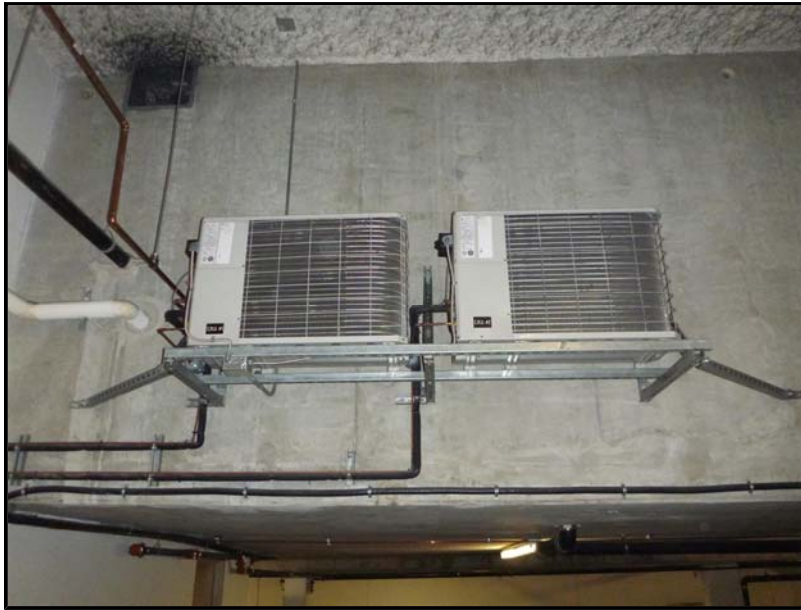
Photo No. 15: Air conditioning unit condensers

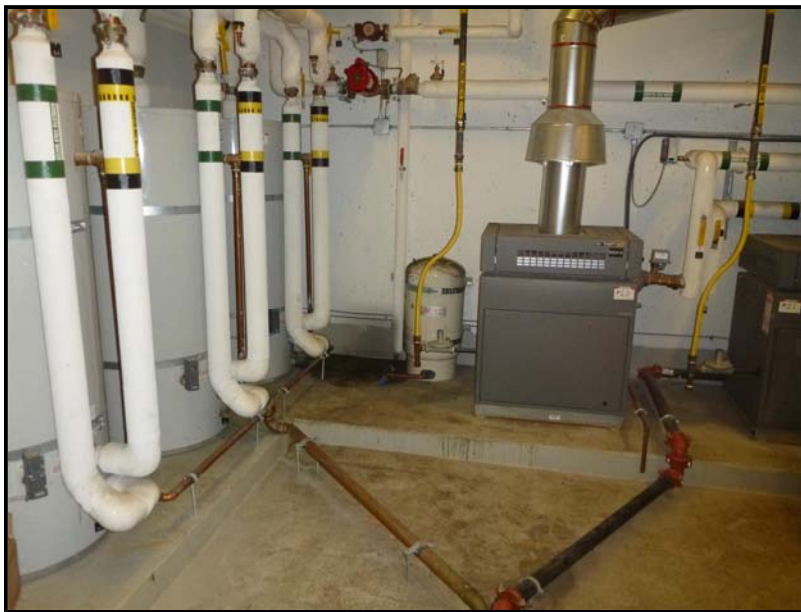
Photo No. 16: Domestic hot water boilers and storage tanks

7.1.1	Overhaul Domestic Water Boilers	3	Forecasted	\$15,000	2018	20							\$16,561										
7.1.2	Replace Domestic Hot Water Storage Tank(s)	3	Forecasted	\$14,175	2021	15										\$16,608

7.1.3	Replace Domestic Water Boilers	3	Forecasted	\$73,080	2026	20																\$94,537	
7.2.1	Install Back-flow Preventer (domestic line)	3	Forecasted	\$8,400	2016	25					\$8,914

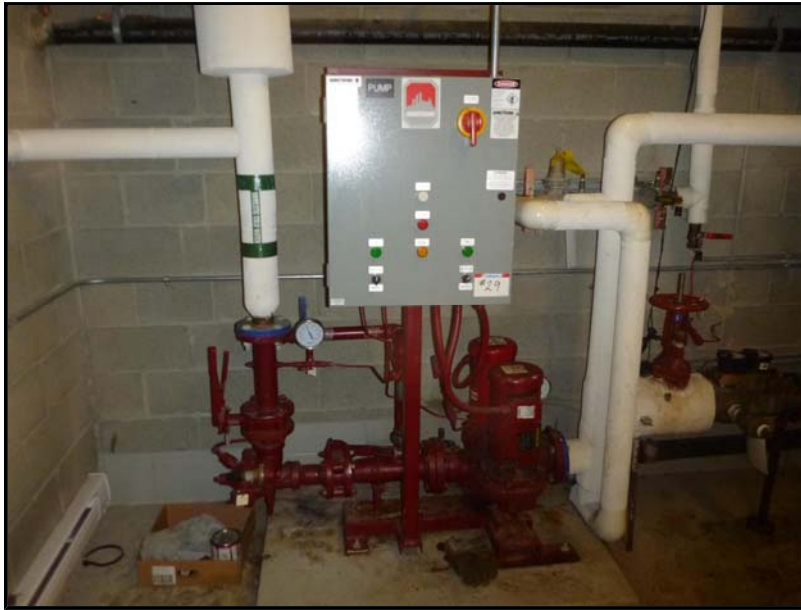
Photo No. 17: Booster pumps

7.2.4	Replace Hot and Cold Supply Piping and Valves	3	Forecasted	\$213,906	2035	30																	
7.2.5	Replace Booster Pumps	3	Forecasted	\$21,000	2031	25																	
<b>8</b>	<b>ELECTRICAL</b>

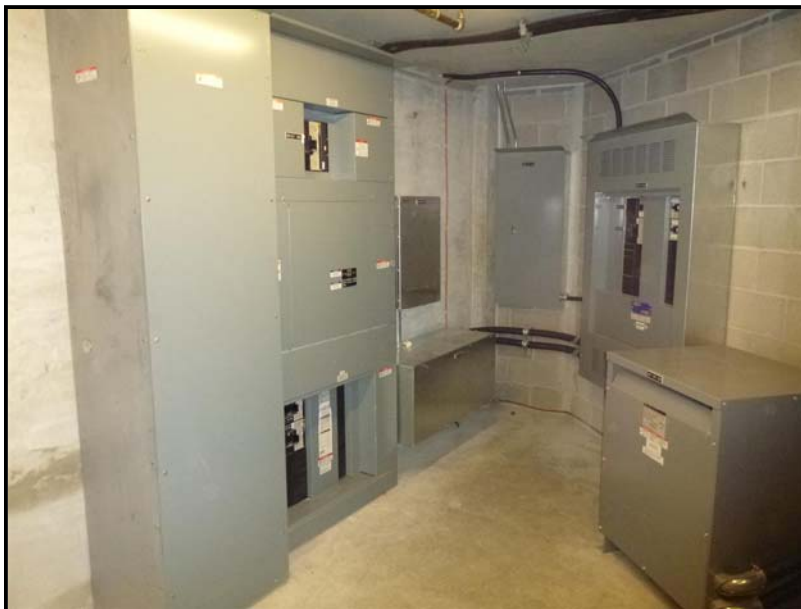
Photo No. 18: Main electrical equipment

8.1.1	Replace Main Switchgear	3	Forecasted	\$96,752	2046	40																	
8.1.2	Replace Transformers	3	Forecasted	\$46,200	2046	40																	
8.2.1	Replace Exterior Lighting	3	Forecasted	\$15,160	2031	25

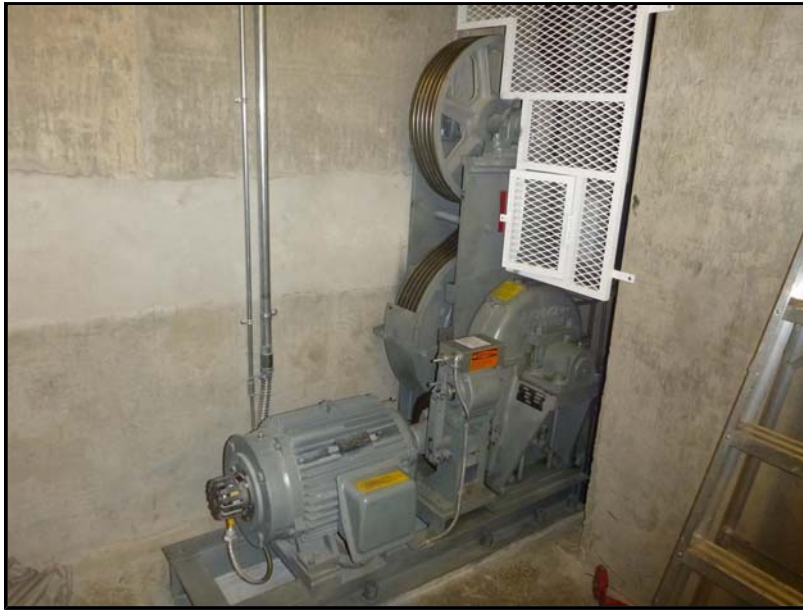
Photo No. 19: Elevator machine

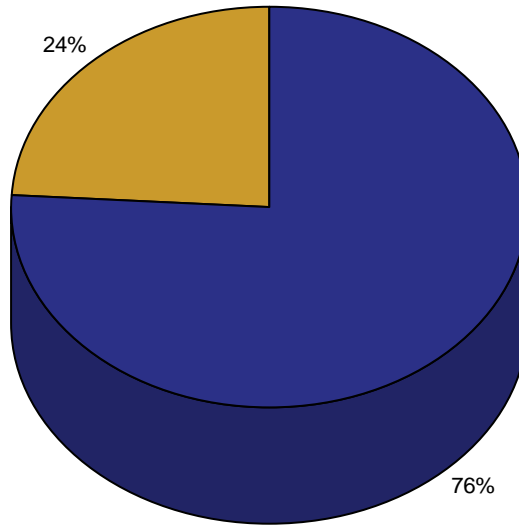
## 2017 - Total Annual Expenditures by System

Projects for 2017 listed by System		
<b>STRUCTURE</b>		
Parking Garage Condition Evaluation	Forecasted	\$8,524
<b>MISCELLANEOUS</b>		
Contingency for Small/Unexpected Repairs/Replacements	Forecasted	\$2,706
	<b>TOTAL:</b>	<b>\$11,230</b>

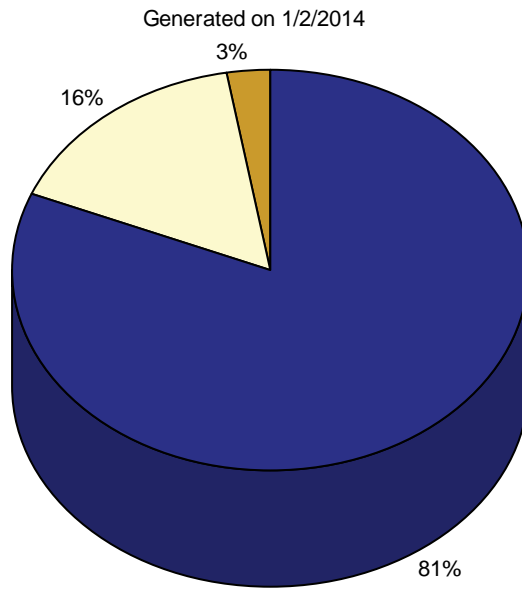
## 2018 - Total Annual Expenditures by System

Projects for 2018 listed by System		
<b>STRUCTURE</b>		
Repair Garage Slab Waterproofing	Forecasted	\$83,284
<b>PLUMBING</b>		
Overhaul Domestic Water Boilers	Forecasted	\$16,561
<b>MISCELLANEOUS</b>		
Contingency for Small/Unexpected Repairs/Replacements	Forecasted	\$2,760
	<b>TOTAL:</b>	<b>\$102,605</b>
